Inspection Report (Backhoe Loader)

Year	2001
Make	Case
Model	580 Super M
Serial Number	JJG0377074
Hour Meter Reading	3452
Previous Application (e.g., earth moving, mining, demolition, etc)	Demo and general construction

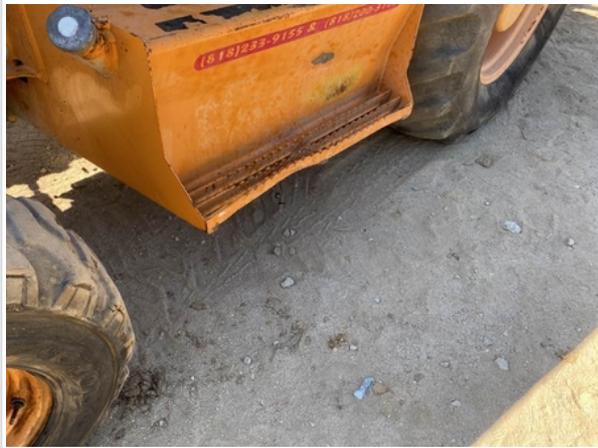
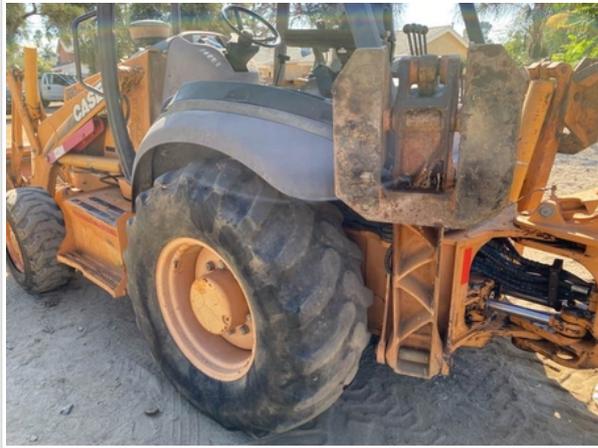
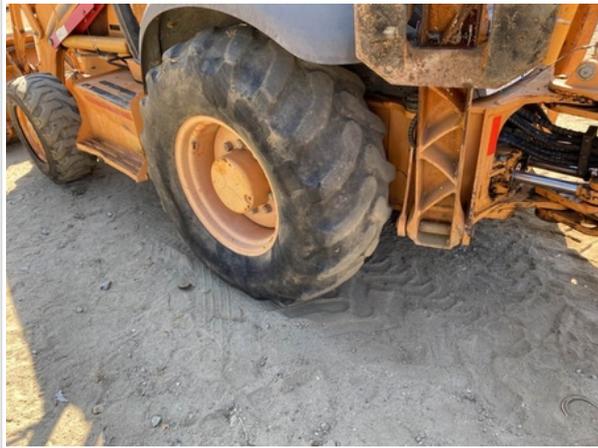
Left	3 - Normal Wear & Tear	
Left Condition	Visible chipped paint or dents, Other (see comments)	
Comments	Lest side step bent, rest of left side looks good	
Left Photos

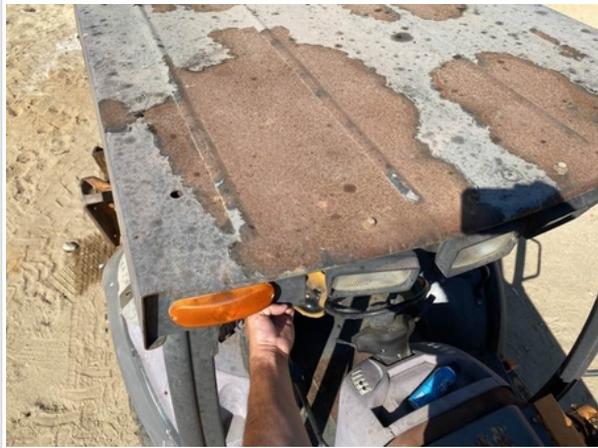
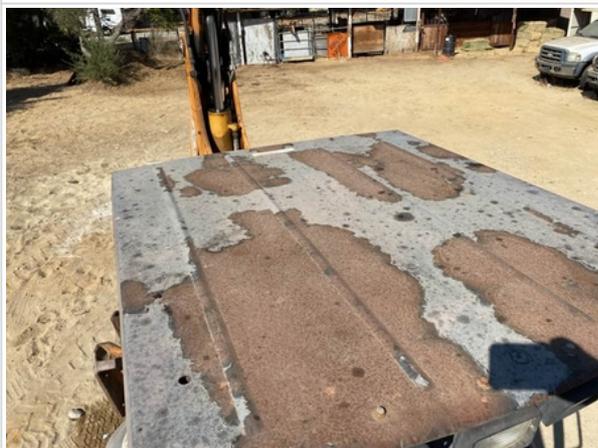
Upper	3 - Normal Wear & Tear	
Upper Condition	Areas of surface rust observed, Other (see comments)	
Comments	Normal wear and tear	
Upper Photos

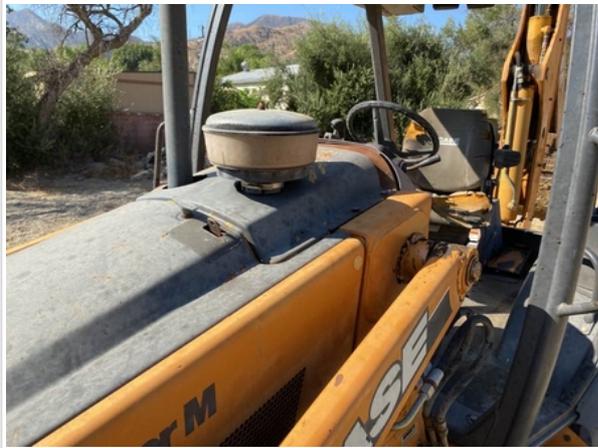
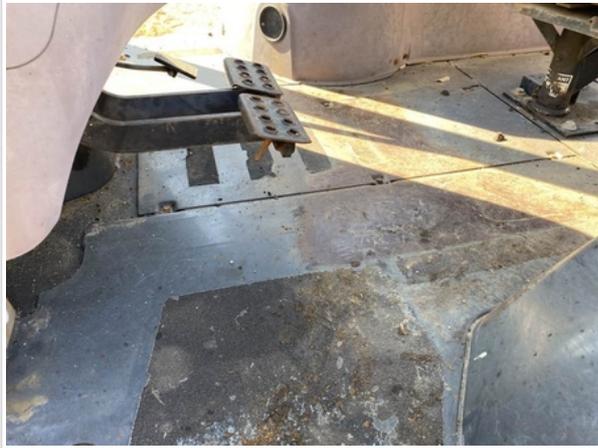
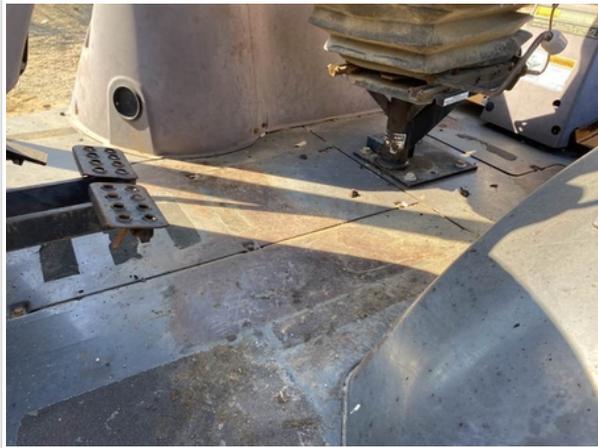
Body Panels (Any Rust Damage?)	3 - Normal Wear & Tear	
Body Panel Condition	Other (see comments)	
Comments	Front grill only panel damaged	
Body Panels Photos

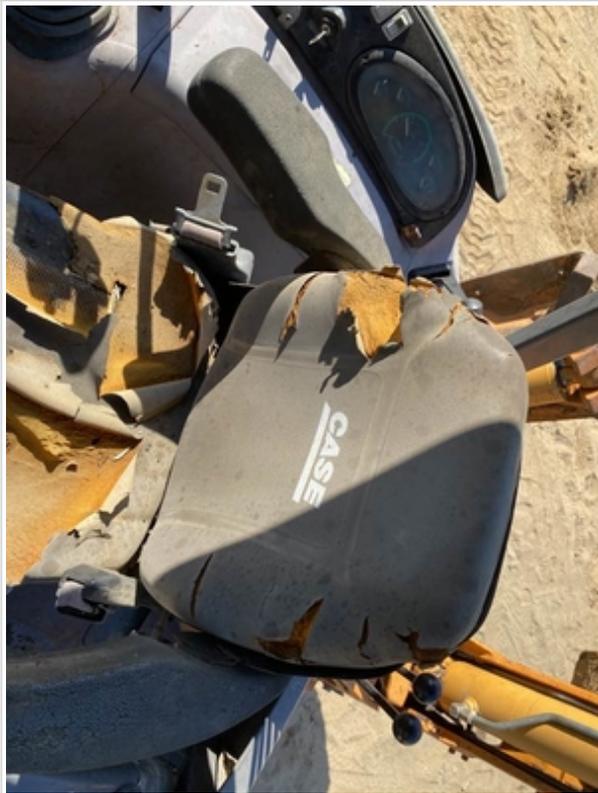
Operator's Seat & Arm Rests	1 - Service Required
Operator's Seat & Arm Rests Condition	Seat(s) is damaged due to sun exposure; fading, cracking observed, Seat(s) has major surface staining or tears
Operator's Seat & Arm Rests Photos

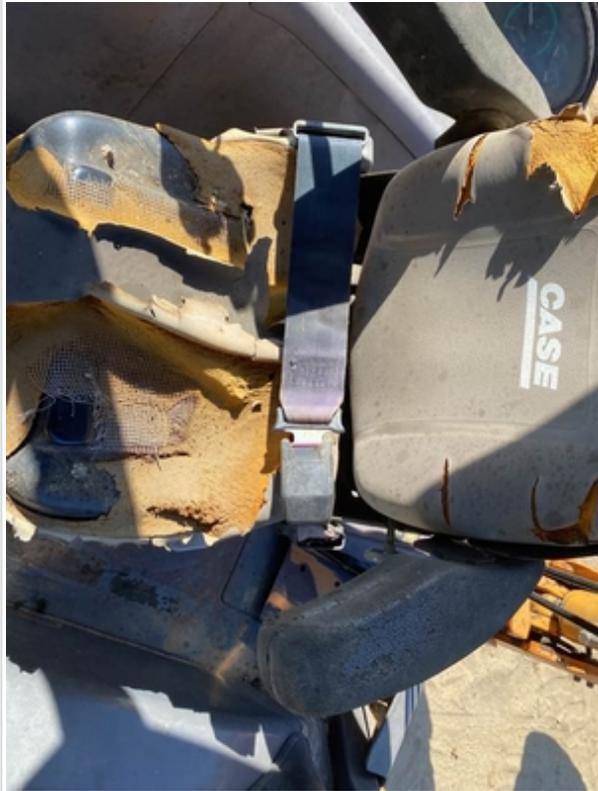
Seat Belt	2 - Above Average Wear	
Seat Belt Condition	Seat belt shows limited functionality or does not secure properly	
Comments	Rusty lock mechanism

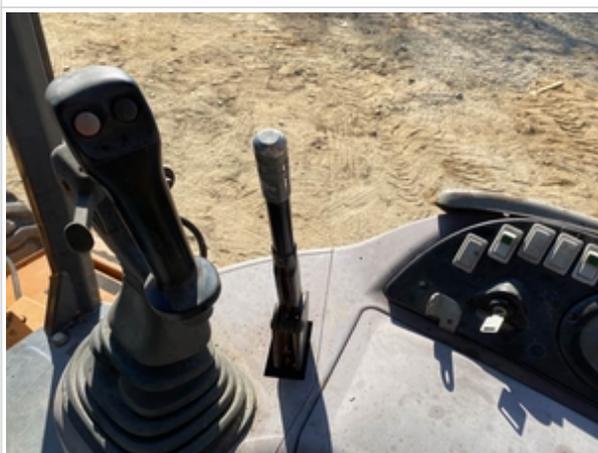
Inching Brake	0
Parking Brake	1 - Service Required
Parking Brake Condition	Poor performance; brake won't hold
Comments	May just need an adjustment
Parking Brake Photos

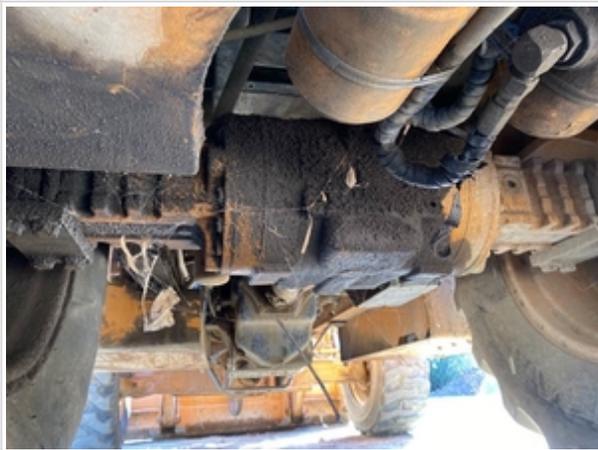
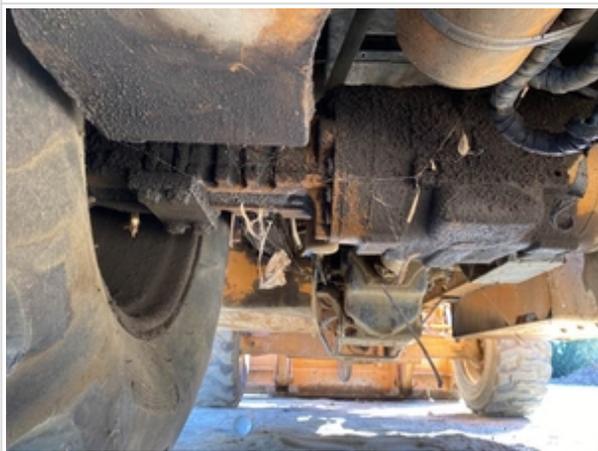
Rear Axle Appearance	3 - Normal Wear & Tear	
Comments	Possible leak coming from top and or around rear axle	
Rear Axle Appearance Photos

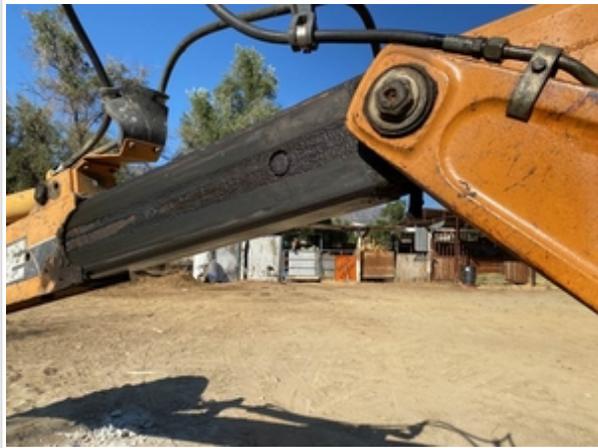
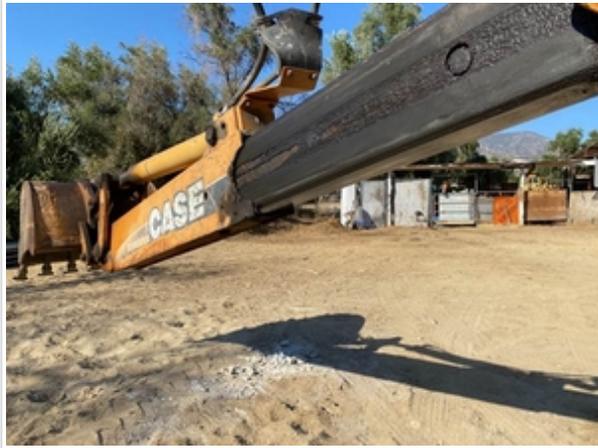
Boom Lock	2 - Above Average Wear
Comments	Boom lock will not go into place with ease
Boom Lock Photos

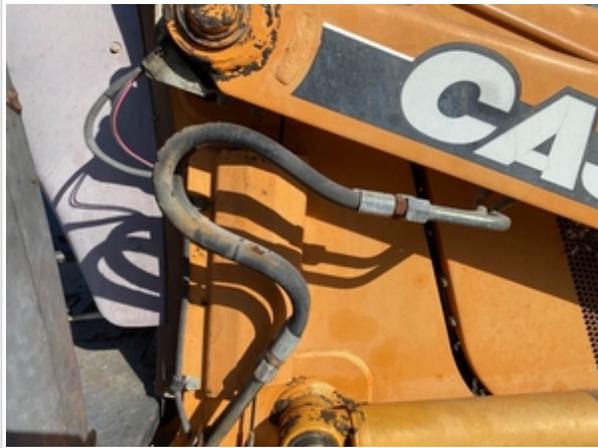
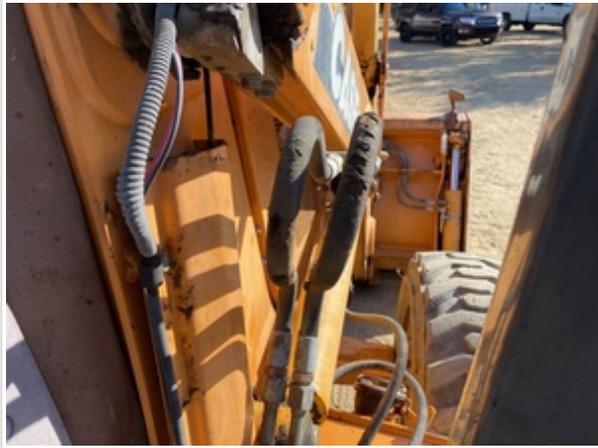
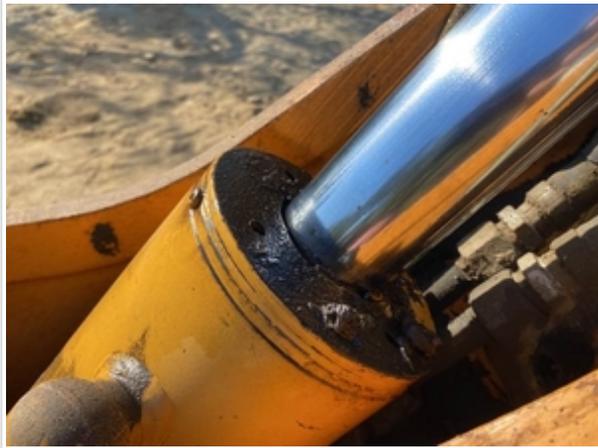
Wet or Damp Hydraulic Lines / Fittings	Yes
Appearance of Hydraulic Lines / Fittings	3
Hydraulic Lines / Fittings Condition	Active leaks in hoses or fittings observed, Cracking, stiff, or charred hydraulic hoses, Other (see comments)
Comments	2 hoses actively leaking, 1 at swing cylinders, 1 at steer cylinders, others hoses weather cracked, others need to be replaced soon

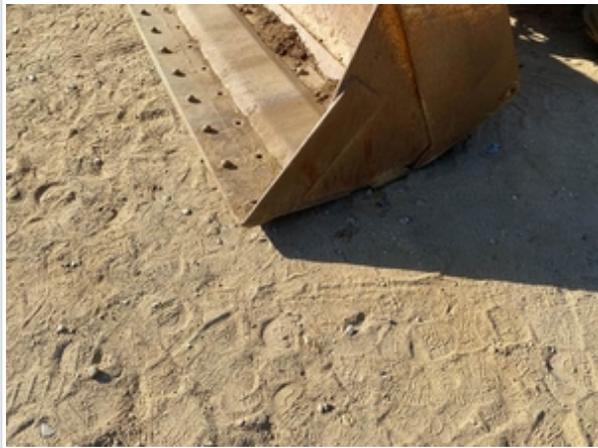
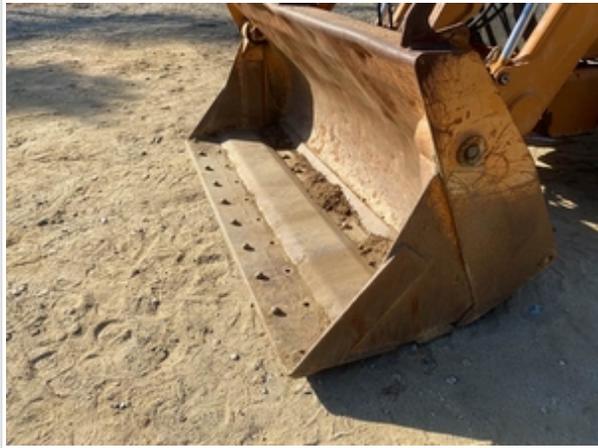
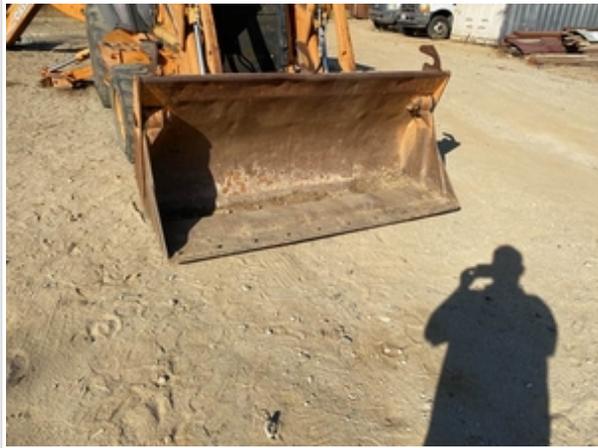
Instructions	Evaluate the following on a 4 point scale (leave comments where an explanation is appropriate): 4 = Like New, Recently Replaced 3 = Normal Wear & Tear 2 = Above Average Wear 1 = Service Required
Loader Bucket	3 - Normal Wear & Tear
Comments	Normal wear and tear

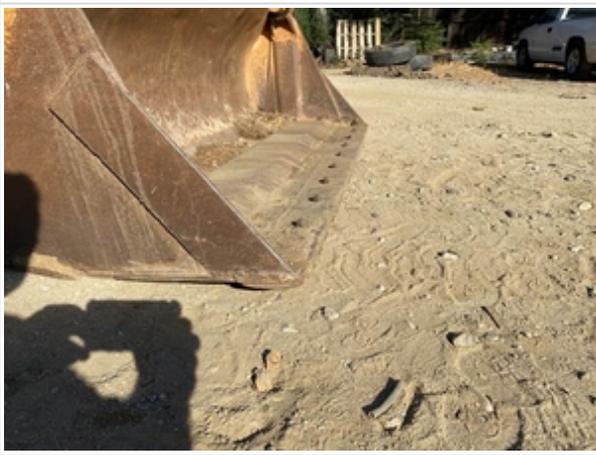
<p>Loader Bucket Edge / Deflectors</p>	<p>2 - Above Average Wear</p>
<p>Comments</p>	<p>Bucket cutting edge worn on both sides</p>

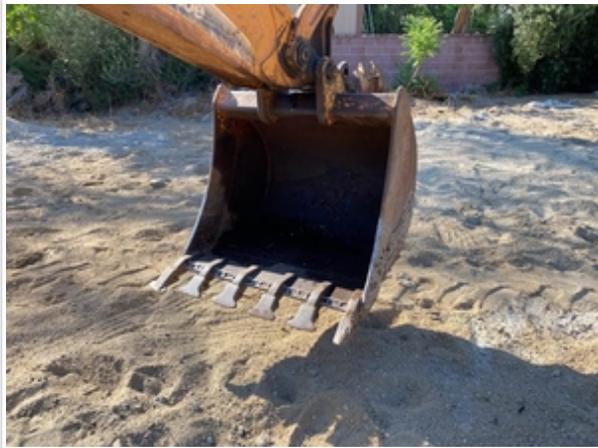
Backhoe Bucket Edge / Deflectors	3 - Normal Wear & Tear	
Comments	Bucket teeth worn and need to be replaced soon	
Backhoe Bucket Edge / Deflectors Photos
