Inspection Report (Wheel Loader)

Year	2010
Make	Kubota
Model	L39
Serial Number	12552 - 12434
Hour Meter Reading	2039.5
Previous Application (e.g., earth moving, mining, demolition, etc)	General Construction, Commercial Plumbing Contractor

Quality Rating	3
Functionality Rating	3
Overall Rating	3
What's Great About the Machine	This machine is well kept and has a great bundle of attachments like : 5' fork attachment : skip loader Gannon type attachment (for rear) : 6' front loader gp bucket for wet dirt or mixing concrete applications : hitch receiver style from center front bucket attachments and 6' extension for lifting objects into place
What Needs Work	A few rear hydraulic hoses for backhoe attachment need to be replaced. Service brakes need to be adjusted or repaired for a more firm brake application
Any Additional Info from the Seller?	Original owner of this machine
Inspector's Name	Mario Ramirez
Date/Time	08-25-2022

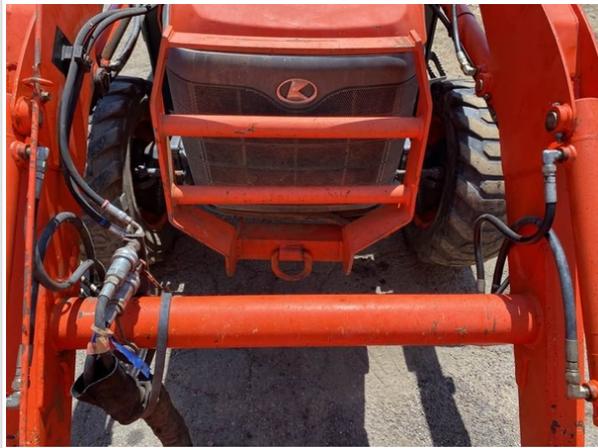
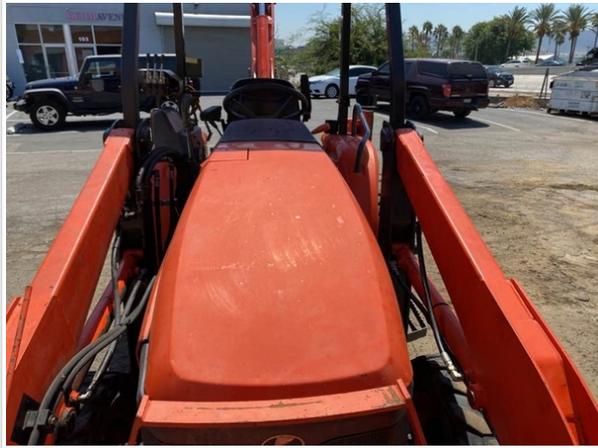
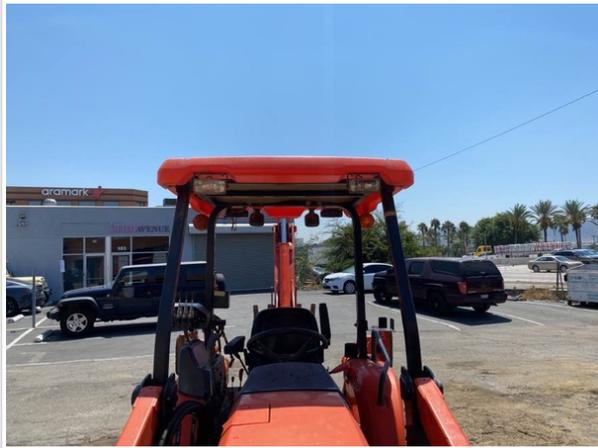
Front	3 - Normal Wear & Tear
Front Condition	No visible damage, Other (see comments)
Comments	Normal wear

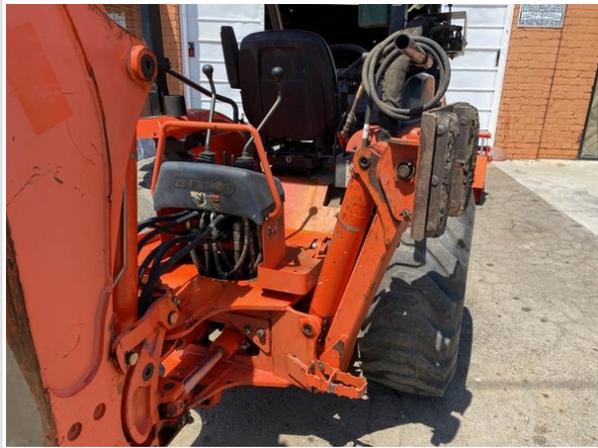
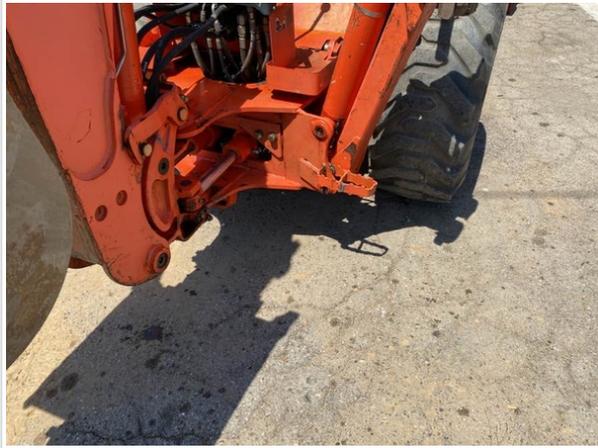
Rear	3 - Normal Wear & Tear
Rear Condition	No visible damage

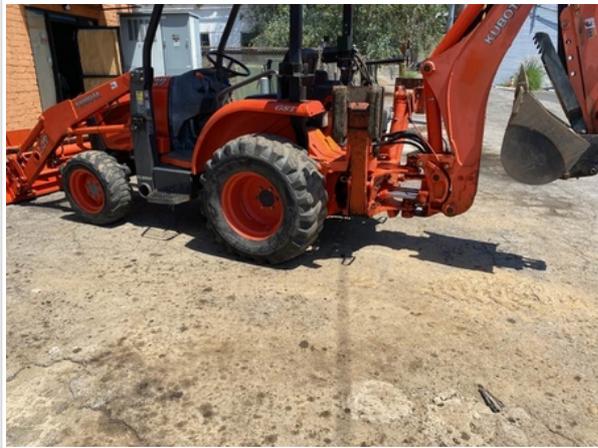
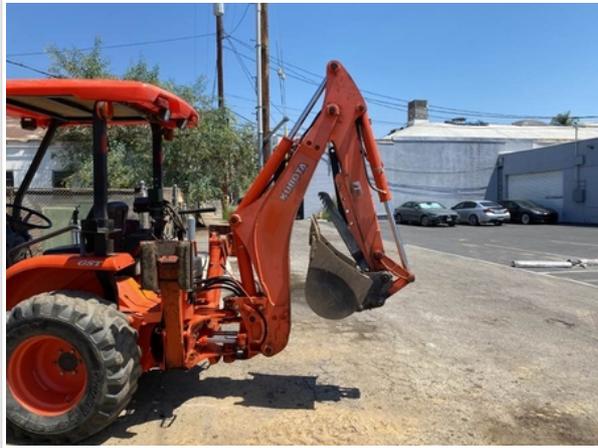
<p>Left</p>	<p>3 - Normal Wear & Tear</p>
<p>Left Condition</p>	<p>No visible damage</p>
<p>Left Photos</p>

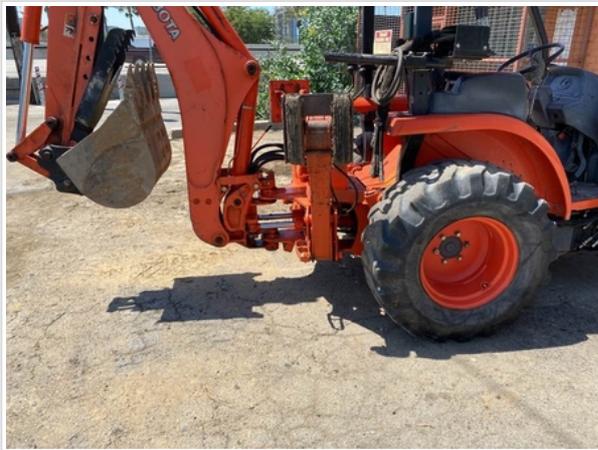
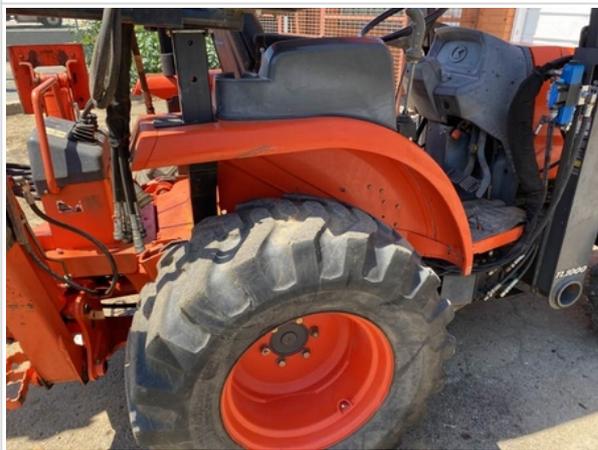
<p>Right</p>	<p>3 - Normal Wear & Tear</p>
<p>Right Condition</p>	<p>No visible damage</p>
<p>Right Photos</p>

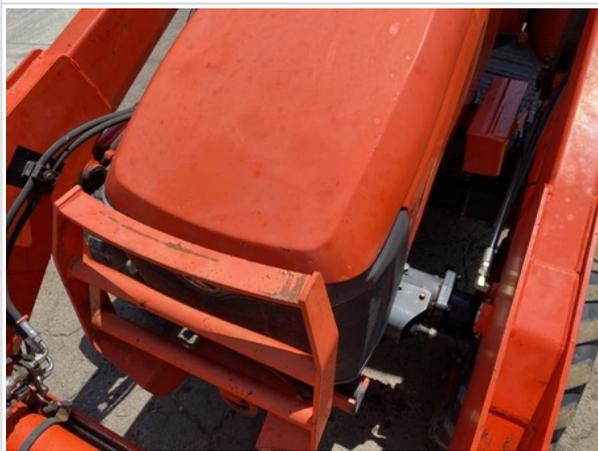
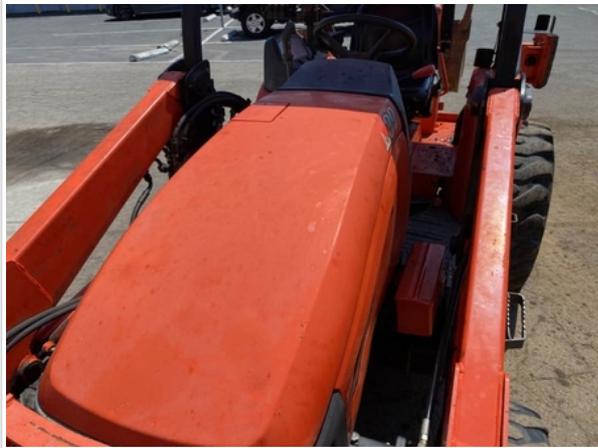
Upper	3 - Normal Wear & Tear	
Upper Condition	No visible damage	
Upper Photos

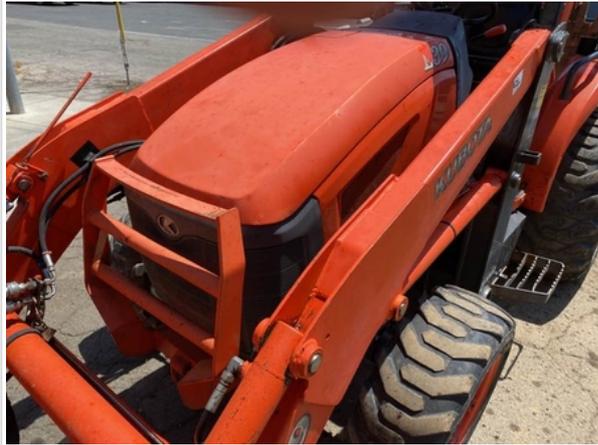
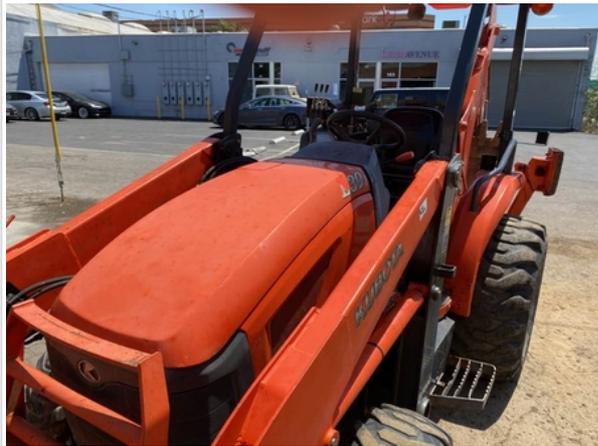
Body Panels (Any Rust Damage?)	3 - Normal Wear & Tear
Body Panel Condition	No visible damage, good paint condition and panel fitment
Body Panels Photos

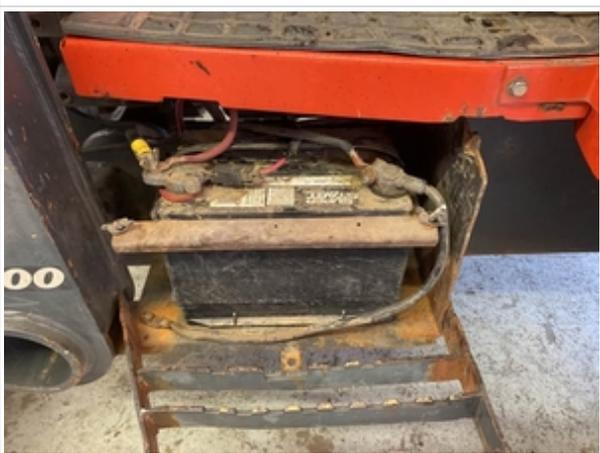
Blow-by (Visual Observation Check)	No	
Unusual Noises (Upon Start-up, Idle, Shutdown)	No	
Unusual Noise Notes	No unusual noises heard	
Engine Smoke (Upon Start-up, Idle, Shutdown)	No	
Engine Smoke Notes	No engine smoke issues observed	
Engine Exhaust Color	Clear	
Battery	3 - Normal Wear & Tear	
Battery Condition	Dusty & dirty appearance	
Comments	battery cables tight, battery hold down tight, battery aged at 6 years	
Battery Condition Photos

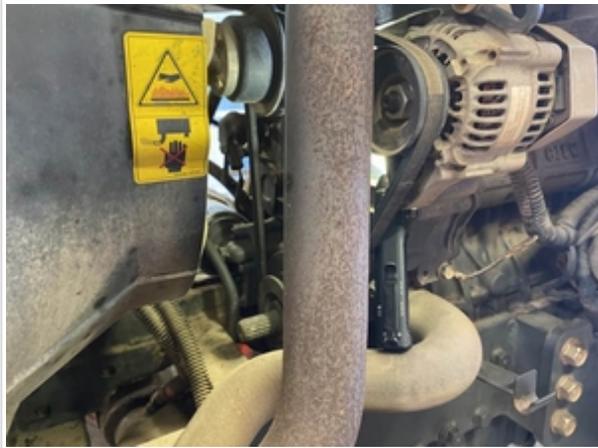
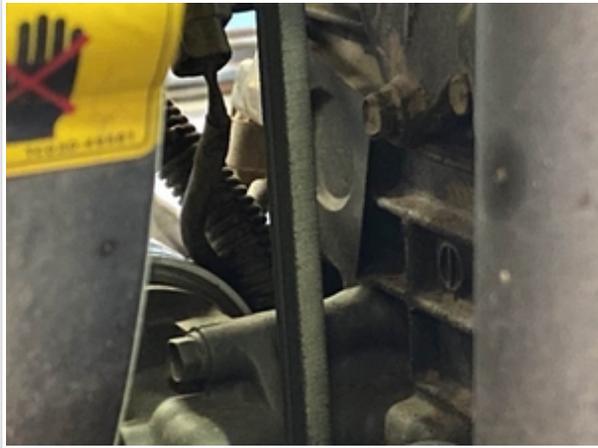
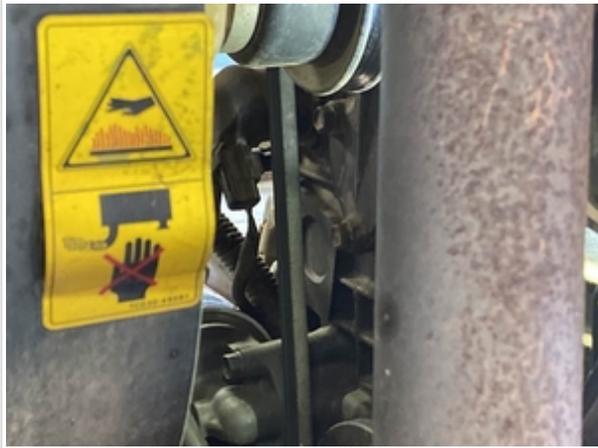
Belts	3 - Normal Wear & Tear
Belt Condition	Other (see comments)
Comments	Normal wear, belt needs to be adjusted
Belt Photos

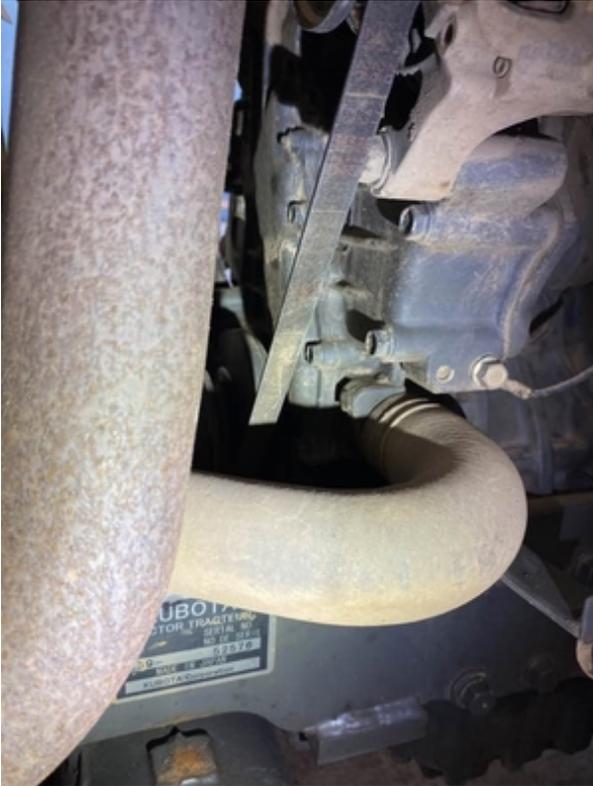
Water Pump	3 - Normal Wear & Tear
Water Pump Condition	No unusual pump noises heard
Water Pump Photos

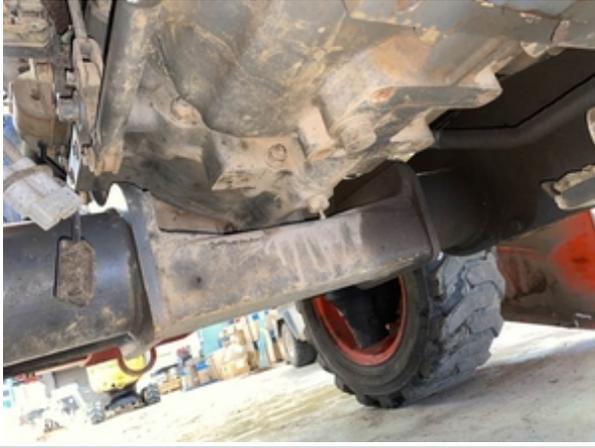
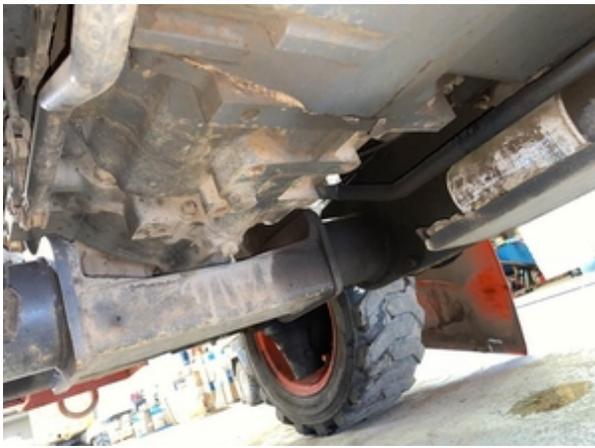
Transmission Info	4x4
Transmission	3 - Normal Wear & Tear
Transmission Condition	No unusual noises or vibrations
Transmission Photos

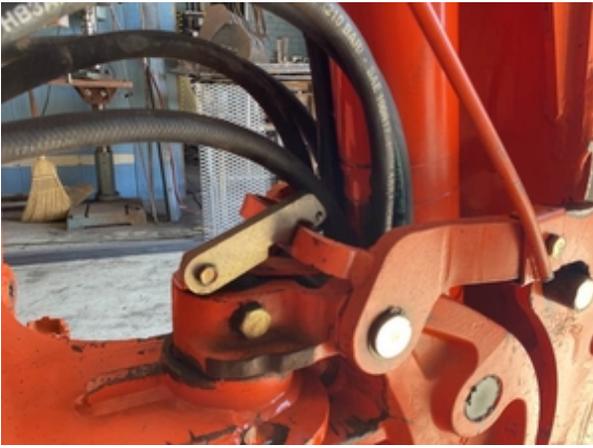
Appearance of Hydraulic Lines / Fittings	3
Hydraulic Lines / Fittings Condition	Hydraulic lines & fittings are clean and in good condition, Worn, cut, or damaged hose covering, Active leaks in hoses or fittings observed, Other (see comments)
Comments	Most hydraulic hoses good condition, 1 active seepage leak at hyd. Hose that goes down backhoe boom area
Appearance of Hydraulic Lines / Fittings Photos

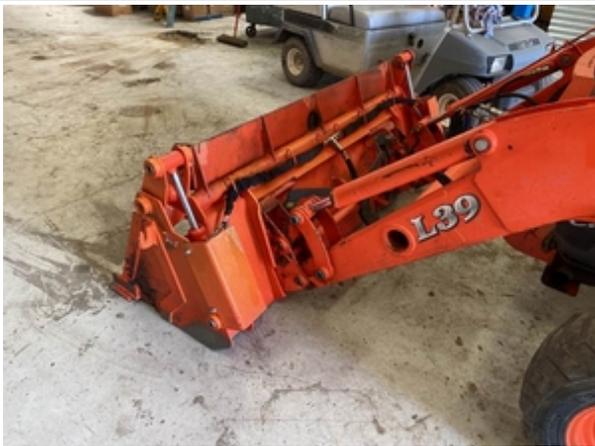
Instructions	<p>Evaluate the following on a 4 point scale (leave comments where an explanation is appropriate):</p> <p>4 = Like New, Recently Replaced 3 = Normal Wear & Tear 2 = Above Average Wear 1 = Service Required</p>
Bucket	<p>3 - Normal Wear & Tear</p>
Comments	<p>Certified welder fabricated 7" top shield to 4 to 1 bucket, fab. Center hold bracket inside bucket, and 8', 2" square extension for cherry picking and attaching hitch receiver for moving small tow behind equipment around job site!</p>
Bucket Photos

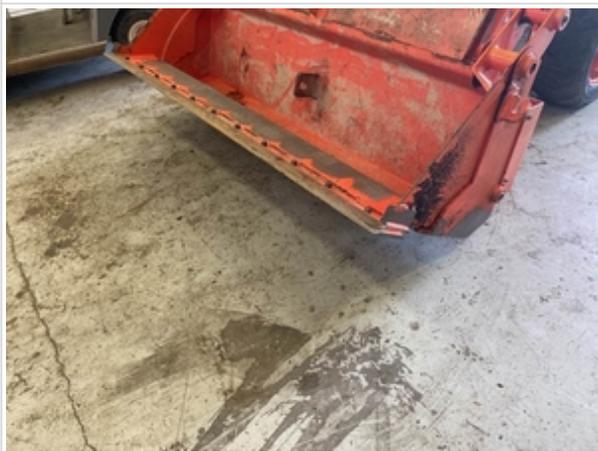
Bucket Edge/Shanks/Teeth	3 - Normal Wear & Tear	
Comments	Only 1 backhoe bucket to this machine 16"	
Bucket Edge/Shanks/Teeth Photos
