Inspection Report (On-Highway Dump Truck)

Year	2011
Make	Peterbilt
Model	367
Serial Number	1NPTLU0X4BD127976
Truck Odometer Reading	425,002 miles
Current Inspection / State Cert / DOT	90 day b.i.t. Inspection performed 6/20/22 @424,994
Previous Application (e.g., earth moving, mining, demolition, etc)	asphalt road work

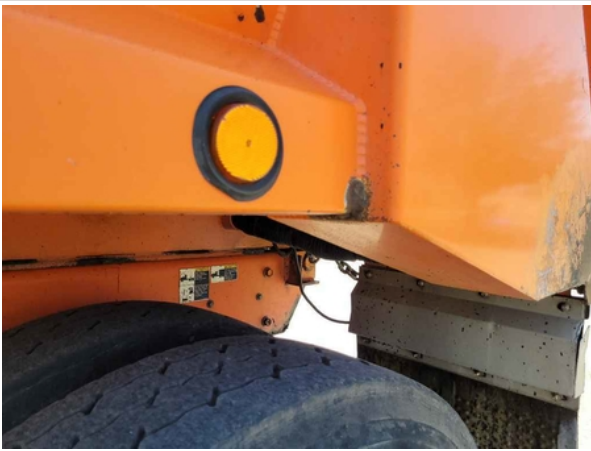
Left	3 - Normal Wear & Tear	
Left Condition	Other (see comments), No visible damage	
Comments	front left behind fender cover cracked (cosmetic) and rear left side discoloration from weld repairs	
Left Photos

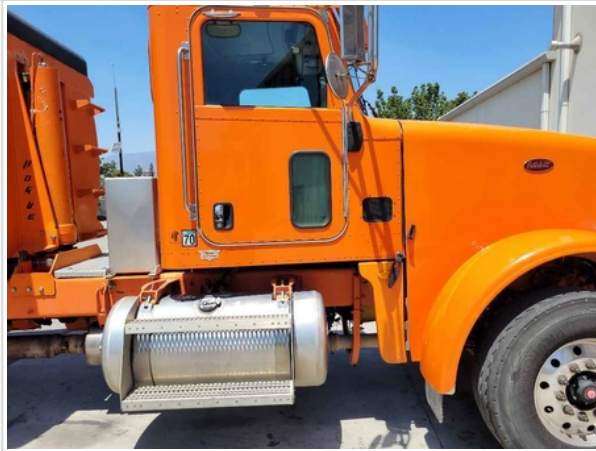
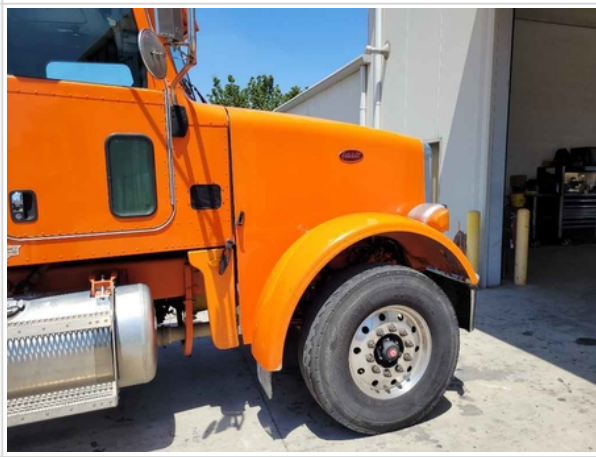
Right	3 - Normal Wear & Tear	
Right Condition	No visible damage, Other (see comments)	
Comments	discoloration from weld repairs

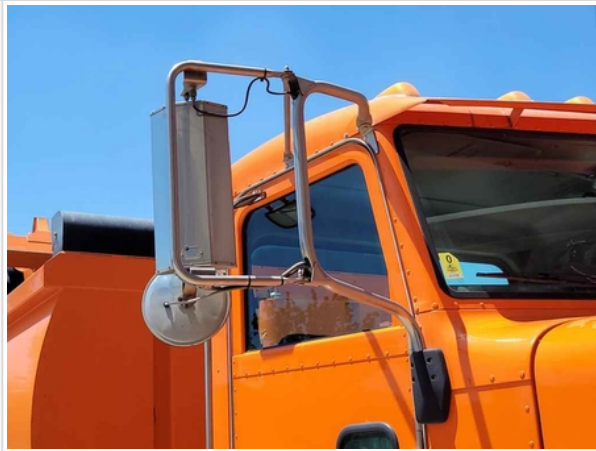
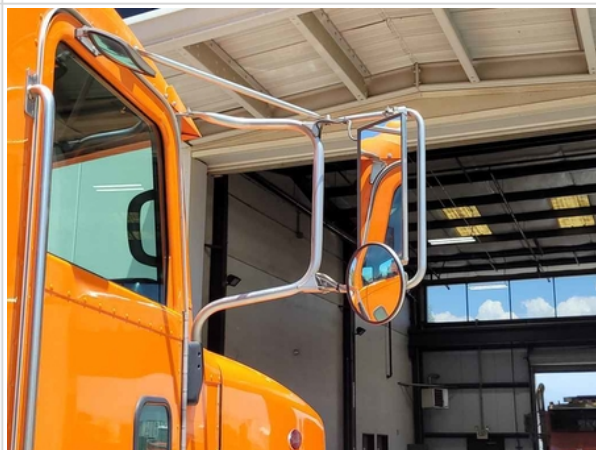
Lighting System	3 - Normal Wear & Tear	
Lighting System Condition	Other (see comments), One or more exterior lights are non-operational	
Comments	rear auxiliary work light inoperable, top cab marker lamps inop.	
Lighting System Photos

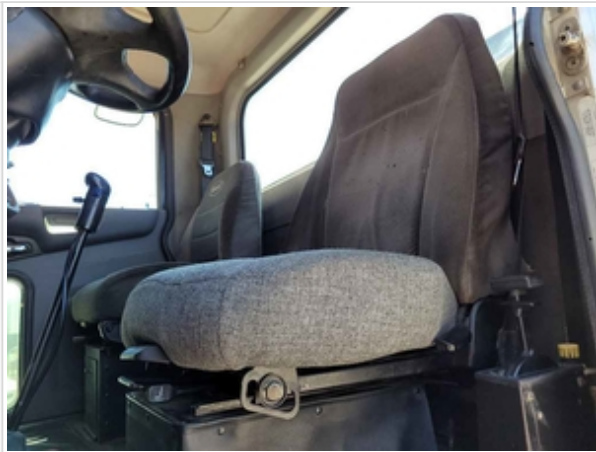
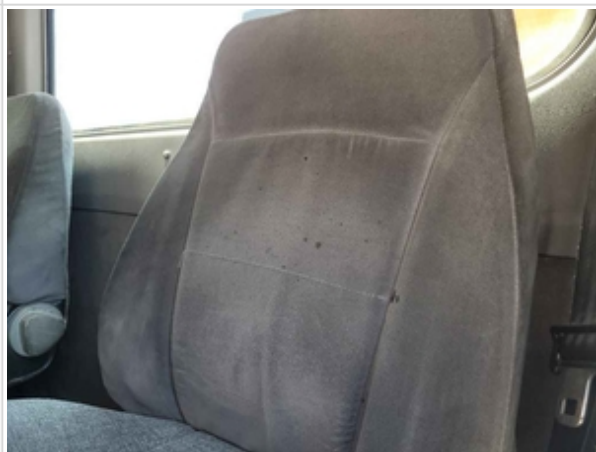
<p>Operator Cabin</p>	<p>3 - Normal Wear & Tear</p>	
<p>Comments</p>	<p>normal wear, seats stained but interior pretty much intact</p>	
<p>Operator's Seat & Arm Rests</p>	<p>3 - Normal Wear & Tear</p>	
<p>Comments</p>	<p>cushion replaced, doesn't match original (cosmetic)</p>	
<p>Operator's Seat & Arm Rests Photos</p>

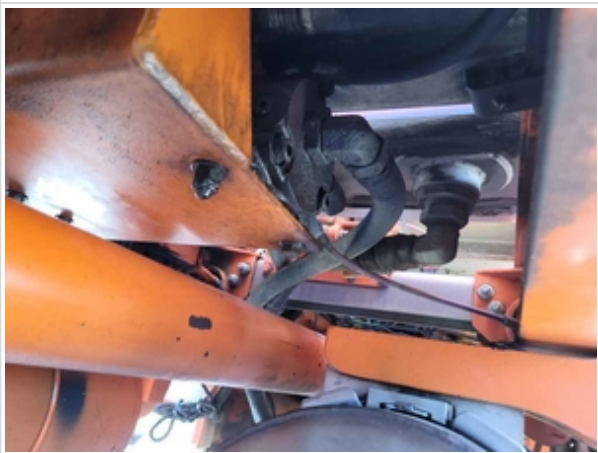
Hoses	3	
Comments	hoses from pto tank in good condition	
Hose Photos

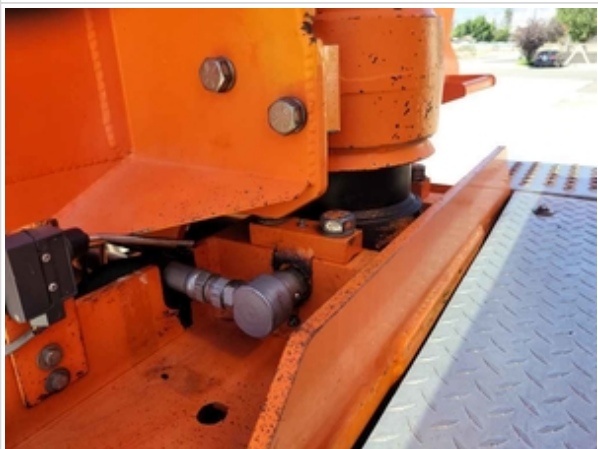
Hydraulic Cylinders	3	
Comments	hoses to strong arm axle worn (at rear)	
Hydraulic Cylinder Photos
