Inspection Report (On-Highway Flatbed Truck)

Year	2012
Make	Kenworth
Model	T800
Serial Number	1XKDDP9X6CJ300188
Truck Odometer Reading	362,335 Miles 22,953 Hours
Current Inspection / State Cert / DOT	Annual Inspection Performed 12/2021 per 49CFR-396
Previous Application (e.g., earth moving, mining, demolition, etc)	Rental Equipment Transportation

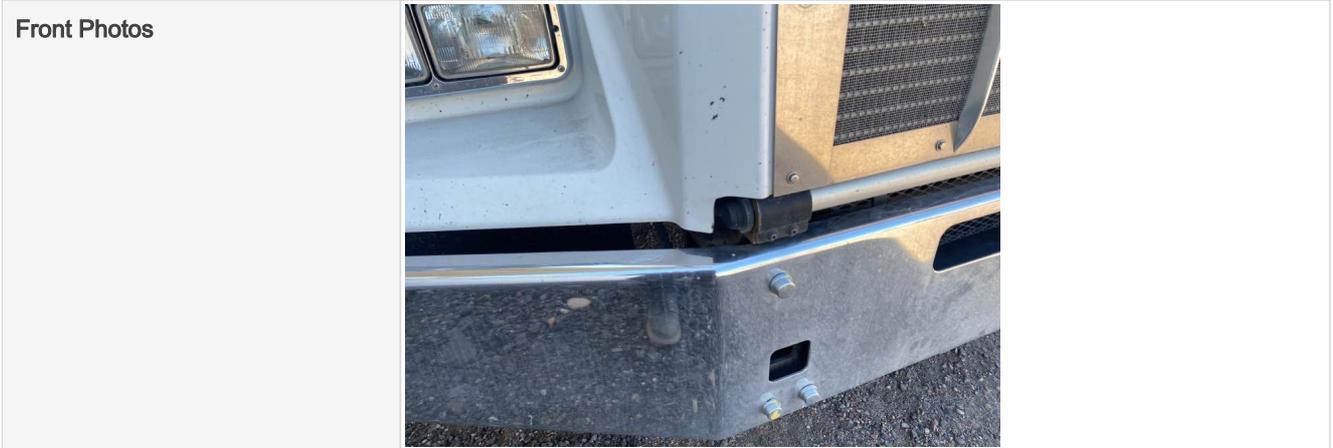
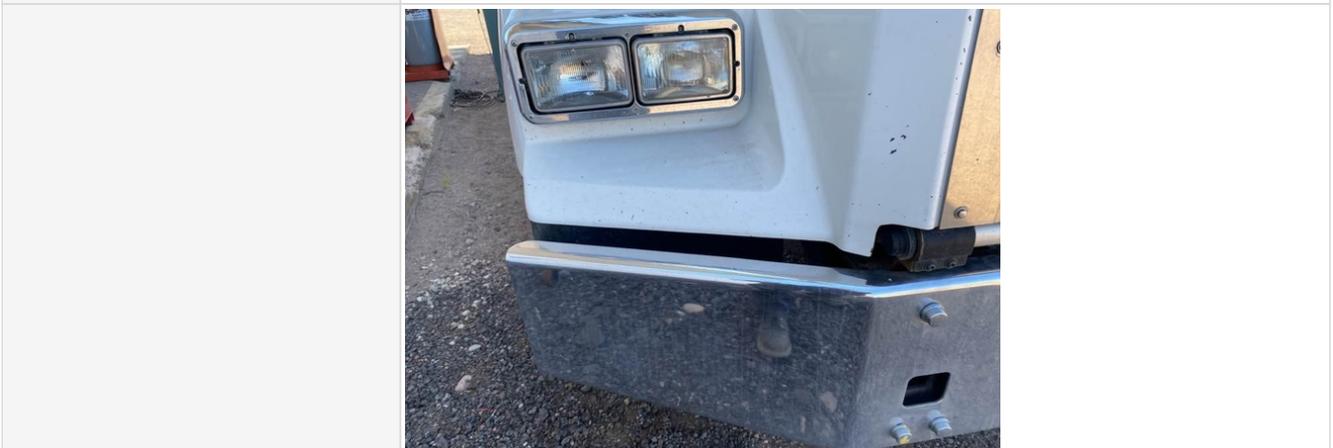
Front	3 - Normal Wear & Tear
Front Condition	No visible damage, Visible chipped paint or dents
Comments	Front tires 11r22.5 70 to 80% to 90% of tread life left

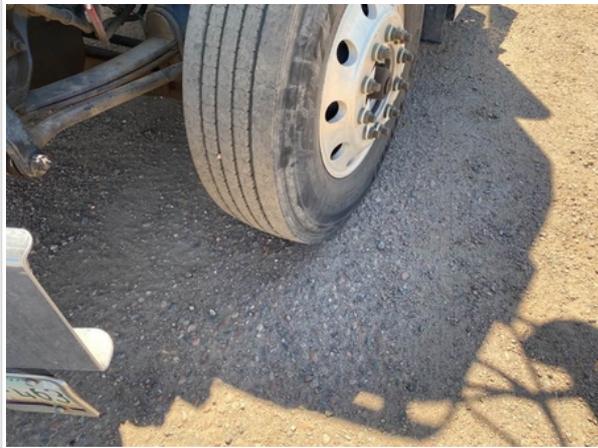
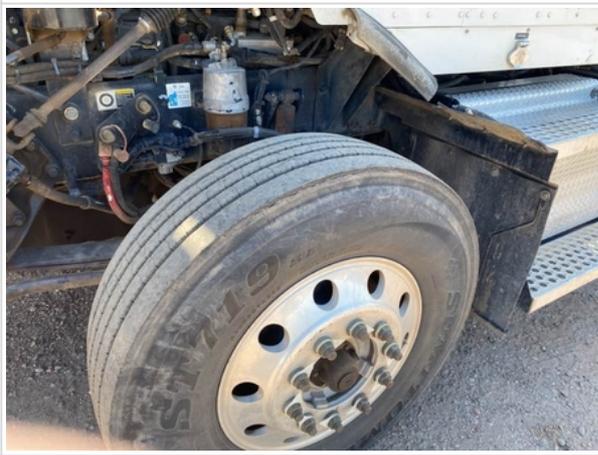
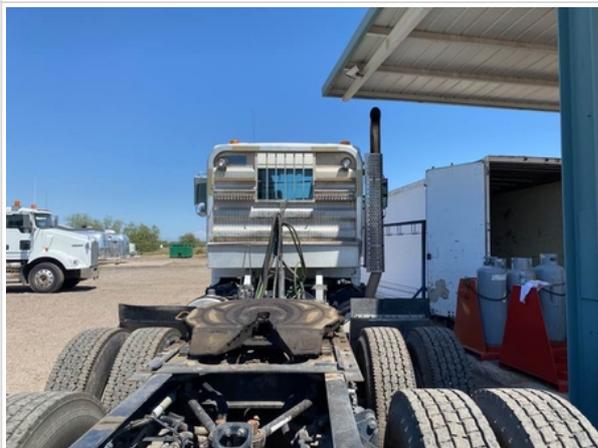
Rear	3 - Normal Wear & Tear	
Rear Condition	No visible damage, Other (see comments)	
Comments	Rear tires 11r22.5 80% to 90% of tread life left on all 8 tires	
Rear Photos

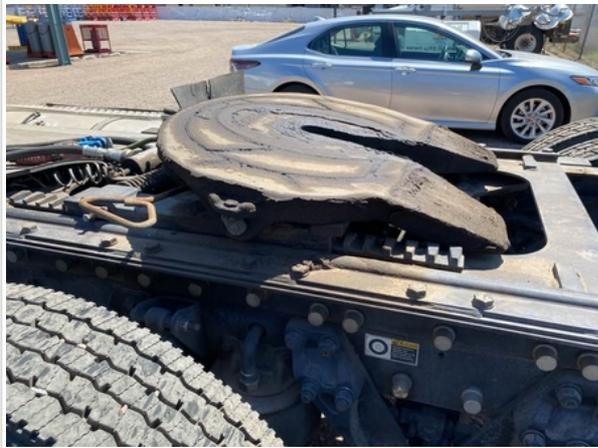
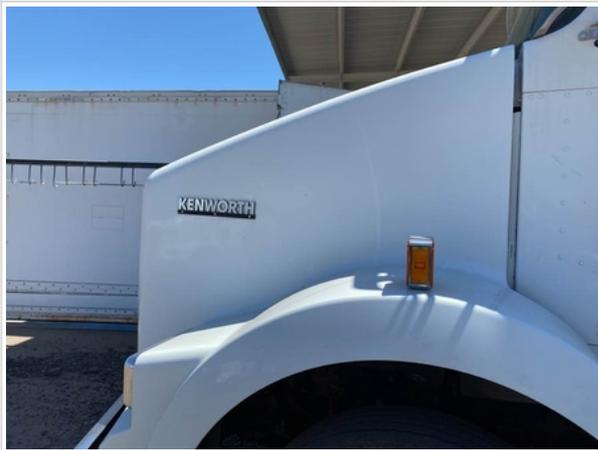
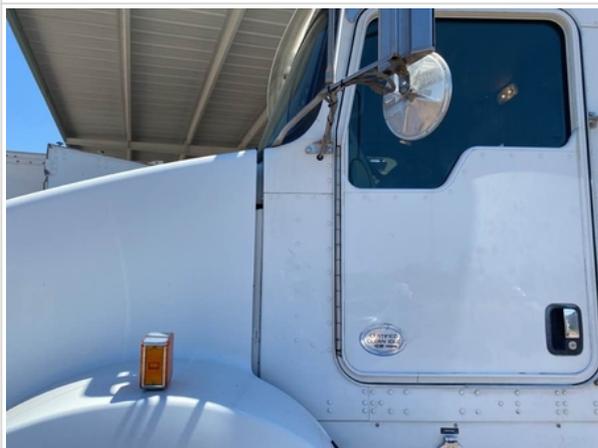
Left	3 - Normal Wear & Tear
Left Condition	No visible damage
Left Photos

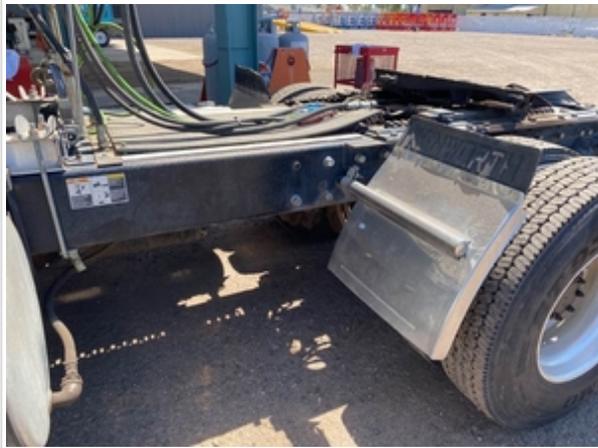
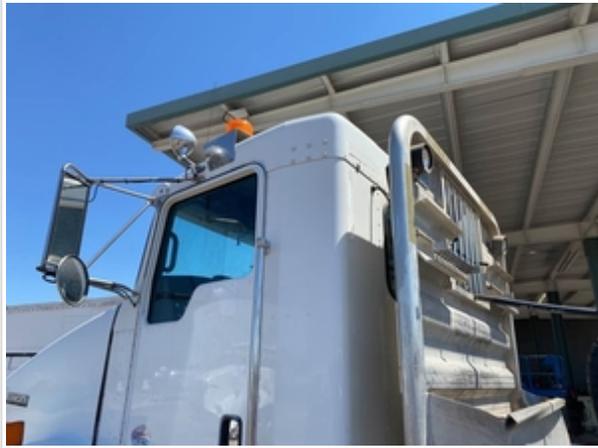
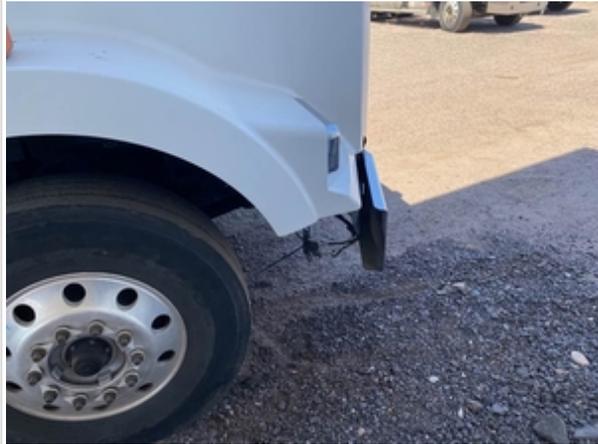
Right	3 - Normal Wear & Tear
Right Condition	No visible damage
Right Photos

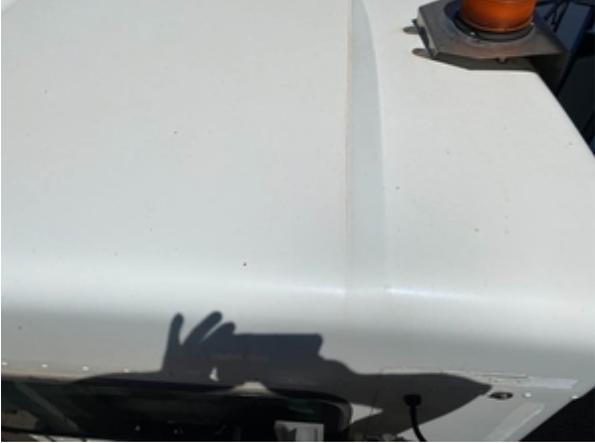
Body Panels (Any Rust Damage?)	3 - Normal Wear & Tear	
Body Panel Condition	No visible damage, good paint condition and panel fitment	
Body Panels Photos

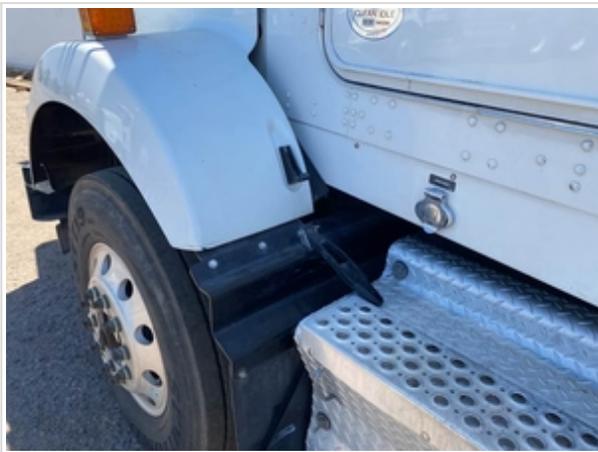
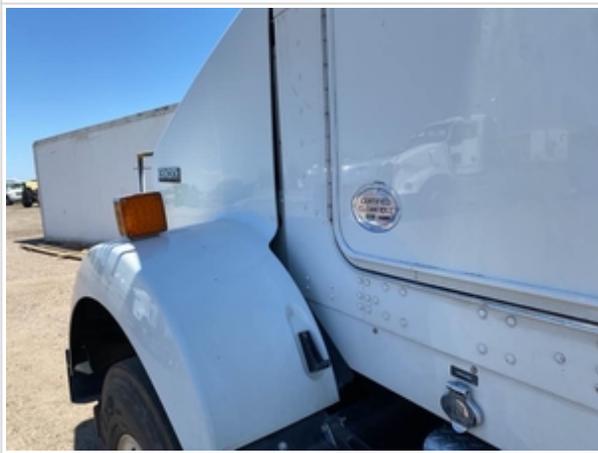
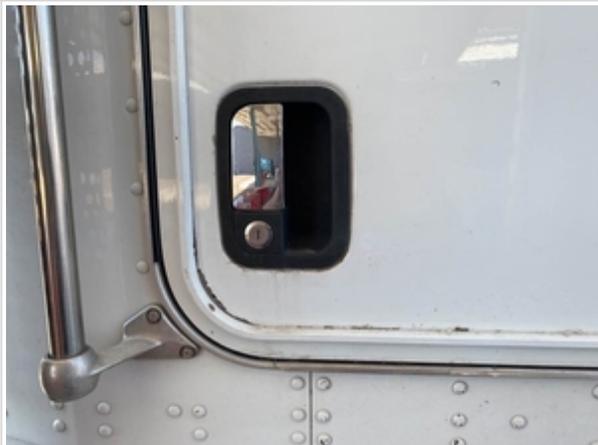
Doors / Canopy Latches	3 - Normal Wear & Tear	
Doors / Canopy Latches Condition	No visible damage	
Doors / Canopy Latches Photos

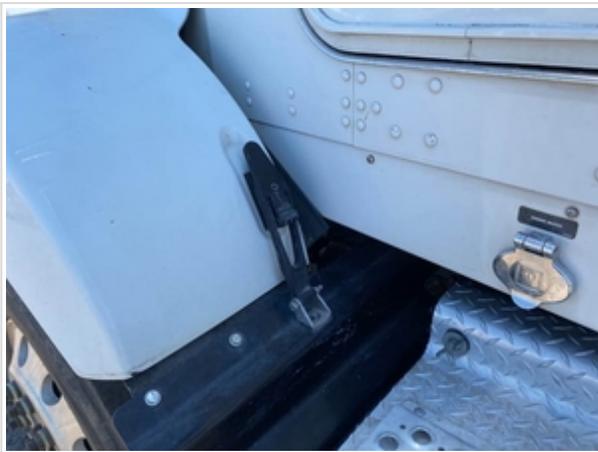
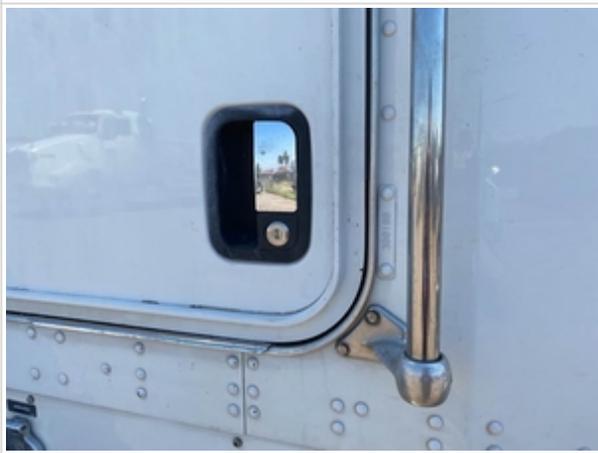
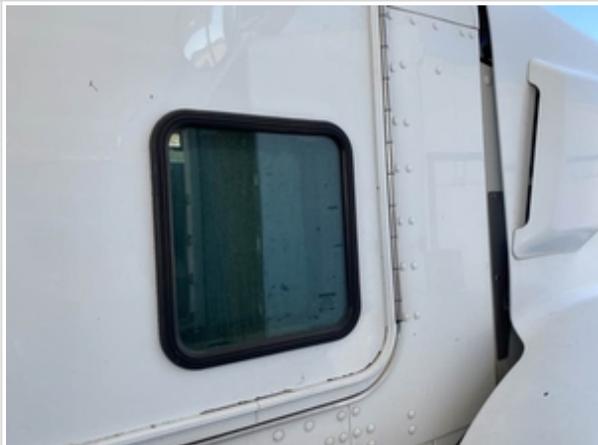
Glass Condition	3 - Normal Wear & Tear	
Glass Condition Notes	Glass intact, no visible damage, Minor chips or cracks observed	
Glass Condition Photos

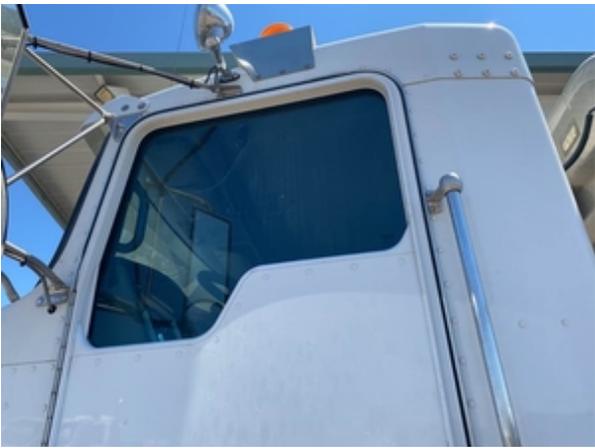
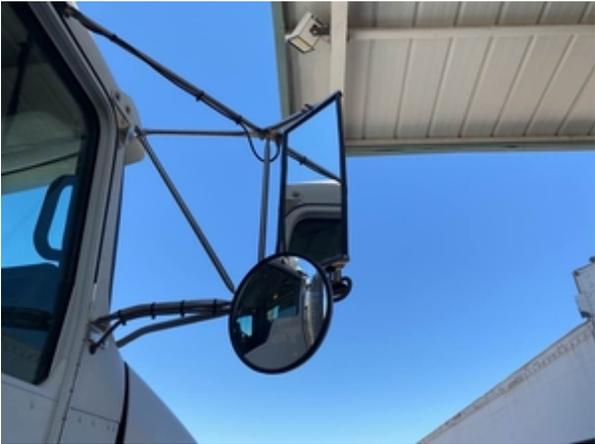
Mirrors	3 - Normal Wear & Tear	
Mirror Condition Notes	Mirrors present and intact, no visible damage	
Mirrors Photos

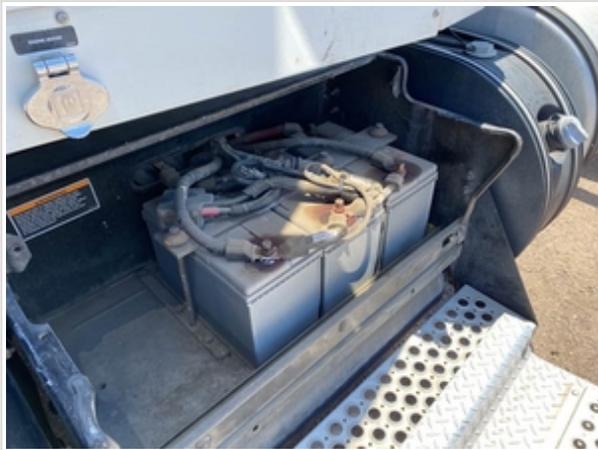
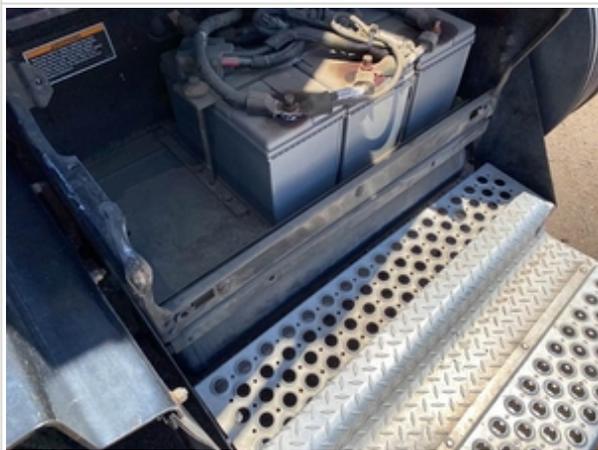
Blow-by (Visual Observation Check)	No
Unusual Noises (Upon Start-up, Idle, Shutdown)	No
Unusual Noise Notes	No unusual noises heard
Engine Smoke (Upon Start-up, Idle, Shutdown)	No
Engine Smoke Notes	No engine smoke issues observed
Engine Exhaust Color	Clear
Battery	3 - Normal Wear & Tear
Battery Condition	Dusty & dirty appearance, Other (see comments)
Comments	Batteries function okay

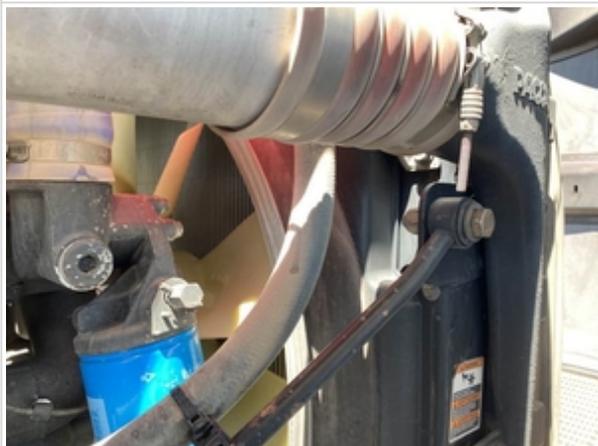
Radiator	3 - Normal Wear & Tear
Radiator Condition	Radiator fins & components appear to be in good working order, no signs of damage or leaks
Radiator Photos

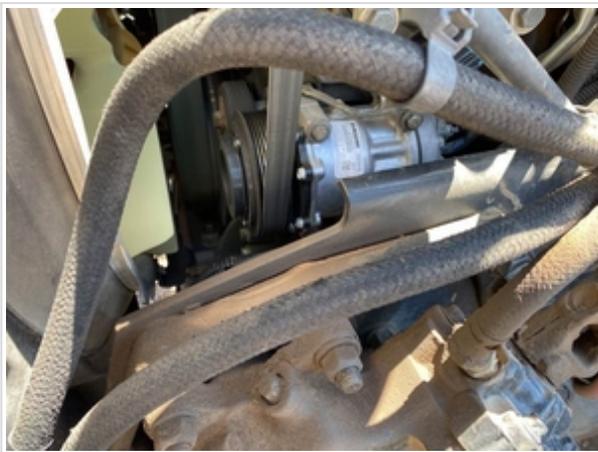
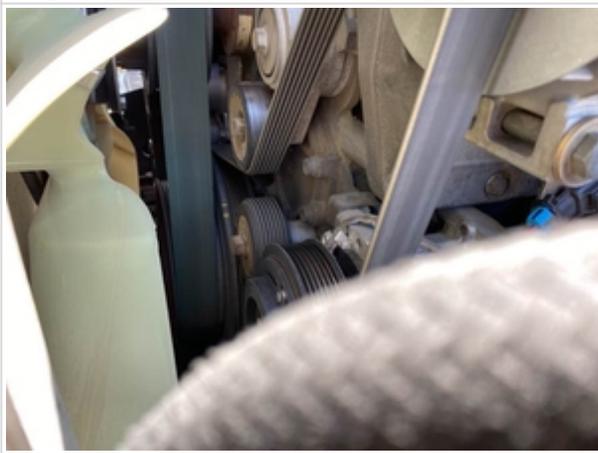
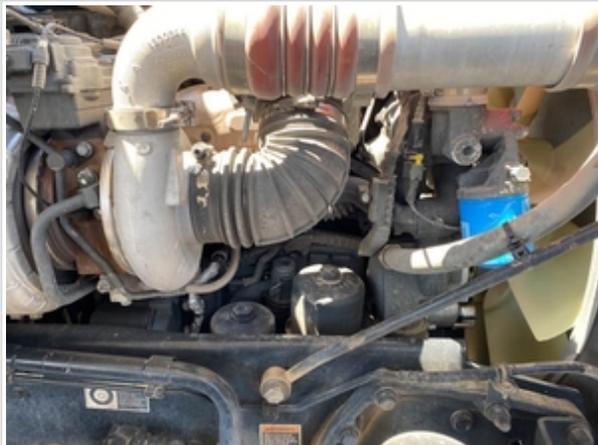
Hoses	3 - Normal Wear & Tear	
Hose Condition	Firm, pliant hoses with no signs of wear or leaks	
Hose Photos

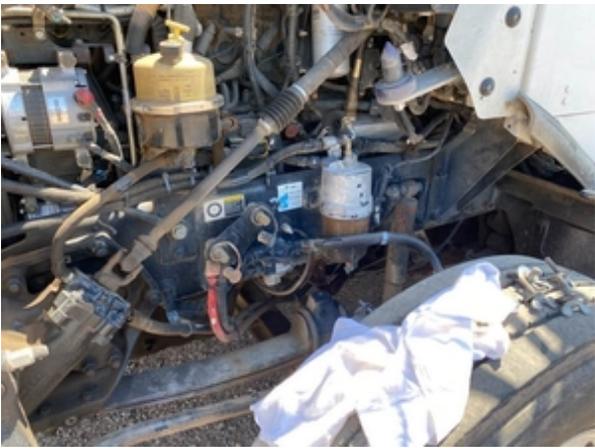
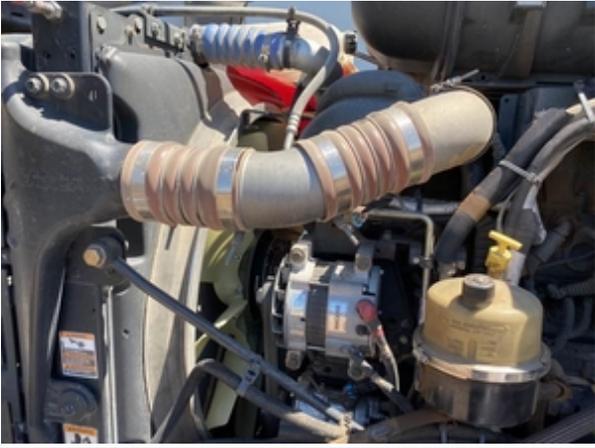
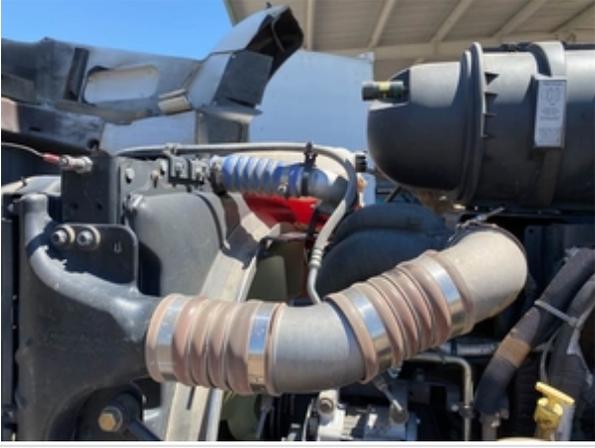
Water Pump	3 - Normal Wear & Tear	
Water Pump Condition	No unusual pump noises heard, Other (see comments)	
Comments	Recently replaced

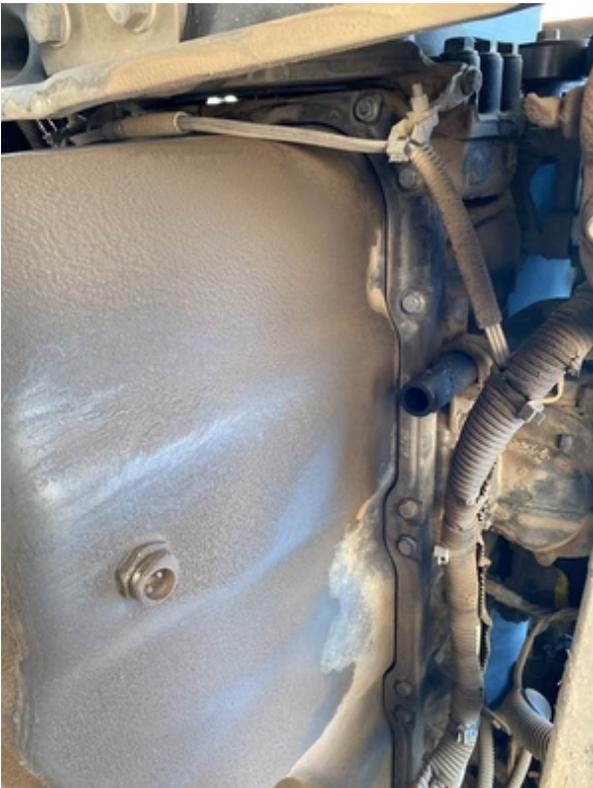
Cooling System Leaks	No
Coolant Color / Appearance	3 - Normal Wear & Tear
Coolant Color/Appearance Notes	Normal Translucent appearance, no visual signs of contamination
Oil Leaks	Yes
Oil Leak Notes	No oil leaks seen, Dried oil seepages seen
Oil Leak Photos

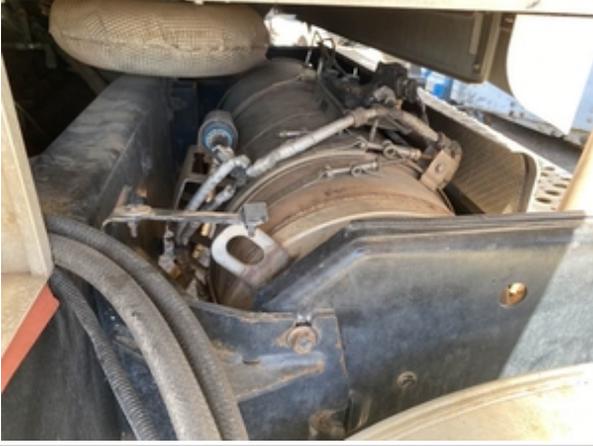
Oil Color / Appearance	3 - Normal Wear & Tear
Oil Color / Appearance Notes	Clean oil appearance, no signs of cross contamination, Appropriate oil level
Fuel Leaks	No
Equipped with DPF (Diesel Particulate Filter)	Yes
DPF Condition	3 - Normal Wear & Tear
DPF Condition Notes	Filter housing is intact with no signs of damage or malfunction, DPF indicator is not illuminated
DPF Photos

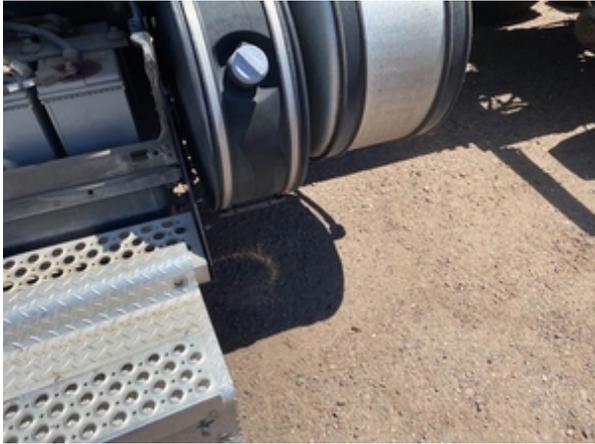
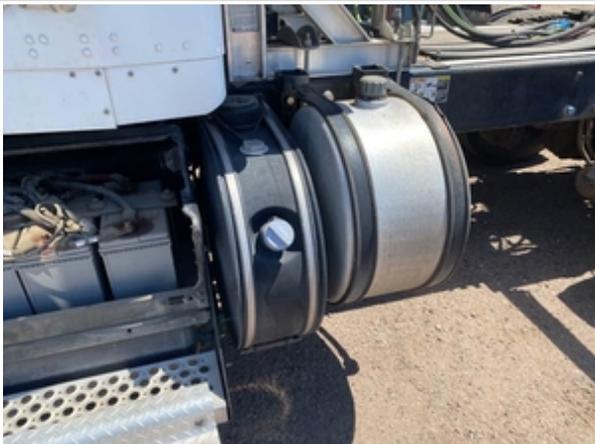
Requires DEF (Diesel Exhaust Fluid)	Yes
DEF Tank	3 - Normal Wear & Tear
DEF Tank Condition	Area around DEF tank cap is clean, fluid is clear & appears free of contaminants
DEF Tank Photos

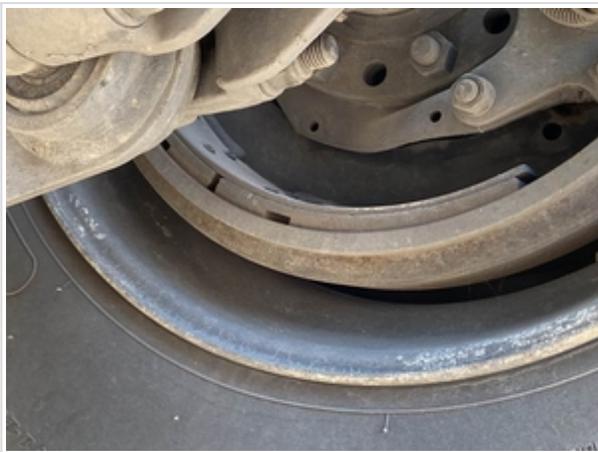
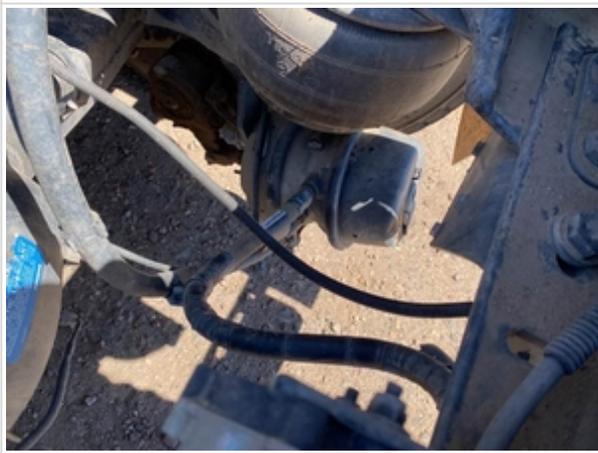
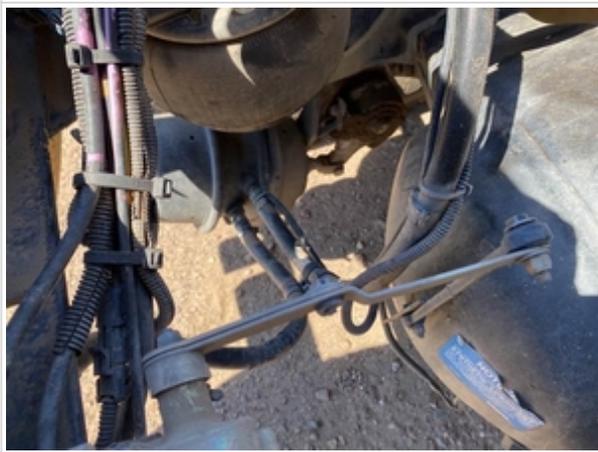
Brake System Type	Air Brakes	
Air Brakes Build Correct Pressure	Yes	
Air Brake System Leaks	Yes	
Comments	Small air leak behind dash	
Air Brake Hose Condition	3 - Normal Wear & Tear	
Comments	Rear brakes shoes less than 50% life left, front between 50 and 60% life left	
Air Brake System Photos
