Inspection Report (On-Highway Flatbed Truck)

Year	2012
Make	Kenworth
Model	T800
Serial Number	1XKDDP9X1CJ300194
Truck Odometer Reading	333,395Miles and 9227.5 hours
Current Inspection / State Cert / DOT	Annual Inspection Performed 02/2022 per 49CFR-396
Previous Application (e.g., earth moving, mining, demolition, etc)	Equipment rental machinery transport

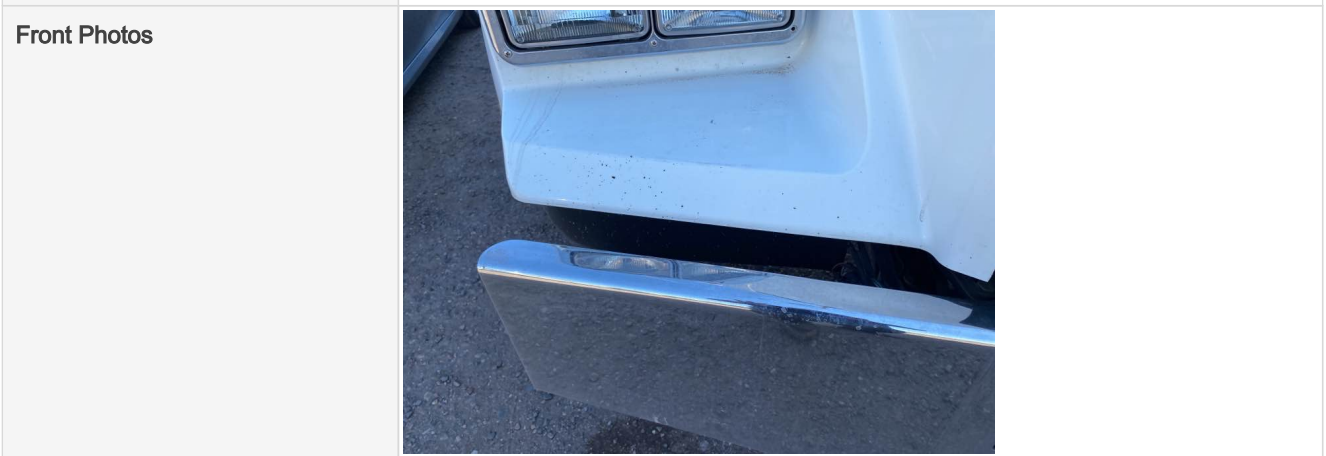
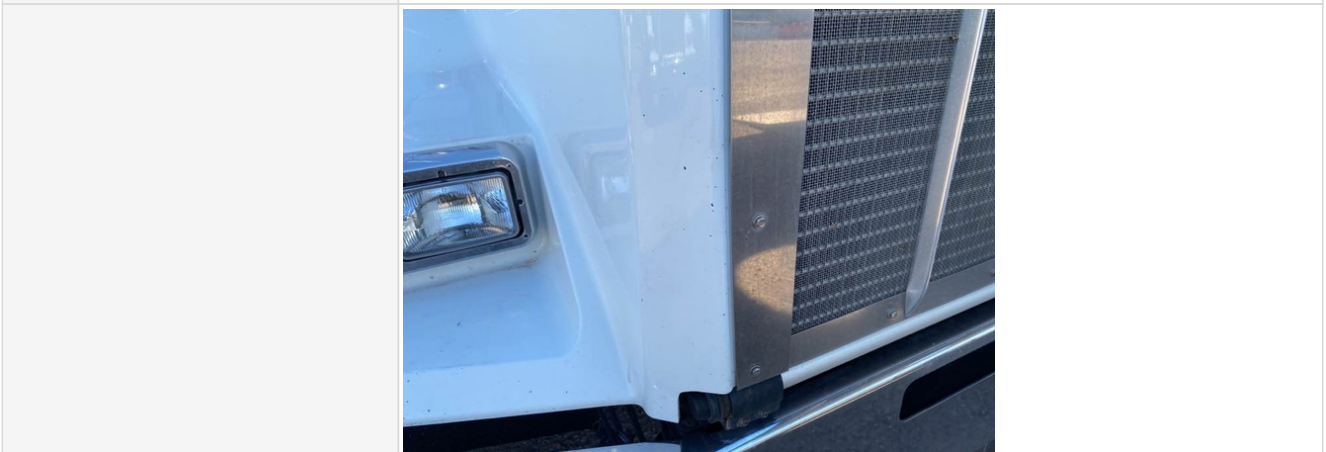
Front	3 - Normal Wear & Tear
Front Condition	No visible damage, Other (see comments)
Comments	Front tires 11r22.5 have 80 to 90% tread life left

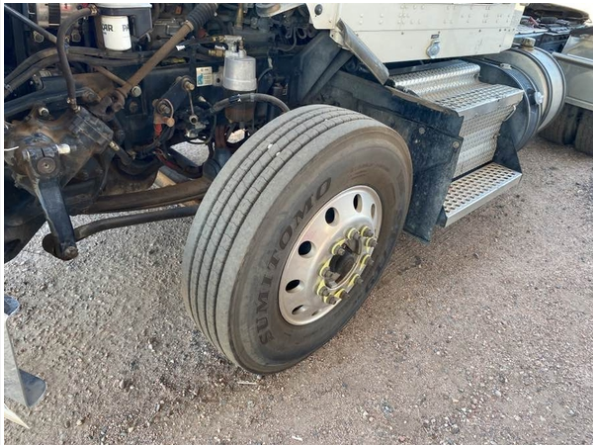
Rear	3 - Normal Wear & Tear
Rear Condition	No visible damage, Other (see comments)
Comments	2nd axle 11r22.5 have 30 to 40 % tread life left 3rd axle has 60 to 70%
Rear Photos

Parking Brake Photos	 
Overall Drivetrain Comments	Overall 2nd axle tires getting low and will need to be replaced soon. Also 2nd axle right side brake shoes getting low and will need to be replaced soon.

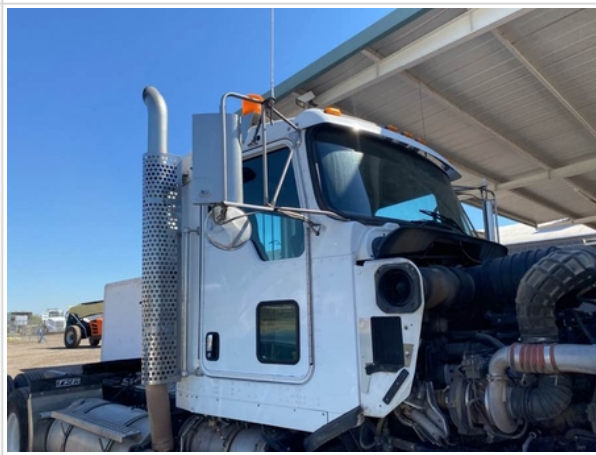
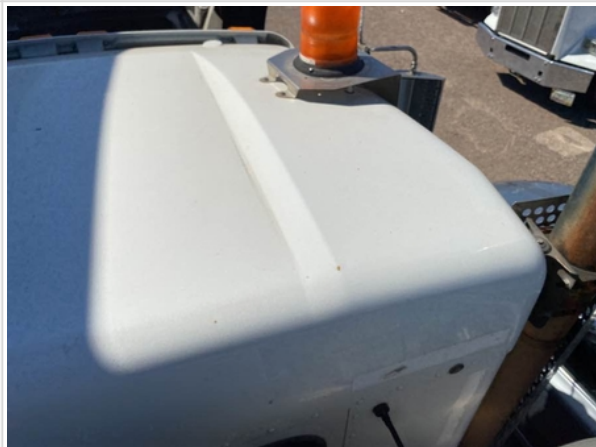
Upper	3 - Normal Wear & Tear	
Upper Condition	No visible damage	
Upper Photos

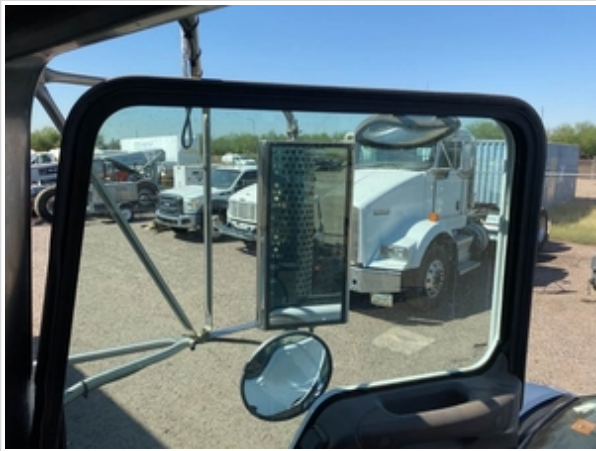
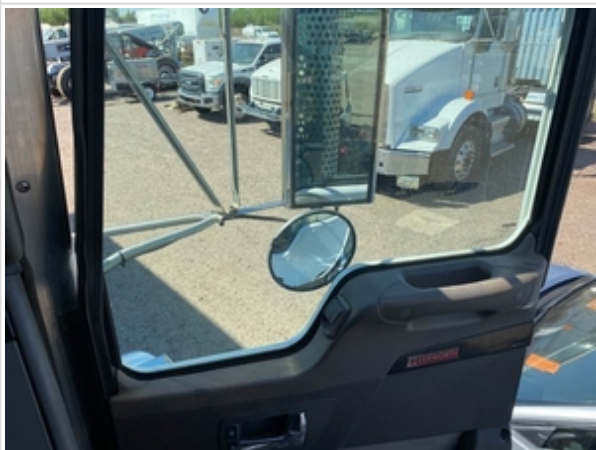
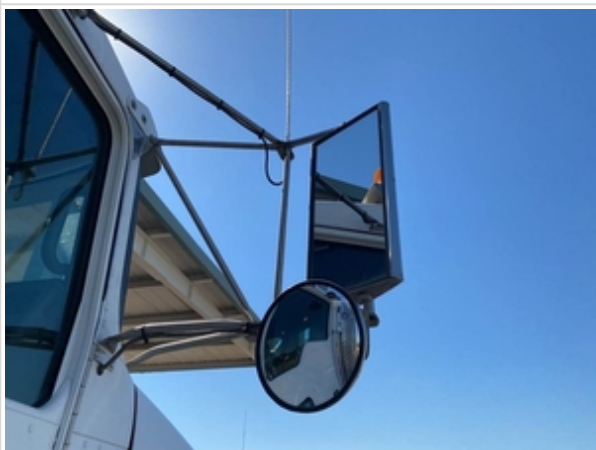
Mirrors	3 - Normal Wear & Tear	
Mirror Condition Notes	Mirrors present and intact, no visible damage	
Mirrors Photos

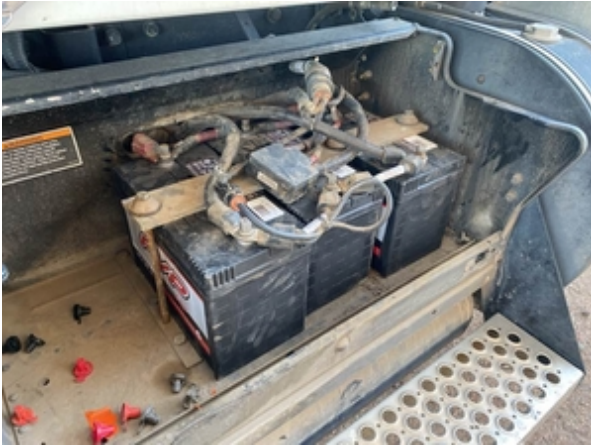
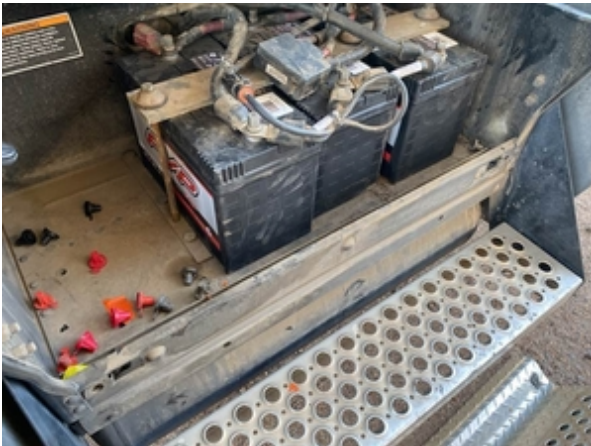
Battery	4 - Like New, Recently Replaced
Battery Condition	Like new, recently replaced
Battery Condition Photos

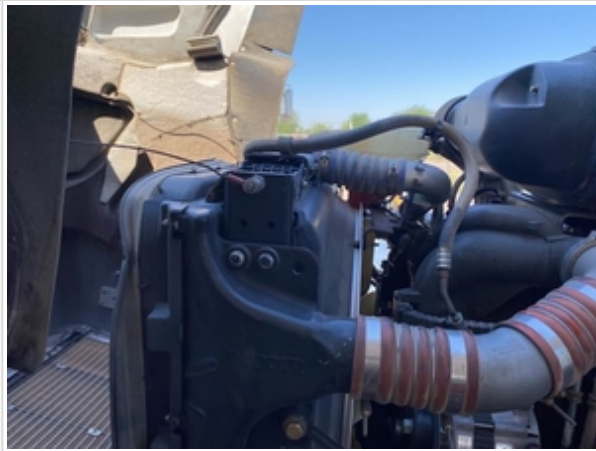
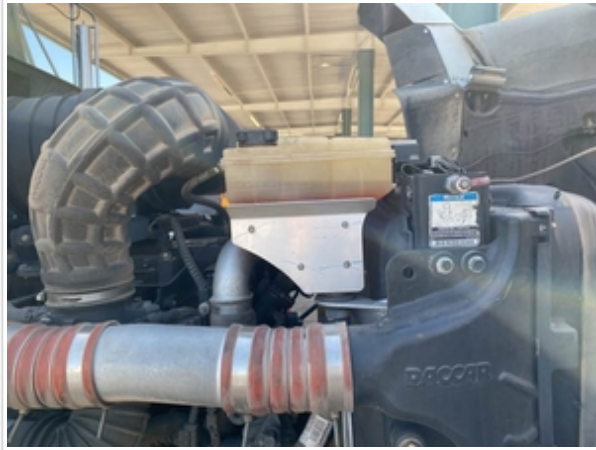
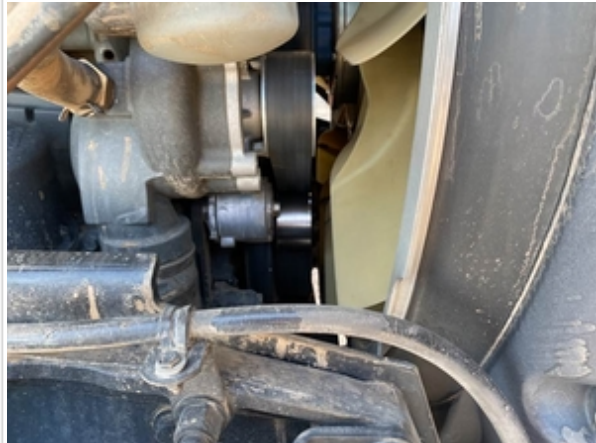
Belts	3 - Normal Wear & Tear
Belt Condition	Belts appear in good condition & alignment with proper tension
Belt Photos

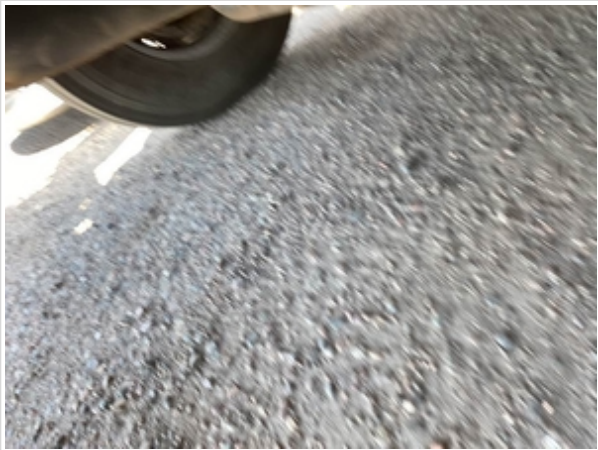
Cooling System Leaks	No
Coolant Color / Appearance	3 - Normal Wear & Tear
Coolant Color/Appearance Notes	Normal Translucent appearance, no visual signs of contamination
Oil Leaks	Yes
Oil Leak Notes	No oil leaks seen, Dried oil seepages seen, Other (see comments)
Comments	From around front crank pulley/damper
Oil Leak Photos

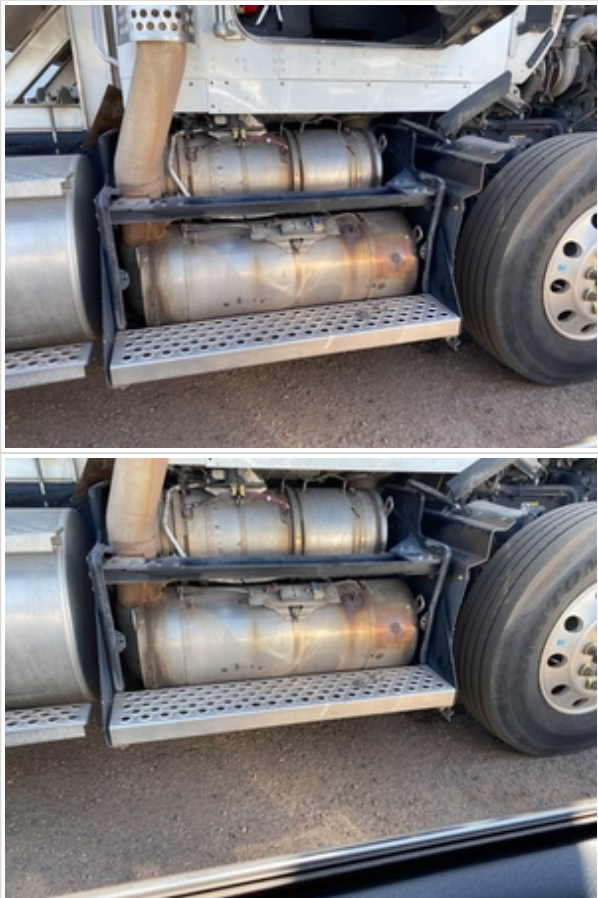
Oil Color / Appearance	3 - Normal Wear & Tear	
Oil Color / Appearance Notes	Clean oil appearance, no signs of cross contamination, Appropriate oil level	
Fuel Leaks	No	
Equipped with DPF (Diesel Particulate Filter)	Yes	
DPF Condition	3 - Normal Wear & Tear	
DPF Condition Notes	Filter housing is intact with no signs of damage or malfunction, DPF indicator is not illuminated	
DPF Photos

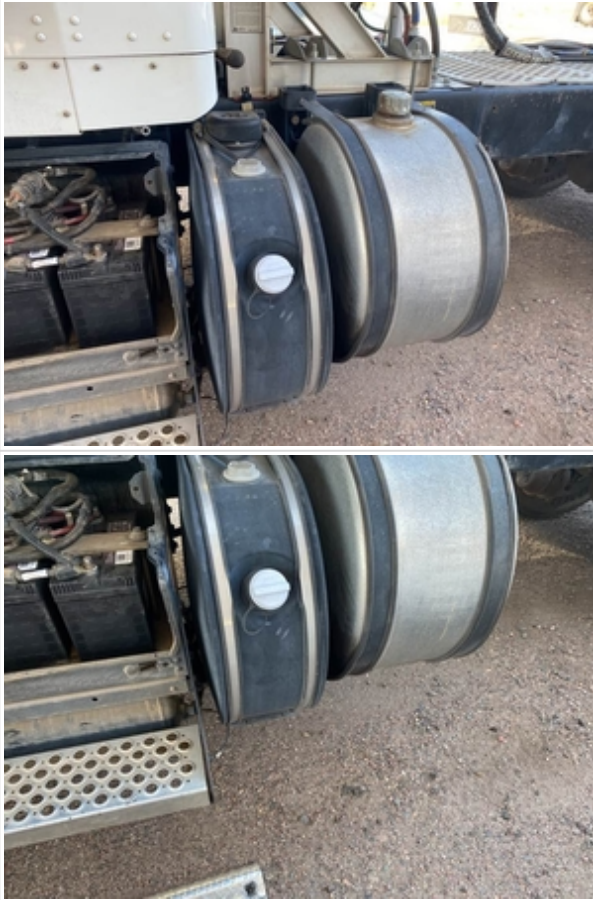
Requires DEF (Diesel Exhaust Fluid)	Yes
DEF Tank	3 - Normal Wear & Tear
DEF Tank Condition	Area around DEF tank cap is clean, fluid is clear & appears free of contaminants
DEF Tank Photos

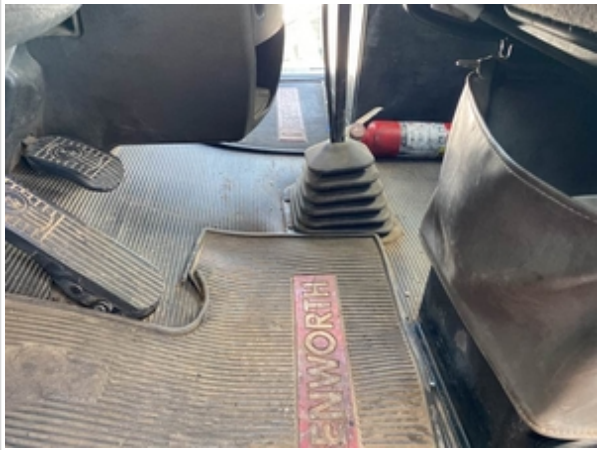
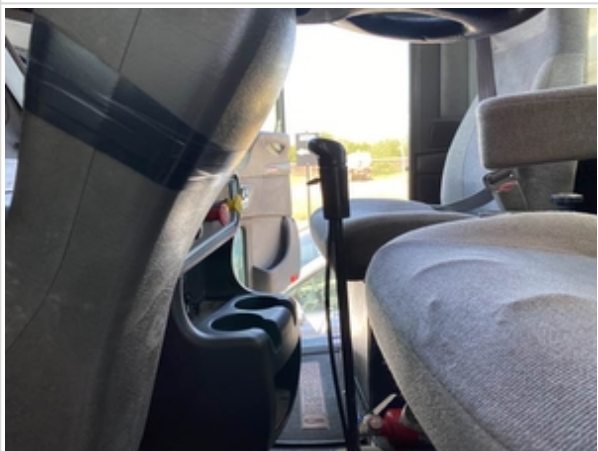
Clutch	3 - Normal Wear & Tear	
Clutch Condition	Other (see comments)	
Comments	Clutch pedal has no play adjustment required	
Shift Lever	3 - Normal Wear & Tear	
Shift Lever Condition	Good forward and reverse function	
Shift Lever Photos
