## Inspection Report (On-Highway Flatbed Truck)

| Make | Kenworth |
| Model | T800 |
| Serial Number | 1XKDDP9X7CJ300183 |

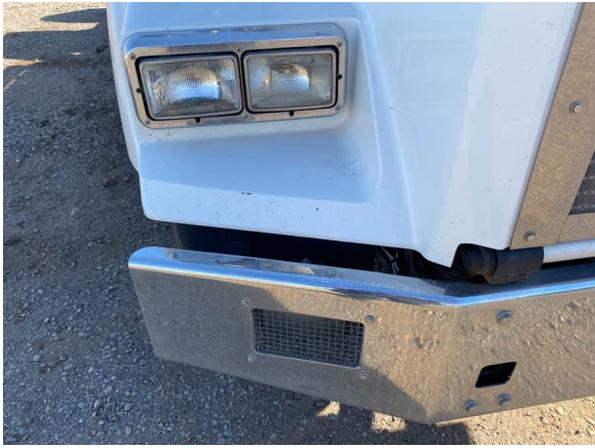
| Front Photos | |

| Front | 3 - Normal Wear & Tear |
| Front Condition | No visible damage, Other (see comments) |
| Comments | Normal paint wear, front tires 11r22.5 have 40 to 50 % tread life left |

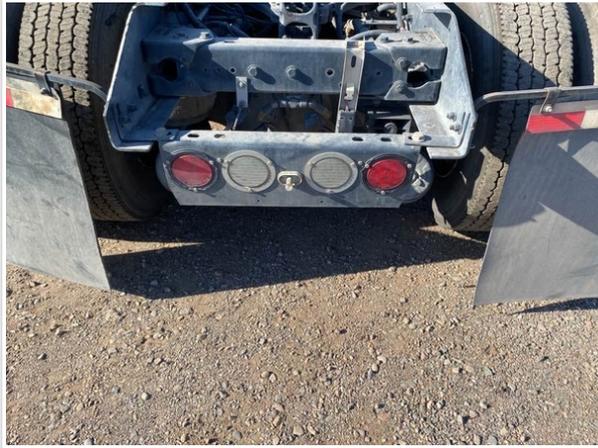
| <b>Rear Photos</b> | |

| <b>Rear</b> | 3 - Normal Wear & Tear |
| <b>Rear Condition</b> | No visible damage, Other (see comments) |
| <b>Comments</b> | Rear tires are 11r22.5 have 40 to 50 % tread life left |

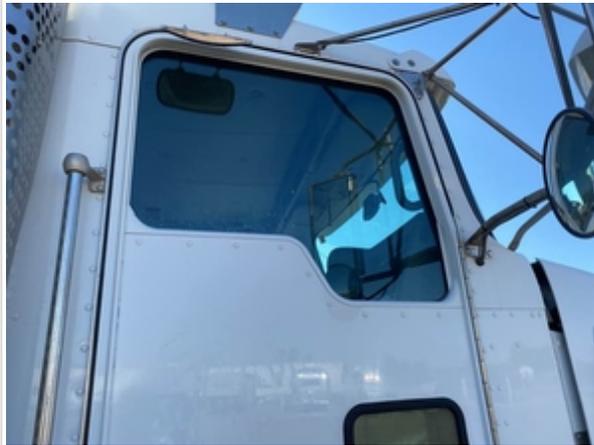
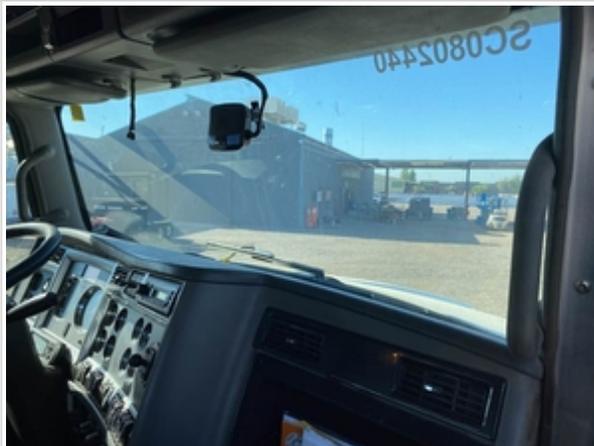
Glass Condition Photos

| <b>Glass Condition</b> | 3 - Normal Wear & Tear |
| <b>Glass Condition Notes</b> | Glass intact, no visible damage, Minor chips or cracks observed |

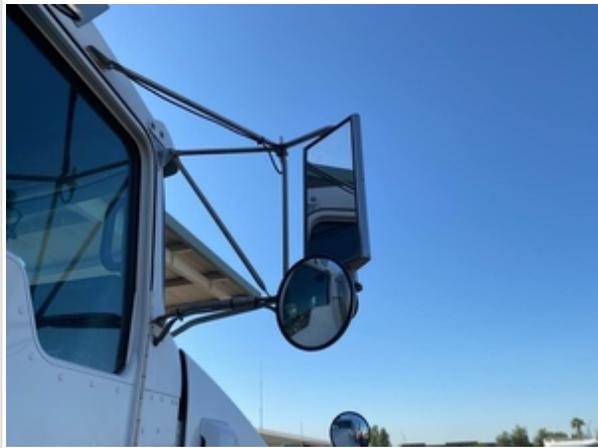
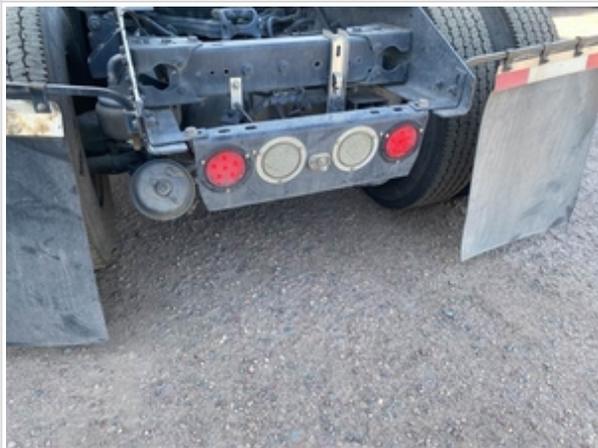
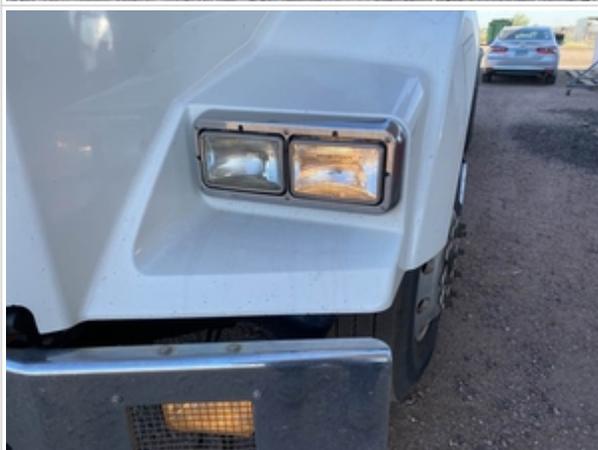
| <b>Lighting System Photos</b> | | |

| <b>Lighting System</b> | 3 - Normal Wear & Tear | |
| <b>Lighting System Condition</b> | No visible damage, lighting system is operational | |

| What Needs Work | Some tires need to be replaced soon, some exterior marker lamps not functioning and passenger seat belt not working properly. |

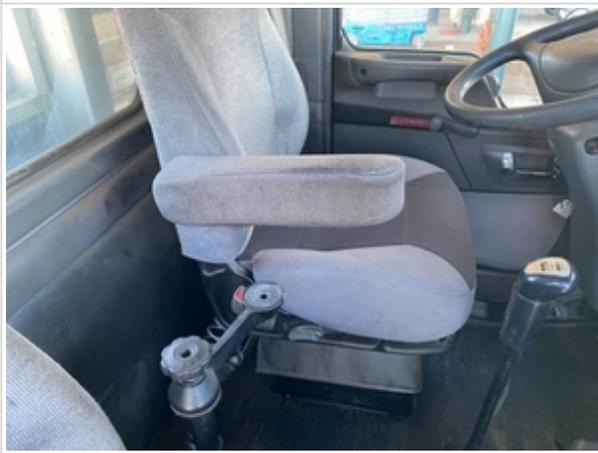
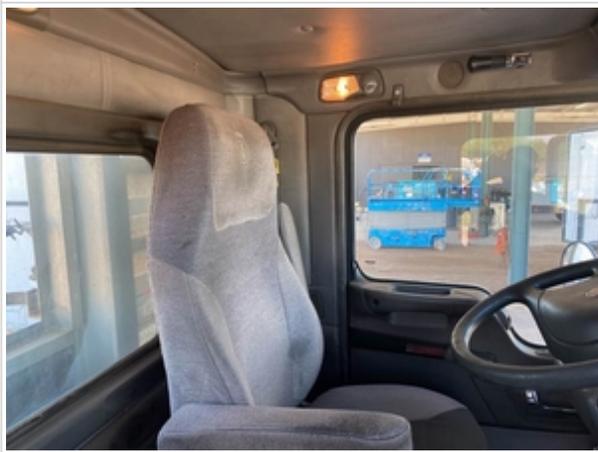
| <b>Seat Belt</b> | 3 - Normal Wear & Tear | |
| <b>Comments</b> | Passenger seat belt inop | |

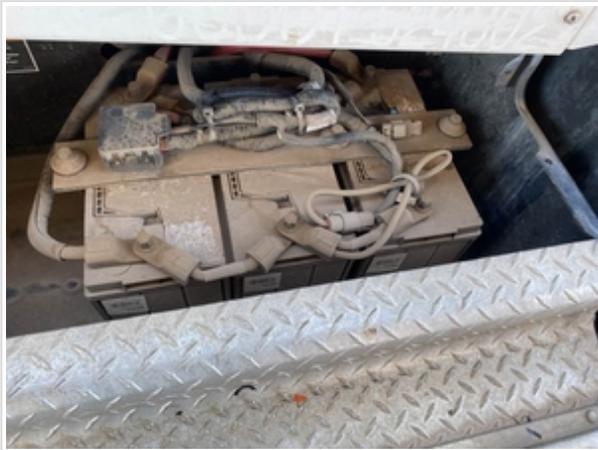
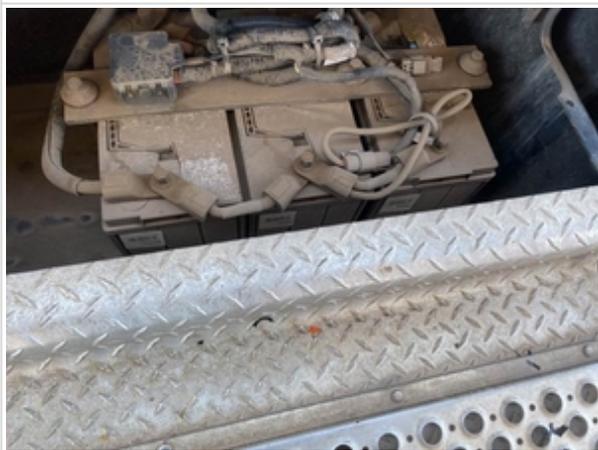
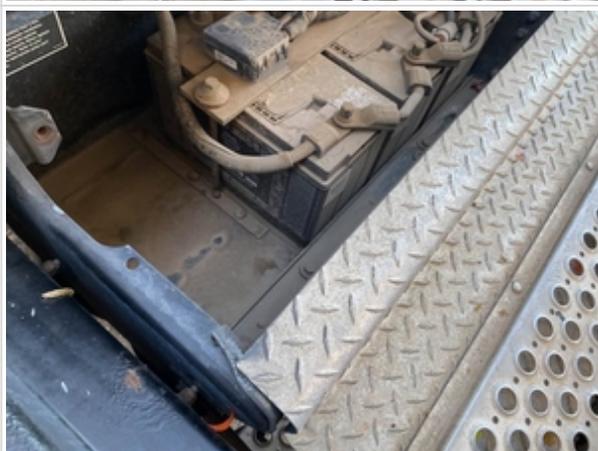
| <p>Battery Condition Photos</p> | |

| <b>Battery</b> | 3 - Normal Wear & Tear | |
| <b>Battery Condition</b> | Other (see comments), Dusty & dirty appearance | |
| <b>Comments</b> | Batteries look okay just dusty | |

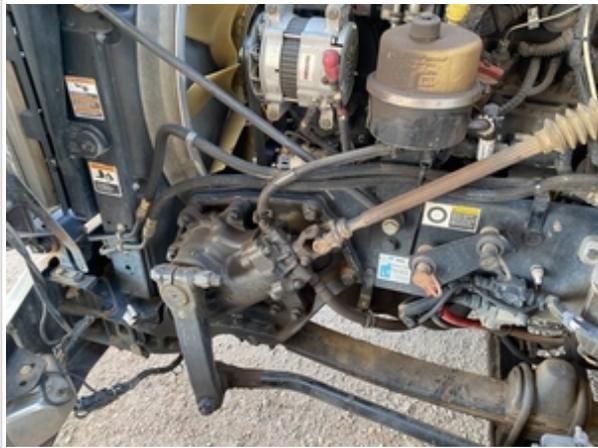
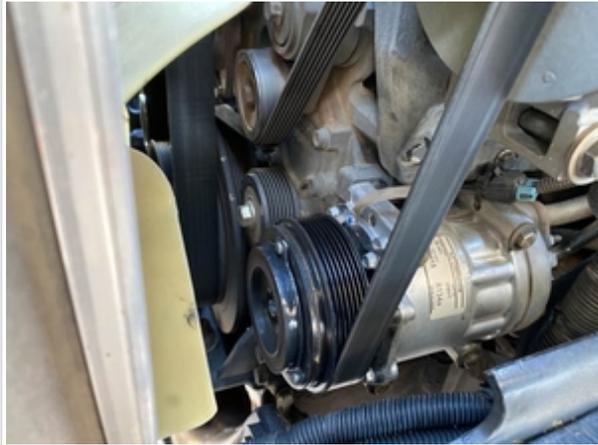
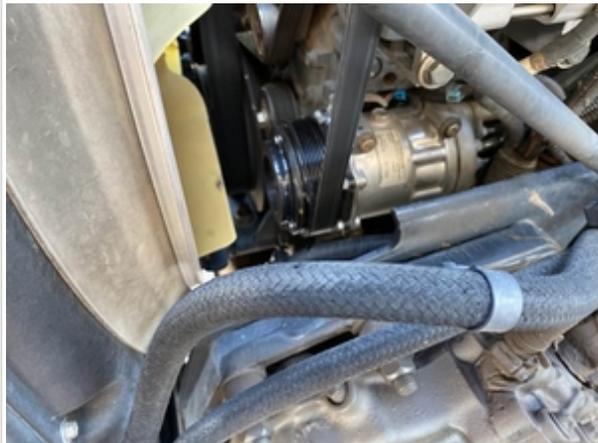
| <b>Belt Photos</b> | |

| <b>Belts</b> | 3 - Normal Wear & Tear |
| <b>Belt Condition</b> | Belts appear in good condition & alignment with proper tension |

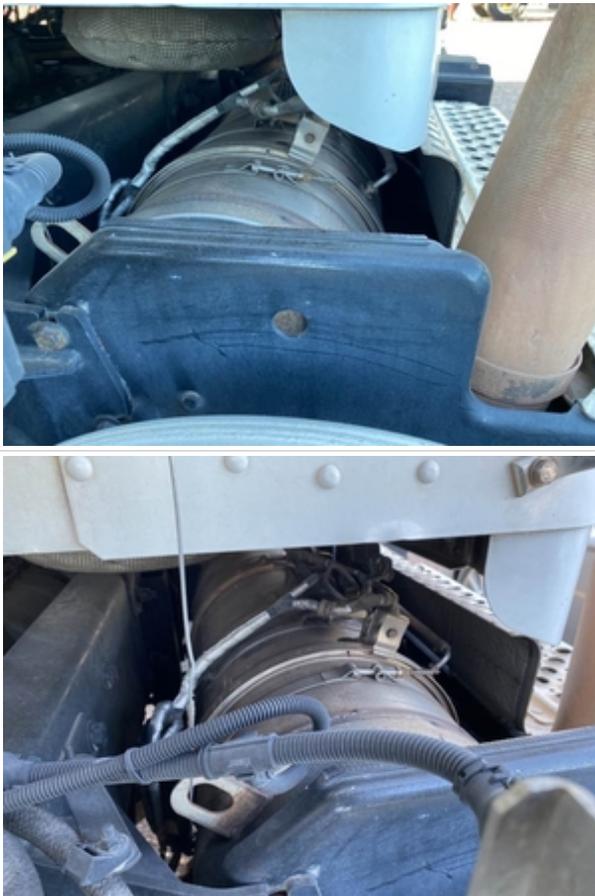
| DPF Photos | |

| DPF Condition | 3 - Normal Wear & Tear |
| DPF Condition Notes | Filter housing is intact with no signs of damage or malfunction, DPF indicator is not illuminated |

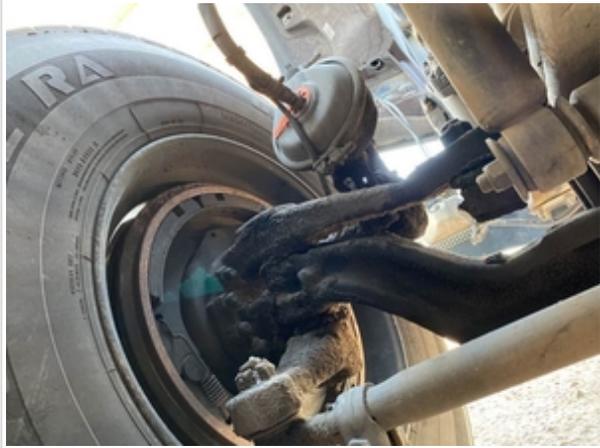
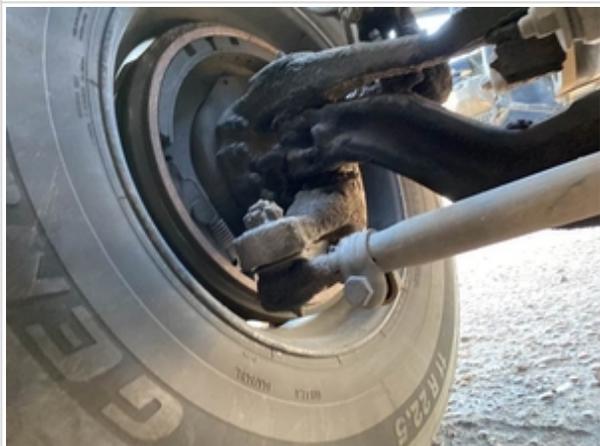
| <b>Air Brake System Photos</b> | | |

| <b>Brake System Type</b> | Air Brakes | |
| <b>Air Brakes Build Correct Pressure</b> | Yes | |
| <b>Air Brake System Leaks</b> | No | |
| <b>Comments</b> | Brake shoes look recently replaced | |
