Inspection Report (Skip Loader)

Year	2016
Make	John Deere
Model	210K
Serial Number	1T8210EKTFG892310
Hour Meter Reading	4,159.3
Previous Application (e.g., earth moving, mining, demolition, etc)	Asphalt Paving

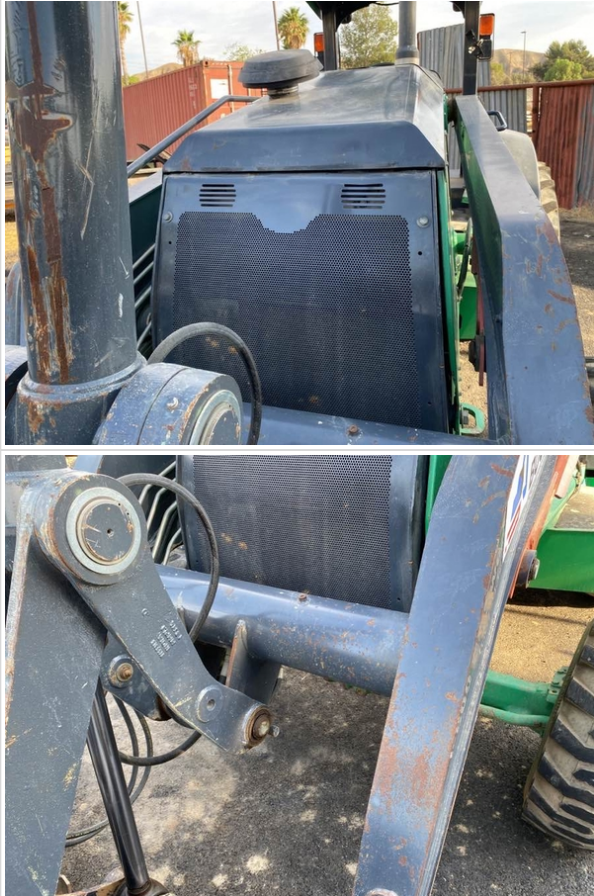
Front	3 - Normal Wear & Tear
Front Condition	Visible chipped paint or dents, Areas of surface rust observed, Other (see comments)
Comments	Normal wear and tear
Front Photos

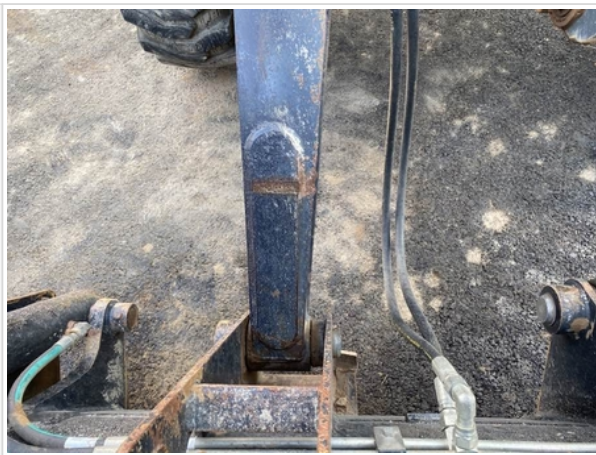
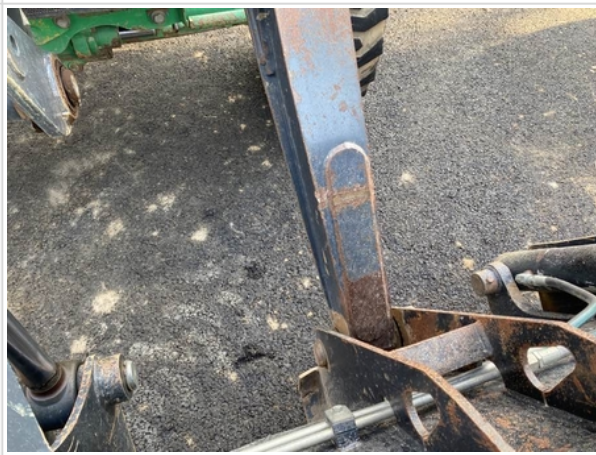
Rear	3 - Normal Wear & Tear
Rear Condition	No visible damage, Other (see comments)
Comments	Normal wear and tear on gannons
Rear Photos

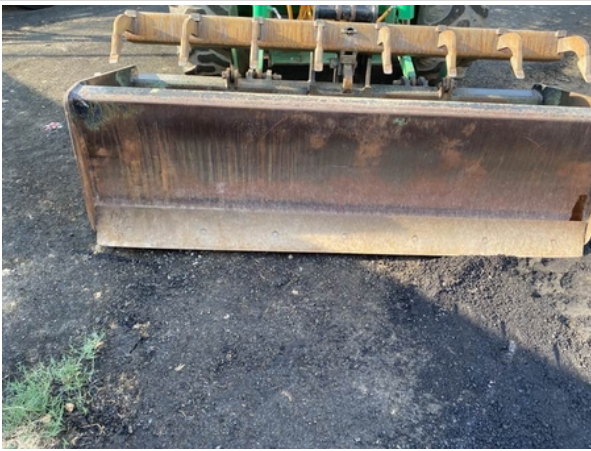
Left	3 - Normal Wear & Tear	
Left Condition	No visible damage, Other (see comments)	
Comments	Rear wheel scuff marks	
Left Photos

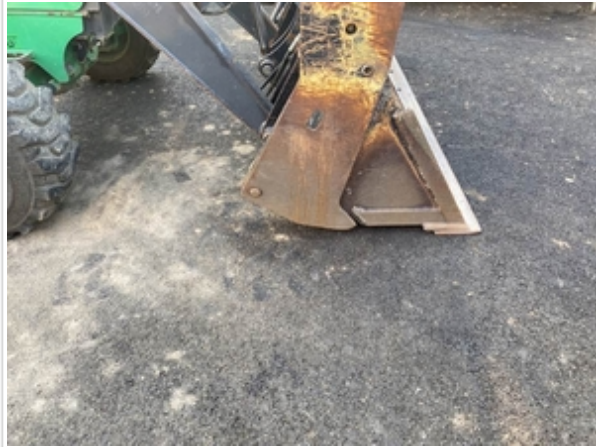
Right	3 - Normal Wear & Tear
Right Condition	No visible damage
Right Photos

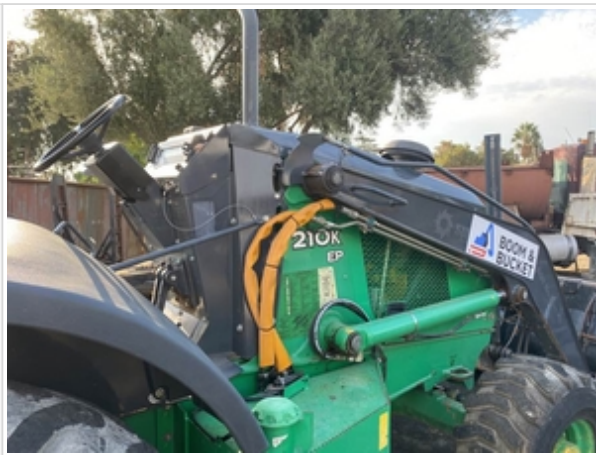
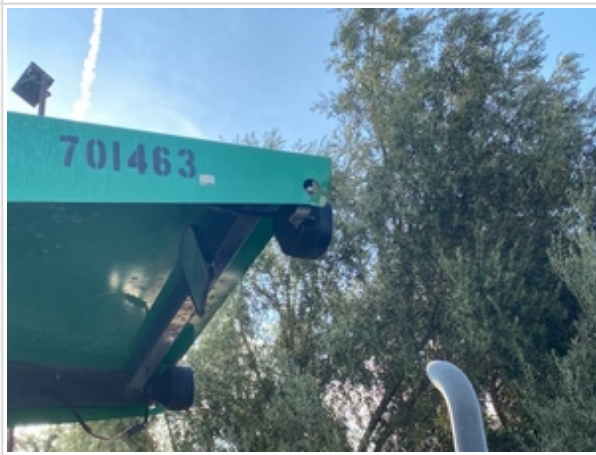
Upper	3 - Normal Wear & Tear
Upper Condition	Visible chipped paint or dents, Other (see comments)
Comments	Small dents on corner and rear
Upper Photos

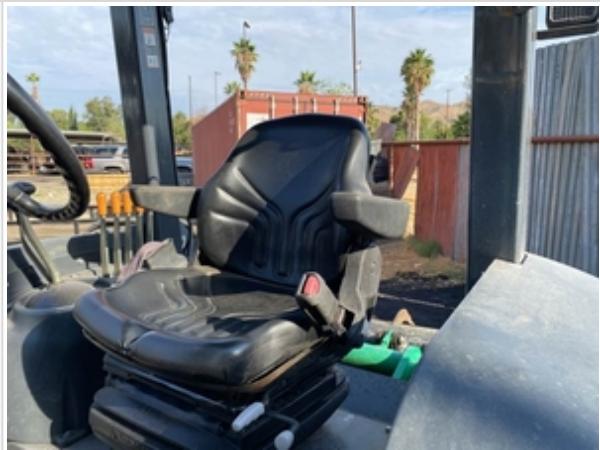
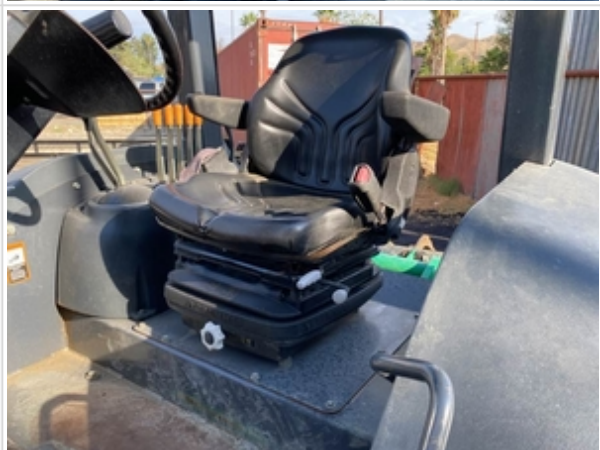
Operator's Seat & Arm Rests	3 - Normal Wear & Tear	
Operator's Seat & Arm Rests Condition	Seat(s) in good condition, no stains or tears in upholstery	
Operator's Seat & Arm Rests Photos

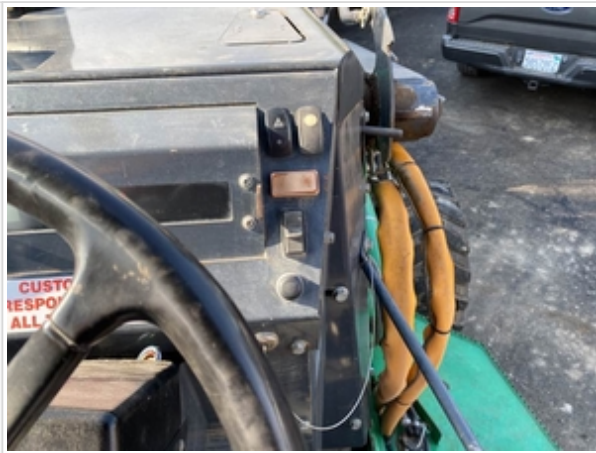
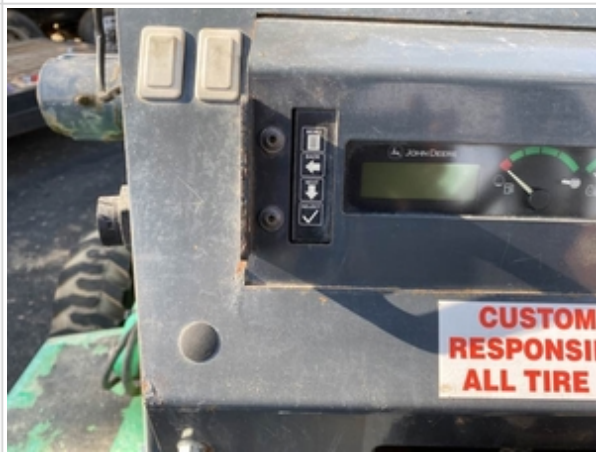
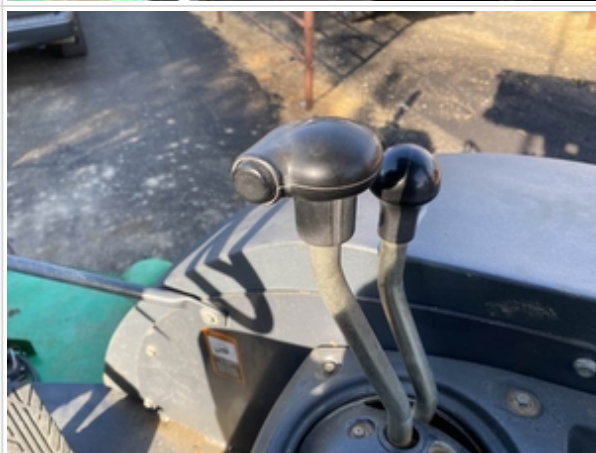
<p>Controls & Switches Photos</p>

Cabin Lights	0
Safety Lock Out / Stop	0
Controls & Switches	3 - Normal Wear & Tear
Controls & Switches Condition	All switches are installed and functional, Switches have good functionality, minor cosmetic damage observed

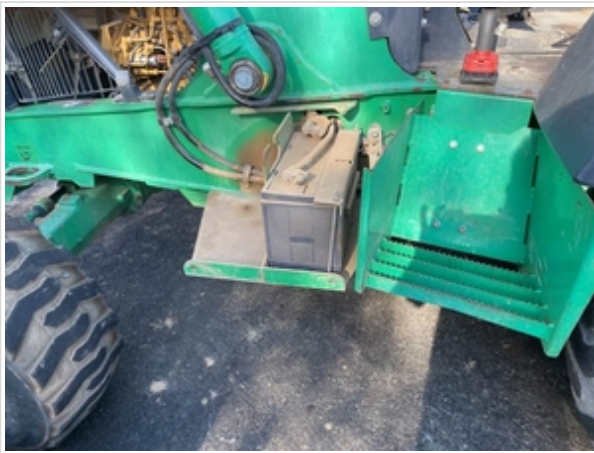
Battery Condition Photos

Blow-by (Visual Observation Check)	No
Unusual Noises (Upon Start-up, Idle, Shutdown)	No
Unusual Noise Notes	No unusual noises heard
Engine Smoke (Upon Start-up, Idle, Shutdown)	No
Engine Smoke Notes	Engine smoke observed upon start up, Continuous engine smoke observed during operation
Comments	Engine smoke consistent from start up to being put under load. Not heavy smoke but visible
Engine Exhaust Color	Black
Battery	3 - Normal Wear & Tear

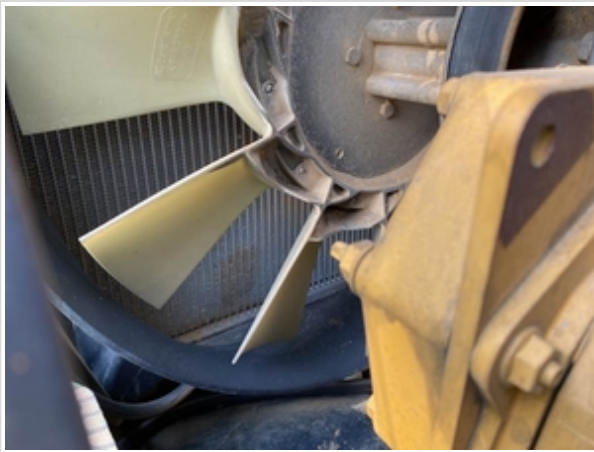
Radiator	3 - Normal Wear & Tear
Radiator Condition	Radiator fins & components appear to be in good working order, no signs of damage or leaks
Radiator Photos

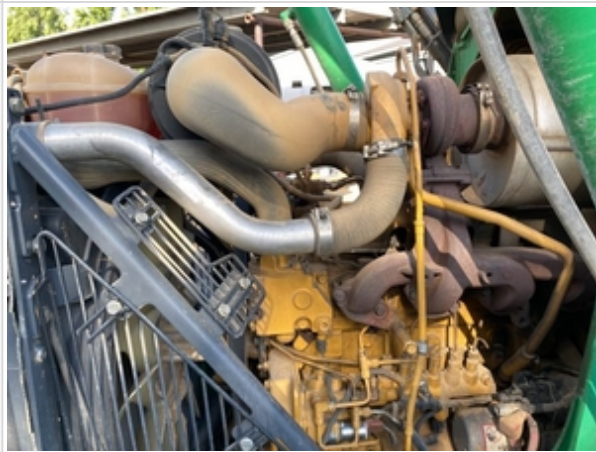
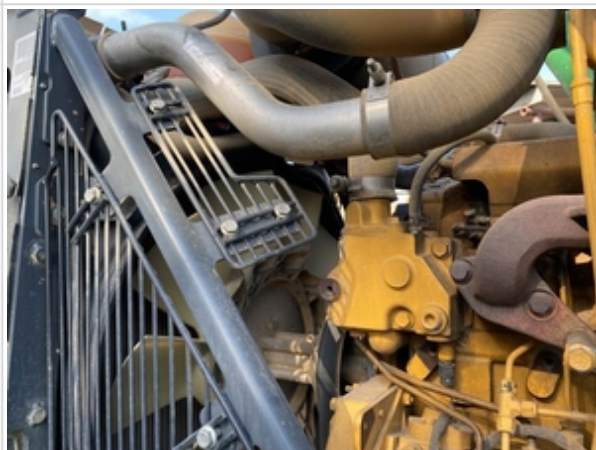
Hoses	3 - Normal Wear & Tear	
Hose Condition	Firm, pliant hoses with no signs of wear or leaks	
Hose Photos

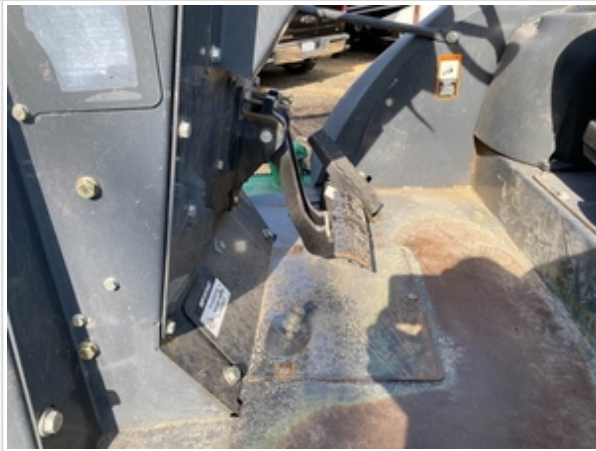
Foot Brake Photos

Foot Brake	3 - Normal Wear & Tear	
Foot Brake Condition	Good brake function

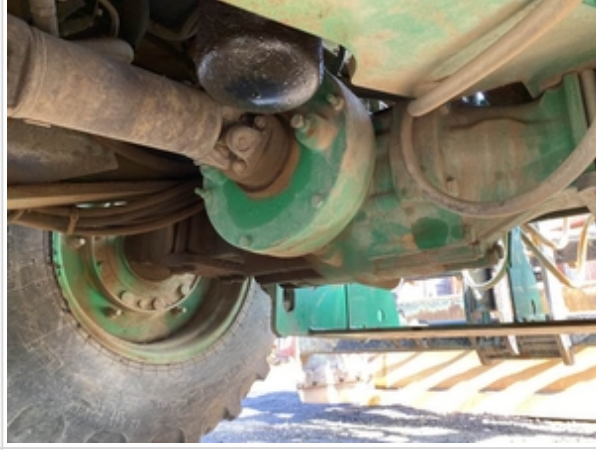
Inching Brake	0
Parking Brake	3 - Normal Wear & Tear
Parking Brake Condition	Good brake function
Parking Brake Photos

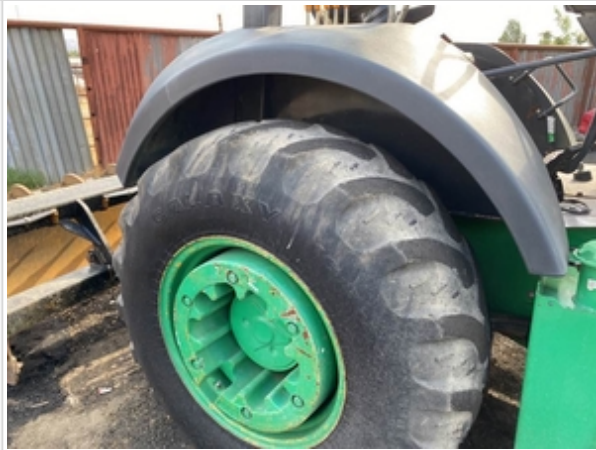
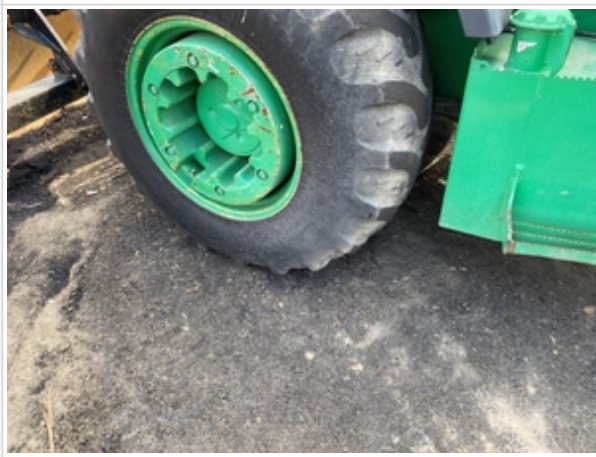
Tire Brand	Front Camso rear Galaxy
Tire Size	Front 12 -16.5 Rear 16.9 -24
Front Left Tire - Ratio Remaining	30%
Rear Left Tire - Ratio Remaining	10%
Front Right Tire - Ratio Remaining	90%
Rear Right Tire - Ratio Remaining	10%
Lift Arm	3 - Normal Wear & Tear
Lift Arm Photos

Quality Rating	3
Functionality Rating	4
Overall Rating	3
What's Great About the Machine	This machine is solid all the way around. No leaks found and no major repairs required from a visual standpoint.
What Needs Work	3 of the 4 tires need to be replaced soon. Front bucket pins squeal and may just need grease. Engine needs to be serviced to start addressing minor exhaust smoke. Control panel buttons and switches decals worn. (Unable to read switch functions) Hydraulic filter seepage, should be replaced. Work lights, turn signals inoperable. Valve cover gasket may need to be replaced soon.
Any Additional Info from the Seller?	N/a
Date/Time	09-09-2022

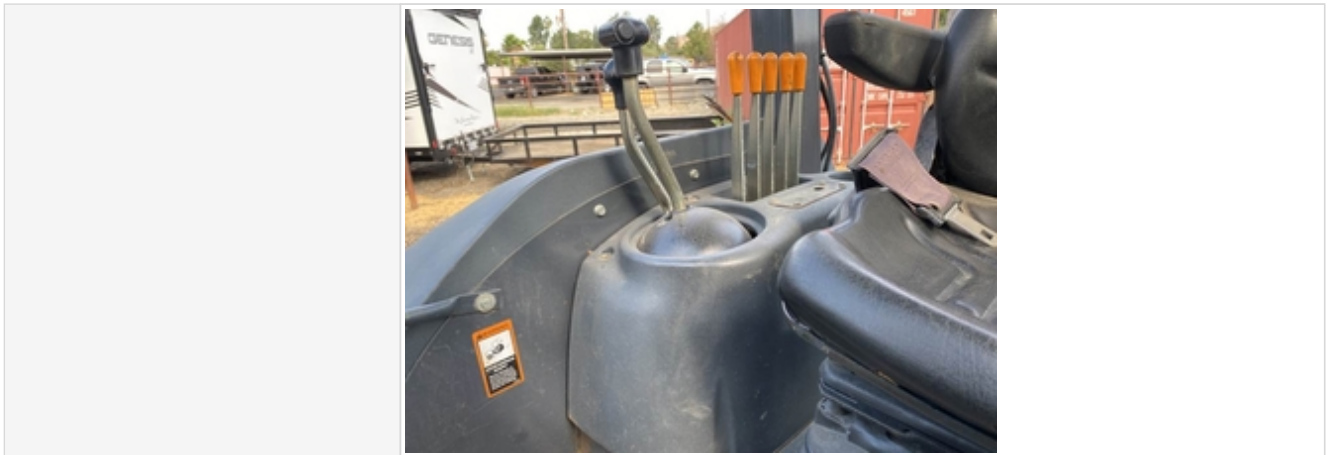
Hydraulic Lines / Fittings Condition	Hydraulic lines & fittings are clean and in good condition, Twisted, kinked, or flattened hydraulic hoses, Other (see comments)
Comments	Front hardlines for front bucket tilt cylinder slightly bent but functions well
Unusual Noises (Hydraulic Pump)	No
External Controls / Levers	3
External Controls / Levers Condition	Good function & condition of hydraulic controls
External Controls / Levers Photos

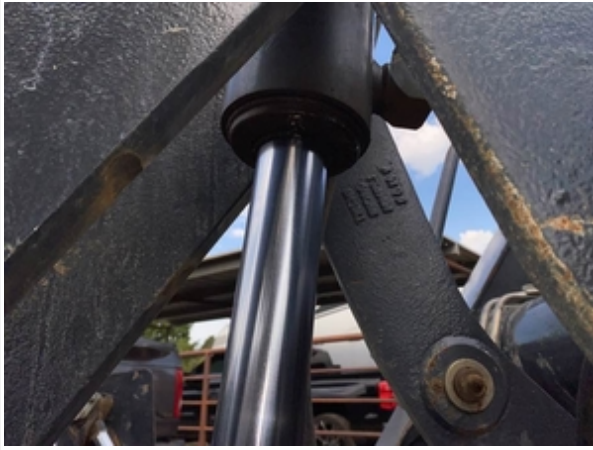
Bucket Lift / Tilt Cylinders	Check the bucket lift and tilt cylinders. Note any wear, pitting, discoloration, etc. Take photos.
Bucket Lift / Tilt Cylinders: Mounting Pin	3
Bucket Lift / Tilt Cylinders: Oil Leaks	No
Comments	Front tilt cylinder starting to seep oil out of rod seal
Bucket Lift / Tilt Cylinders Photos
