## Inspection Report (Vibratory Compactor)

Year	2016
Make	HAMM
Model	HD 12 VV
Serial Number	H2300767
Hour Meter Reading	881.2
Previous Application (e.g., earth moving, mining, demolition, etc)	Equipment Rental

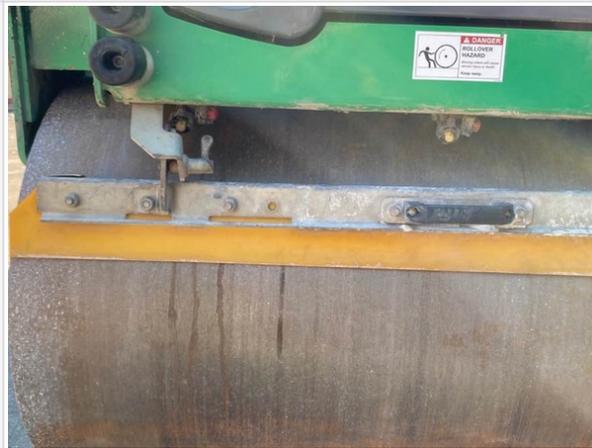
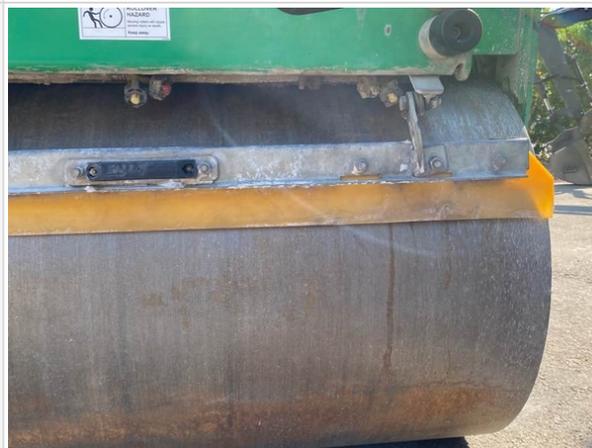
Front Photos

Front	3 - Normal Wear & Tear
Front Condition	No visible damage, Visible chipped paint or dents, Other (see comments)
Comments	Normal wear and tear no major damage

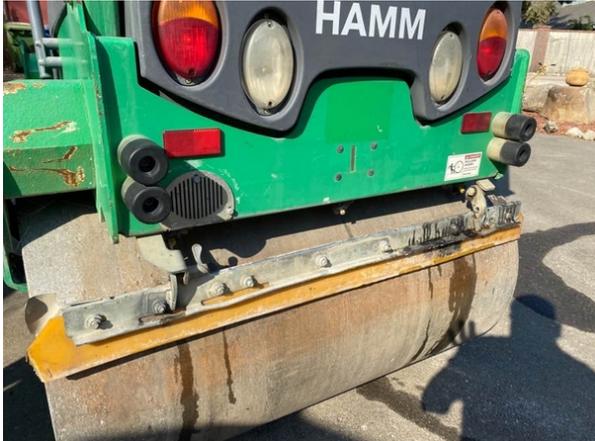
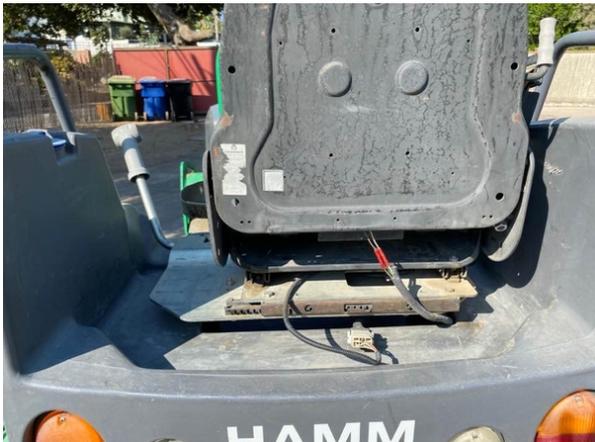
<b>Rear</b>	3 - Normal Wear & Tear
<b>Rear Condition</b>	No visible damage, Visible chipped paint or dents
<b>Comments</b>	Normal wear and tear no major damage
<b>Rear Photos</b>

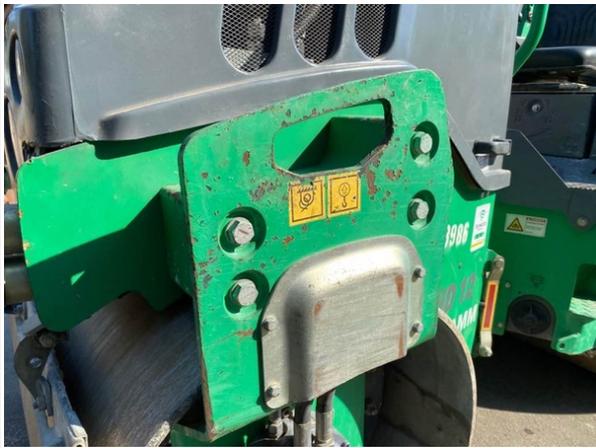
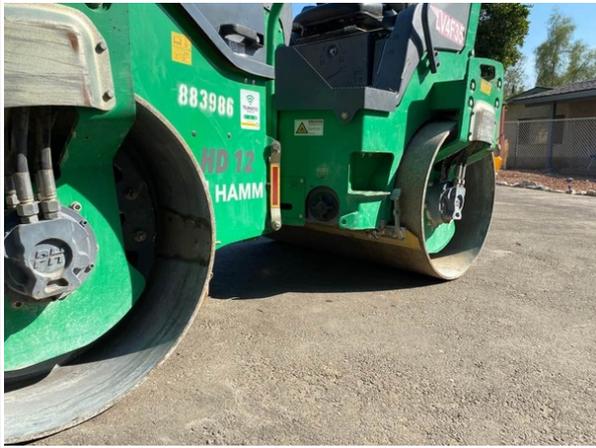
Left Photos

<b>Left</b>	3 - Normal Wear & Tear
<b>Left Condition</b>	No visible damage, Visible chipped paint or dents, Other (see comments)
<b>Comments</b>	Normal wear and tear minor scuff marks

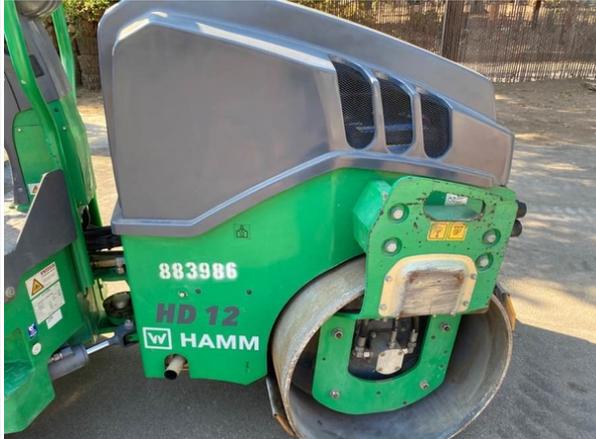
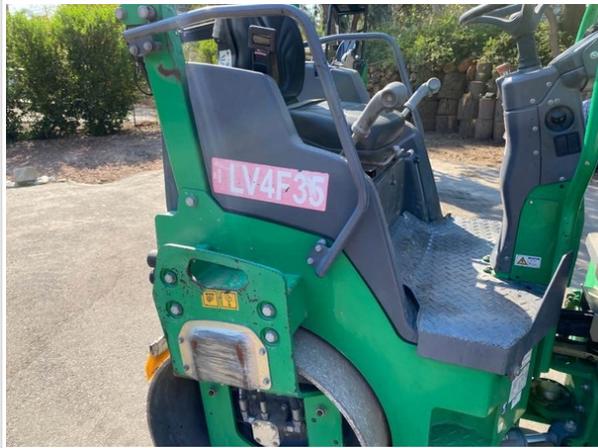
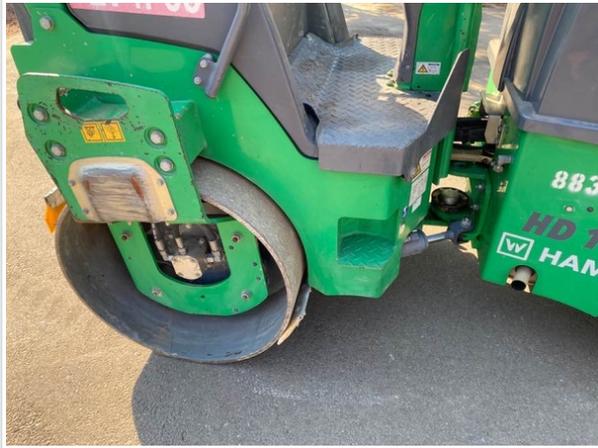
<b>Right</b>	3 - Normal Wear & Tear
<b>Right Condition</b>	No visible damage, Visible chipped paint or dents, Other (see comments)
<b>Comments</b>	Normal wear and tear scuff marks
<b>Right Photos</b>

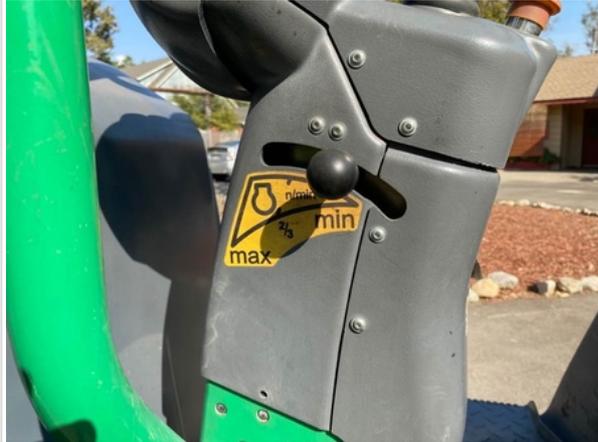
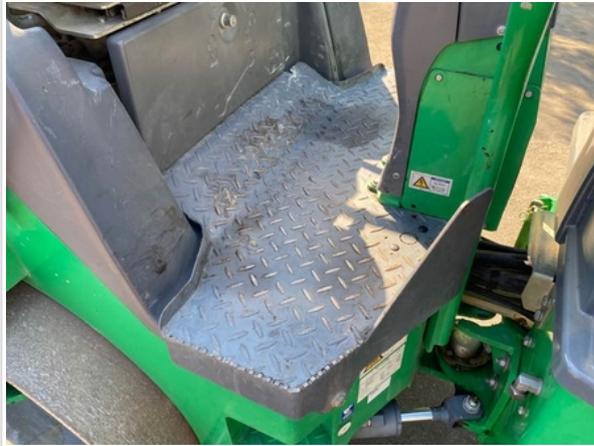
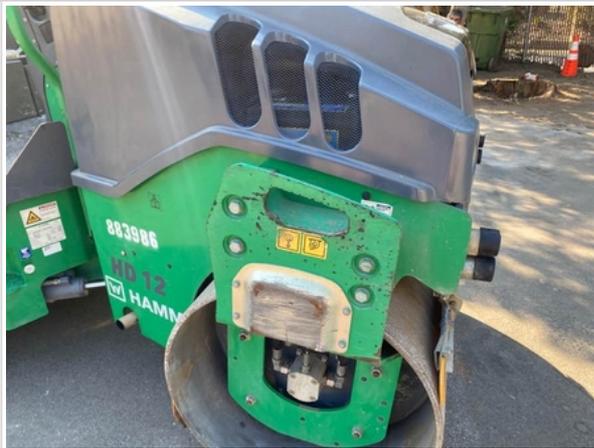
<b>Body Panels (Any Rust Damage?)</b>	3 - Normal Wear & Tear
<b>Body Panel Condition</b>	No visible damage, good paint condition and panel fitment, Other (see comments)
<b>Comments</b>	Small crack on front left side of hood and scuff marks on some panels but most minor scratches
<b>Body Panels Photos</b>

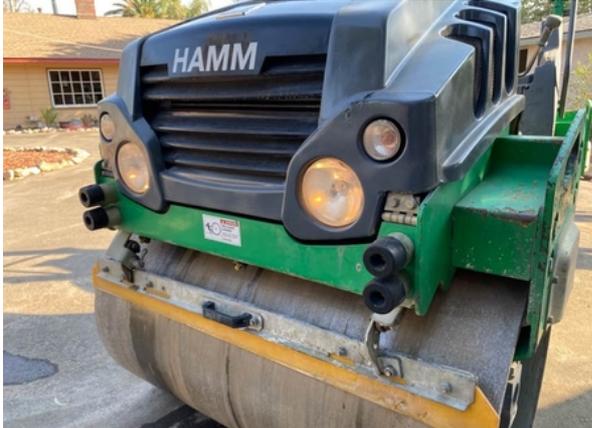
Doors / Canopy Latches	3 - Normal Wear & Tear	
Doors / Canopy Latches Condition	No visible damage	
Glass Condition	0	
Mirrors	0	
Lighting System	3 - Normal Wear & Tear	
Lighting System Condition	No visible damage, lighting system is operational	
Lighting System Photos

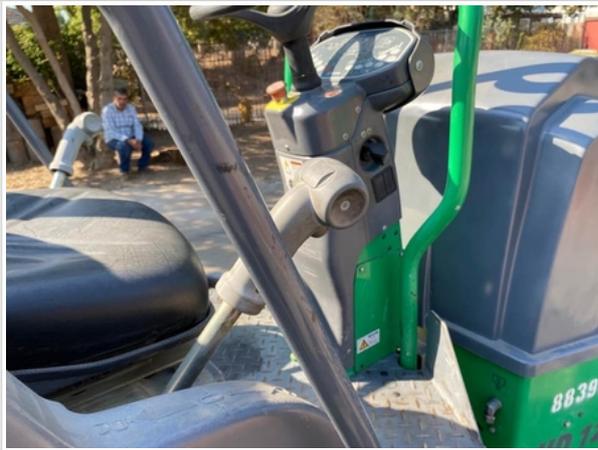
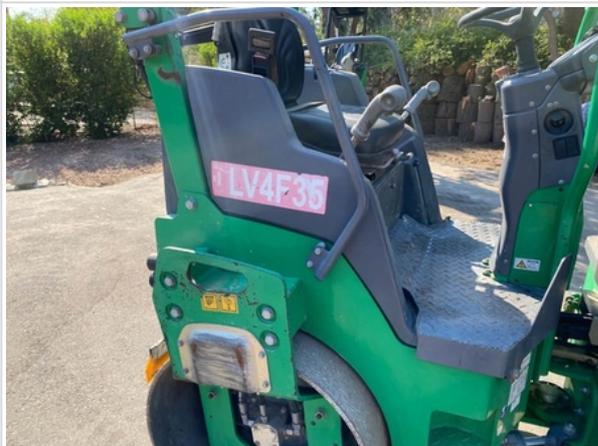
<p>Operator Cabin Overall</p>	<p>3 - Normal Wear &amp; Tear</p>
<p>Operator Cabin Overall Condition</p>	<p>Good cabin appearance, solid floors, panels, and ceiling, Minor cosmetic wear to cabin surfaces, floors, panels, and ceiling</p>
<p>Operator Cabin Photos</p>

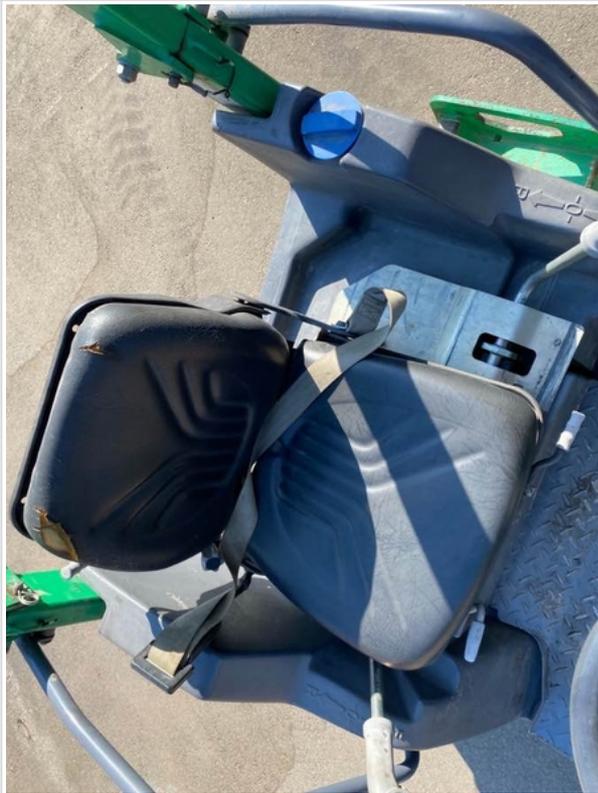
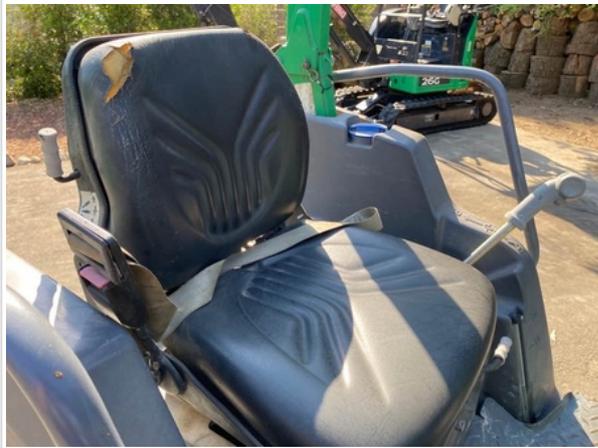
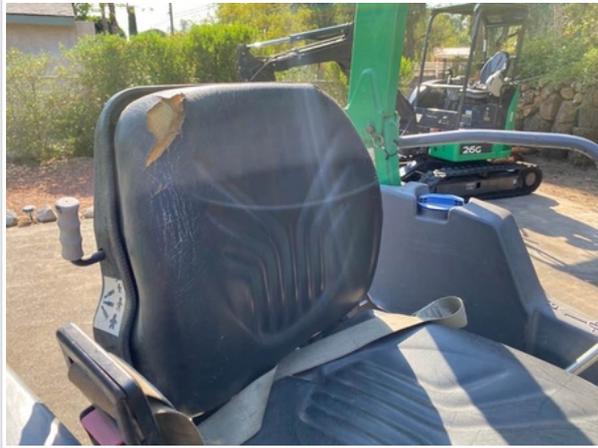
<b>Operator's Seat &amp; Arm Rests</b>	3 - Normal Wear & Tear
<b>Operator's Seat &amp; Arm Rests Condition</b>	Seat(s) in good condition, no stains or tears in upholstery, Seat(s) have minor surface staining or small tears, Other (see comments)
<b>Comments</b>	Top of seat cushion torn
<b>Operator's Seat &amp; Arm Rests Photos</b>

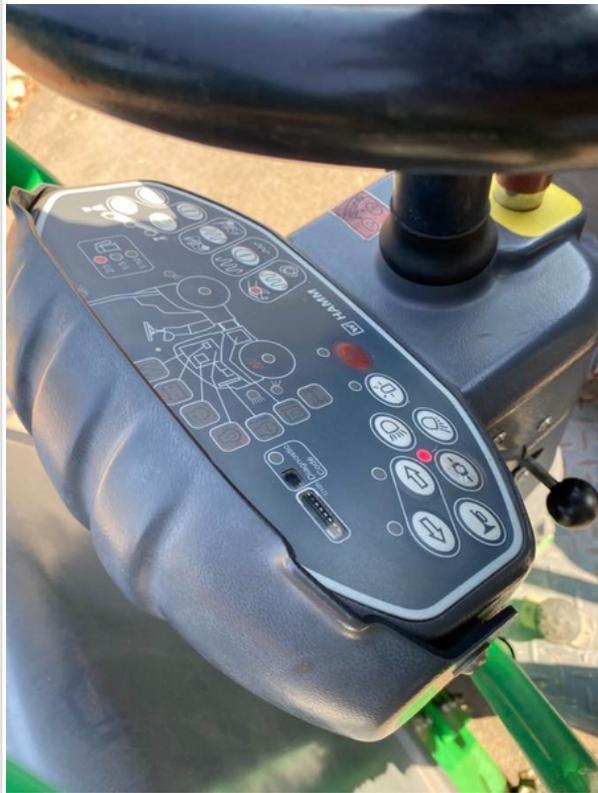
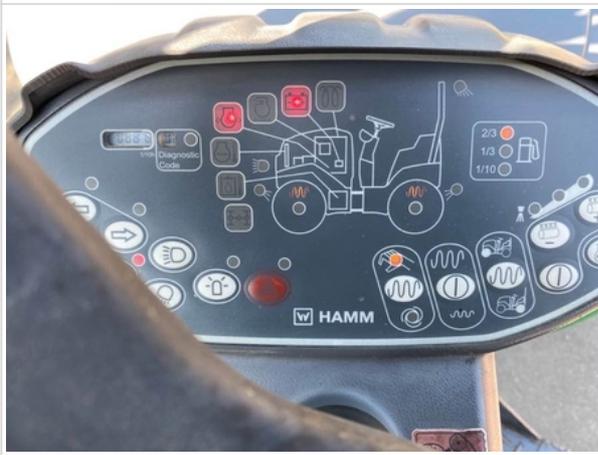
<p>Controls &amp; Switches Photos</p>

<b>Seat Belt</b>	3 - Normal Wear & Tear
<b>Seat Belt Condition</b>	Seat belt secures properly. Belt is intact and in good condition
<b>Cabin Lights</b>	0
<b>Safety Lock Out / Stop</b>	0
<b>Controls &amp; Switches</b>	3 - Normal Wear & Tear
<b>Controls &amp; Switches Condition</b>	All switches are installed and functional

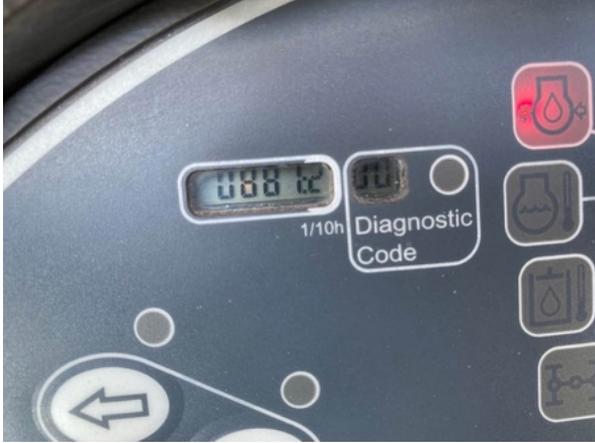
Hour Meter Activity Photos

<p>Hour Meter Activity</p>	<p>3 - Normal Wear &amp; Tear</p>
<p>Hour Meter Condition</p>	<p>Hour meter is functional and in good condition</p>

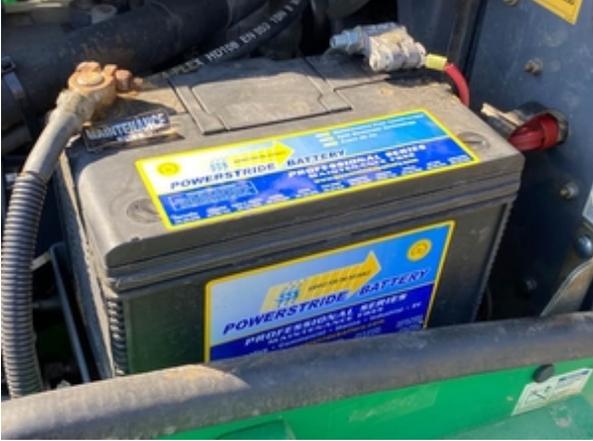
<b>Battery Condition Photos</b>

<b>Blow-by (Visual Observation Check)</b>	No	
<b>Unusual Noises (Upon Start-up, Idle, Shutdown)</b>	No	
<b>Unusual Noise Notes</b>	No unusual noises heard	
<b>Engine Smoke (Upon Start-up, Idle, Shutdown)</b>	No	
<b>Engine Smoke Notes</b>	No engine smoke issues observed	
<b>Engine Exhaust Color</b>	Clear	
<b>Battery</b>	3 - Normal Wear & Tear	
<b>Battery Condition</b>	Like new, recently replaced

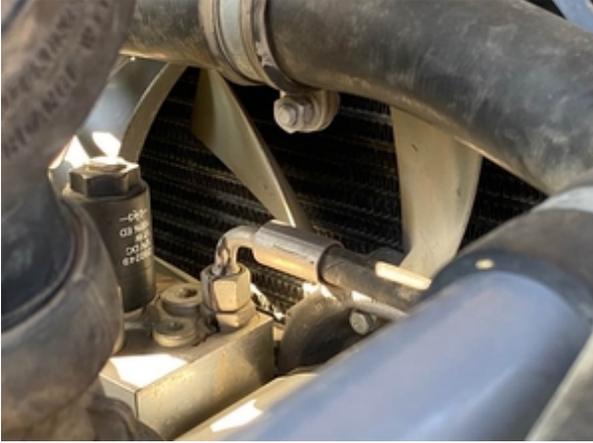
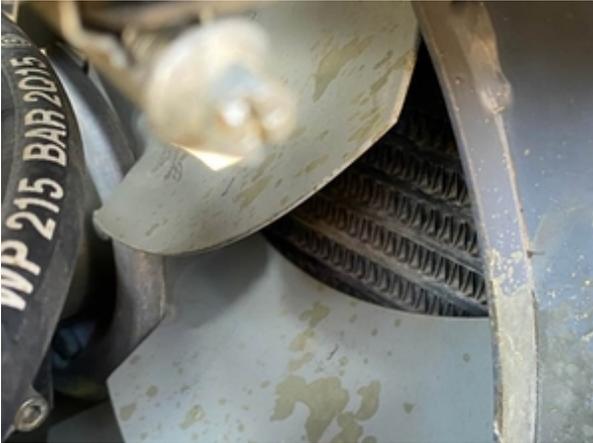
<b>Radiator</b>	3 - Normal Wear & Tear
<b>Radiator Condition</b>	Radiator fins & components appear to be in good working order, no signs of damage or leaks
<b>Radiator Photos</b>

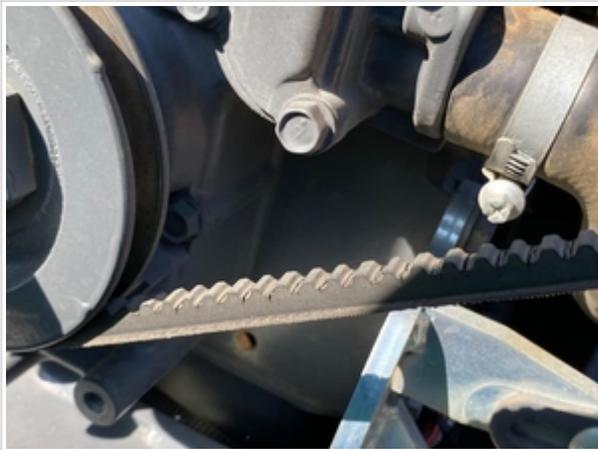
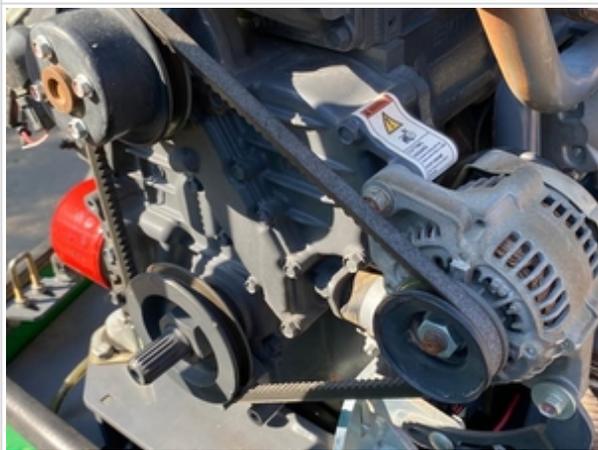
<b>Belt Photos</b>

<b>Belts</b>	3 - Normal Wear & Tear
<b>Belt Condition</b>	Belts appear in good condition & alignment with proper tension

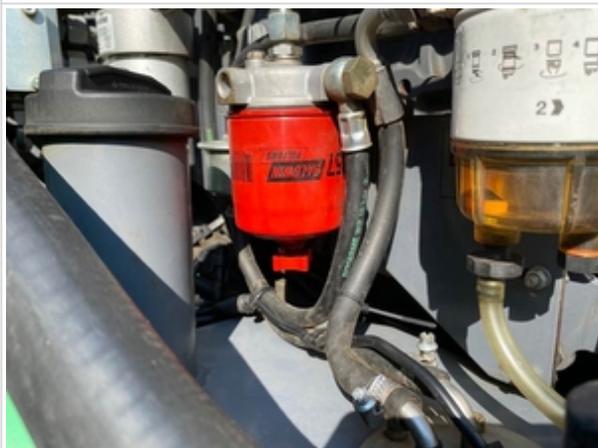
<b>Hoses</b>	3 - Normal Wear & Tear
<b>Hose Condition</b>	Firm, pliant hoses with no signs of wear or leaks
<b>Hose Photos</b>

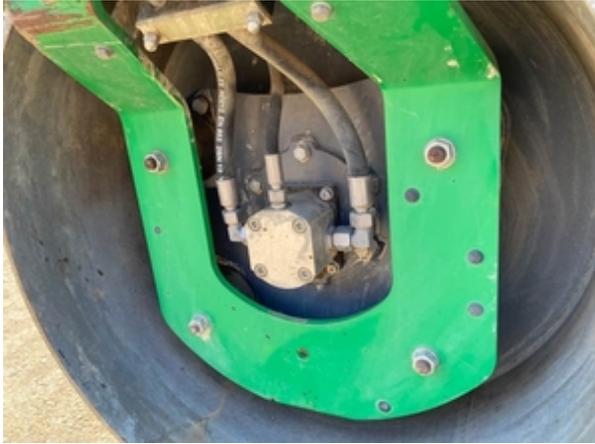
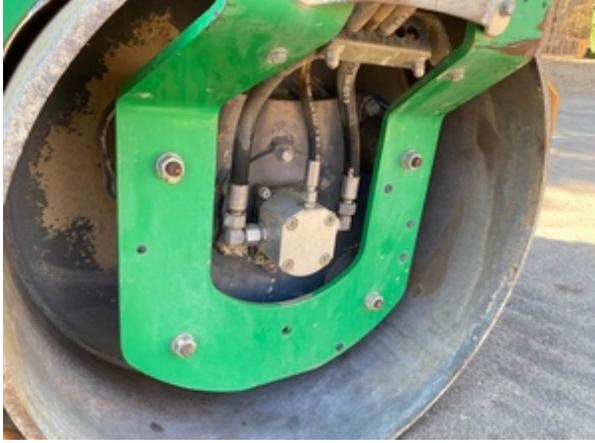
Hydrostatic Transmission?	Yes
2 Speed?	Yes
Hydrostatic Drive Configuration	Other (see comments)
Comments	Hydrostatic driven
Drive Motors	2 - Above Average Wear
Comments	In good shape
Drive Motor Photos

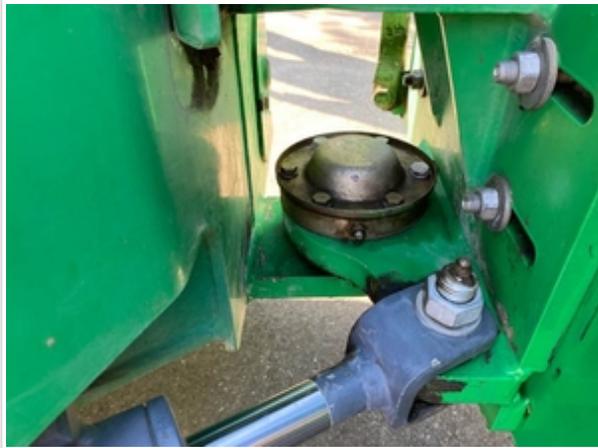
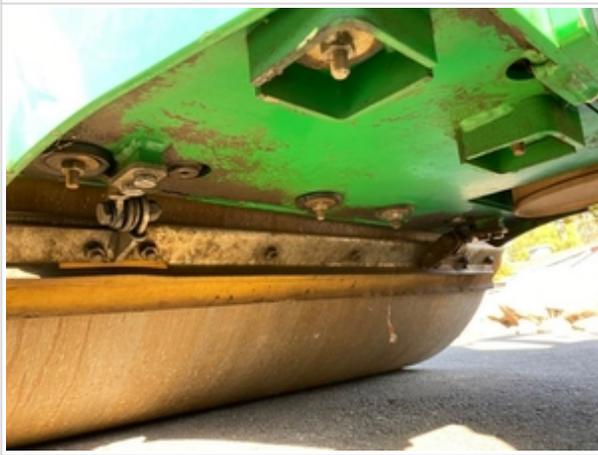
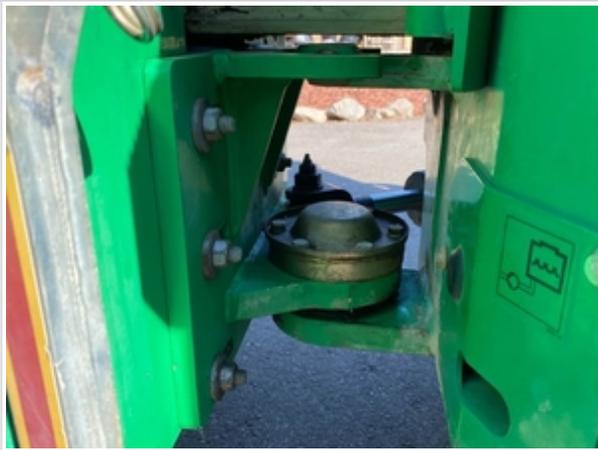
<p>Frame Photos</p>

Frame	3 - Normal Wear & Tear
Comments	No issues found with frame

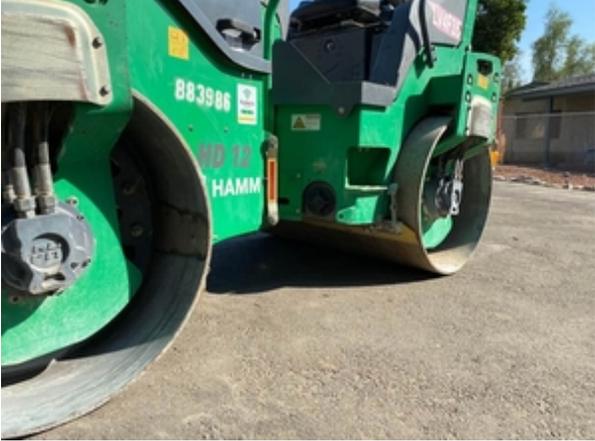
<b>Level Stance</b>	3 - Normal Wear & Tear	
<b>Comments</b>	Machine sits normal	
<b>Level Stance Photos</b>

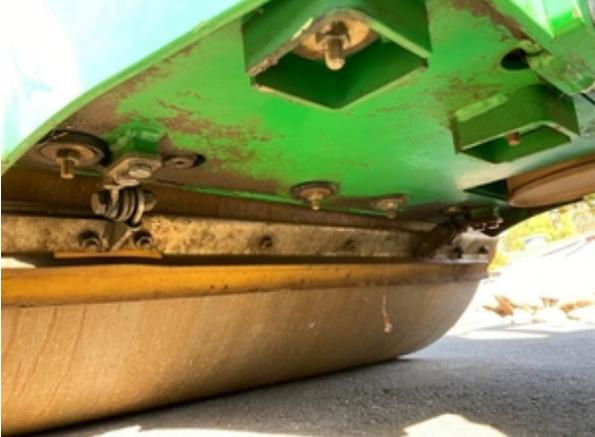
<b>Drum(s) Condition</b>	3 - Normal Wear & Tear	
<b>Comments</b>	Drums in great condition	
<b>Drum(s) Photos</b>

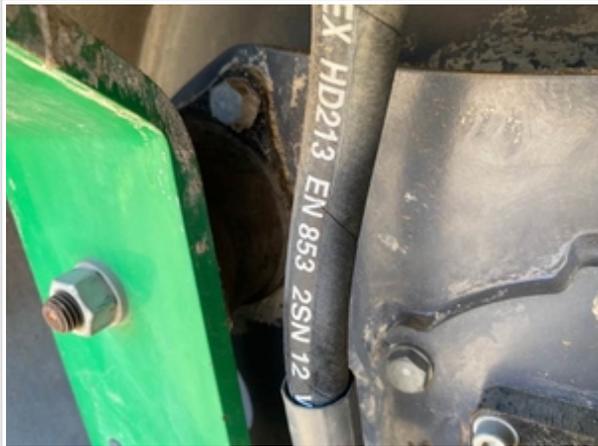
<p>Vibratory Rubber Mounts (Front &amp; Rear)</p>	<p>3 - Normal Wear &amp; Tear</p>	
<p>Vibratory Rubber Mounts (Front &amp; Rear) Photos</p>

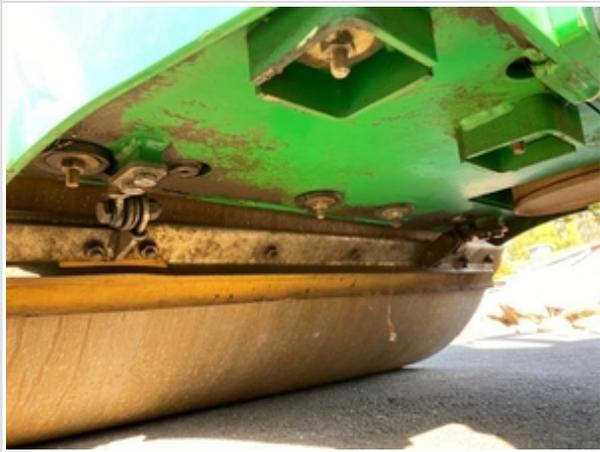
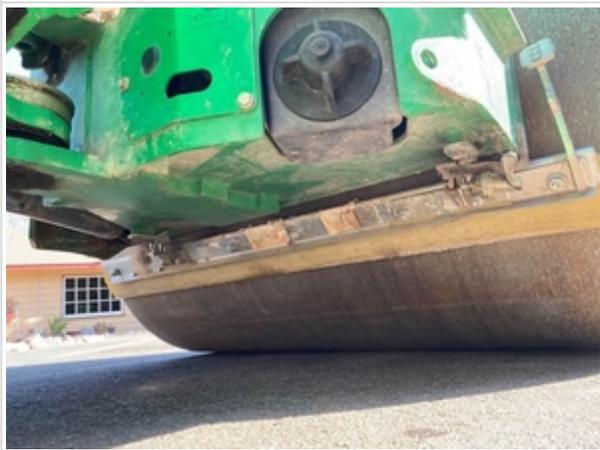
<p>Drum Scraper</p>	<p>3 - Normal Wear &amp; Tear</p>	
<p>Drum Scraper Photos</p>

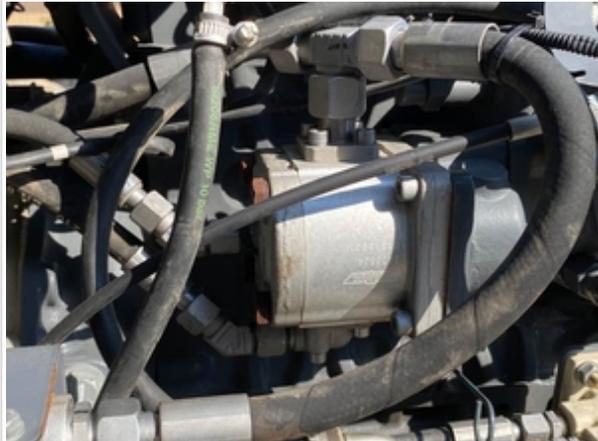
<b>Wet or Damp Hydraulic Lines / Fittings</b>	No
<b>Appearance of Hydraulic Lines / Fittings</b>	3
<b>Hydraulic Lines / Fittings Condition</b>	Hydraulic lines & fittings are clean and in good condition
<b>Appearance of Hydraulic Lines / Fittings Photos</b>

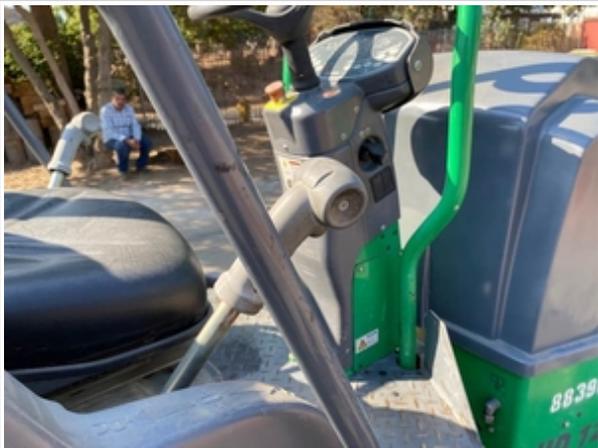
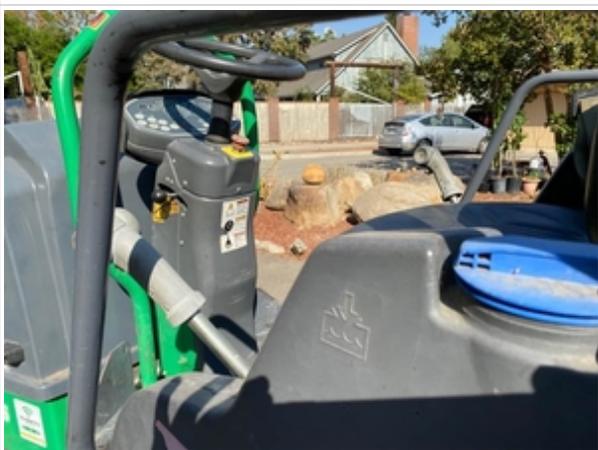
<b>Unusual Noises (Hydraulic Pump)</b>	No	
<b>Hydraulic Pump Notes</b>	No unusual noises heard during operation	
<b>External Controls / Levers</b>	3	
<b>External Controls / Levers Condition</b>	Good function & condition of hydraulic controls	
<b>External Controls / Levers Photos</b>

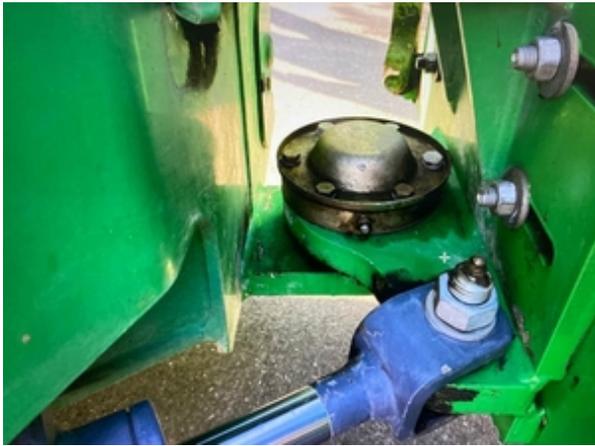
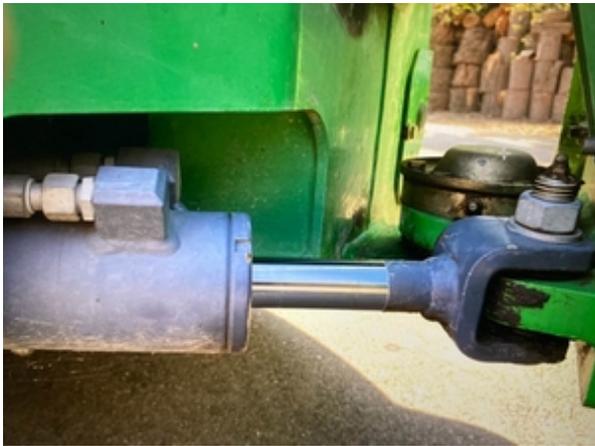
Steering Cylinders	Check the steering cylinder. Note any wear, pitting, discoloration, etc. Take photos.
Steering Cylinders: Mounting Pin	3
Steering Cylinders: Oil Leaks	No
Steering Cylinders Photos
