## Inspection Report (Skid Steer)

Year	2017
Make	Bobcat
Model	S770
Serial Number	AT5A12197
Hour Meter Reading	2673 hours
Previous Application (e.g., earth moving, mining, demolition, etc)	Asphalt Paving General Construction

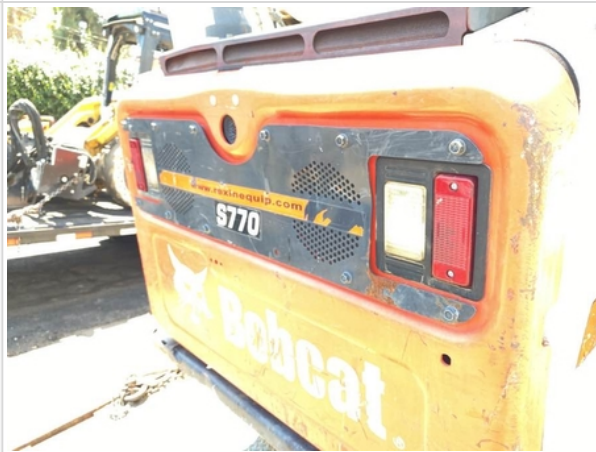
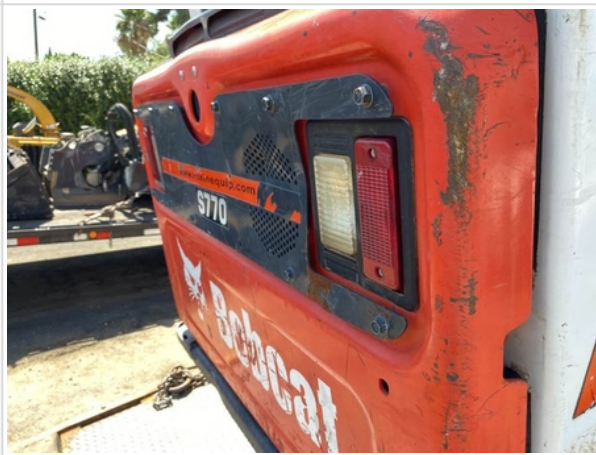
Rear	3 - Normal Wear & Tear
Comments	Small dent in rear door vent cover
Rear Photos

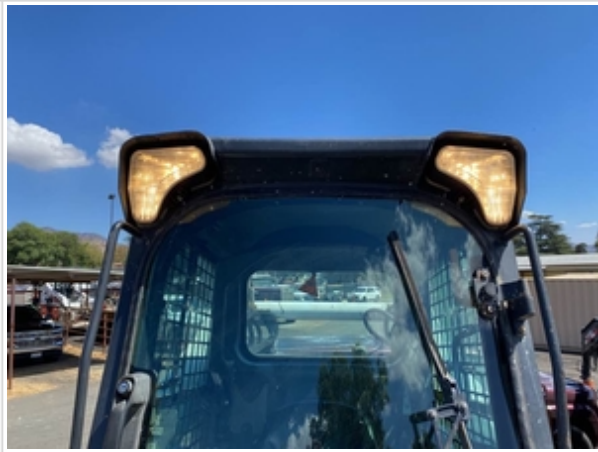
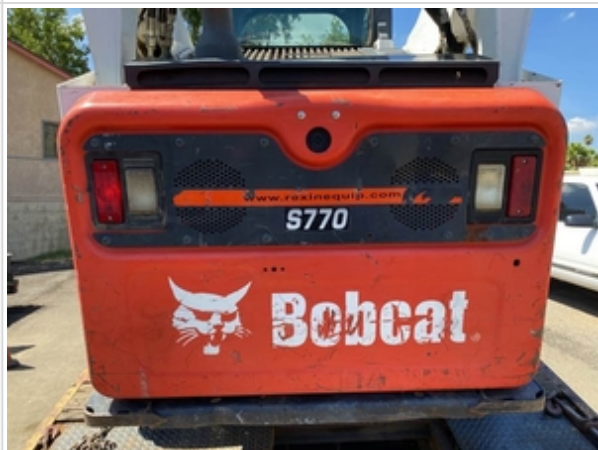
Mirrors	0	
Lighting System	3 - Normal Wear & Tear	
Comments	Front lights okay. Left side running lamp okay. Rear lights inop.	
Lighting System Photos

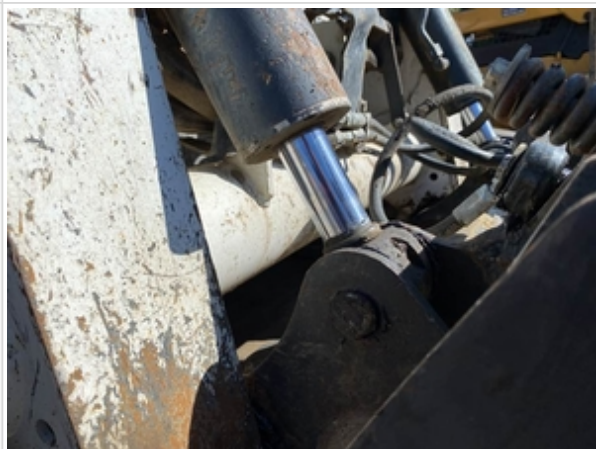
<b>Bucket Cylinder</b>	Check the bucket cylinder. Note any wear, pitting, discoloration, etc. Take photos.
<b>Bucket Cylinder: Mounting Pin</b>	3
<b>Bucket Cylinder: Oil Leaks</b>	No
<b>Comments</b>	Slight damage to left side bucket tilt cylinder barrel nut but not leaking
<b>Bucket Cylinder Photos</b>
