Inspection Report (Vibratory Compactor)

Year	2008
Make	Volvo
Model	SD 116DX
Serial Number	198742
Hour Meter Reading	1,688
Previous Application (e.g., earth moving, mining, demolition, etc)	Paving General Contractor

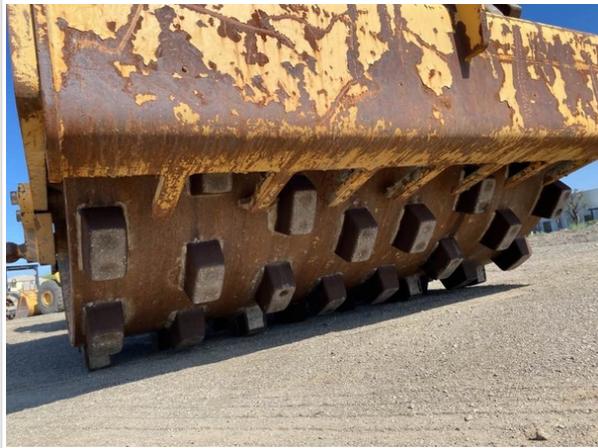
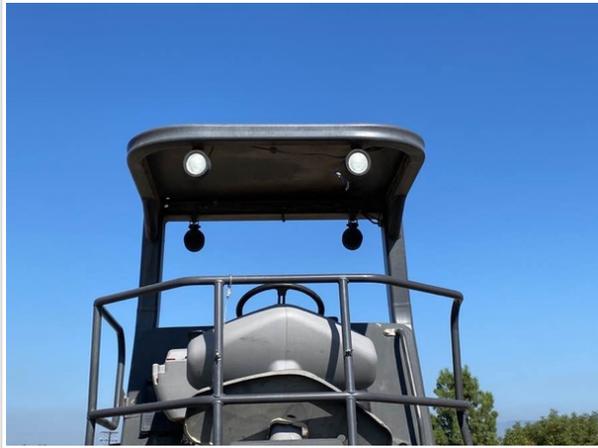
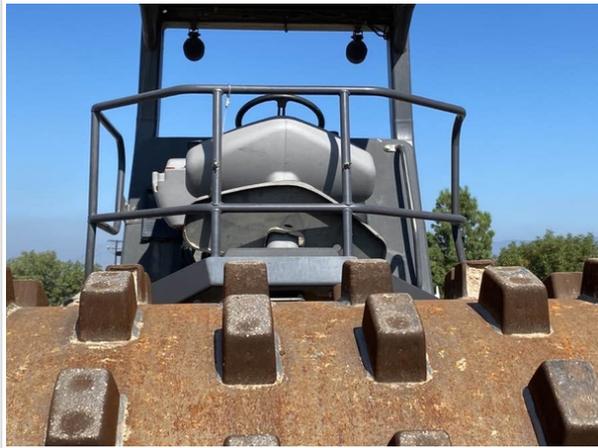
Front	3 - Normal Wear & Tear
Front Condition	No visible damage, Visible chipped paint or dents, Other (see comments)
Comments	No damage just cosmetic scuff marks
Front Photos

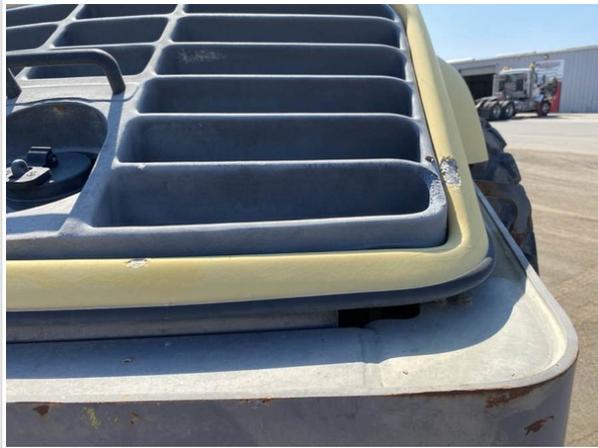
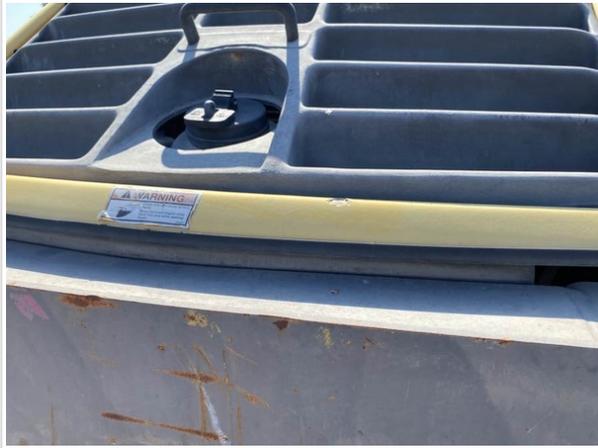
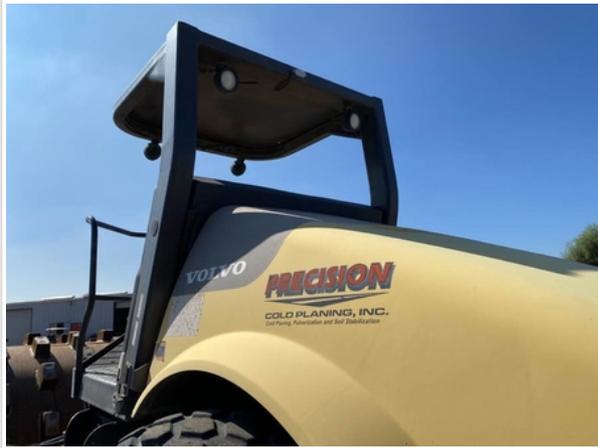
Rear Photos

Rear	3 - Normal Wear & Tear
Rear Condition	No visible damage, Visible chipped paint or dents, Other (see comments)
Comments	No damage just cosmetic scuff marks and minor cracks in fiberglass hood

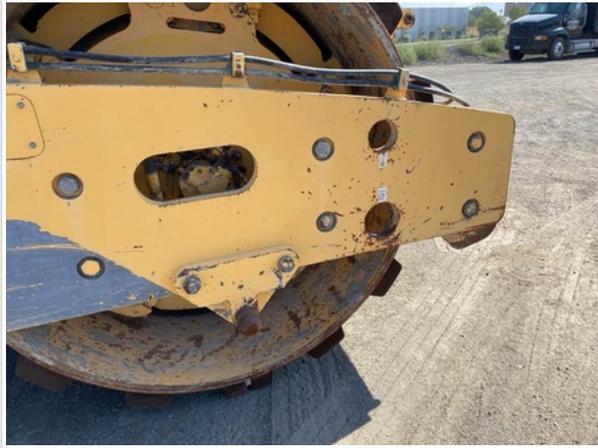
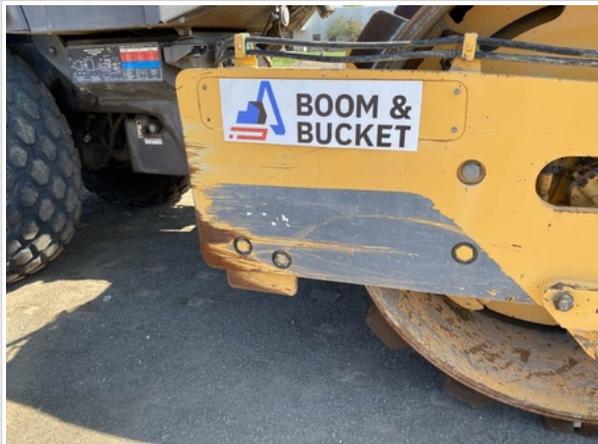
Right	3 - Normal Wear & Tear	
Right Condition	No visible damage, Visible chipped paint or dents, Other (see comments)	
Comments	Slight damage to rear right side tie down hook (bent) and scuff marks	
Right Photos

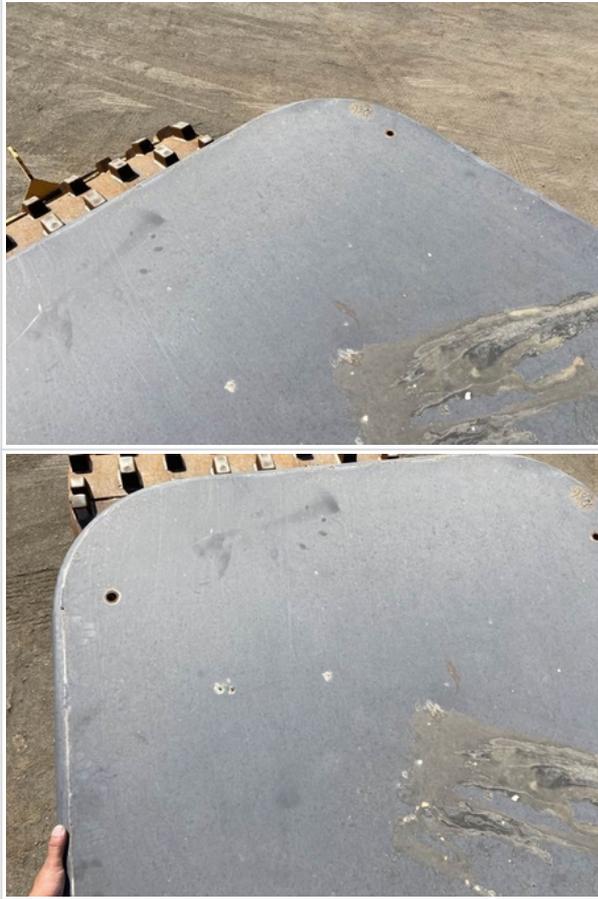
Upper Photos

Upper	3 - Normal Wear & Tear
Upper Condition	No visible damage

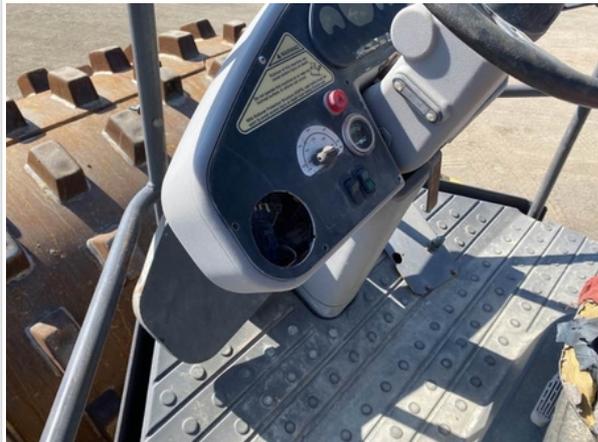
Body Panels (Any Rust Damage?)	3 - Normal Wear & Tear
Body Panel Condition	No visible damage, good paint condition and panel fitment, Other (see comments)
Comments	Operator control panel missing some covers(cosmetic)
Body Panels Photos

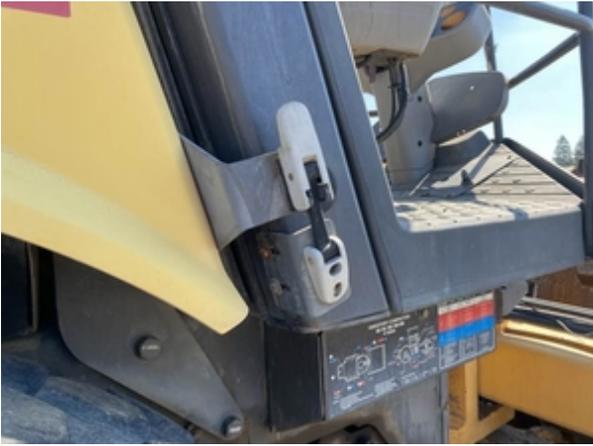
Doors / Canopy Latches	3 - Normal Wear & Tear	
Doors / Canopy Latches Condition	No visible damage	
Doors / Canopy Latches Photos

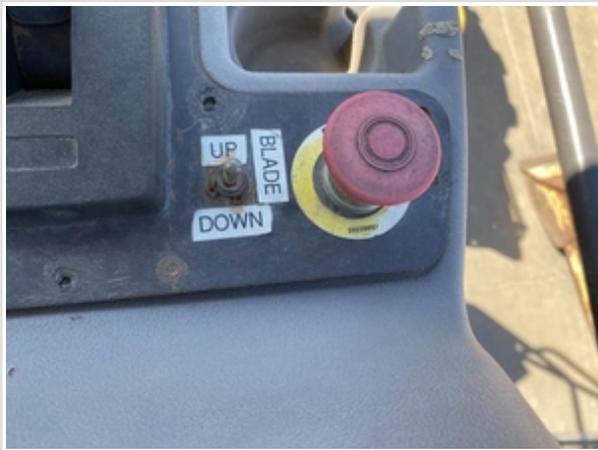
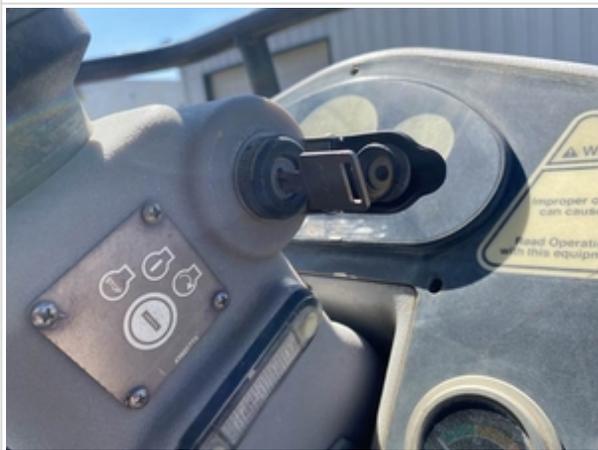
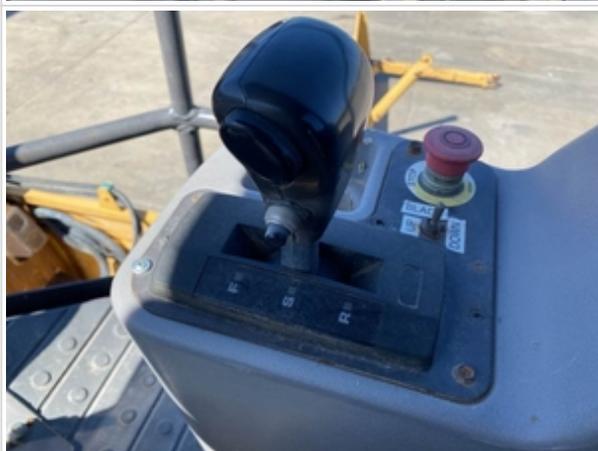
Controls & Switches Condition	All switches are installed and functional, Other (see comments)
Comments	Unable to read front control panel switches (decals worn off)
Controls & Switches Photos

Overall Assessment	
Exterior Rating	3
Interior Rating	3
Safety Rating	3
Quality Rating	3
Functionality Rating	3
Overall Rating	3
What's Great About the Machine	Machine is well maintained with minor repairs needed to have no leaks. All powertrain and hydraulic functions work as expected. No engine leaks found.
What Needs Work	Small fuel leak at rear. (Possibly hose to tank) Small hydraulic leak underneath at center hose and solenoid valve. Some front drum scrapers missing. All 4 r.o.p.s. Work lights inop. Need to label operator switches. Forward, neutral and reverse lever stiff and needs attention.

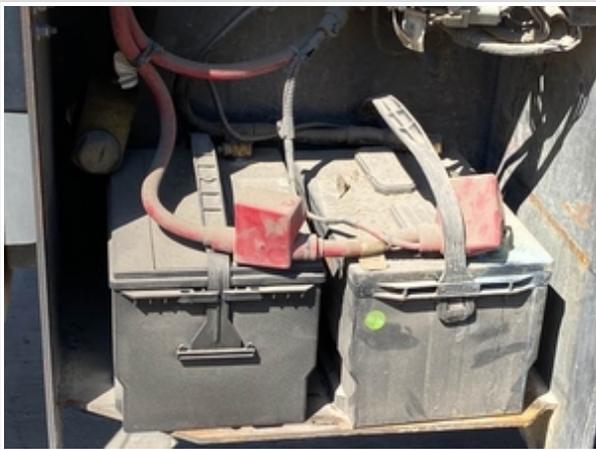
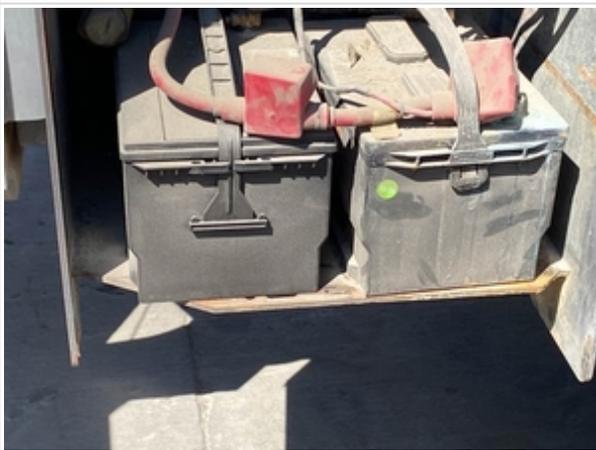
Battery Condition Photos

Blow-by (Visual Observation Check)	No	
Unusual Noises (Upon Start-up, Idle, Shutdown)	No	
Unusual Noise Notes	No unusual noises heard, Other (see comments)	
Comments	Exhaust piping to muffler broken so it sounds like open exhaust loud	
Engine Smoke (Upon Start-up, Idle, Shutdown)	No	
Engine Exhaust Color	Clear	
Battery	2 - Above Average Wear	
Battery Condition	Dusty & dirty appearance, Other (see comments)	
Comments	Battery hold down missing

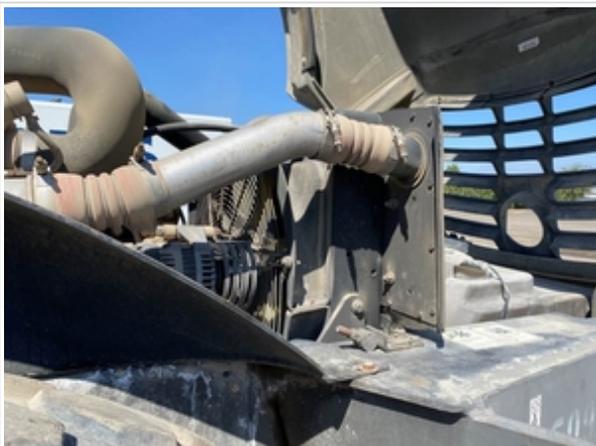
Radiator	3 - Normal Wear & Tear
Radiator Condition	Radiator fins & components appear to be in good working order, no signs of damage or leaks
Radiator Photos

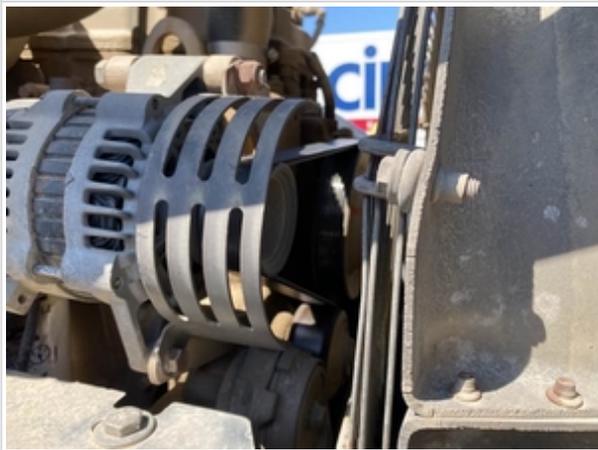
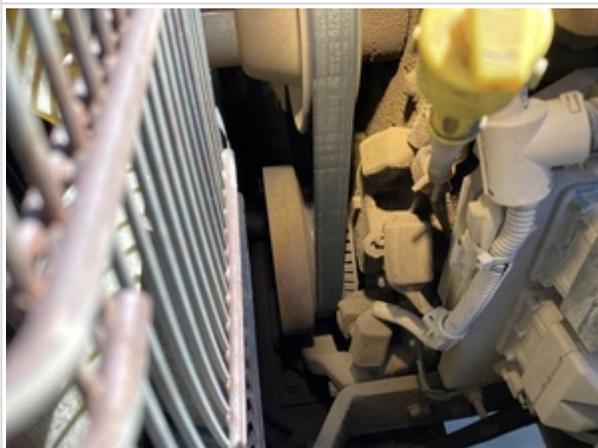
Belts	3 - Normal Wear & Tear	
Belt Condition	Belts appear in good condition & alignment with proper tension	
Belt Photos

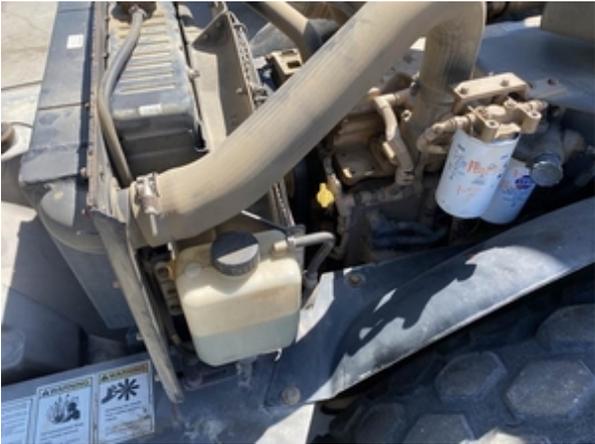
Hoses	3 - Normal Wear & Tear	
Hose Condition	Firm, pliant hoses with no signs of wear or leaks	
Hose Photos

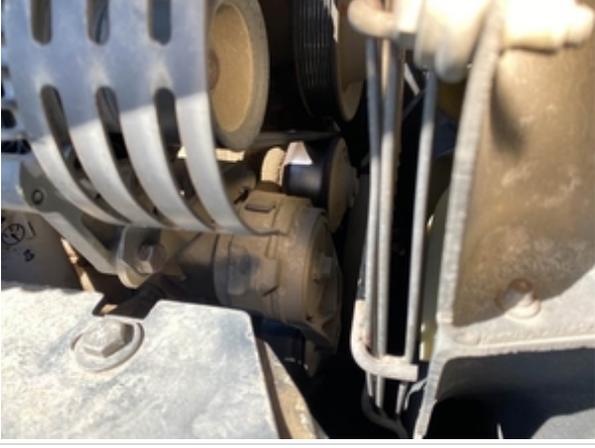
Water Pump	3 - Normal Wear & Tear	
Water Pump Condition	No unusual pump noises heard	
Water Pump Photos

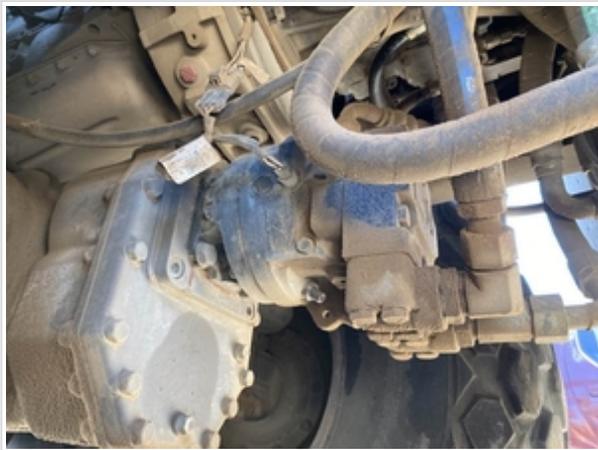
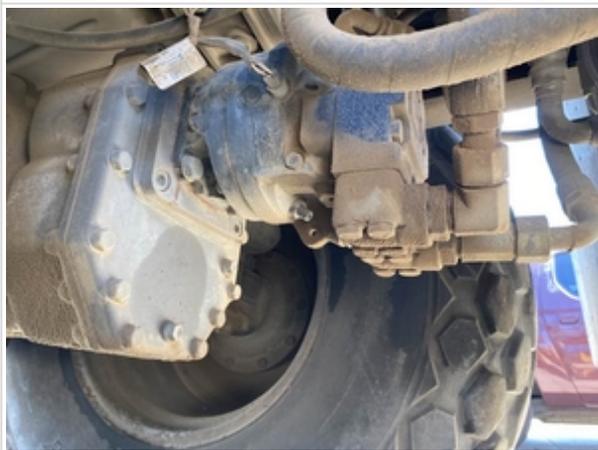
Hydrostatic Parking Brake Photos

Hydrostatic Parking Brake	3 - Normal Wear & Tear
Hydrostatic Parking Brake Condition	Good brake function

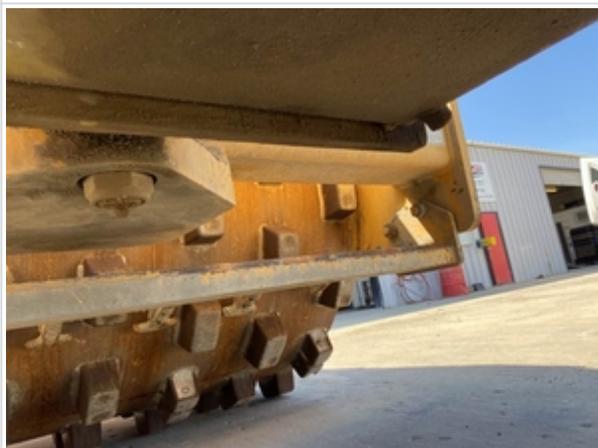
Frame	3 - Normal Wear & Tear
Frame Photos

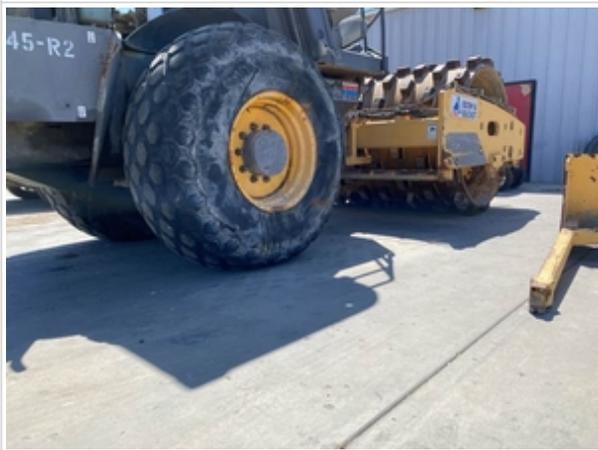
<p>Level Stance</p>	<p>3 - Normal Wear & Tear</p>
<p>Level Stance Photos</p>

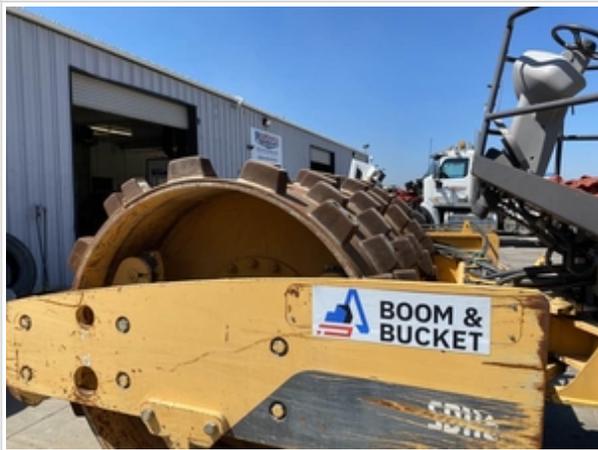
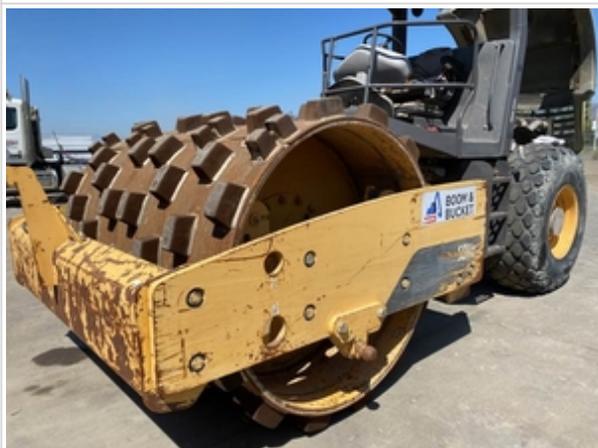
Drum(s) Condition	3 - Normal Wear & Tear	
Comments	Sheepfoot stich welded to smooth drum	
Drum(s) Photos

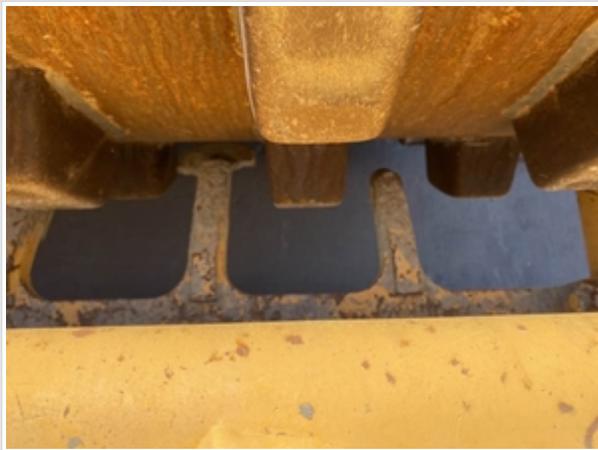
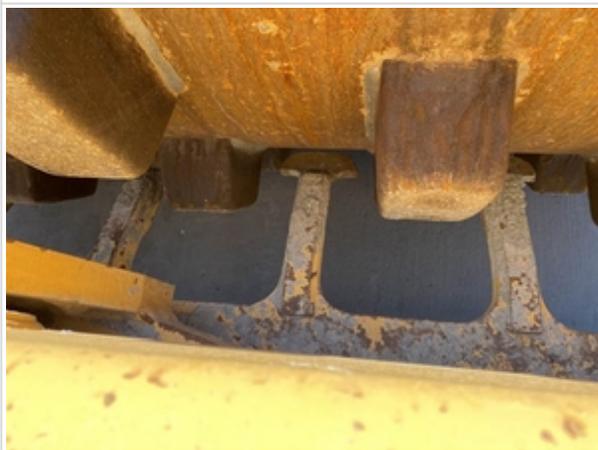
<p>Drum Scraper Photos</p>

Drum Scraper	2 - Above Average Wear	
Comments	Scraper frames in place, the scrapers that bolt to these are mostly missing

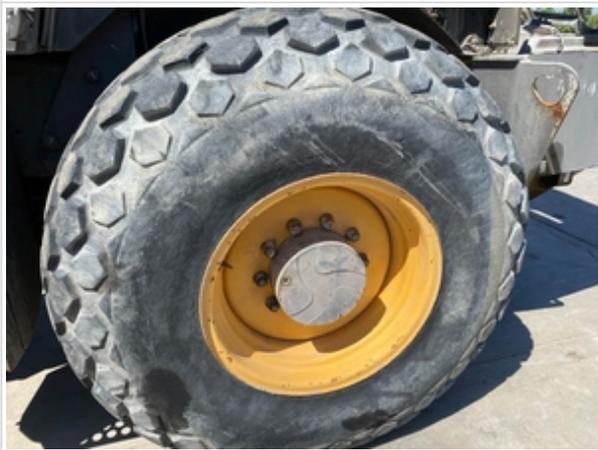
<p>Wheels & Hub Condition</p>	<p>3 - Normal Wear & Tear</p>	
<p>Wheels & Hub Condition Photos</p>

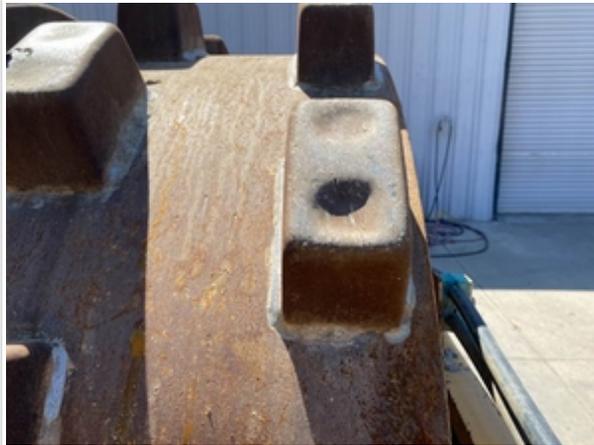
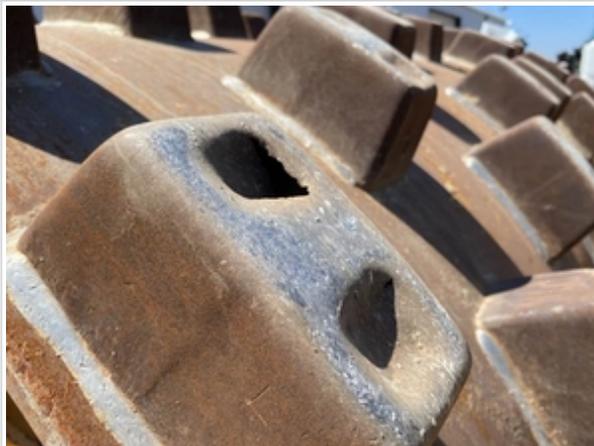
Padfoot Feet Condition Photos

Padfoot Feet Condition	3 - Normal Wear & Tear	
Comments	Some are in great condition others worn through surface. Most okay

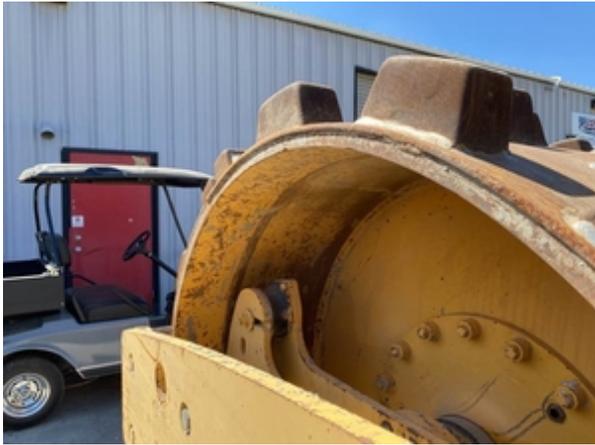
Padfoot Fitment	3 - Normal Wear & Tear	
Comments	Solid to smooth drum not loose	
Padfoot Fitment Photos

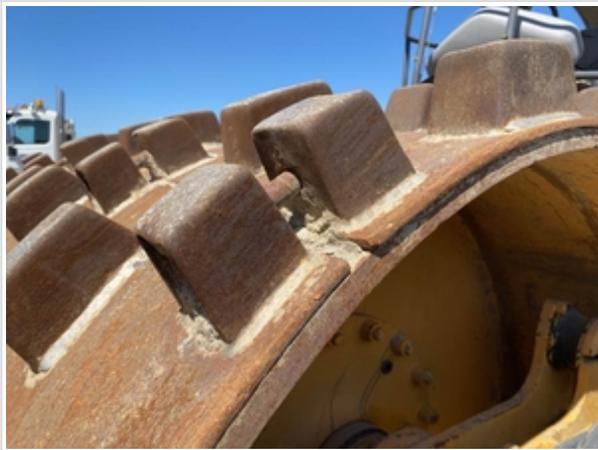
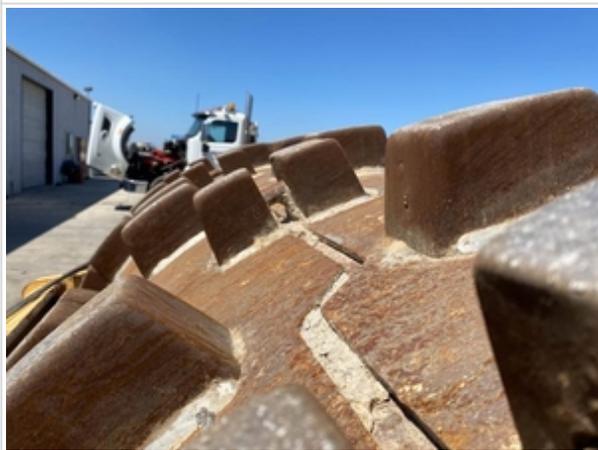
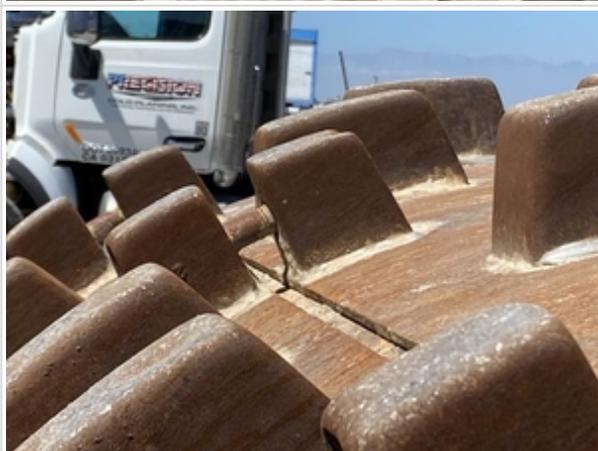
Padfoot Hardware Photos

Padfoot Hardware	3 - Normal Wear & Tear
Comments	All intact plus welded on edges

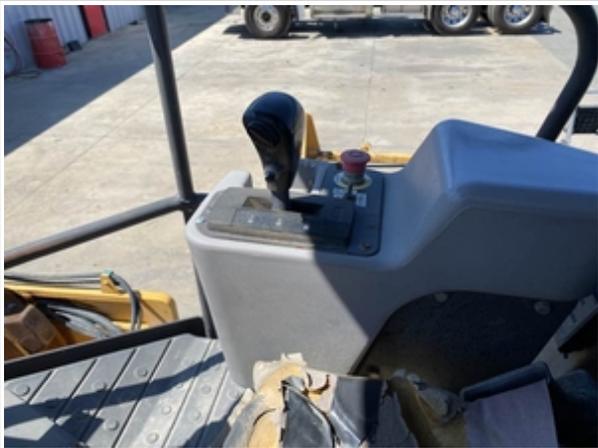
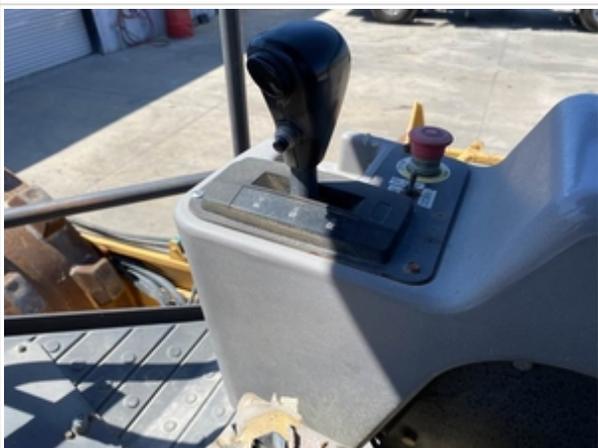
Unusual Noises (Hydraulic Pump)	No	
Hydraulic Pump Notes	No unusual noises heard during operation	
External Controls / Levers	3	
External Controls / Levers Condition	Good function & condition of hydraulic controls, Other (see comments)	
Comments	Forward and reverse controller stiff	
External Controls / Levers Photos

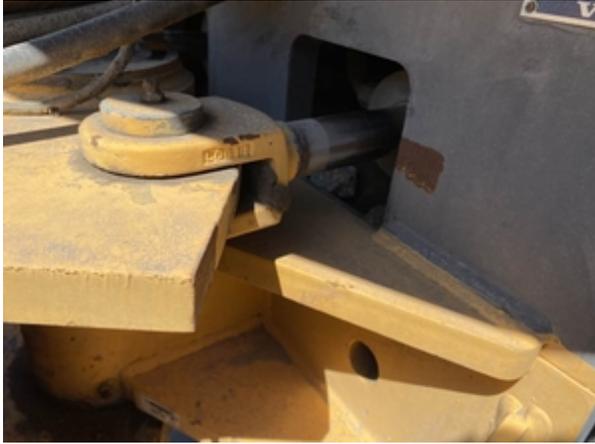
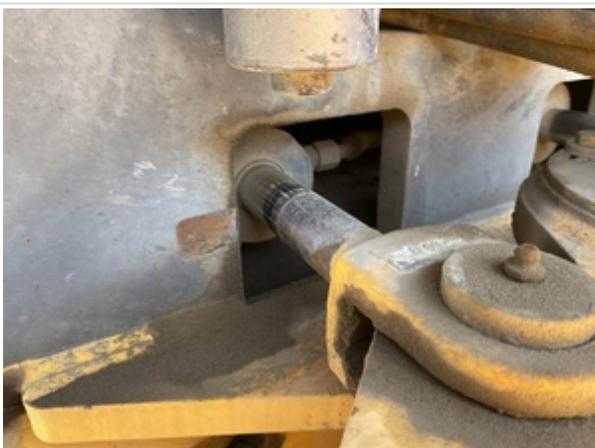
Steering Cylinders: Mounting Pin	3
Steering Cylinders: Oil Leaks	No
Steering Cylinders Photos
