## Inspection Report (Telehandler)

Year	2014
Make	JLG
Model	10054
Serial Number	0160060545
Hour Meter Reading	4,230
Previous Application (e.g., earth moving, mining, demolition, etc)	Equipment Rentals

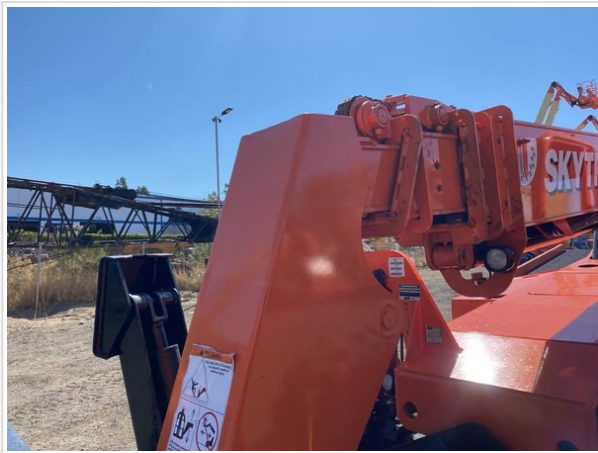
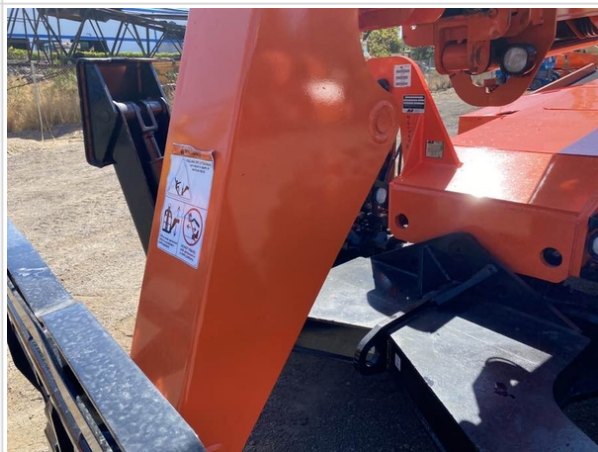
Front	3 - Normal Wear & Tear
Front Condition	No visible damage, Other (see comments)
Comments	Small dent to topside of front fork backrest
Front Photos

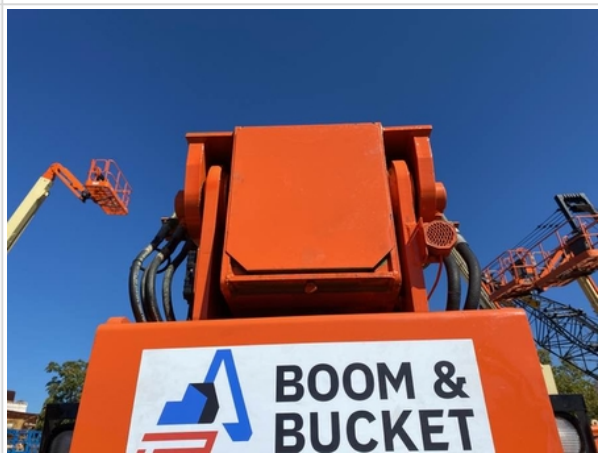
<p><b>Rear</b></p>	<p>3 - Normal Wear &amp; Tear</p>	
<p><b>Rear Condition</b></p>	<p>No visible damage</p>	
<p><b>Rear Photos</b></p>

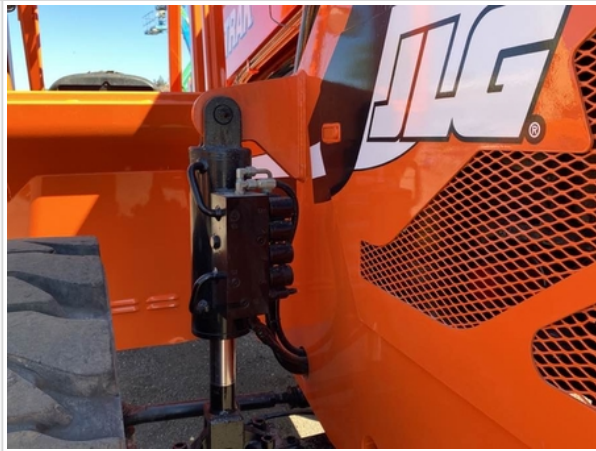
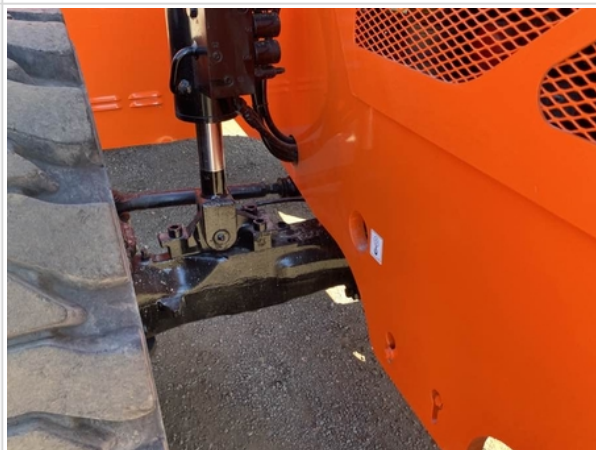
<b>Left</b>	3 - Normal Wear & Tear	
<b>Left Condition</b>	No visible damage, Other (see comments)	
<b>Comments</b>	Small dent on bottom left side of side step	
<b>Left Photos</b>

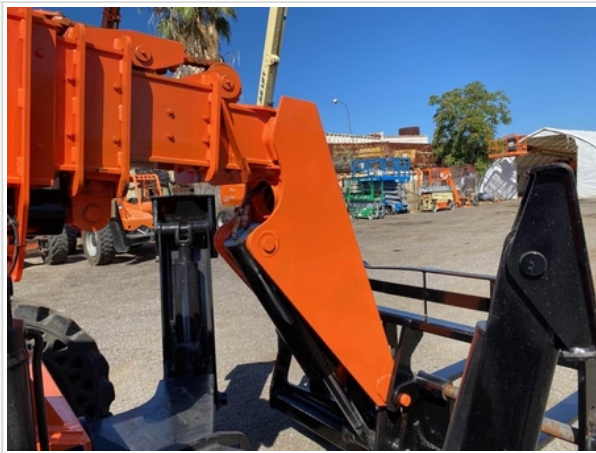
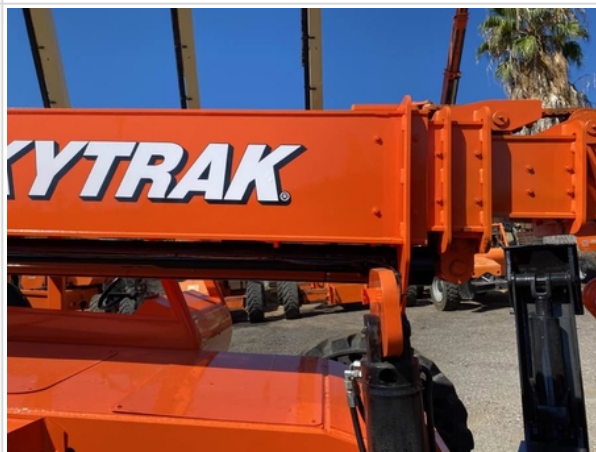
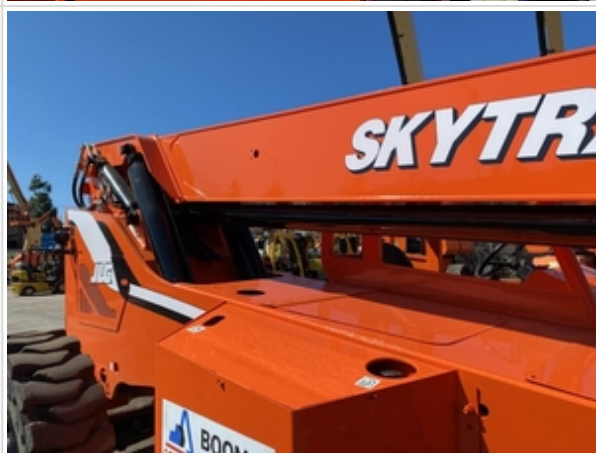
<b>Right</b>	3 - Normal Wear & Tear	
<b>Right Condition</b>	No visible damage, Other (see comments)	
<b>Right Photos</b>

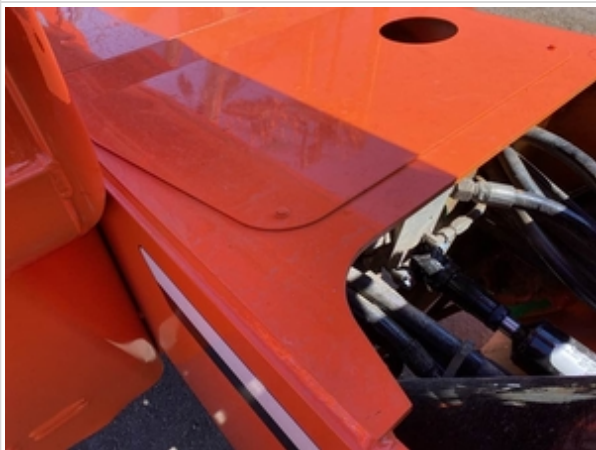
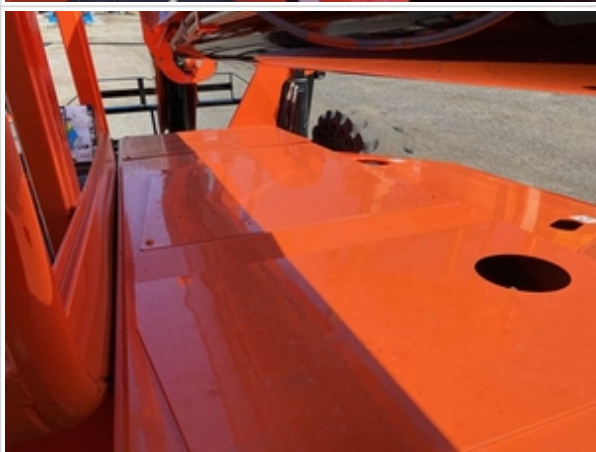
<b>Body Panels (Any Rust Damage?)</b>	3 - Normal Wear & Tear	
<b>Body Panel Condition</b>	No visible damage, good paint condition and panel fitment	
<b>Body Panels Photos</b>

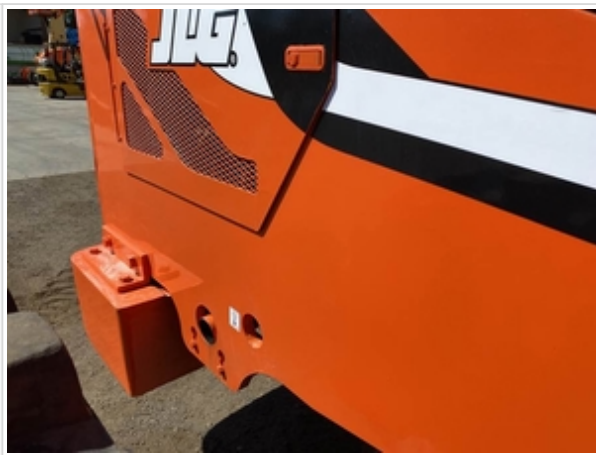
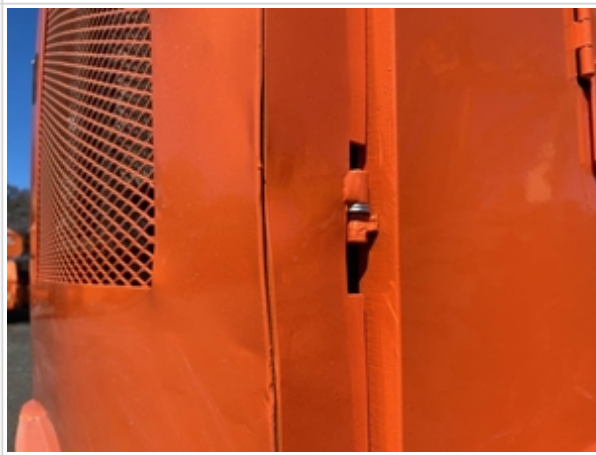
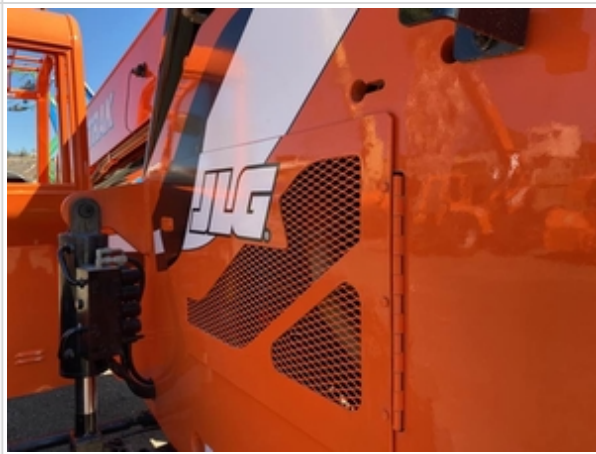
<b>Doors / Canopy Latches</b>	3 - Normal Wear & Tear	
<b>Doors / Canopy Latches Condition</b>	No visible damage

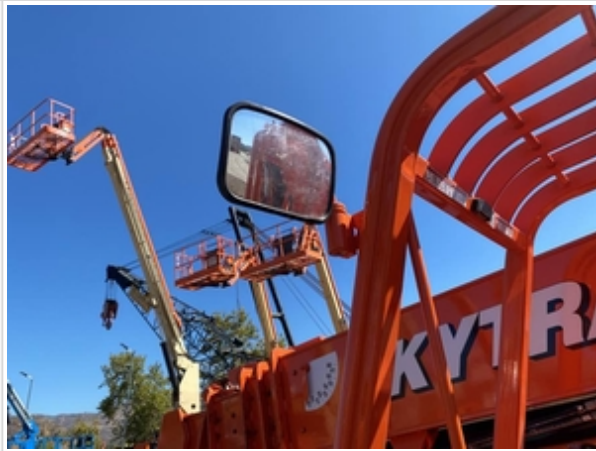
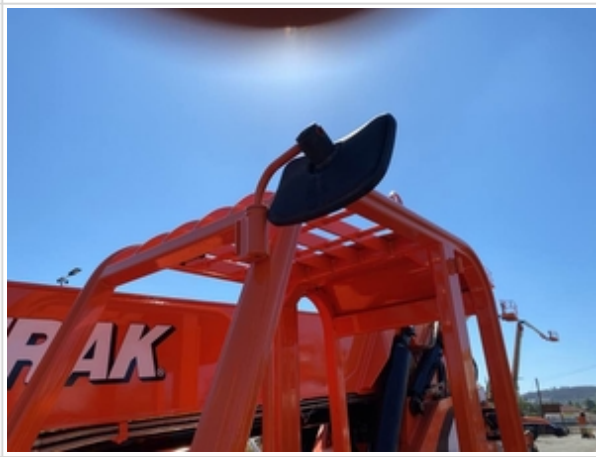
<b>Glass Condition</b>	0
<b>Mirrors</b>	3 - Normal Wear & Tear
<b>Mirror Condition Notes</b>	Mirrors present and intact, no visible damage

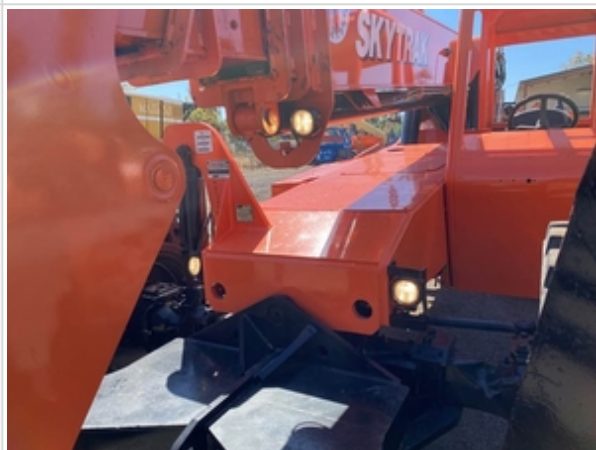
<b>Lighting System</b>	3 - Normal Wear & Tear
<b>Lighting System Condition</b>	No visible damage, lighting system is operational
<b>Lighting System Photos</b>

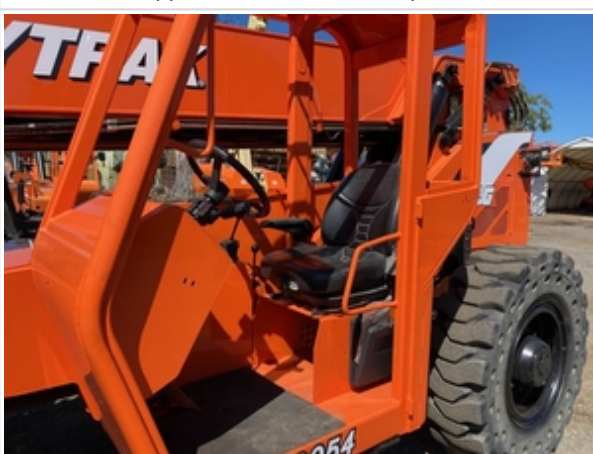
Operator Cabin Overall	3 - Normal Wear & Tear
Operator Cabin Overall Condition	Good cabin appearance, solid floors, panels, and ceiling
Operator Cabin Photos

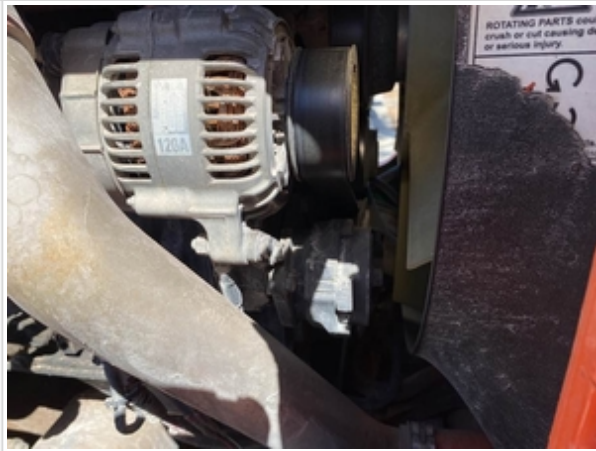
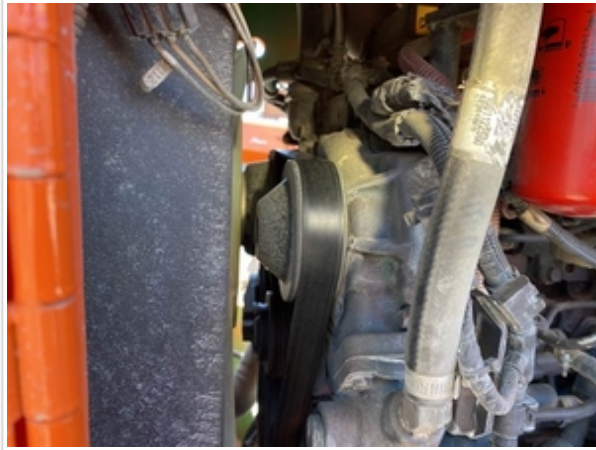
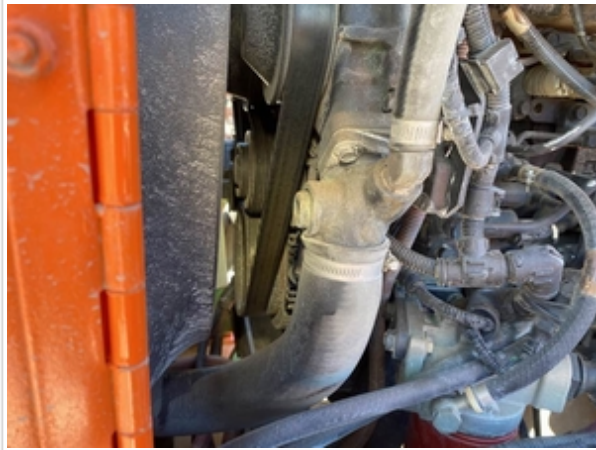
<b>Belts</b>	3 - Normal Wear & Tear
<b>Belt Condition</b>	Belts appear in good condition & alignment with proper tension
<b>Belt Photos</b>

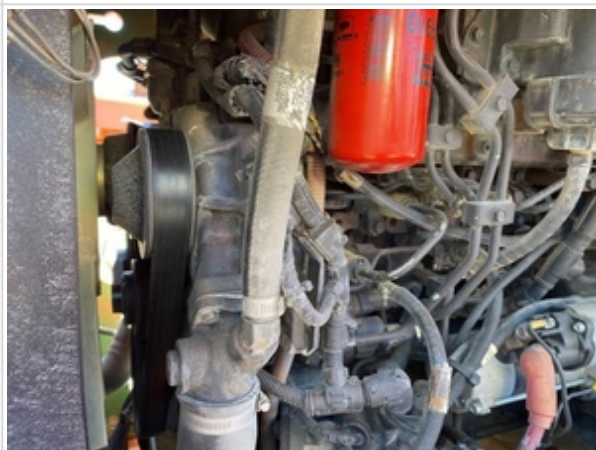
<b>Water Pump</b>	3 - Normal Wear & Tear	
<b>Water Pump Condition</b>	No unusual pump noises heard	
<b>Water Pump Photos</b>

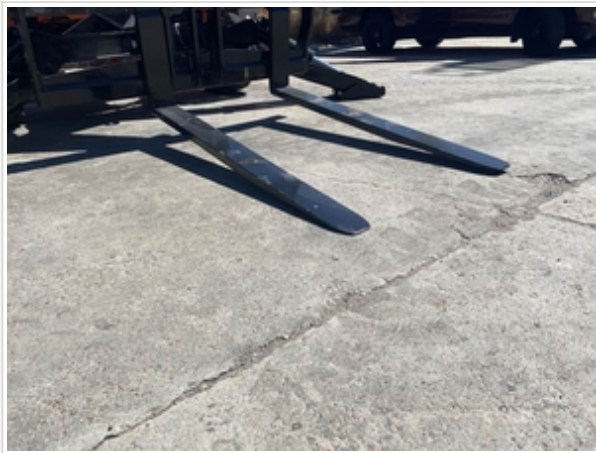
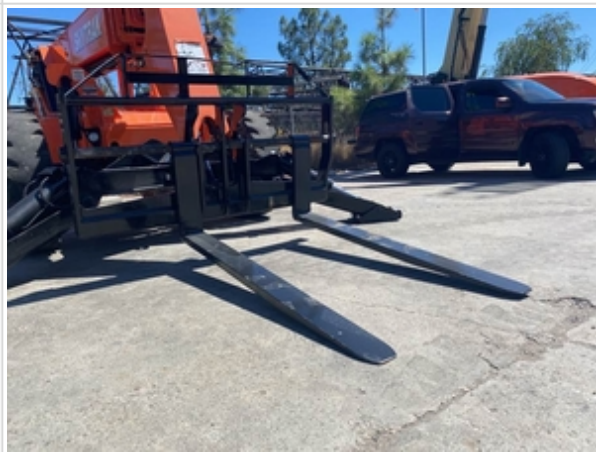
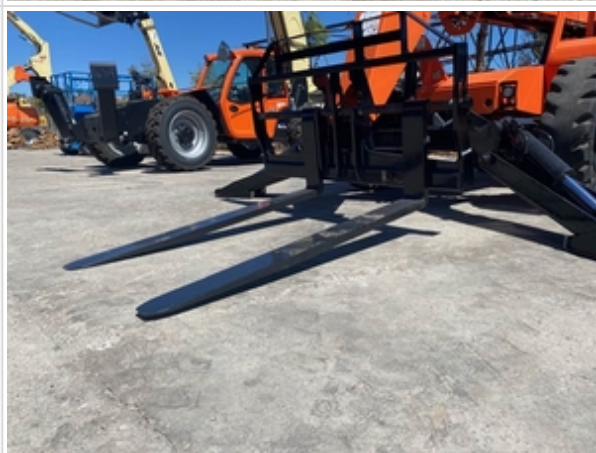
<b>Instructions</b>	Evaluate the following on a 4 point scale (leave comments where an explanation is appropriate):  4 = Like New, Recently Replaced 3 = Normal Wear & Tear 2 = Above Average Wear 1 = Service Required
<b>Forks / Work Tool Condition</b>	3 - Normal Wear & Tear
<b>Comments</b>	6' forks

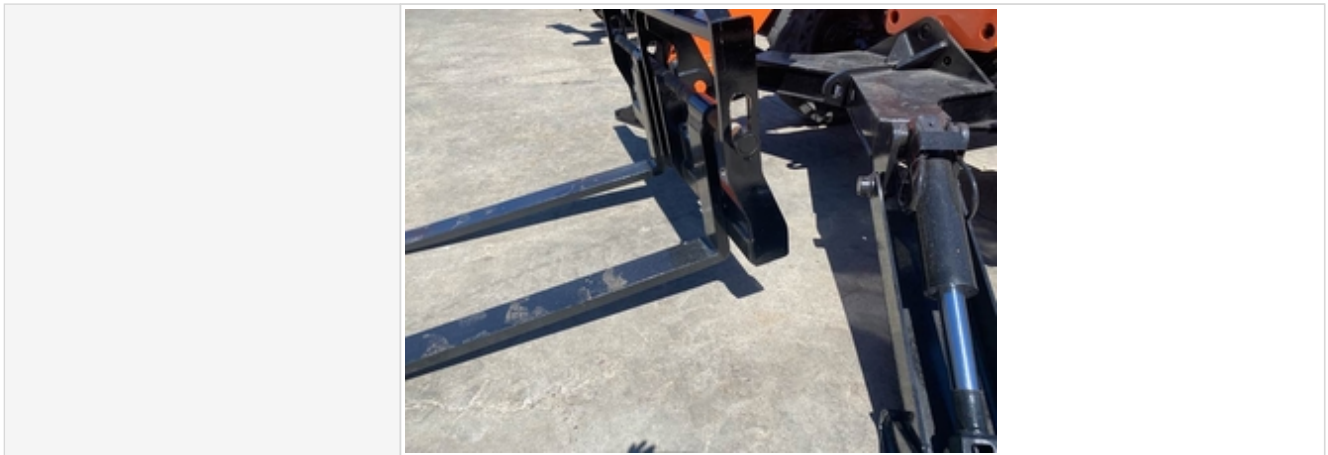
<b>Back Rest Condition</b>	3 - Normal Wear & Tear
<b>Comments</b>	Smal dent on top center
