Inspection Report (Wheel Loader)

Year	1998
Make	Komatsu
Model	WA380-3L
Serial Number	A50435
Hour Meter Reading	7,589
Previous Application (e.g., earth moving, mining, demolition, etc)	General Construction

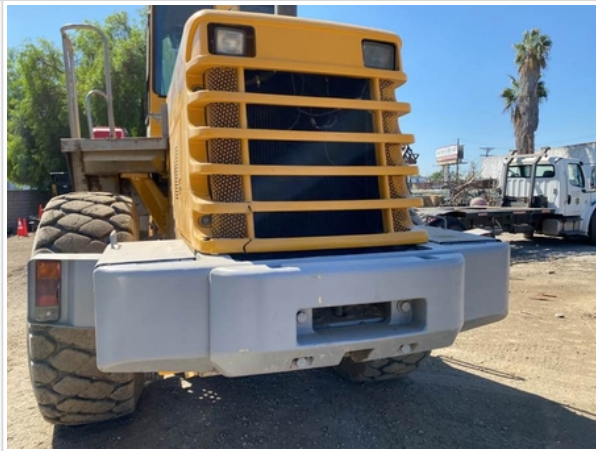
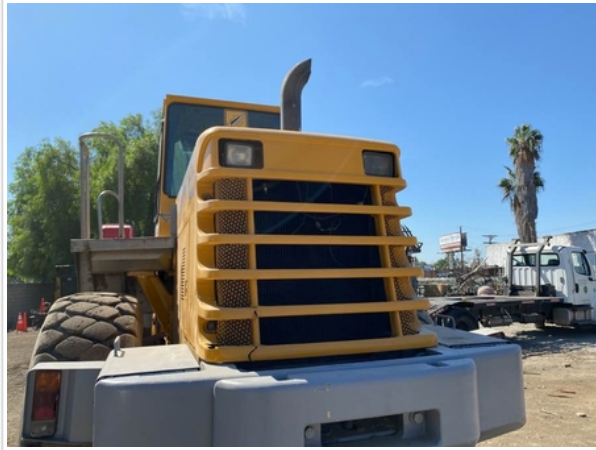
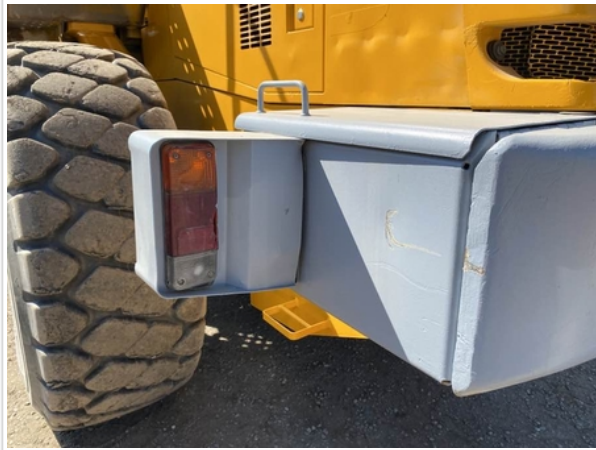
Rear	2 - Above Average Wear
Rear Condition	Large dents or cracks, Other (see comments)
Comments	Rear hood cracked, right side batter box/light bent

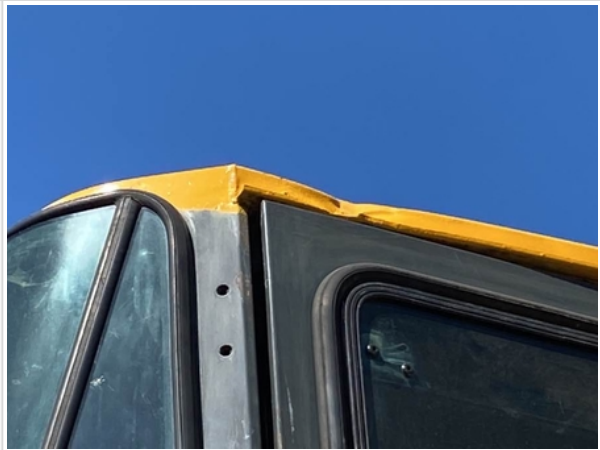
Left	3 - Normal Wear & Tear
Left Condition	Other (see comments)
Comments	Left side operator step ladder bent in, small dent on top side of cab

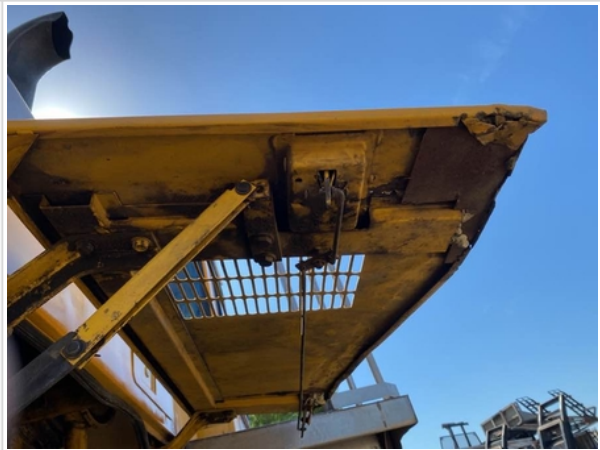
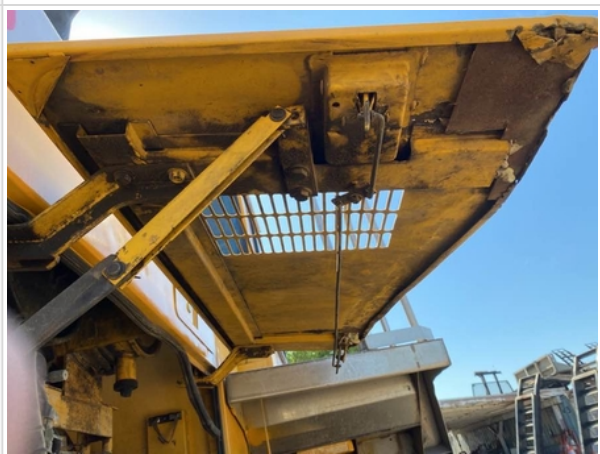
Right	3 - Normal Wear & Tear	
Right Condition	Other (see comments)	
Comments	Right side engine compartment door warped, body repair done on front bottom of cab ,	
Right Photos

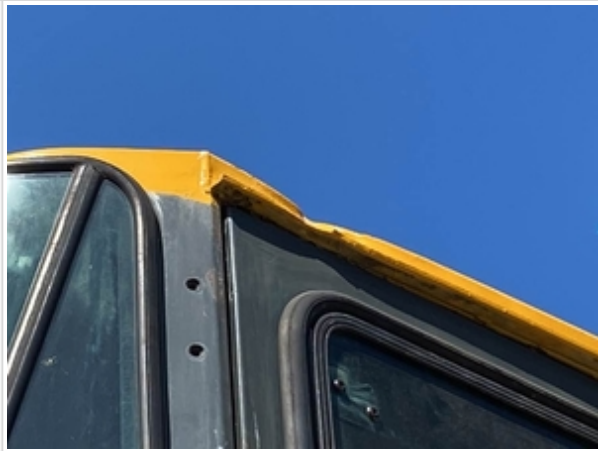
Body Panels (Any Rust Damage?)	3 - Normal Wear & Tear
Body Panel Condition	Some panel misalignment observed, Other (see comments)
Comments	Body repaired areas visible

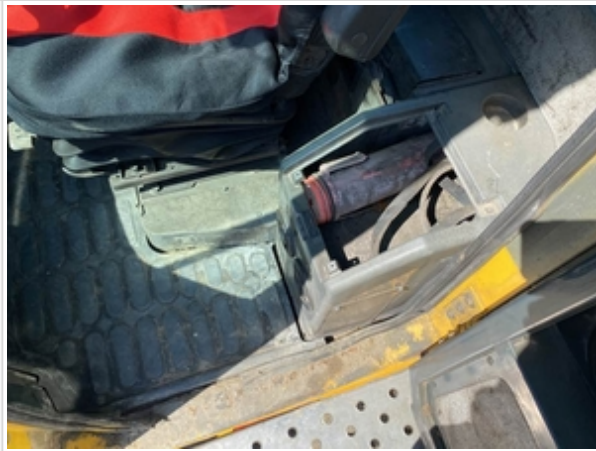
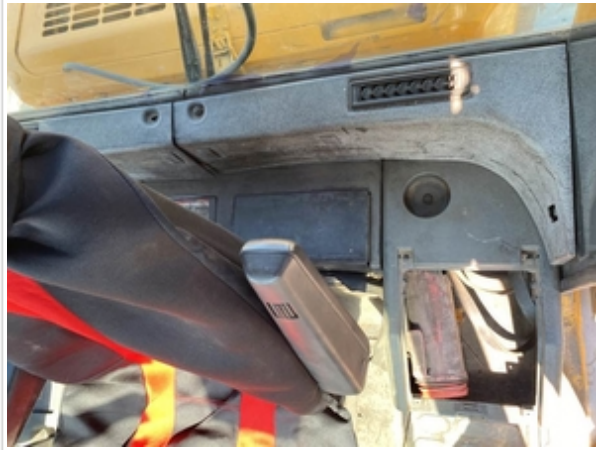
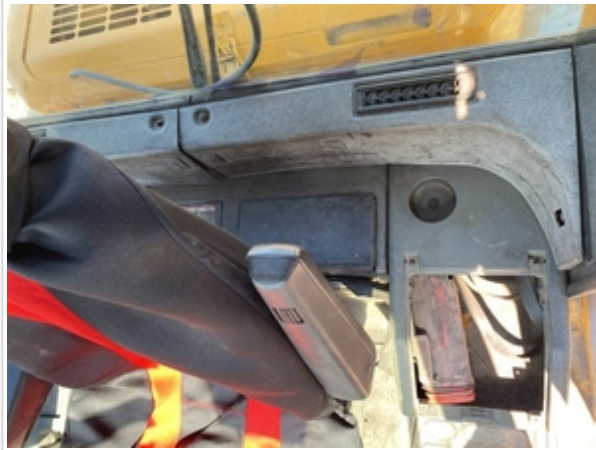
Operator Cabin Overall	2 - Above Average Wear
Operator Cabin Overall Condition	Minor cosmetic wear to cabin surfaces, floors, panels, and ceiling, Other (see comments)
Comments	Seat cover on, seat upholstery worn underneath
Operator Cabin Photos

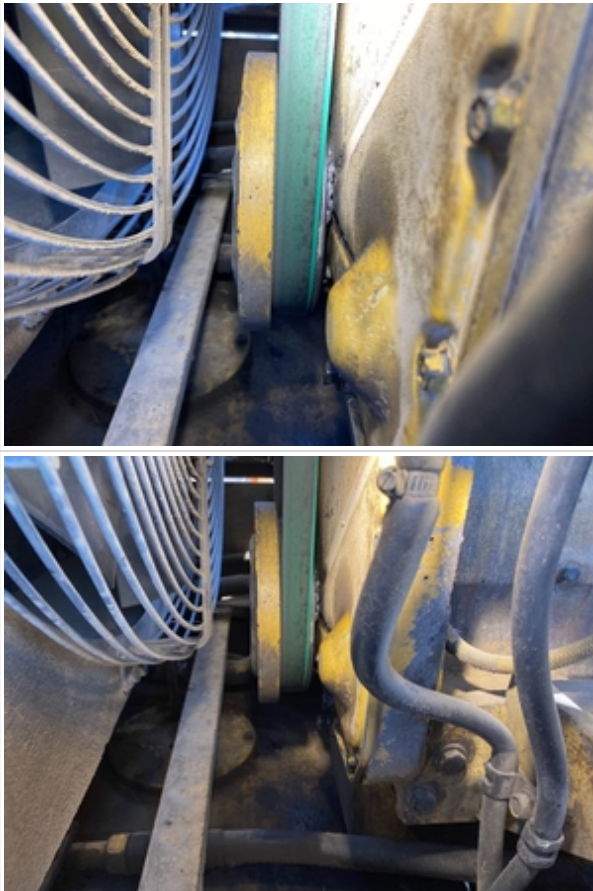
Cooling System Leaks	No	
Coolant Color / Appearance	3 - Normal Wear & Tear	
Coolant Color/Appearance Notes	Normal Translucent appearance, no visual signs of contamination	
Oil Leaks	Yes	
Oil Leak Notes	Wetness & discoloration observed, Other (see comments)	
Comments	Possible blowby cylinder #6, Seepage from front main seal, leak from starter area, possible seepage from oil pan gasket, small leak r/s engine next to breather hose	
Oil Leak Photos

Oil Color / Appearance	3 - Normal Wear & Tear
Oil Color / Appearance Notes	Clean oil appearance, no signs of cross contamination, Appropriate oil level
Fuel Leaks	No
Equipped with DPF (Diesel Particulate Filter)	No
Requires DEF (Diesel Exhaust Fluid)	No
Overall Engine Appearance	Areas of dried seepage seen on engine hoses & components, Dusty & dry
Overall Engine Comments	Exhaust pipe broken from hot side of turbo. I advise checking health condition of Cyl. #6 due to oil or soot buildup around exhaust manifold connection to head. Oil seepage coming from r/s block cover. Seepage leak from Front main seal and oil pan.

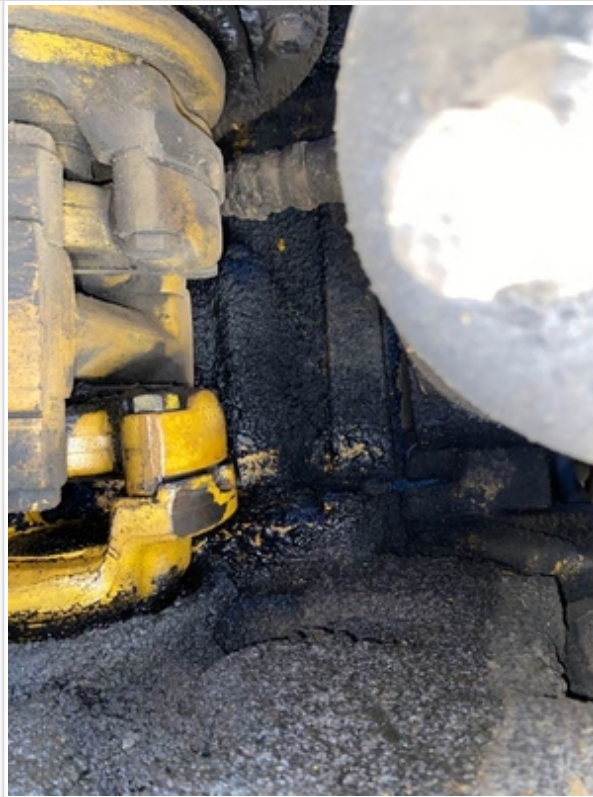
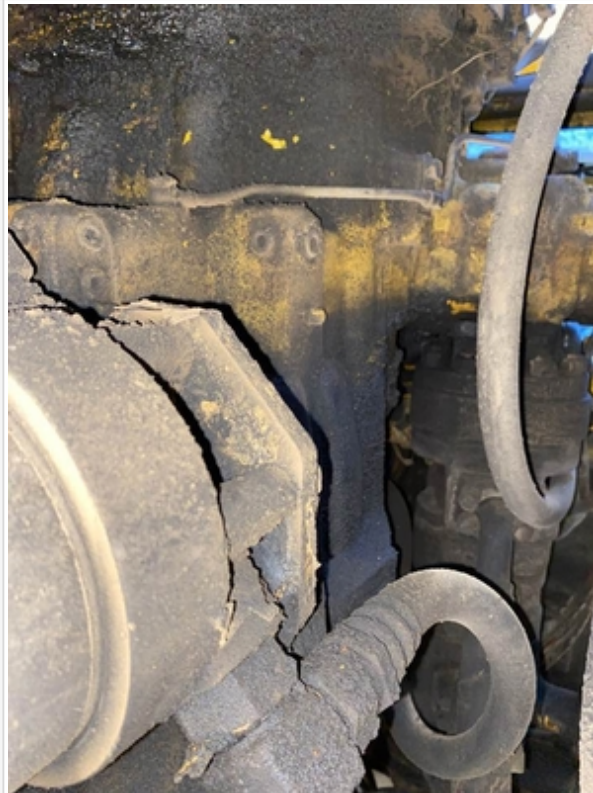
Transmission Info	Powershift 4 speed trans
Transmission	3 - Normal Wear & Tear
Transmission Condition	No unusual noises or vibrations, Leaking transmission fluid observed, Other (see comments)
Comments	Leaks observed from output shaft seal

Inching Brake	3 - Normal Wear & Tear	
Inching Brake Condition	Good brake function	
Inching Brake Photos	 	
Parking Brake	3 - Normal Wear & Tear	
Parking Brake Condition	Good brake function	
Parking Brake Photos	 	
Overall Drivetrain Comments	Overall transmission runs good. Multiple leaks from rear side of trans

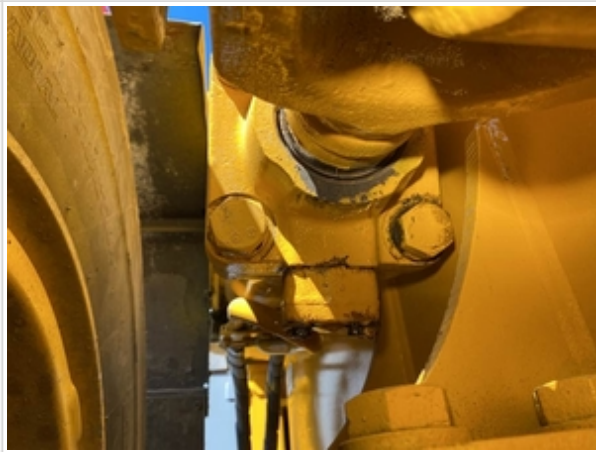
Lift Cylinder	Check the lift cylinder. Note any wear, pitting, discoloration, etc. Take photos.
Lift Cylinder: Mounting Pin	3
Lift Cylinder: Oil Leaks	Yes
Comments	Right side cylinder leak at hard line oring
Lift Cylinder Photos

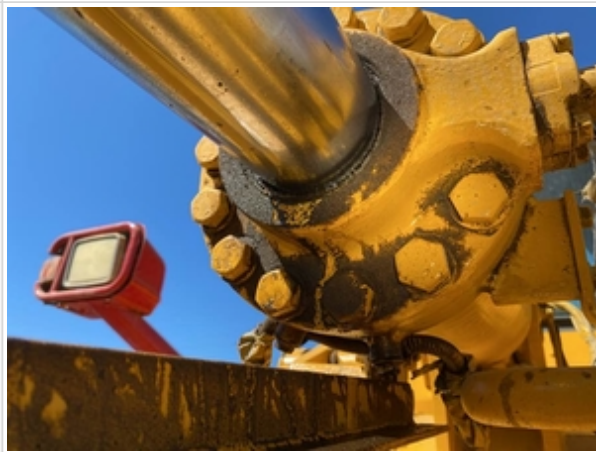
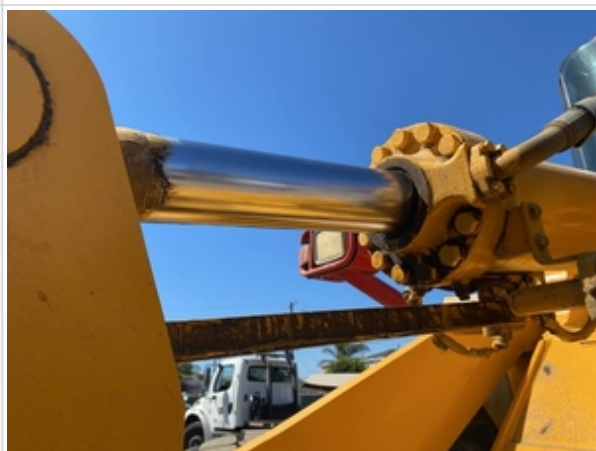
Bucket Cylinder	Check the bucket cylinder. Note any wear, pitting, discoloration, etc. Take photos.	
Bucket Cylinder: Mounting Pin	3	
Bucket Cylinder: Oil Leaks	Yes	
Comments	Oil at rod seal	
Bucket Cylinder Photos

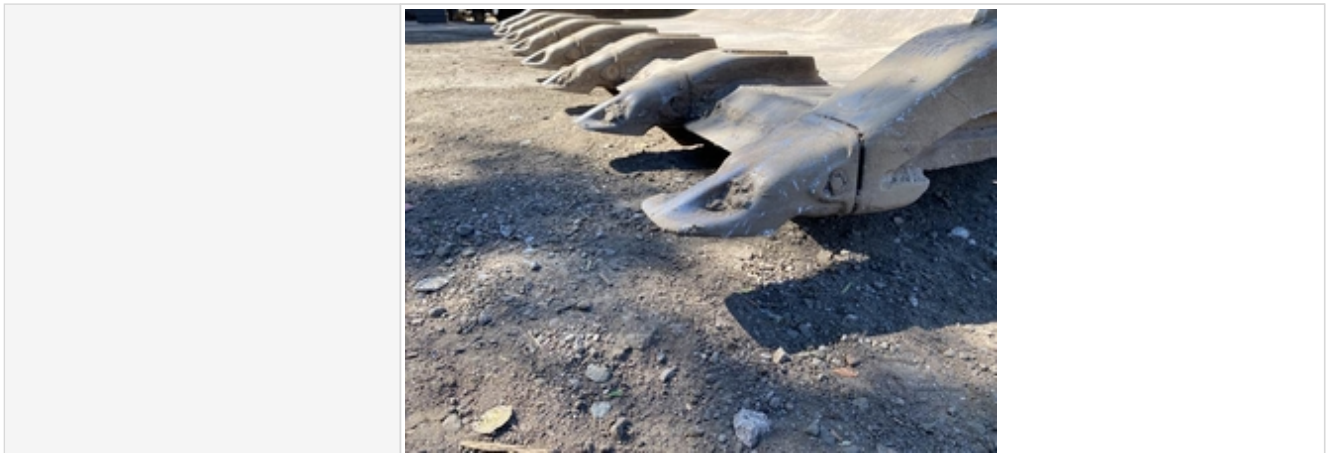
<p>Bucket Edge/Shanks/Teeth</p>	<p>2 - Above Average Wear</p>
<p>Comments</p>	<p>Worn need to be replaced soon</p>
<p>Bucket Edge/Shanks/Teeth Photos</p>
