Inspection Report (On-Highway Dump Truck)

Year	2013
Make	International
Model	4300
Serial Number	3HAMMAAL4DL198252
Truck Odometer Reading	281,798
Current Inspection / State Cert / DOT	N/A
Previous Application (e.g., earth moving, mining, demolition, etc)	General Construction

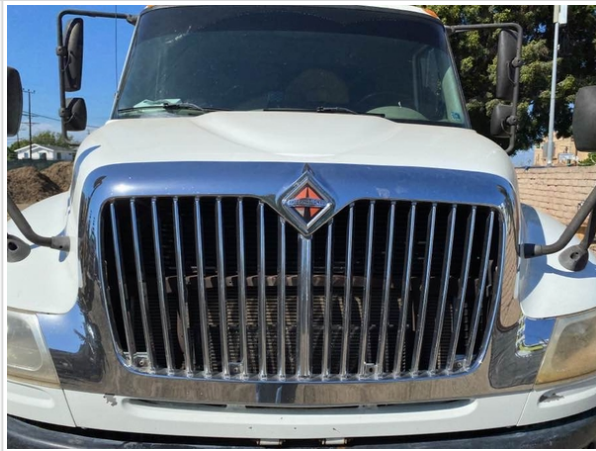
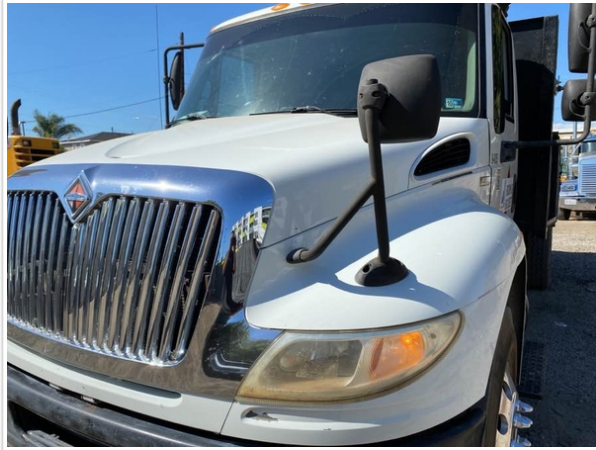
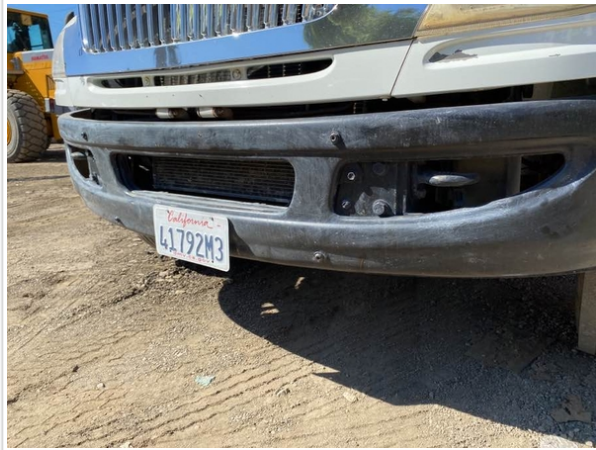
Front	3 - Normal Wear & Tear
Front Condition	No visible damage, Other (see comments)
Comments	Small paint chips lower hood area

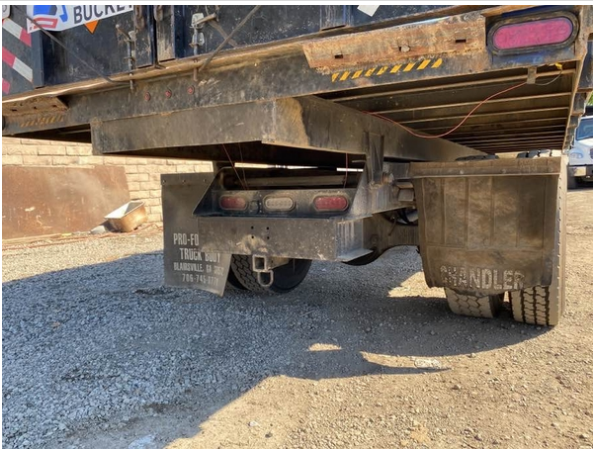
Rear	3 - Normal Wear & Tear
Rear Condition	No visible damage, Other (see comments)
Comments	Small dent bottom of dump body

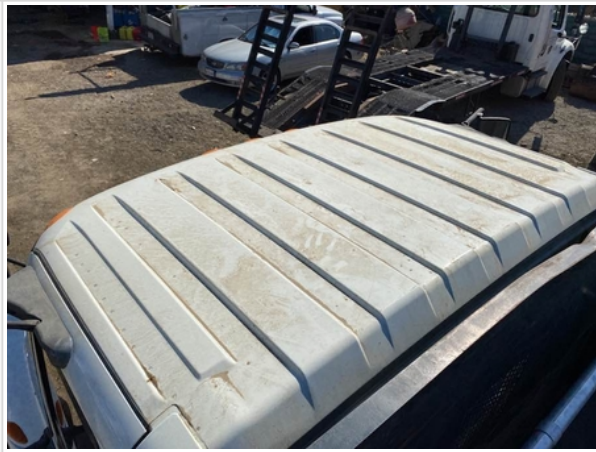
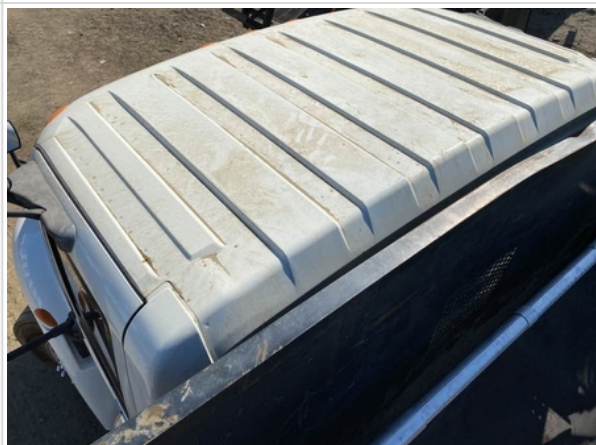
Upper	3 - Normal Wear & Tear	
Upper Condition	No visible damage, Other (see comments)	
Comments	Small dent on dump body	
Upper Photos

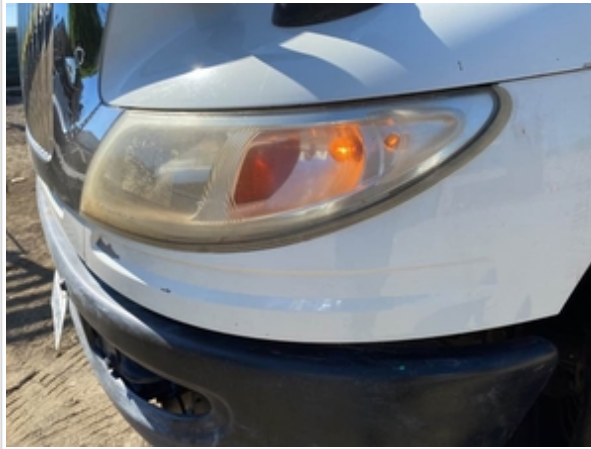
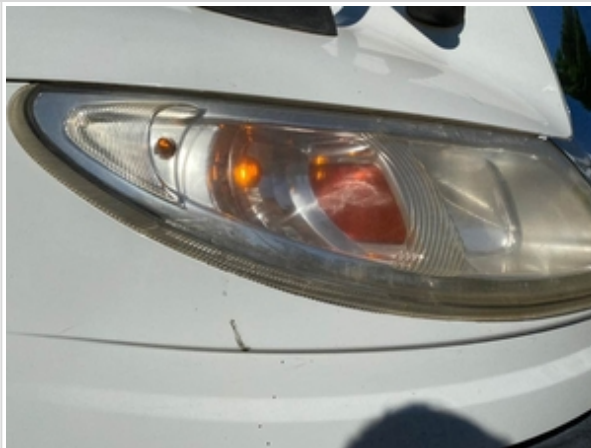
Lighting System	3 - Normal Wear & Tear
Lighting System Condition	No visible damage, lighting system is operational, One or more exterior lights are non-operational, Other (see comments)
Comments	Front l/s headlight inop
Lighting System Photos

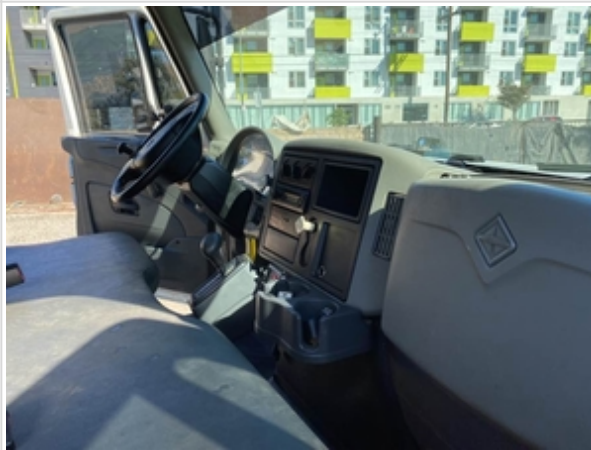
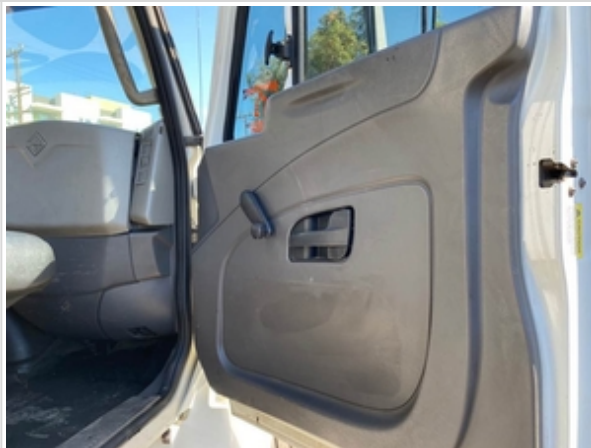
Operator Cabin	3 - Normal Wear & Tear
Comments	R/S Dash Fuse Panel Cover Loose
Operator Cabin Photos

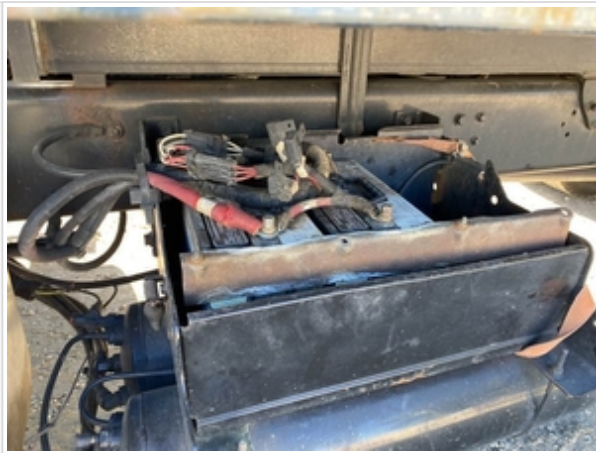
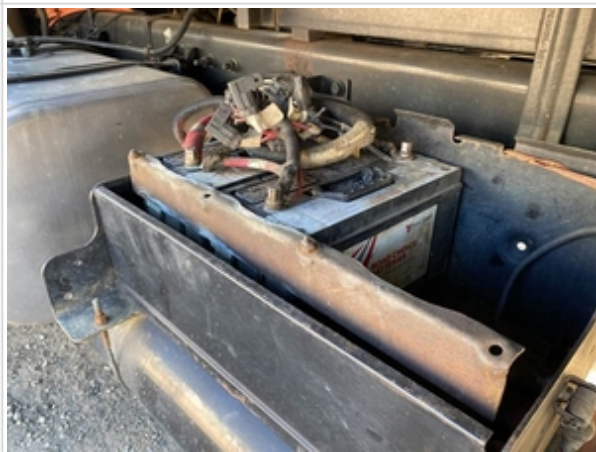
Battery Condition Photos

Blow-by (Visual Observation Check)	No	
Unusual Noises (Upon Start-up, Idle, Shutdown)	No	
Unusual Noise Notes	No unusual noises heard	
Engine Smoke (Upon Start-up, Idle, Shutdown)	No	
Engine Smoke Notes	No engine smoke issues observed	
Engine Exhaust Color	Clear	
Battery	3 - Normal Wear & Tear	
Battery Condition	Clean & dry appearance, tight connections, Other (see comments)	
Comments	Battery cover missing

Functionality Rating	3 - Normal Wear & Tear
Overall Rating	3 - Normal Wear & Tear
What's Great About the Machine	Dump truck has good appearance and engine sounds healthy. Dump body and lift function works well. Truck is in good working condition with no active leaks found.
What Needs Work	Tires will need to be replaced soon. Battery compartment
Inspector's Name	Mario Ramirez
Date/Time	09-27-2022

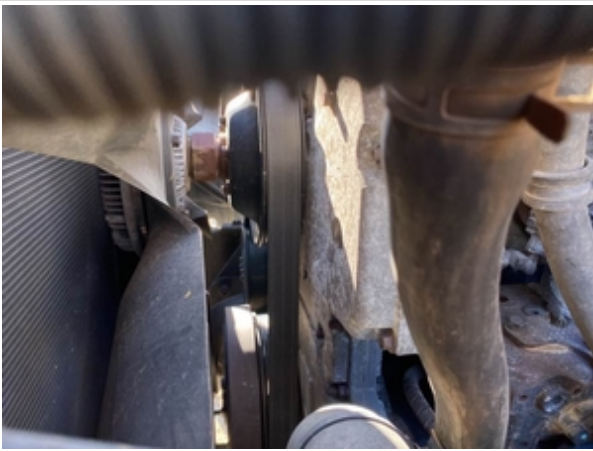
Belts	3 - Normal Wear & Tear
Belt Condition	Belts appear in good condition & alignment with proper tension, Other (see comments)
Comments	Slight worn cracks starting to appear
Belt Photos

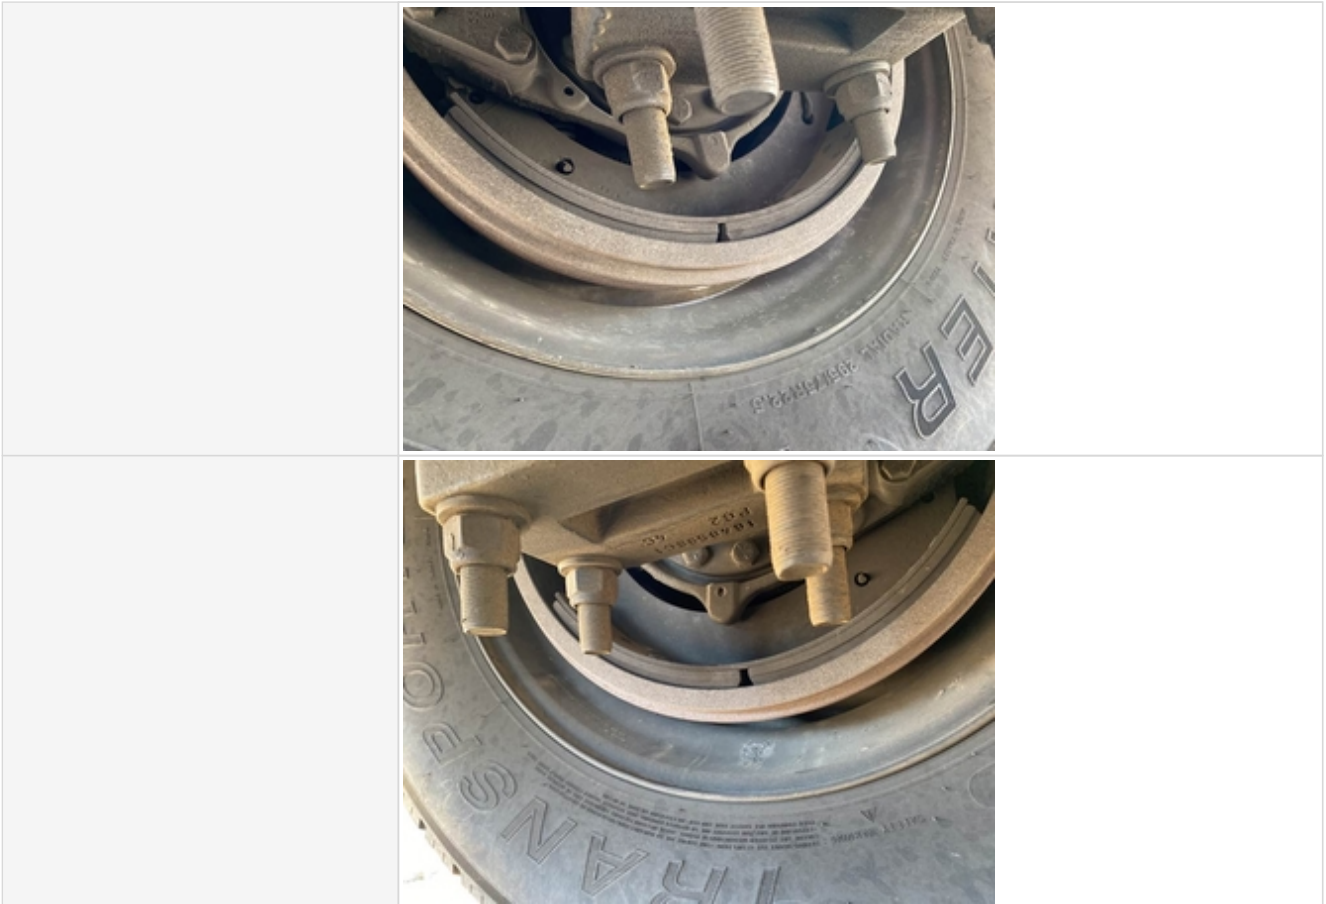
Brake Shoe Thickness	70%
Comments	Rear shoes have 50% of material left front have 70% left
Brake Shoe Photos
