## Inspection Report (Generator)

Year	2013
Make	PECO
Model	0YTT1-101655-501
Serial Number	8995-004
Hour Meter Reading	13,502
Previous Application (e.g., earth moving, mining, demolition, etc)	General Construction

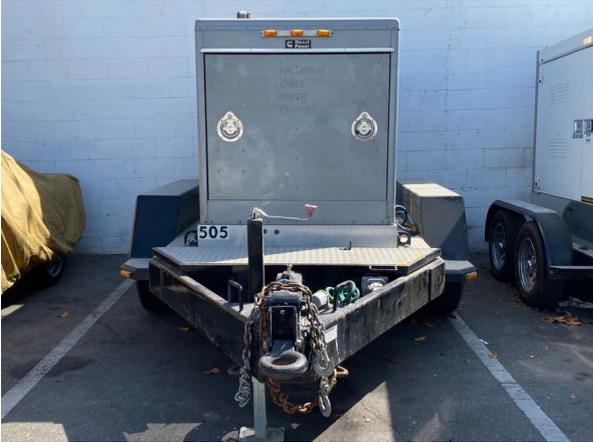
Front Condition	No visible damage, Other (see comments)
Comments	Normal wear and tear, small paint chips
Front Photos

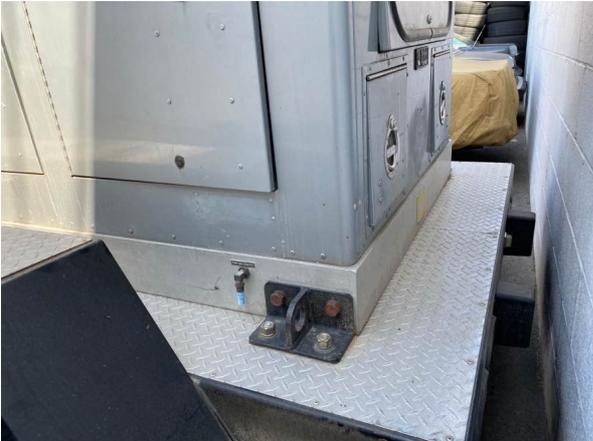
Rear	3 - Normal Wear & Tear
Rear Condition	No visible damage, Other (see comments)
Comments	Normal wear and tear, small paint chips
Rear Photos

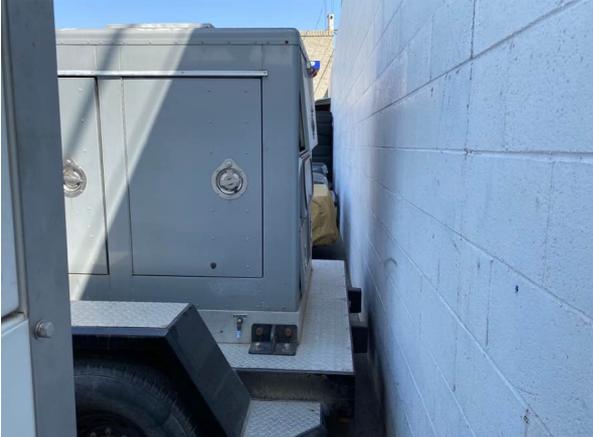
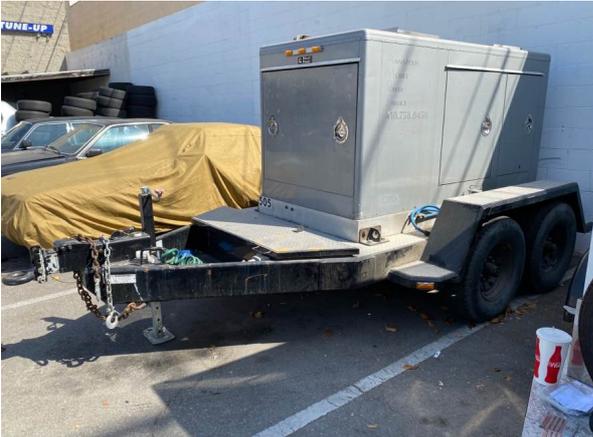
Left	3 - Normal Wear & Tear
Left Condition	No visible damage, Other (see comments)

Comments	Normal wear and tear, small paint chips
Left Photos

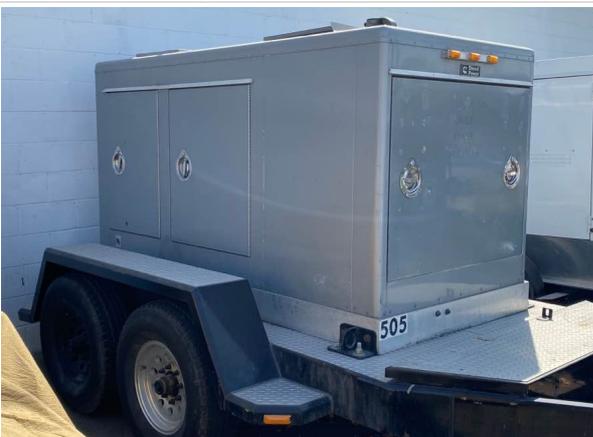
Right	3 - Normal Wear & Tear
Right Condition	No visible damage, Other (see comments)
Comments	Normal wear and tear, small paint chips
Right Photos

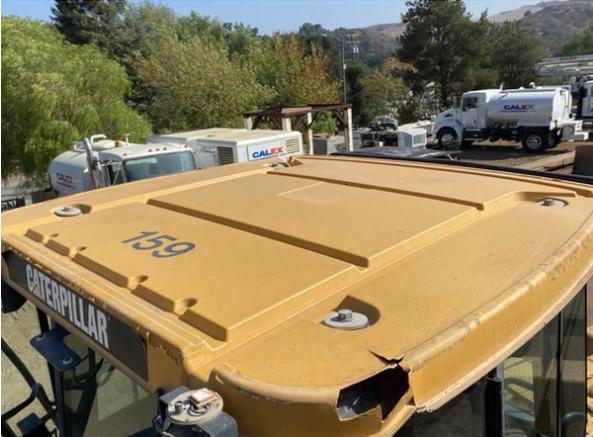
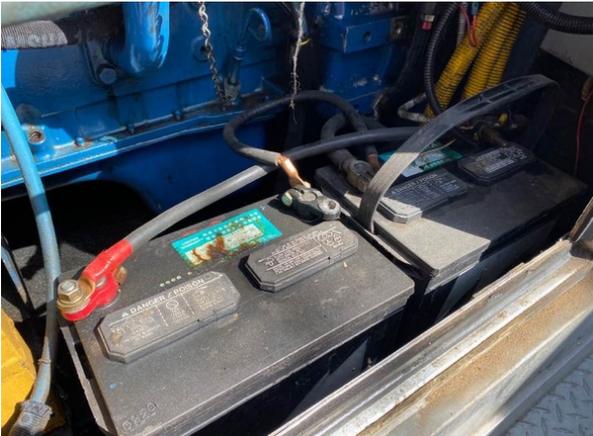
Battery	3 - Normal Wear & Tear
Battery Condition	Clean & dry appearance, tight connections
Battery Condition Photos

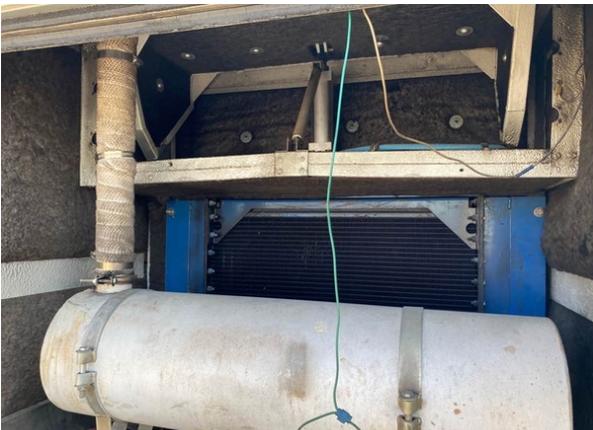
Radiator	3 - Normal Wear & Tear
Radiator Condition	Radiator fins & components appear to be in good working order, no signs of damage or leaks
Radiator Photos

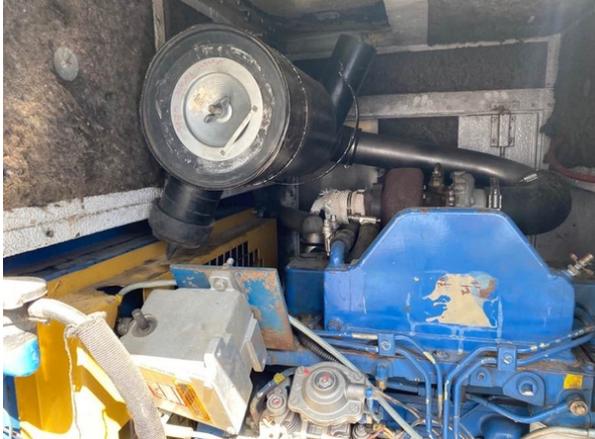
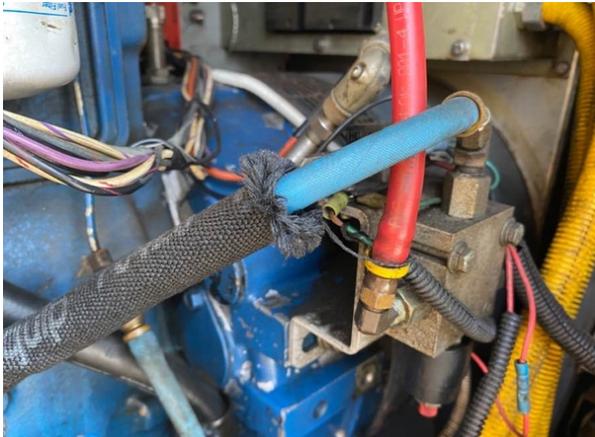
<b>Belts</b>	3 - Normal Wear & Tear	
<b>Belt Condition</b>	Belts appear in good condition & alignment with proper tension	
<b>Hoses</b>	3 - Normal Wear & Tear	
<b>Hose Condition</b>	Firm, pliant hoses with no signs of wear or leaks	
<b>Hose Photos</b>

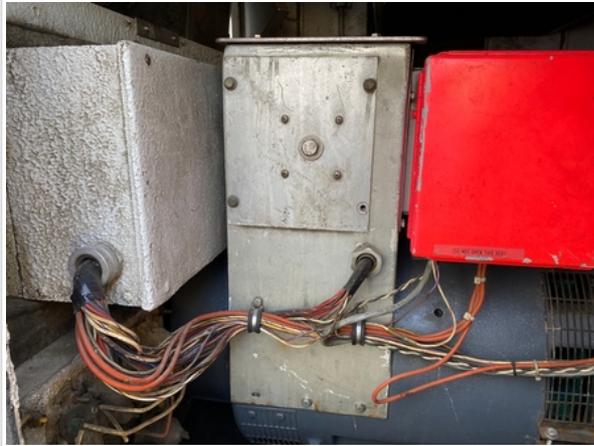
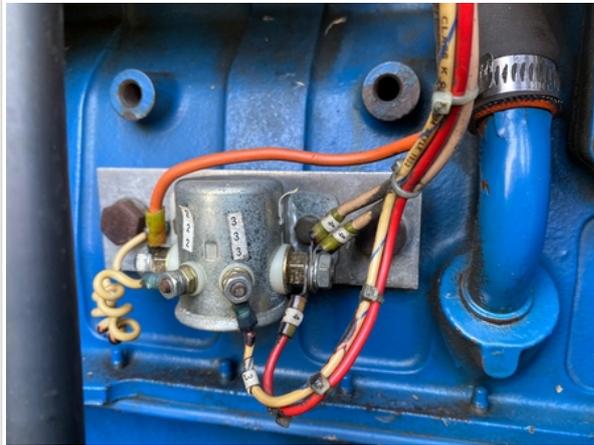
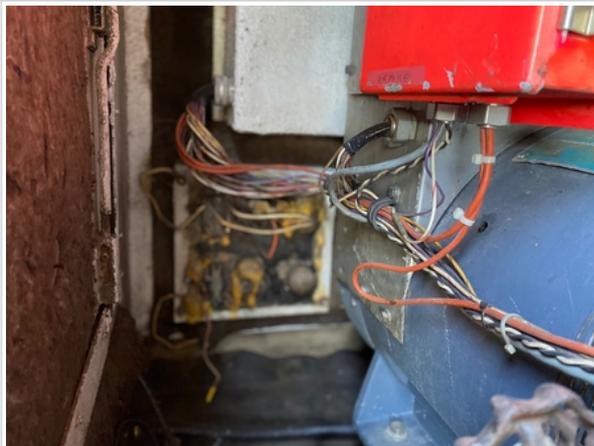
Wire Harness Photos

<b>Wire Harness</b>	2 - Above Average Wear
<b>Comments</b>	Wire harness missing wire loom

Exterior Rating	3
Interior Rating	3
Safety Rating	3
Quality Rating	3
Functionality Rating	3
Overall Rating	3
What's Great About the Machine	Unit is in good condition and generator has recently been replaced. Engine is well maintained and visually all functions operate well.
What Needs Work	Tires may need to be replaced soon. Wire harness needs to be secured in some areas.

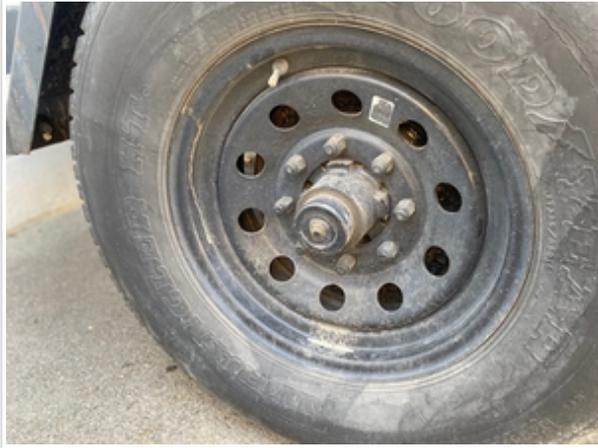
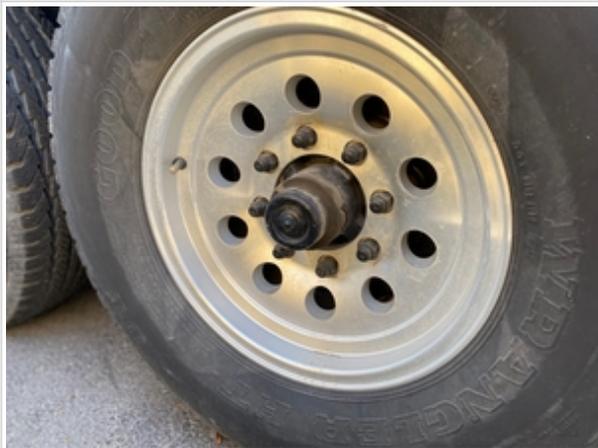
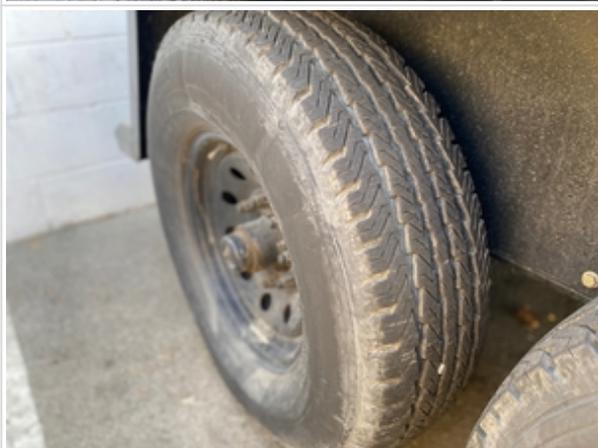
Wheels & Hub Condition	3 - Normal Wear & Tear	
Comments	Both front tires & rear l/s tire ok, rear r/s tire has sidewall cracks appearing	
Wheels & Hub Photos

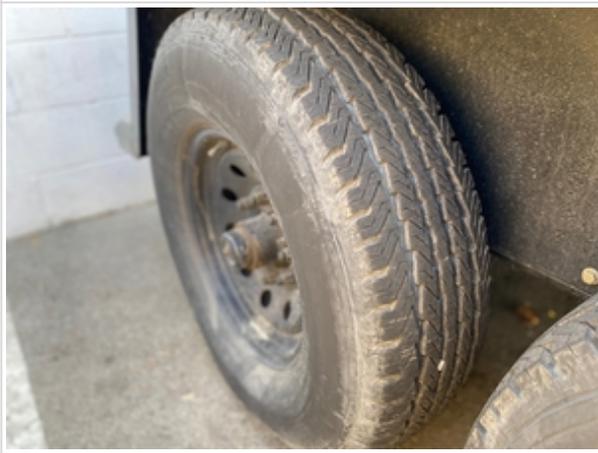
Rear Right Tire - Ratio Remaining	30%
Rear Right Tire Photos

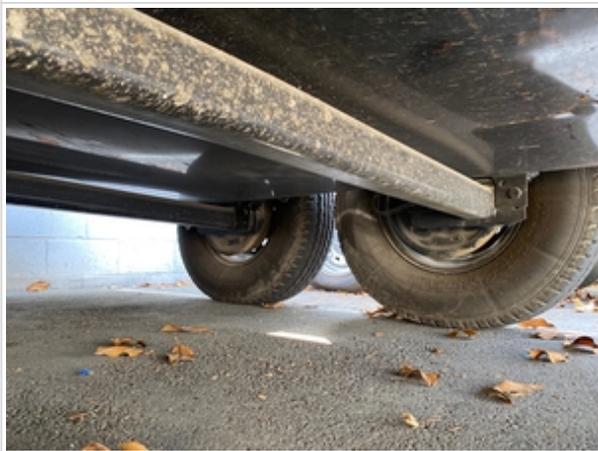
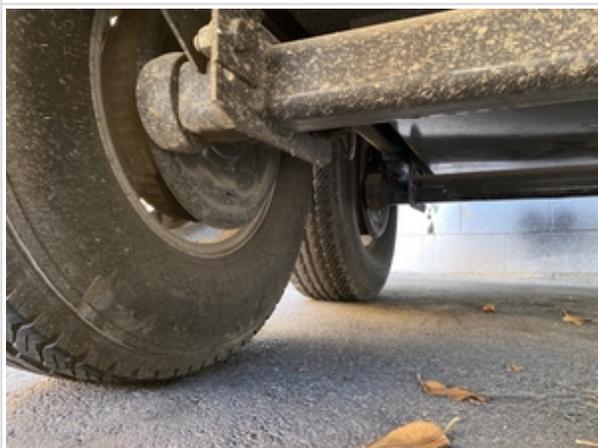
Overall Trailer & Undercarriage Photos

Overall Trailer	3 - Normal Wear & Tear
Overall Trailer Comments	Unable to test brakes and lights. Visually looks okay
