Inspection Report (Generator)

Year	2005
Make	Multiquip
Model	4 x 9 - 500AMP - 3 Phase 60HZ
Serial Number	1E9GF491XCR153808 / 16948 1-2
Hour Meter Reading	9,204
Previous Application (e.g., earth moving, mining, demolition, etc)	General Construction

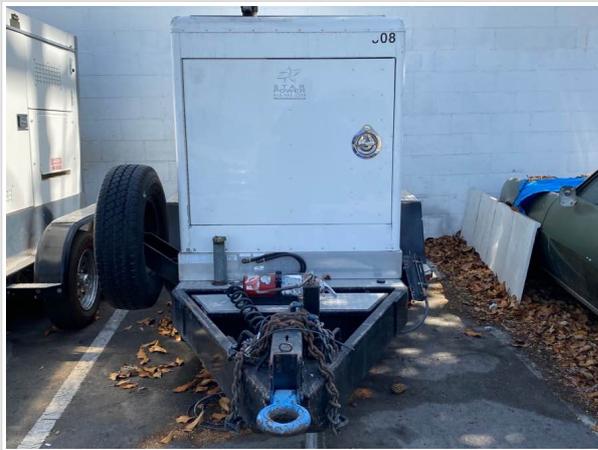
<p>Front Photos</p>

Front	3 - Normal Wear & Tear
Front Condition	No visible damage

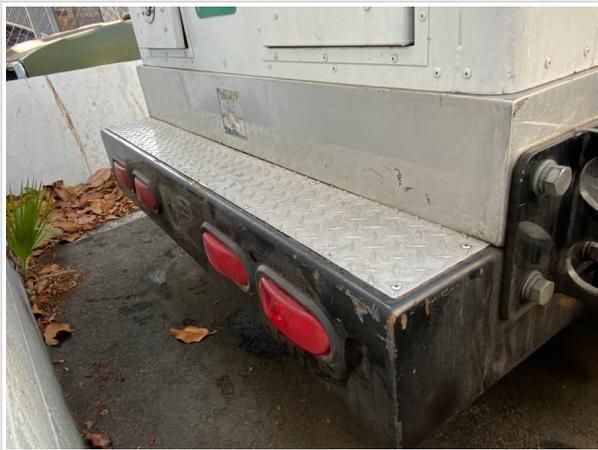
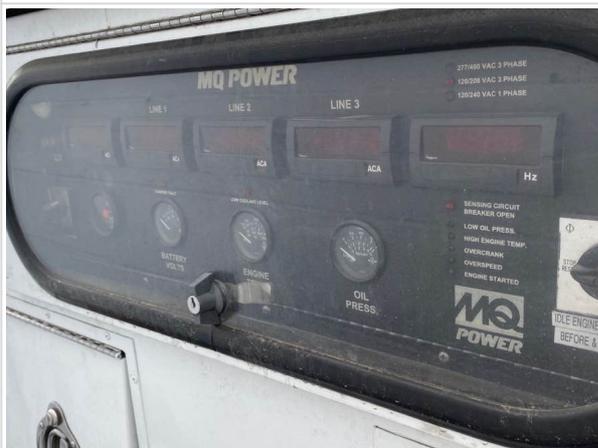
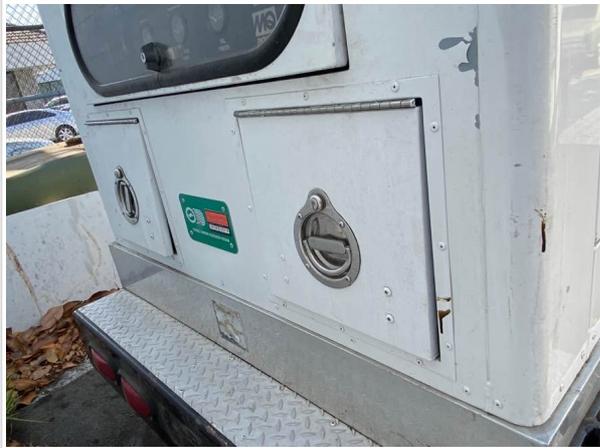
<p>Rear</p>	<p>3 - Normal Wear & Tear</p>
<p>Rear Condition</p>	<p>No visible damage</p>
<p>Rear Photos</p>

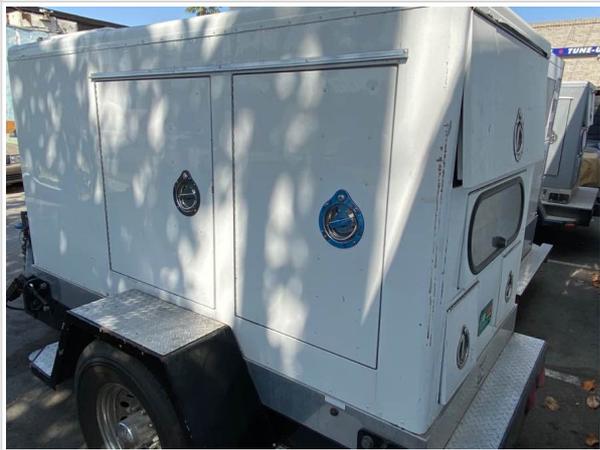
Left	3 - Normal Wear & Tear	
Left Condition	No visible damage	
Left Photos

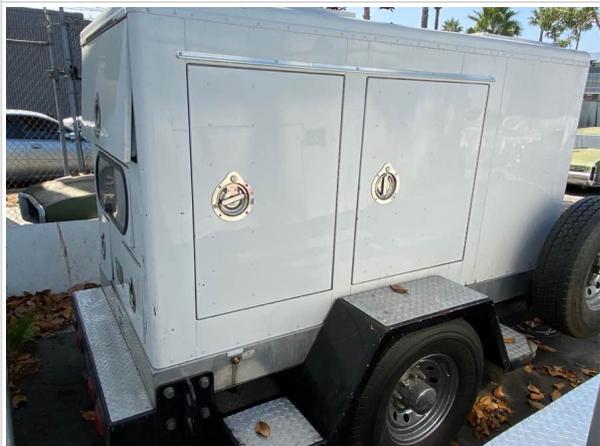
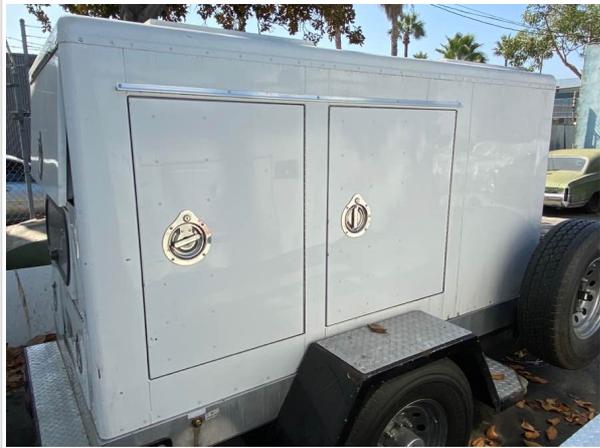
Right	3 - Normal Wear & Tear	
Right Condition	No visible damage	
Right Photos

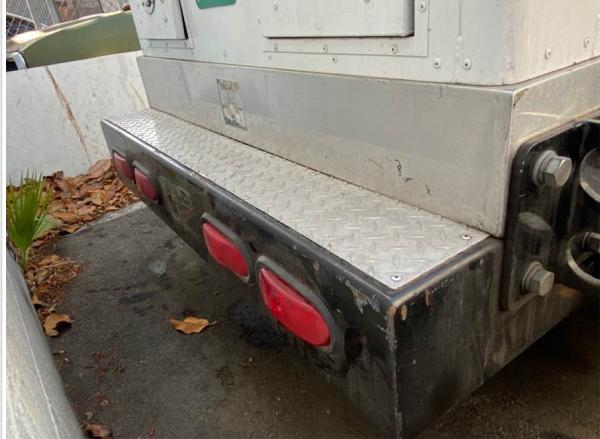
Upper	3 - Normal Wear & Tear	
Upper Condition	No visible damage	
Body Panels (Any Rust Damage?)	3 - Normal Wear & Tear	
Body Panel Condition	No visible damage, good paint condition and panel fitment	
Doors / Canopy Latches	3 - Normal Wear & Tear	
Doors / Canopy Latches Condition	No visible damage	
Glass Condition	0	
Mirrors	0	
Lighting System	3 - Normal Wear & Tear	
Lighting System Condition	No visible damage, lighting system is operational, Other (see comments)	
Comments	Unable to test but lights look to be in good condition	
Lighting System Photos

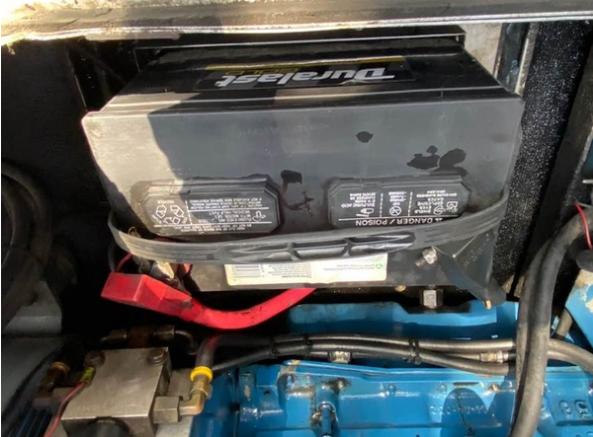
Blow-by (Visual Observation Check)	No
Unusual Noises (Upon Start-up, Idle, Shutdown)	No
Unusual Noise Notes	No unusual noises heard
Engine Smoke (Upon Start-up, Idle, Shutdown)	No
Engine Smoke Notes	No engine smoke issues observed
Engine Exhaust Color	Clear
Battery	3 - Normal Wear & Tear
Battery Condition	Like new, recently replaced, Other (see comments)

Comments	Missing battery hold down
Battery Condition Photos

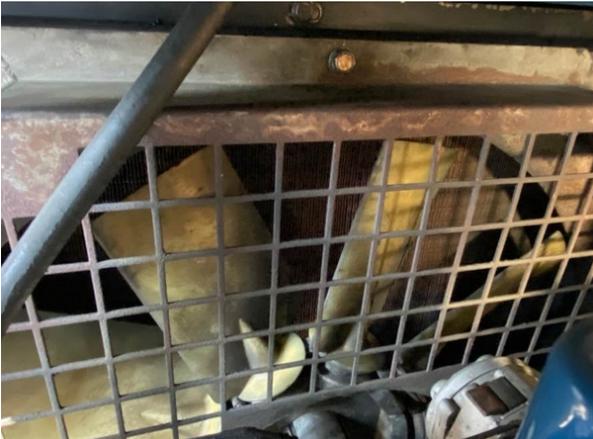
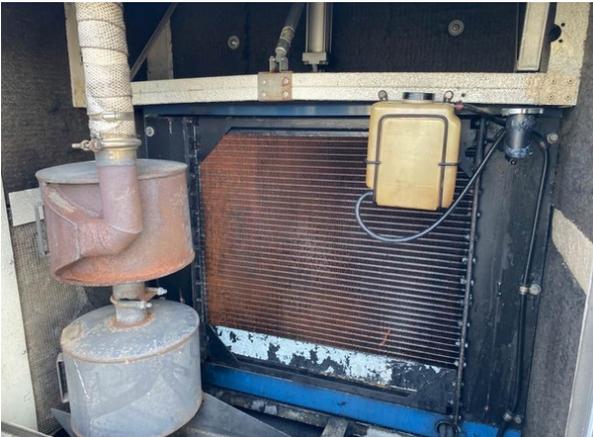
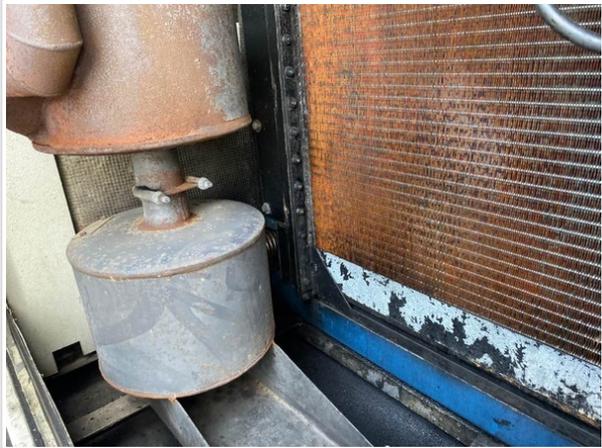
Radiator	3 - Normal Wear & Tear
Radiator Condition	Radiator fins & components appear to be in good working order, no signs of damage or leaks
Radiator Photos

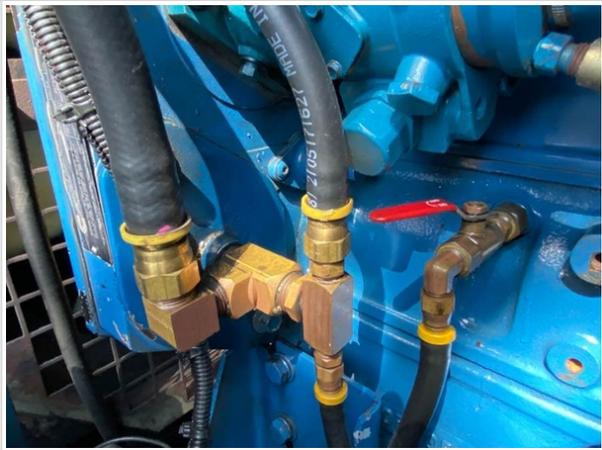
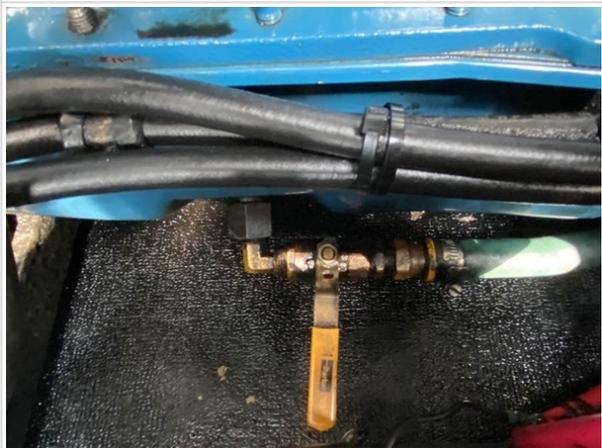
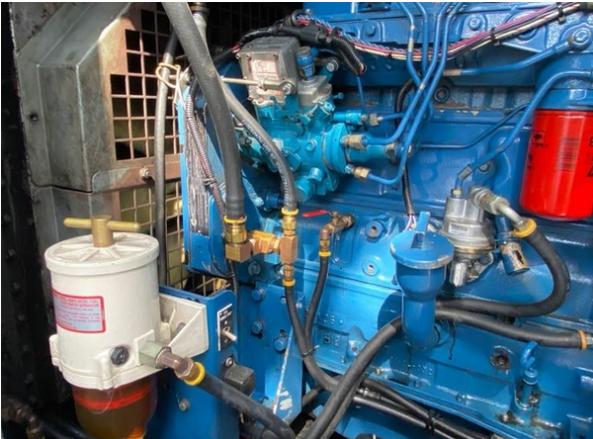
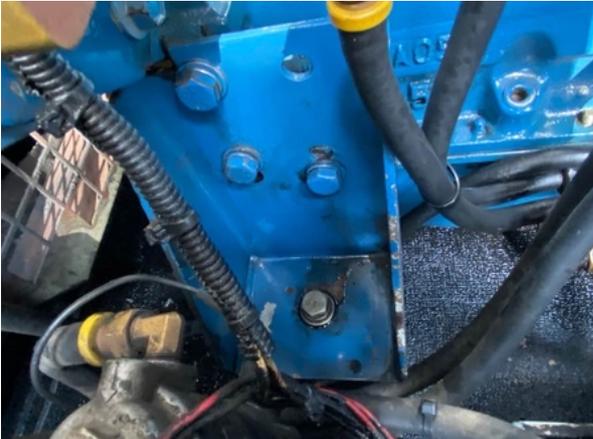
Belts	3 - Normal Wear & Tear	
Belt Condition	Belts appear in good condition & alignment with proper tension	
Hoses	3 - Normal Wear & Tear	
Hose Condition	Leaks in one or more hoses or fittings observed, Other (See comments)	
Comments	Seepage found around some hoses l/s engine ball valve	
Hose Photos

Oil Color / Appearance	3 - Normal Wear & Tear
Oil Color / Appearance Notes	Clean oil appearance, no signs of cross contamination, Appropriate oil level
Fuel Leaks	No
Equipped with DPF (Diesel Particulate Filter)	No
Requires DEF (Diesel Exhaust Fluid)	No
Overall Engine Appearance	Clean & dry, Active leaks/pooling observed in & around engine compartment
Overall Engine Comments	Overall engine sounds healthy. A few engine oil leaks present at l/s hoses. Oil leaks also at engine block component mounted gaskets. (Possible fuel transfer pump)

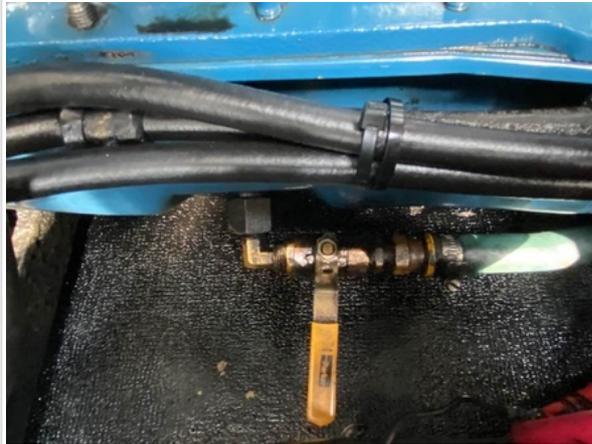
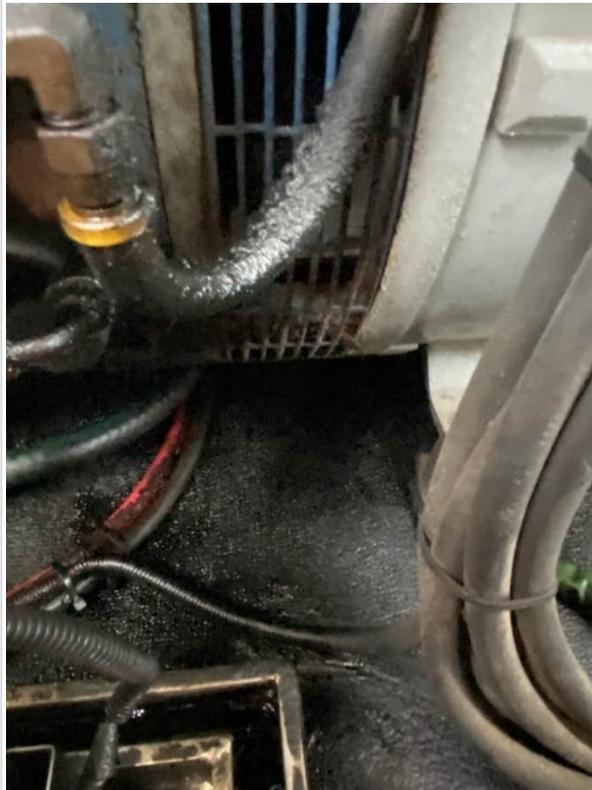
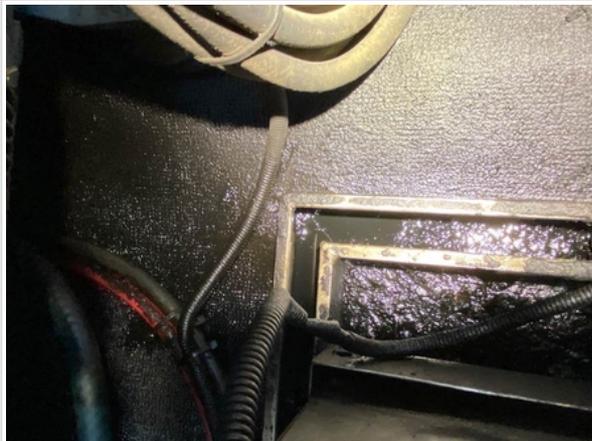
Oil Leak Photos

Water Pump	3 - Normal Wear & Tear
Water Pump Condition	No unusual pump noises heard
Cooling System Leaks	No
Coolant Color / Appearance	3 - Normal Wear & Tear
Coolant Color/Appearance Notes	Normal Translucent appearance, no visual signs of contamination
Oil Leaks	Yes
Oil Leak Notes	Wet areas with drops forming due to oil leakage, Other (see comments)
Comments	Small oil buildup under engine accumulating, could also be residual from engine being serviced

Overall Assessment	
Exterior Rating	3
Interior Rating	3
Safety Rating	3
Quality Rating	3
Functionality Rating	3
Overall Rating	3
What's Great About the Machine	Generator is in good condition all functions operate well. Generator trailer looks to be in good condition. No obvious major repairs required.
What Needs Work	A few engine oil leaks present. Trailer needs to be tested for lights and breakaway system.
Date/Time	10-07-2022

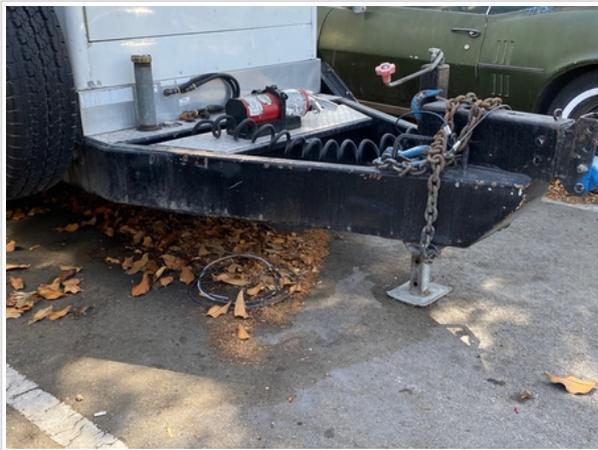
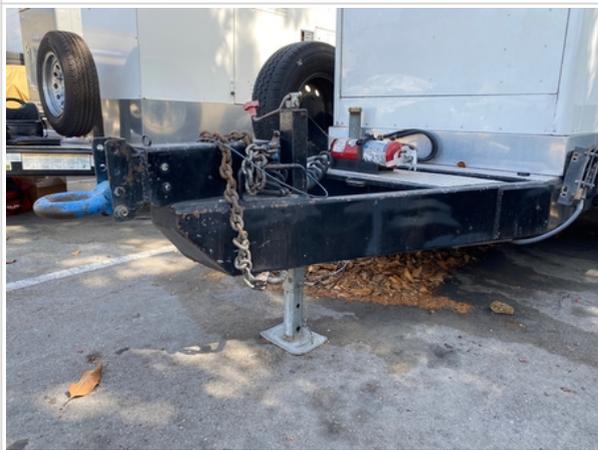
Frame Photos

Frame Condition	3 - Normal Wear & Tear
-----------------	------------------------

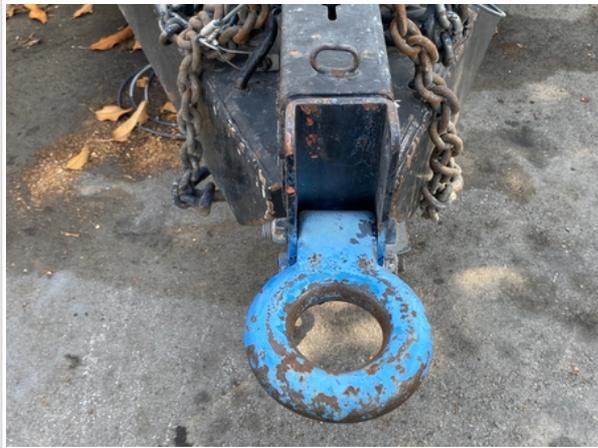
Hitch Photos

Hitch Type	Pintle
Hitch Condition	3 - Normal Wear & Tear
