## Inspection Report (Generator)

Year	2016
Make	Baldor
Model	TS80T
Serial Number	P0404290005
Hour Meter Reading	5,385
Previous Application (e.g., earth moving, mining, demolition, etc)	General Construction

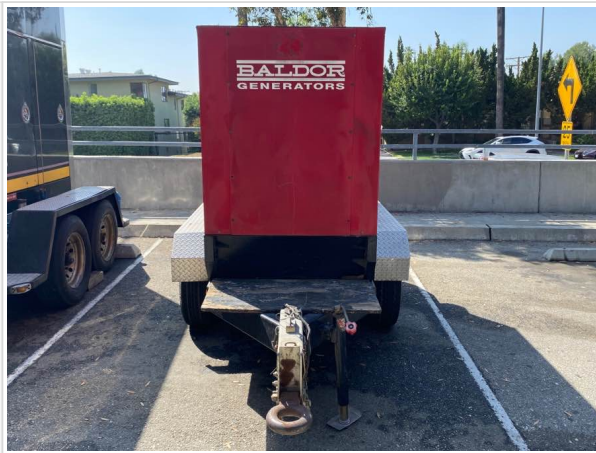
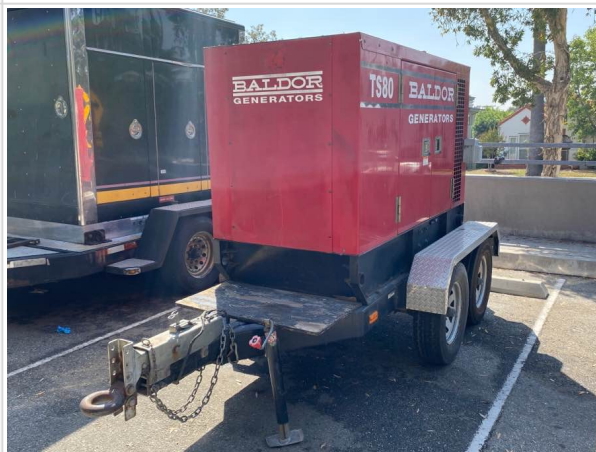
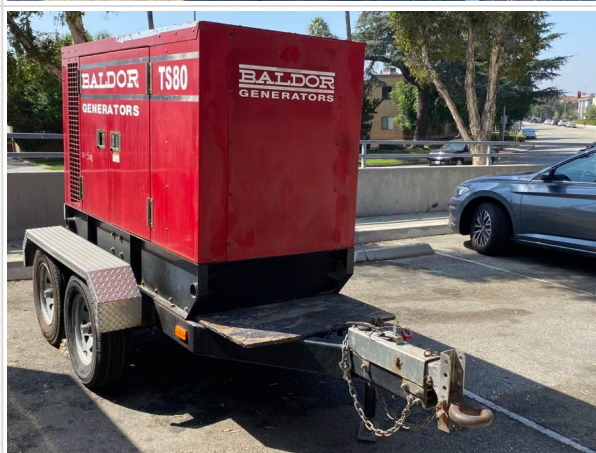
<p>Front Photos</p>

Front	3 - Normal Wear & Tear
Front Condition	No visible damage

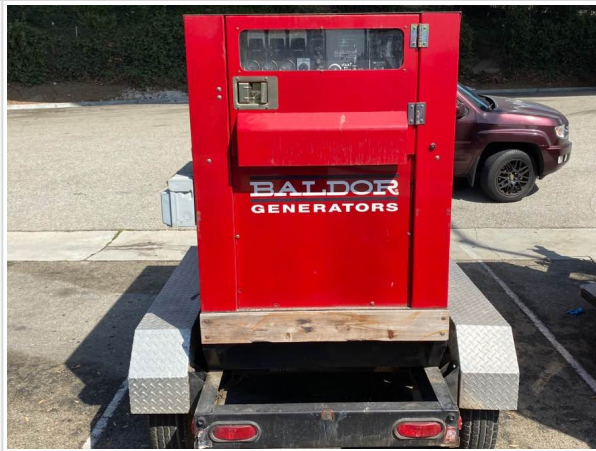
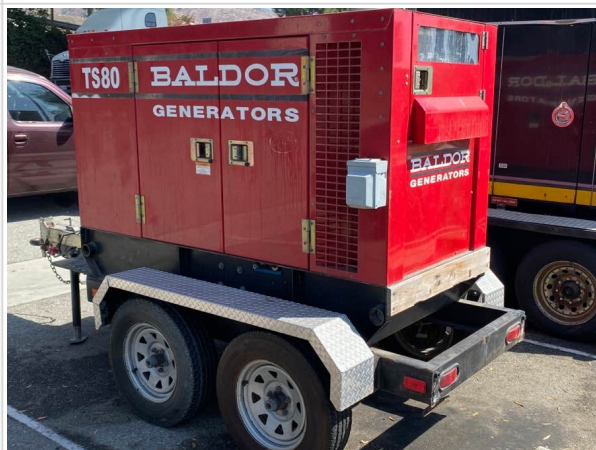
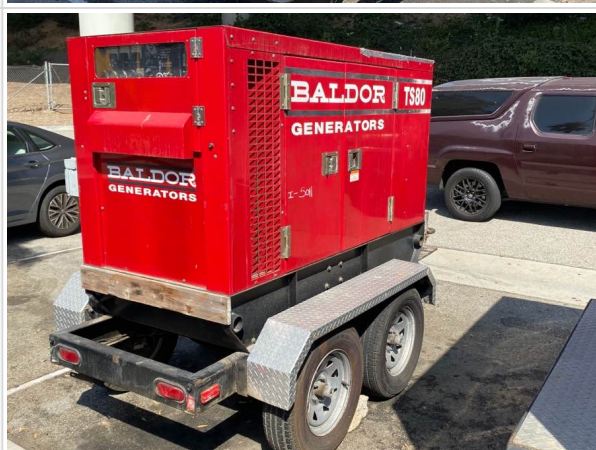
<p>Rear Photos</p>

<p>Rear</p>	<p>3 - Normal Wear &amp; Tear</p>
<p>Rear Condition</p>	<p>No visible damage</p>

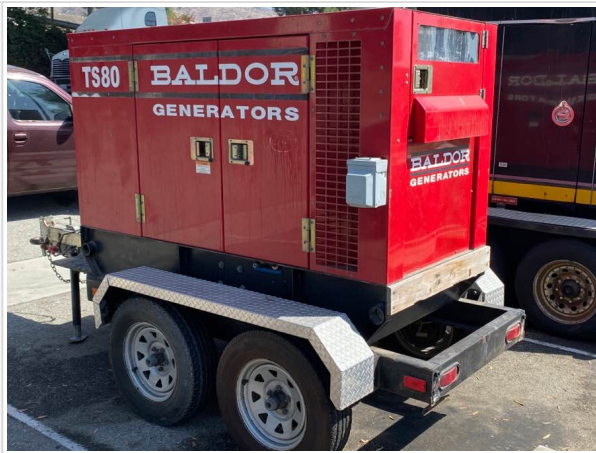
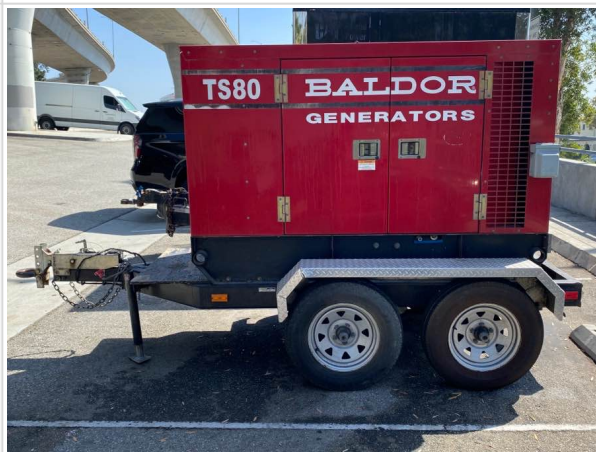
<p>Left Photos</p>

<p>Left</p>	<p>3 - Normal Wear &amp; Tear</p>
<p>Left Condition</p>	<p>No visible damage</p>

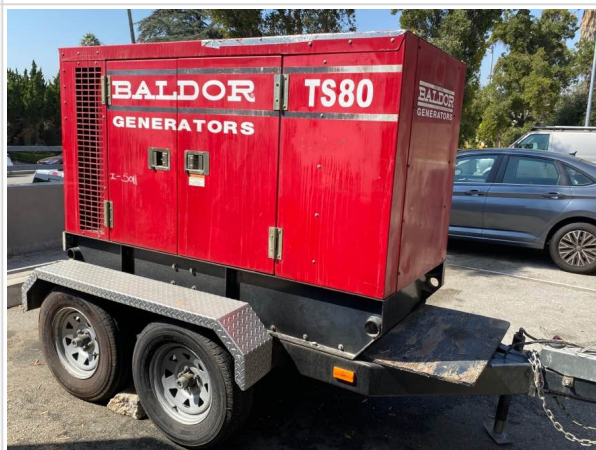
<p>Right</p>	<p>3 - Normal Wear &amp; Tear</p>
<p>Right Condition</p>	<p>No visible damage</p>
<p>Right Photos</p>

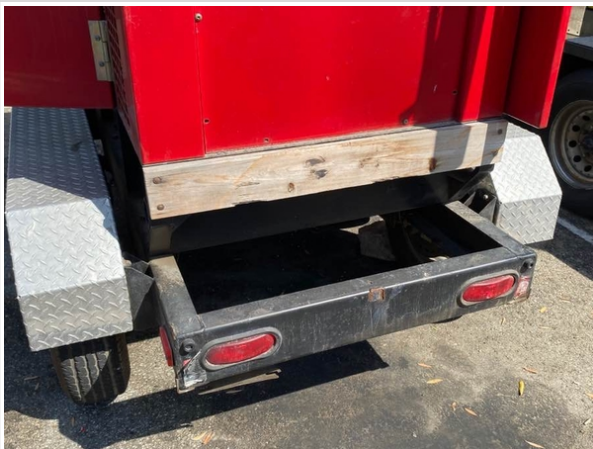
Upper	0	
Body Panels (Any Rust Damage?)	3 - Normal Wear & Tear	
Doors / Canopy Latches	3 - Normal Wear & Tear	
Glass Condition	0	
Mirrors	0	
Lighting System	3 - Normal Wear & Tear	
Lighting System Condition	Other (see comments)	
Comments	Exterior lighting looks okay (unable to test)	
Lighting System Photos

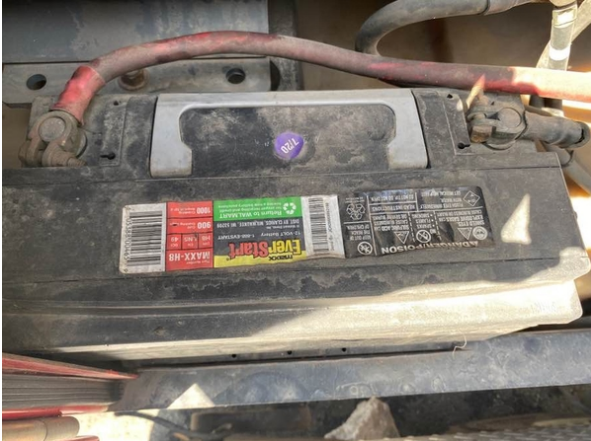
<b>Battery Condition</b>	Clean & dry appearance, tight connections
<b>Battery Condition Photos</b>

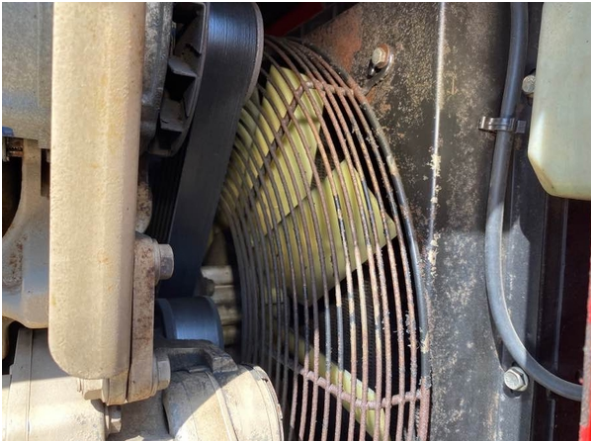
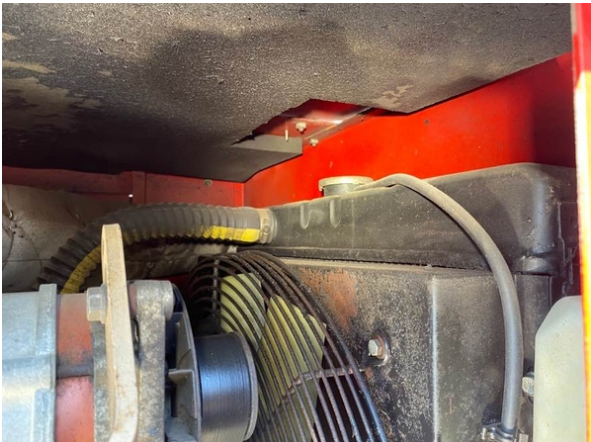
<b>Radiator</b>	3 - Normal Wear & Tear
<b>Radiator Condition</b>	Radiator fins & components appear to be in good working order, no signs of damage or leaks
<b>Radiator Photos</b>

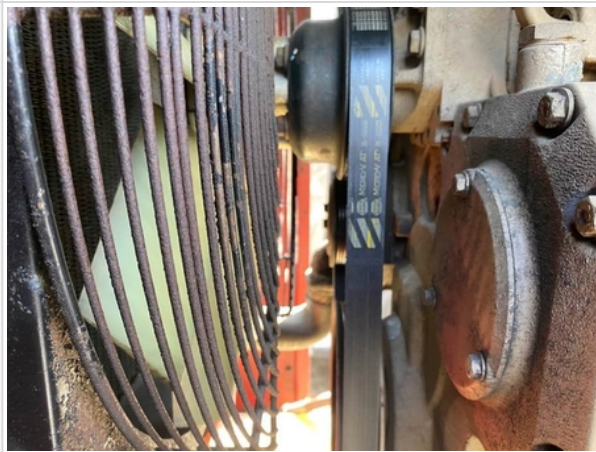
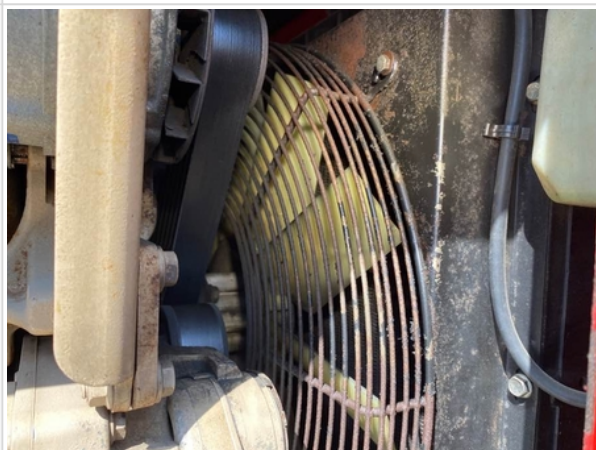
<b>Belts</b>	3 - Normal Wear & Tear
<b>Belt Condition</b>	Belts appear in good condition & alignment with proper tension
<b>Belt Photos</b>

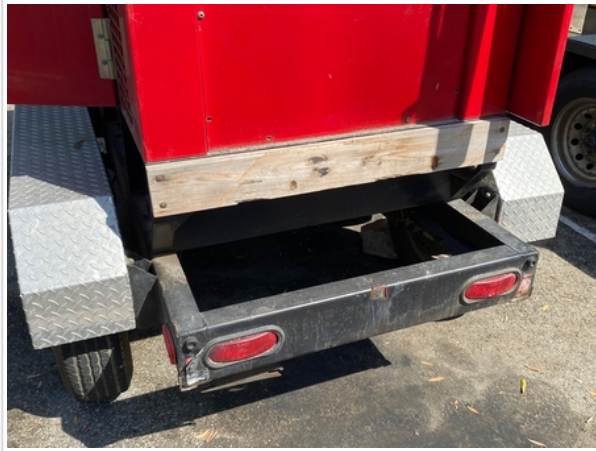
<b>Fenders</b>	3 - Normal Wear & Tear
<b>Mud Flaps</b>	0
<b>Trailer Lights/Wiring (Stop, Tail, Turn)</b>	3 - Normal Wear & Tear
<b>Comments</b>	Look okay (unable to test )
<b>Trailer Lights Photos</b>

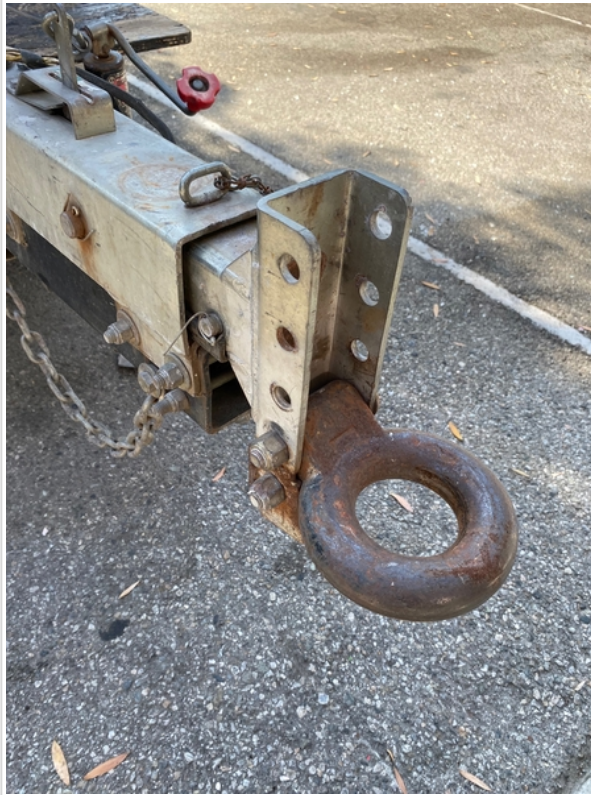
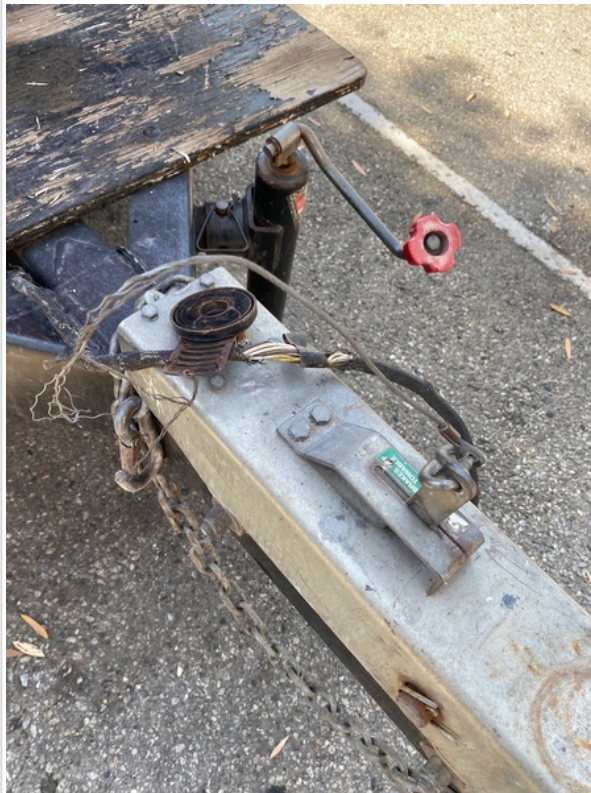
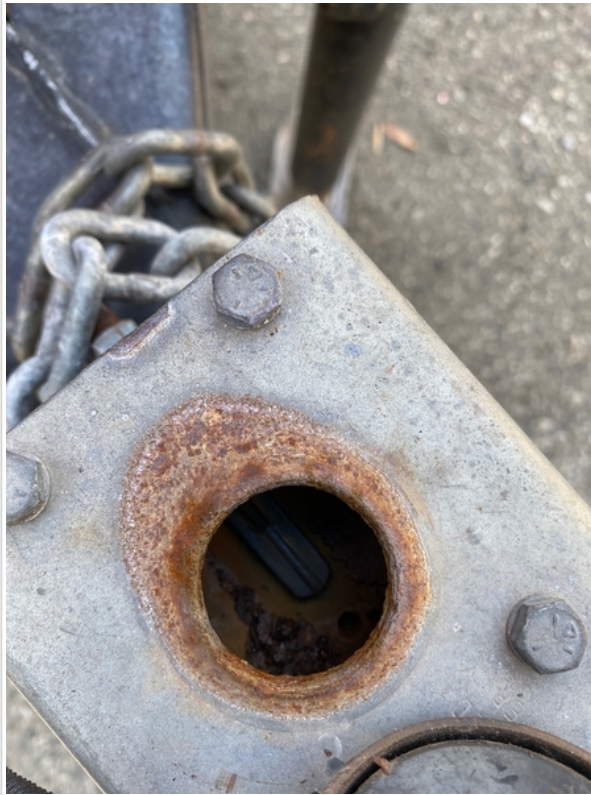
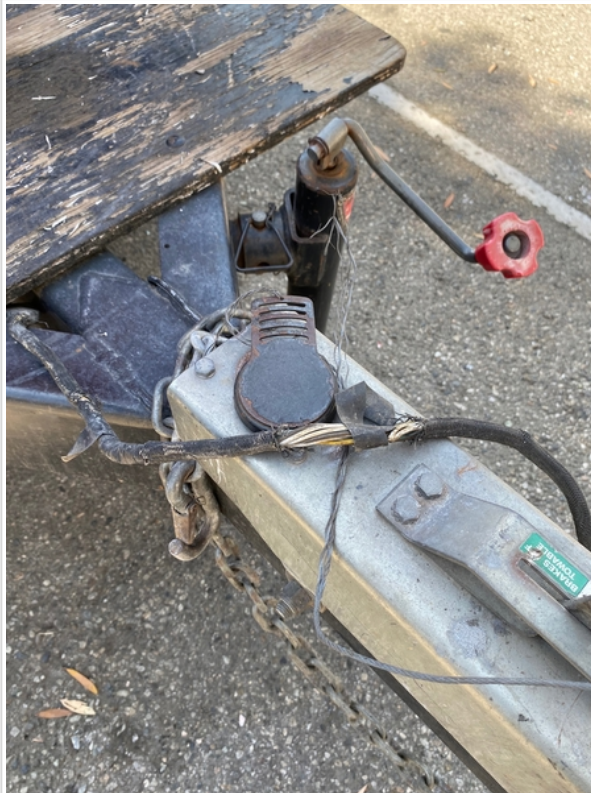
Hitch Photos

<b>Hitch Type</b>	Pintle
<b>Hitch Condition</b>	3 - Normal Wear & Tear
<b>Comments</b>	Hitch Pintle ring okay, surge brake inoperable

<b>What Needs Work</b>	Trailer brake system needs to be repaired. No oil in reservoir and lighting system should be tested.
<b>Date/Time</b>	10-07-2022

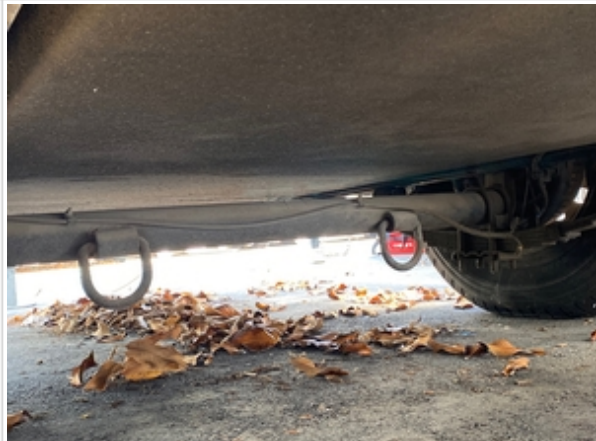
Overall Trailer	3 - Normal Wear & Tear	
Overall Trailer Comments	Overall trailers frame okay, Pintle ring and chains okay, brakes inoperable and unable to test lighting.	
Overall Trailer & Undercarriage Photos
