Inspection Report (Generator)

| Make | Cat |
| Model | 180 KW |
| Serial Number | 1E9GF1524WR153238 |

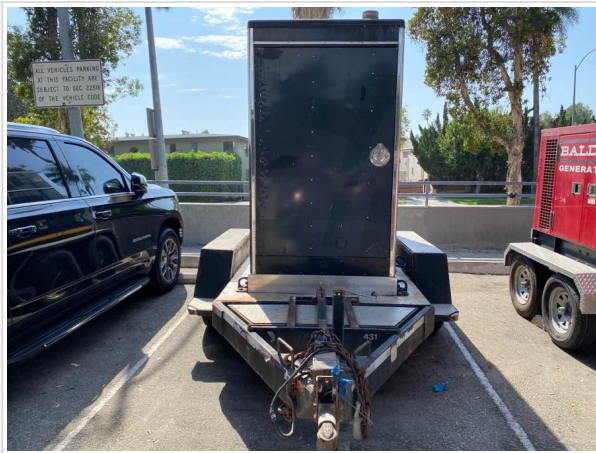
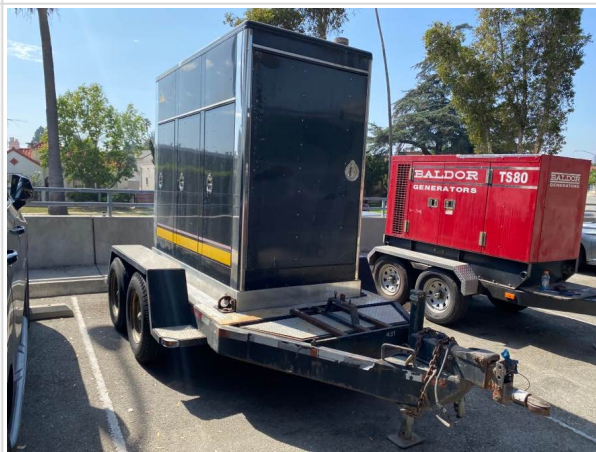
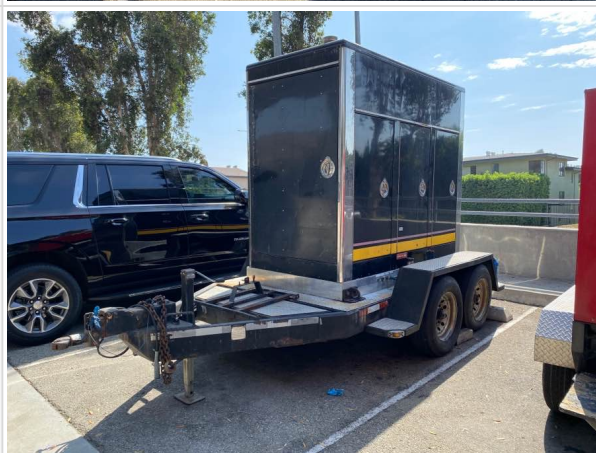
| Front | 3 - Normal Wear & Tear |
| Front Condition | No visible damage |

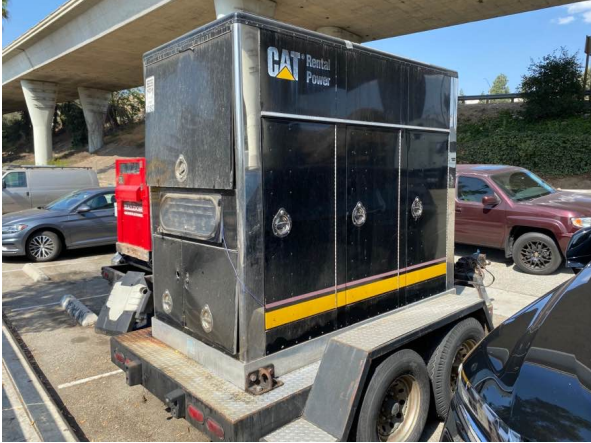
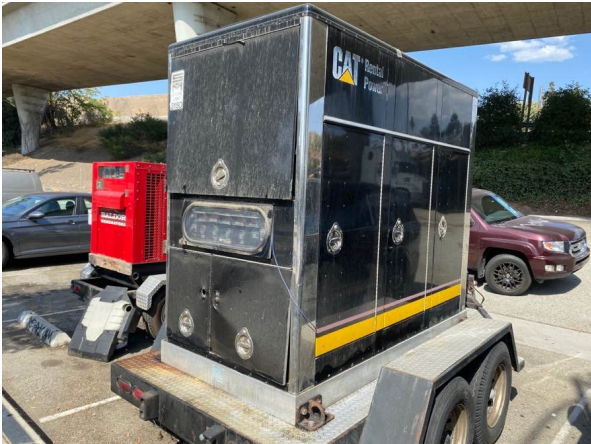
| <p>Rear</p> | <p>3 - Normal Wear & Tear</p> |
| <p>Rear Condition</p> | <p>No visible damage</p> |

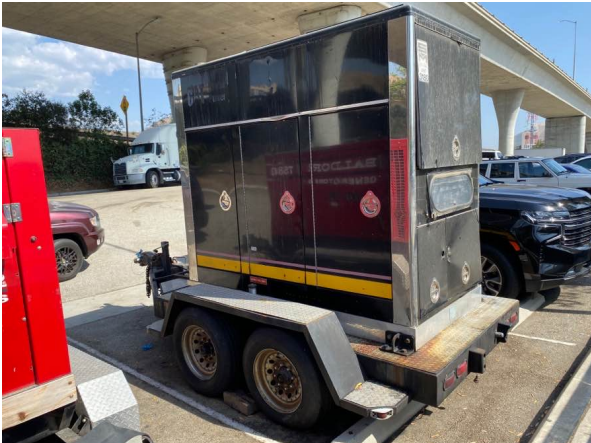
| Left | 3 - Normal Wear & Tear |
| Left Condition | No visible damage |

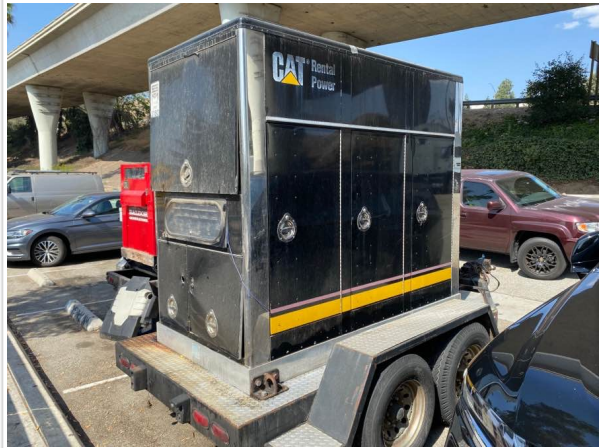
| Right | 3 - Normal Wear & Tear |
| Right Condition | No visible damage |

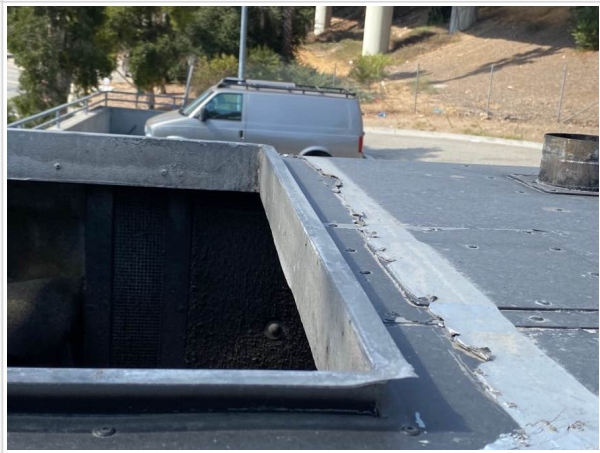
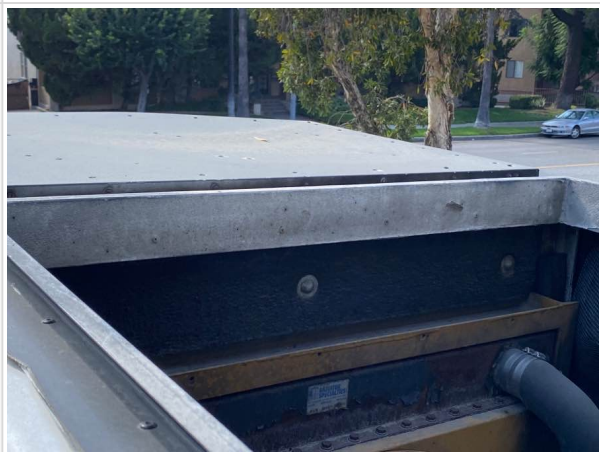
| Upper | 3 - Normal Wear & Tear | |
| Upper Condition | Other (see comments) | |
| Comments | Missing top cover panel | |

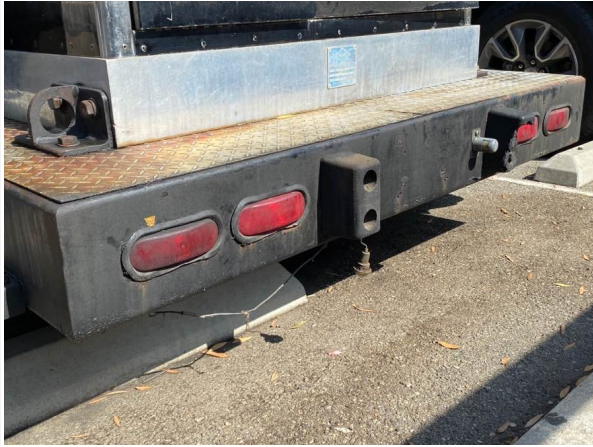
| Lighting System | 3 - Normal Wear & Tear |
| Lighting System Condition | Other (see comments) |
| Comments | Light fixtures look okay (unable to test) |

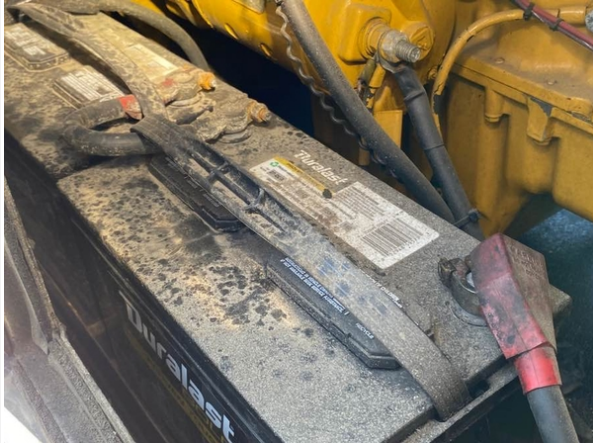
| Battery | 3 - Normal Wear & Tear |
| Battery Condition | Dusty & dirty appearance |

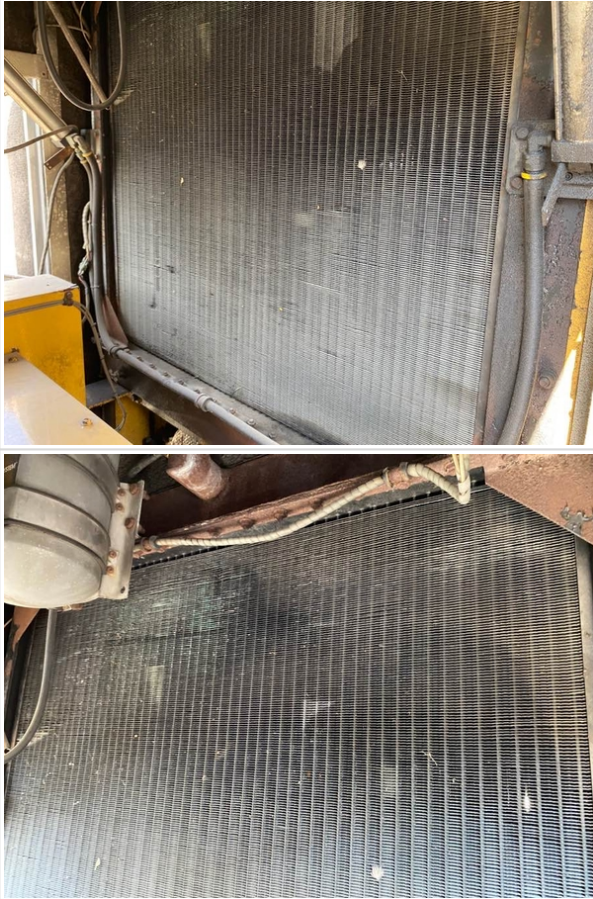
| Radiator | 3 - Normal Wear & Tear |
| Radiator Condition | Radiator fins & components appear to be in good working order, no signs of damage or leaks |

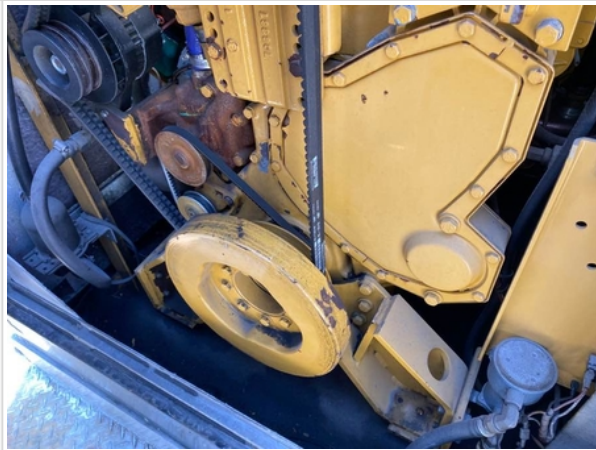
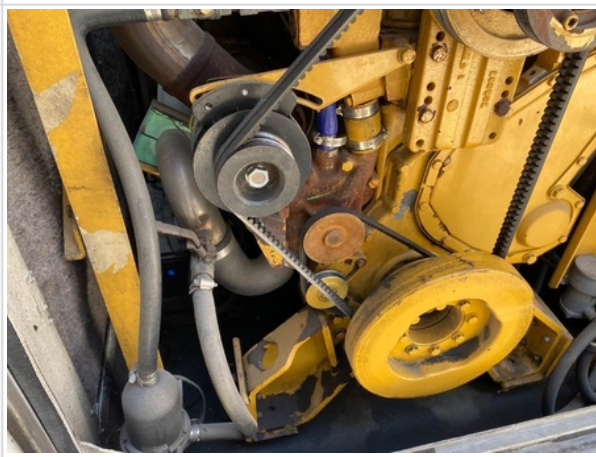
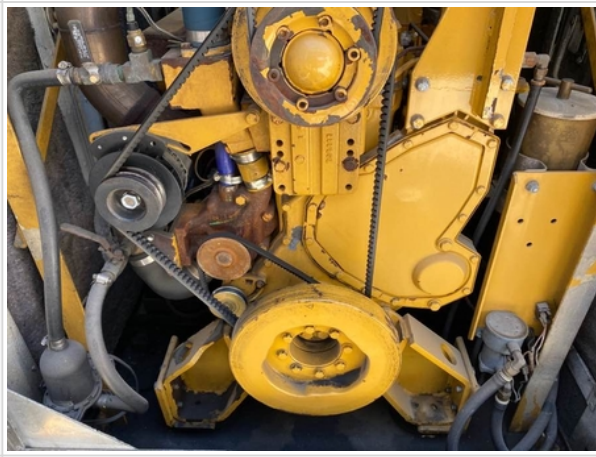
| Belts | 3 - Normal Wear & Tear |
| Belt Condition | Belts appear in good condition & alignment with proper tension |

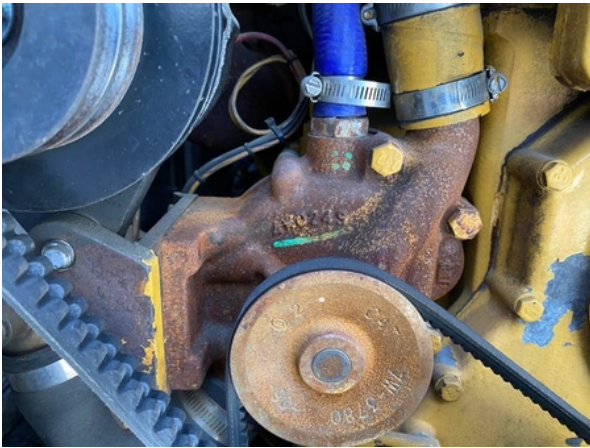
| Water Pump | 3 - Normal Wear & Tear | |
| Water Pump Condition | No unusual pump noises heard | |

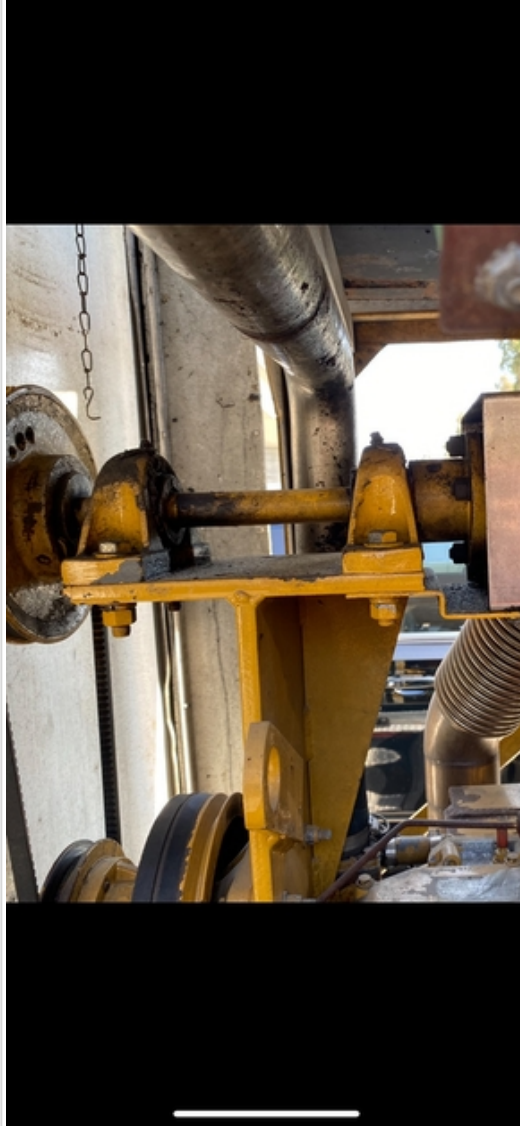
Mounting Plate Photos

| Overall Mounting Plate Appearance | 3 - Normal Wear & Tear |
| Comments | Some mounts missing hardware |

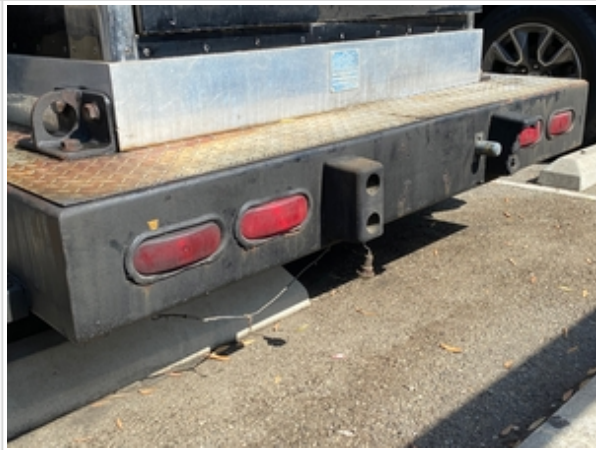
| Trailer Lights/Wiring (Stop, Tail, Turn) | 3 - Normal Wear & Tear |
| Comments | Trailer light fixtures look okay (okay to test) |

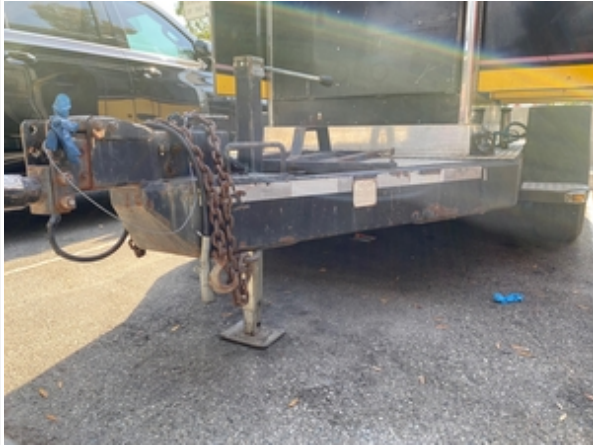
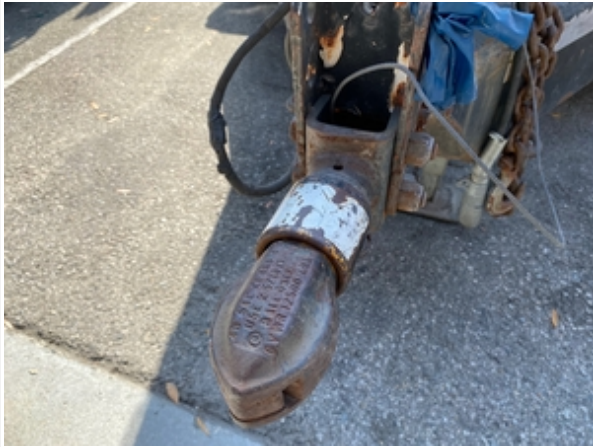
| Emergency Brake/Break-Away | 2 - Above Average Wear |

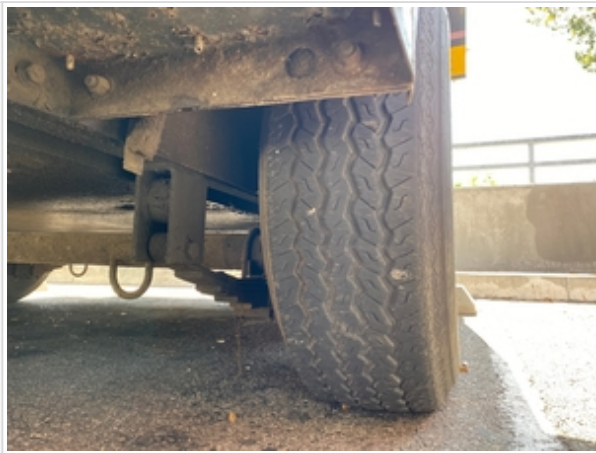
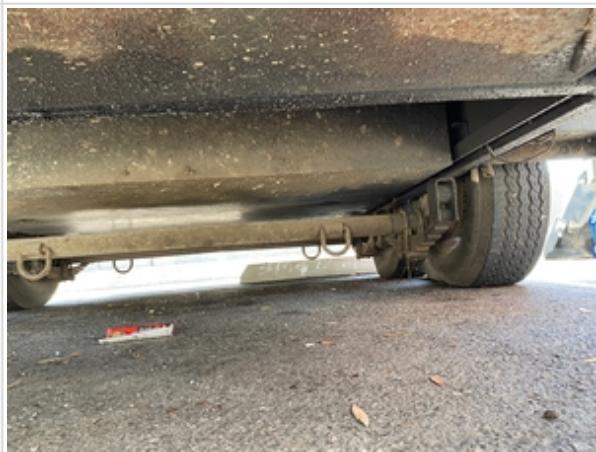
| Overall Trailer | 3 - Normal Wear & Tear |
| Overall Trailer Comments | Overall trailer structure in good shape. Brakes need to be tested as well as lights. |
