## Inspection Report (Excavator)

Year	2007
Make	CAT
Model	345CL
Serial Number	PJW02097
Hour Meter Reading	8,890 + 3,390 = 12,280
Previous Application (e.g., earth moving, mining, demolition, etc)	General Construction

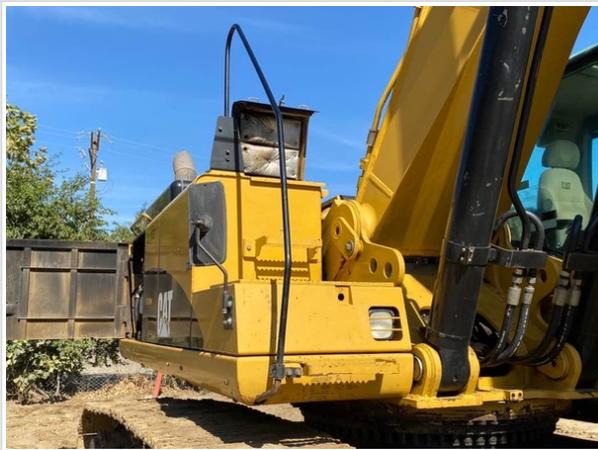
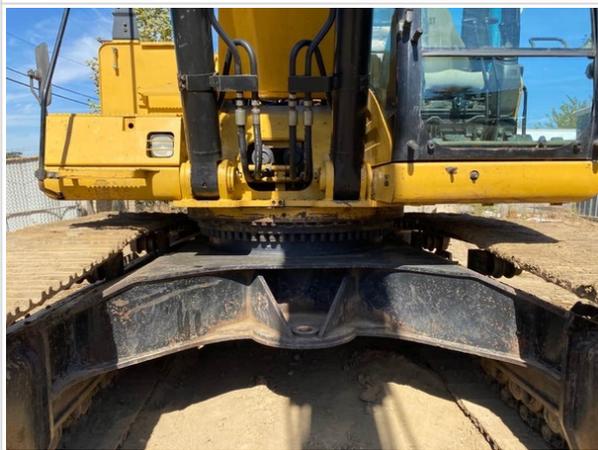
<p>Front Photos</p>

Front	3 - Normal Wear & Tear
Front Condition	No visible damage

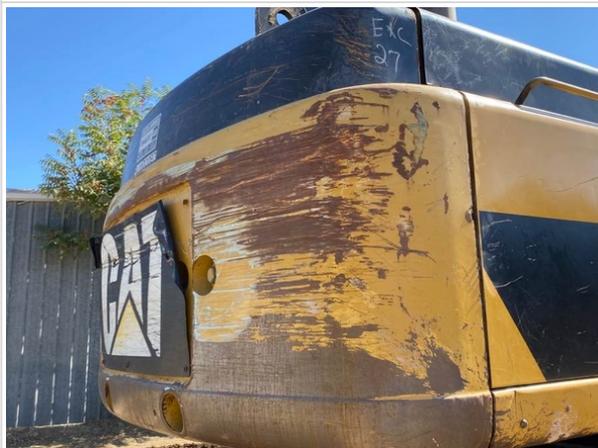
<p>Rear</p>	<p>3 - Normal Wear &amp; Tear</p>
<p>Rear Condition</p>	<p>Other (see comments)</p>
<p>Comments</p>	<p>Minor wear at rear</p>
<p>Rear Photos</p>

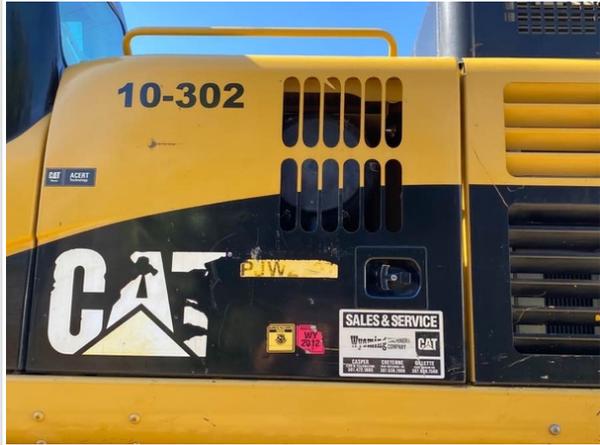
<b>Left</b>	3 - Normal Wear & Tear	
<b>Left Condition</b>	No visible damage	
<b>Left Photos</b>

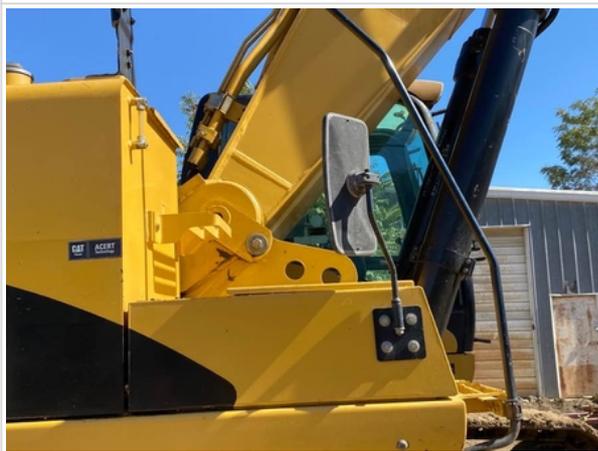
<p>Right</p>	<p>3 - Normal Wear &amp; Tear</p>	
<p>Right Condition</p>	<p>No visible damage</p>	
<p>Right Photos</p>

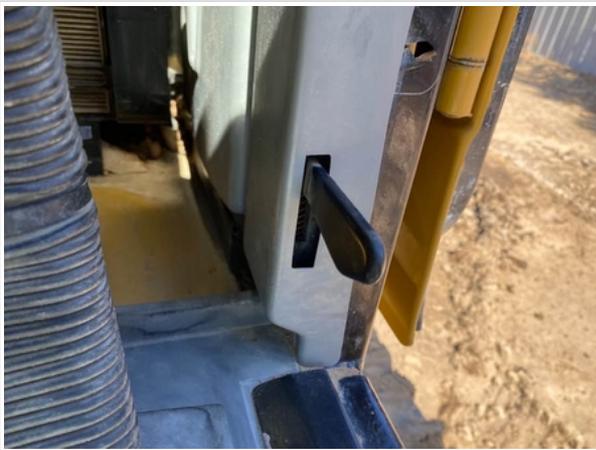
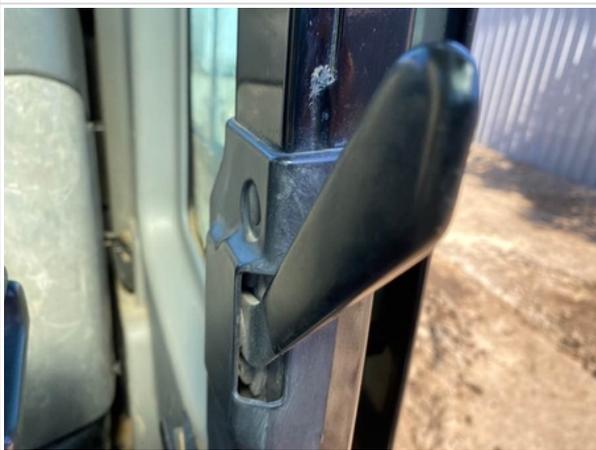
<p>Doors / Canopy Latches Photos</p>

<b>Doors / Canopy Latches</b>	3 - Normal Wear & Tear
<b>Doors / Canopy Latches Condition</b>	No visible damage

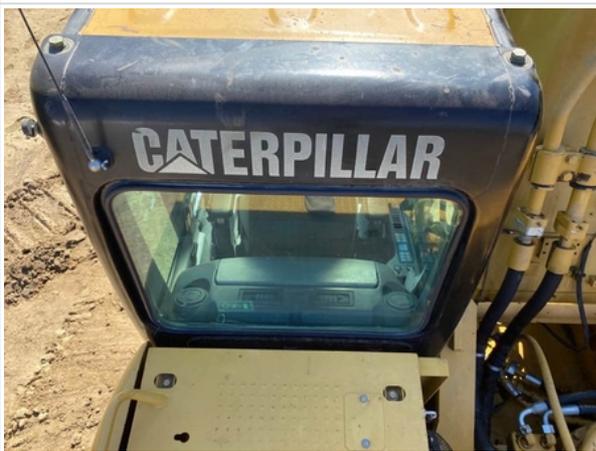
<p>Glass Condition</p>	<p>3 - Normal Wear &amp; Tear</p>
<p>Glass Condition Notes</p>	<p>Glass intact, no visible damage</p>
<p>Glass Condition Photos</p>

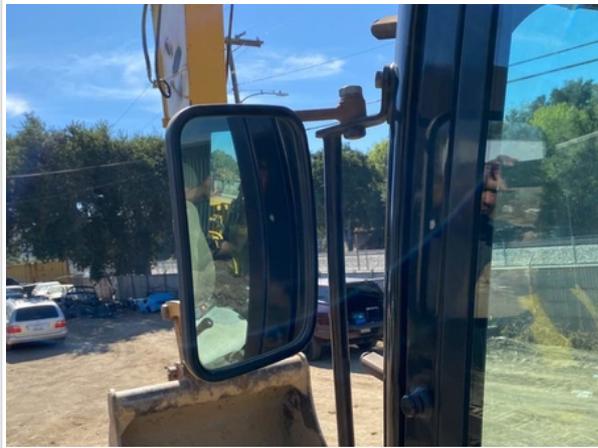
Mirrors Photos

<b>Mirrors</b>	3 - Normal Wear & Tear
<b>Mirror Condition Notes</b>	Mirrors present and intact, no visible damage

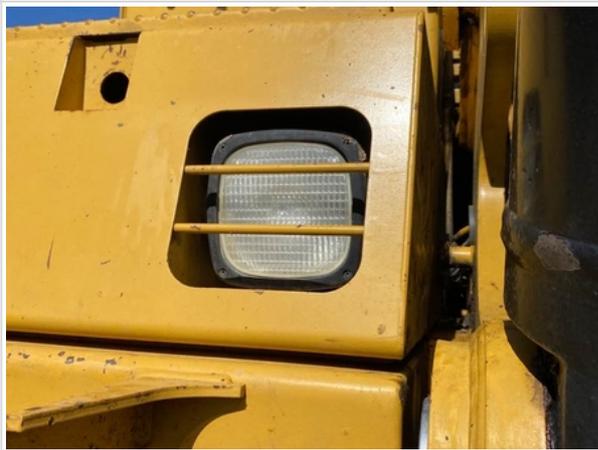
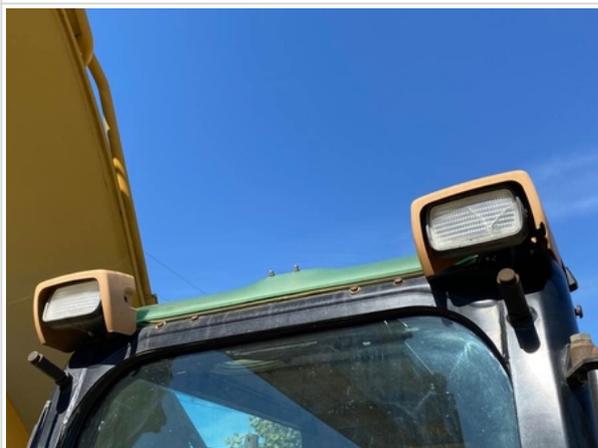
Lighting System	3 - Normal Wear & Tear
Lighting System Condition	No visible damage, lighting system is operational
Lighting System Photos

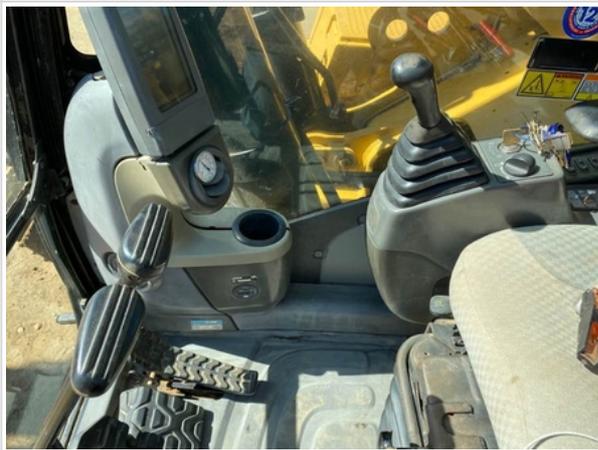
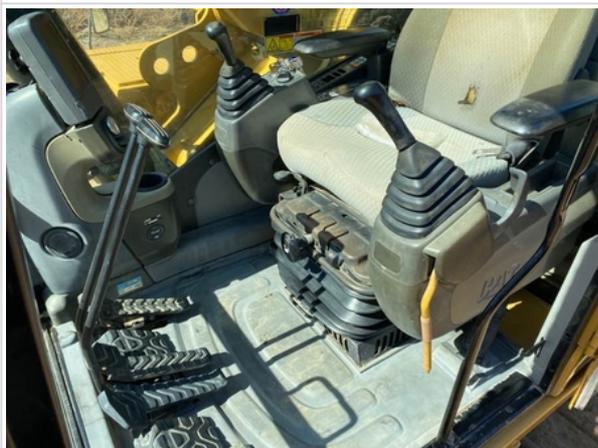
<p>A photograph of a yellow Caterpillar serial number plate. The plate is black with white text and a barcode. It includes the model number 345C, the product number *CAT0345CVPJW02097*, and the Caterpillar logo. The text 'CATERPILLAR INC. PEORIA, IL 61629 USA' and 'PARTS ORDER' are also visible.</p>
<p>Operator Cabin Overall</p>	<p>3 - Normal Wear &amp; Tear</p>
<p>Operator Cabin Overall Condition</p>	<p>Good cabin appearance, solid floors, panels, and ceiling</p>
<p>Operator Cabin Photos</p>

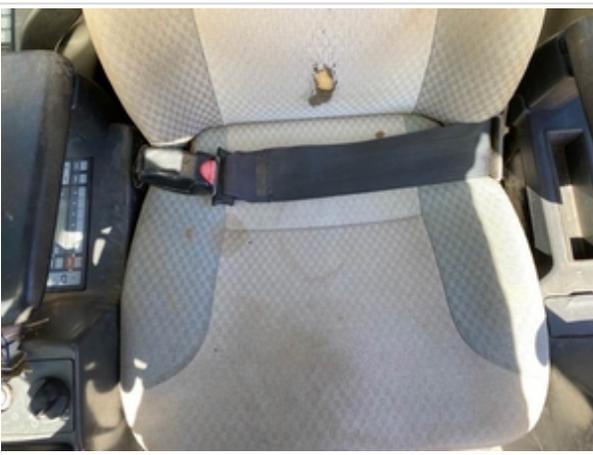
<p>Seat Belt</p>	<p>3 - Normal Wear &amp; Tear</p>
<p>Seat Belt Condition</p>	<p>Seat belt secures properly. Belt is intact and in good condition</p>
<p>Seat Belt Photos</p>

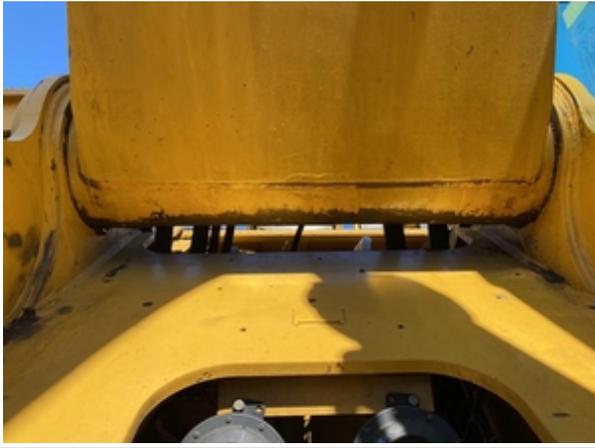
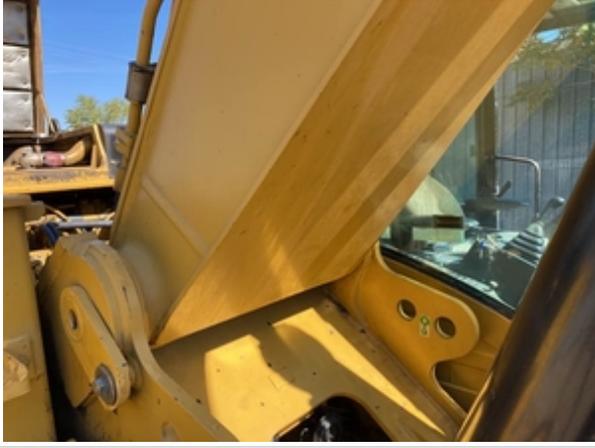
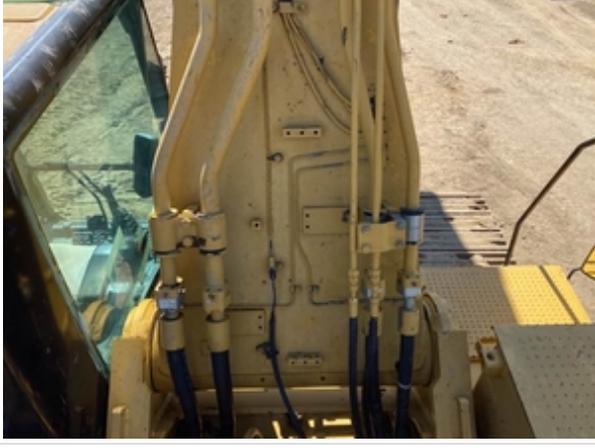
Boom Condition	3 - Normal Wear & Tear
Boom Photos

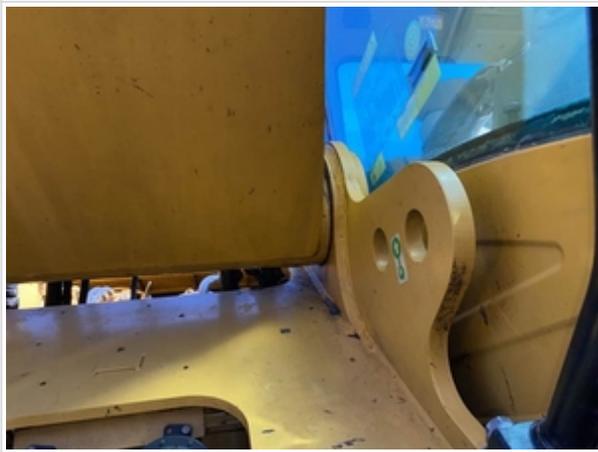
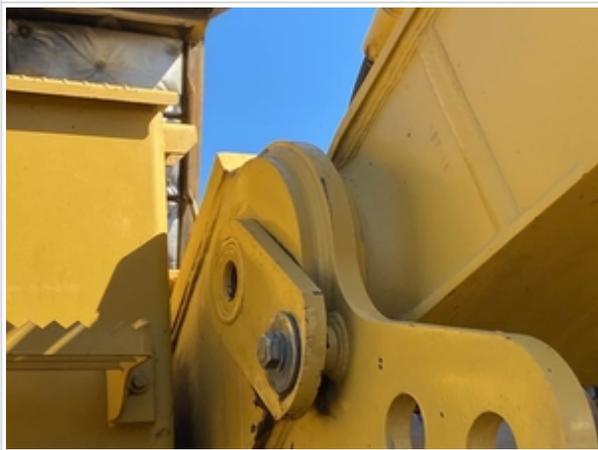
<p><b>Boom Base Pin &amp; Bushings</b></p>	<p>3 - Normal Wear &amp; Tear</p>	
<p><b>Boom Base Pin &amp; Bushings Photos</b></p>

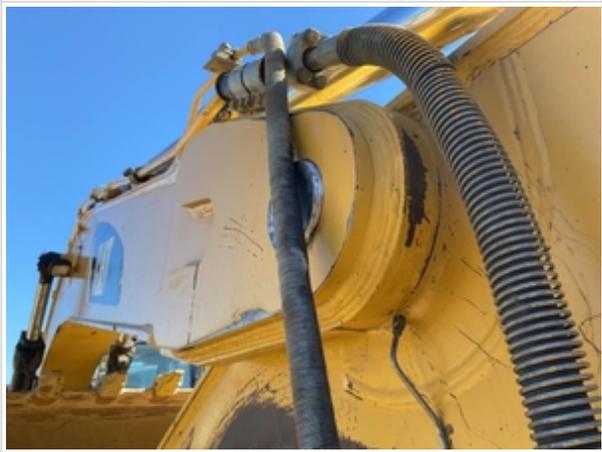
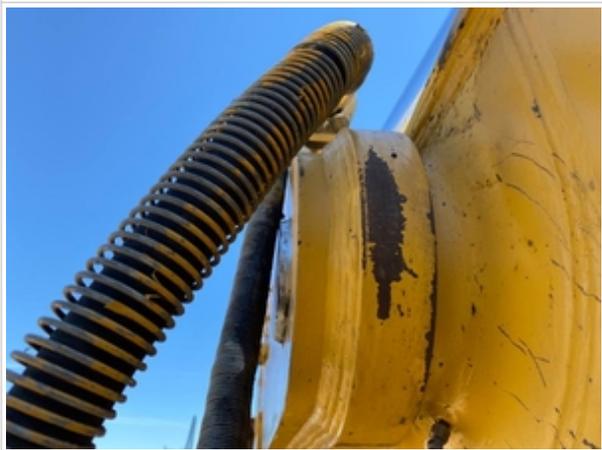
<p><b>Boom to Stick Pin &amp; Bushings</b></p>	<p>3 - Normal Wear &amp; Tear</p>	
<p><b>Boom to Stick Pin &amp; Bushings Photos</b></p>

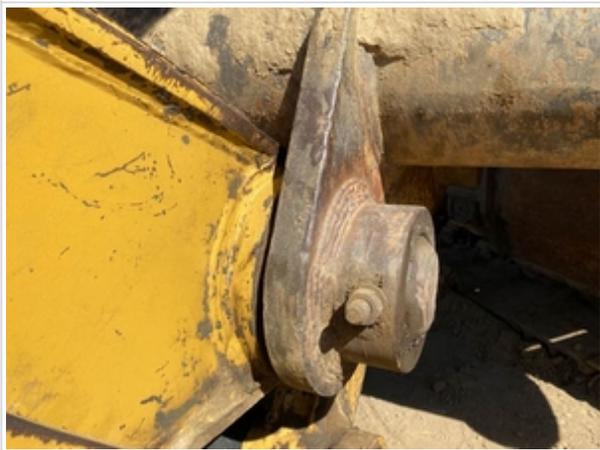
<p><b>Stick to Bucket Pin &amp; Bushings</b></p>	<p>3 - Normal Wear &amp; Tear</p>	
<p><b>Stick to Bucket Pin &amp; Bushings Photos</b></p>

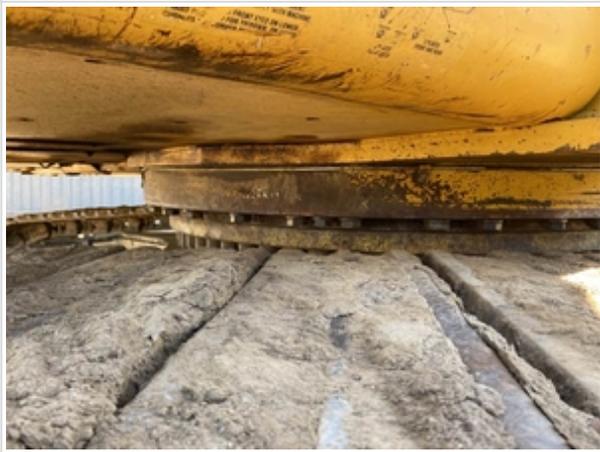
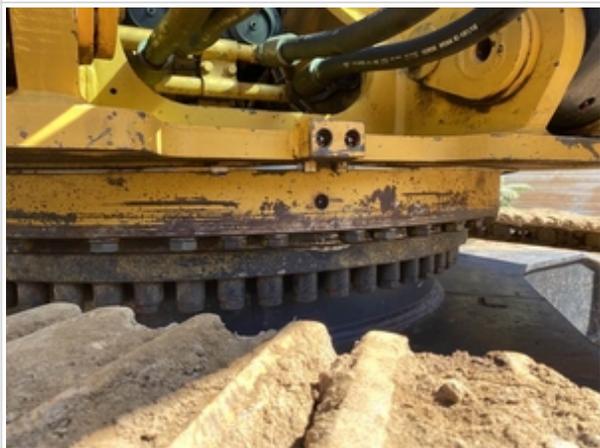
<p><b>Turntable Bearing</b></p>	<p>3 - Normal Wear &amp; Tear</p>	
<p><b>Turntable Bearing Photos</b></p>

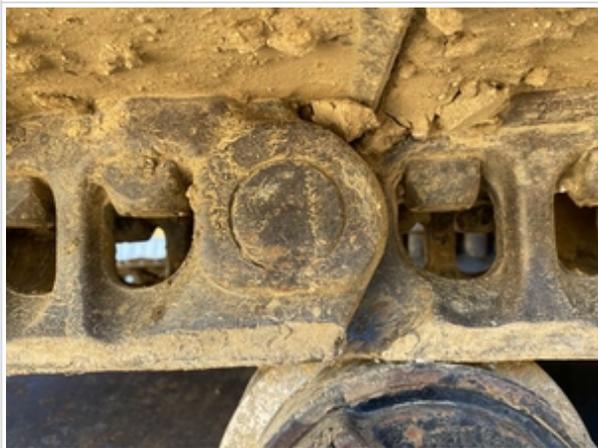
<p><b>Pin &amp; Bushings</b></p>	<p>3 - Normal Wear &amp; Tear</p>	
<p><b>Pin &amp; Bushings Photos</b></p>

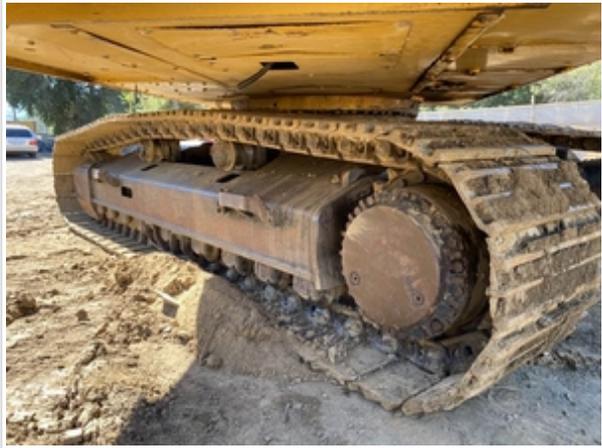
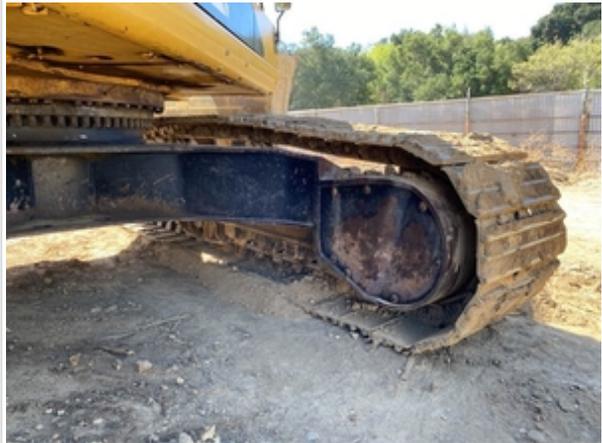
Tracks	3 - Normal Wear & Tear	
Tracks Photos

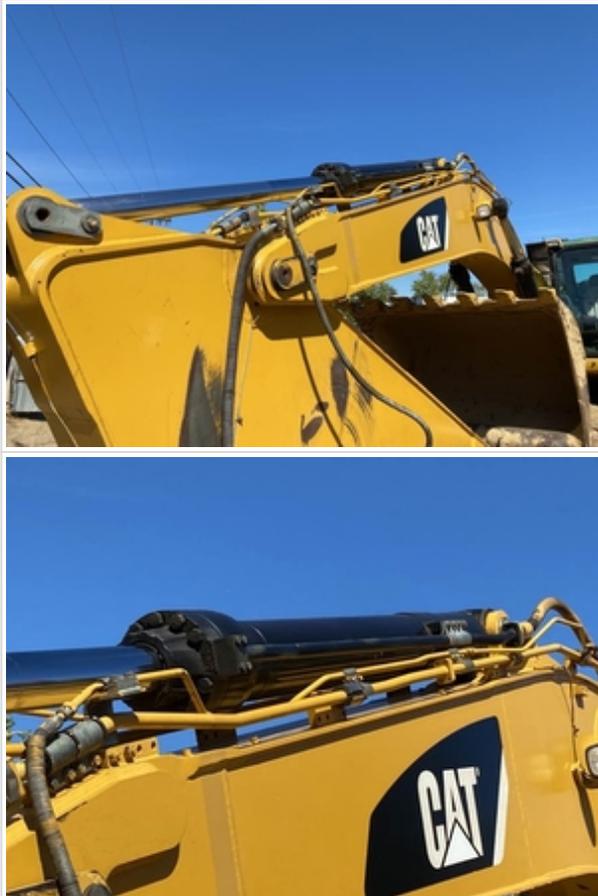
Stick Cylinder	Check the stick cylinder. Note any wear, pitting, discoloration, etc. Take photos.	
Stick Cylinder: Mounting Pin	3	
Stick Cylinder: Oil Leaks	Yes	
Comments	Seepage out of rod seal	
Stick Cylinder Photos
