Inspection Report (Wheel Loader)

Year	1980
Make	Cat
Model	920 unit 15-106
Serial Number	62K10833
Hour Meter Reading	2,514 (hours may be inaccurate)
Previous Application (e.g., earth moving, mining, demolition, etc)	General construction

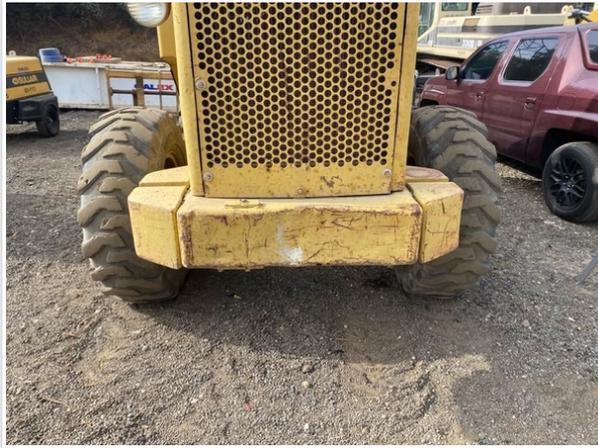
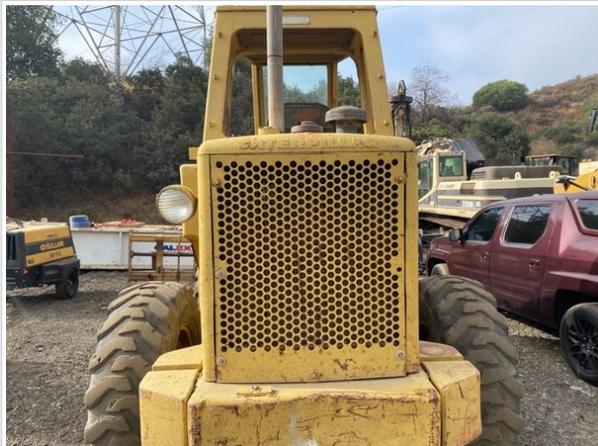
Rear	3 - Normal Wear & Tear	
Rear Condition	Large dents or cracks	
Comments	Rear bumper dented	
Rear Photos

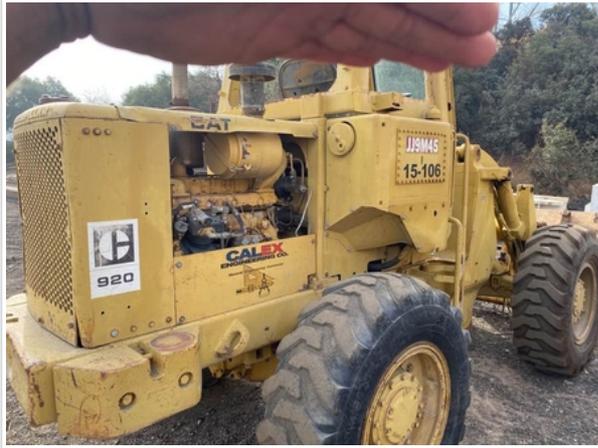
Right	3 - Normal Wear & Tear	
Right Condition	Other (see comments), Large dents or cracks	
Comments	Normal wear	
Right Photos

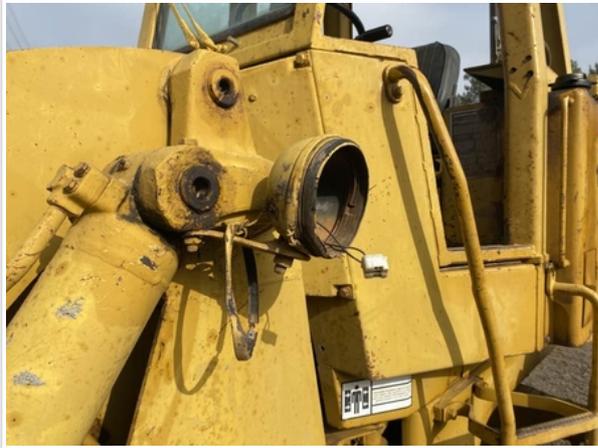
Mirrors	0
Lighting System	1 - Service Required
Lighting System Condition	Overall lighting system is non-operational
Lighting System Photos

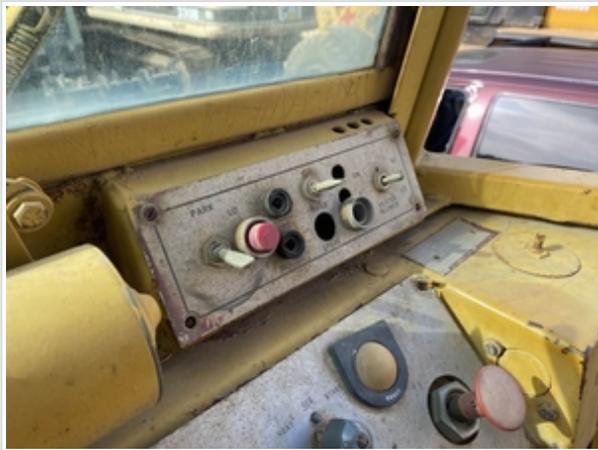
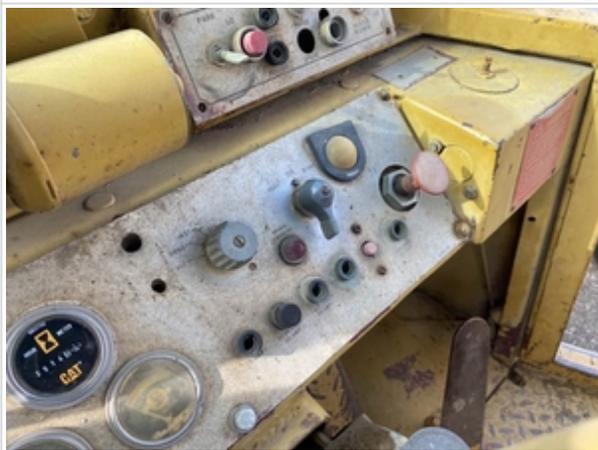
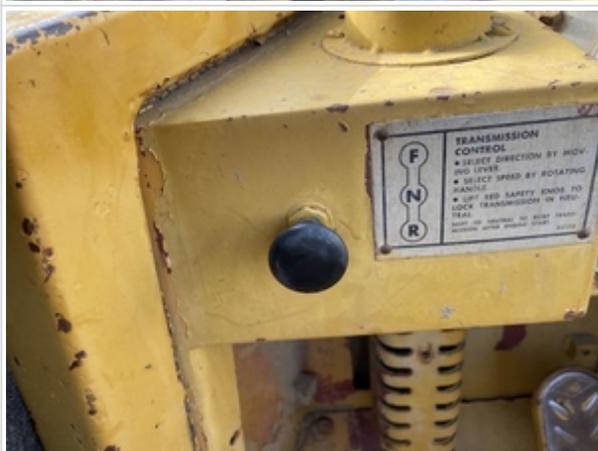
Cabin Lights	0
Safety Lock Out / Stop	0
Controls & Switches	2 - Above Average Wear
Controls & Switches Condition	One or more switches are inoperative or missing

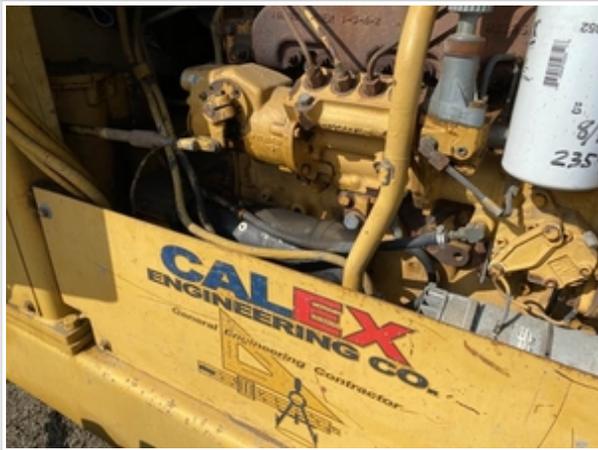
<p>Hoses</p>	<p>3 - Normal Wear & Tear</p>
<p>Hose Condition</p>	<p>Firm, pliant hoses with no signs of wear or leaks, Leaks in one or more hoses or fittings observed</p>
<p>Hose Photos</p>

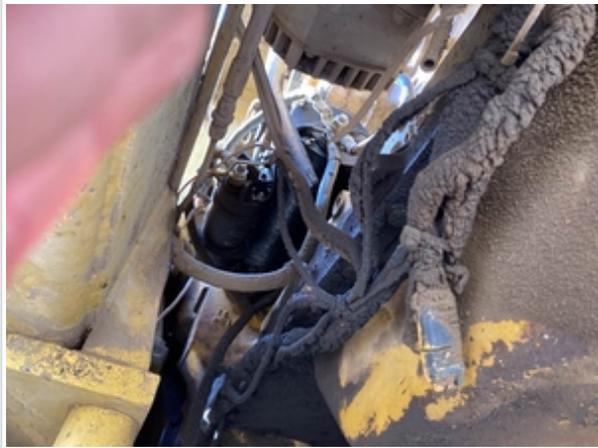
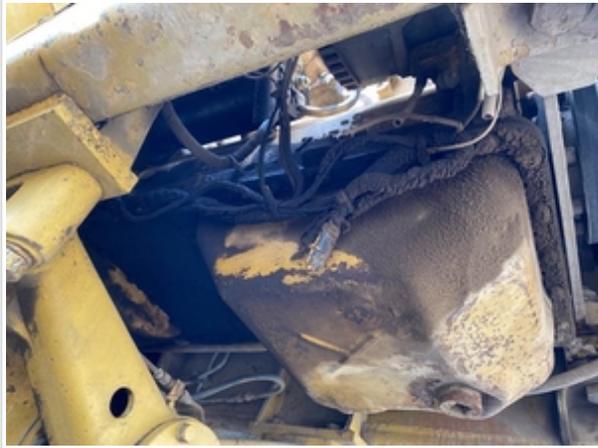
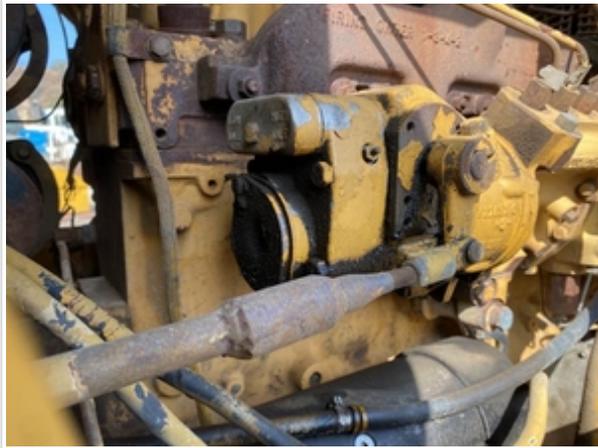
Oil Leak Photos

Coolant Color / Appearance	3 - Normal Wear & Tear
Coolant Color/Appearance Notes	Normal Translucent appearance, no visual signs of contamination
Oil Leaks	Yes
Oil Leak Notes	Wet areas with drops forming due to oil leakage

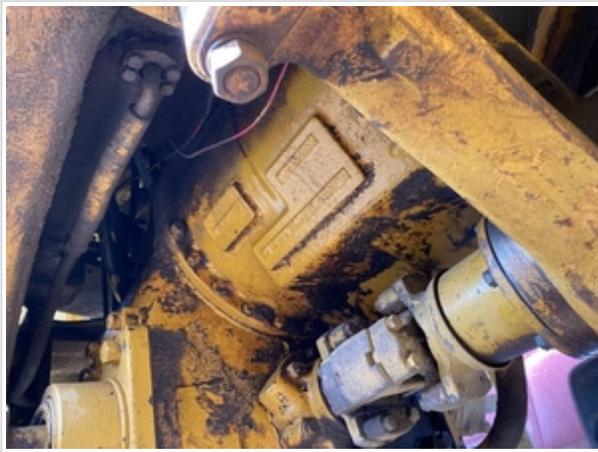
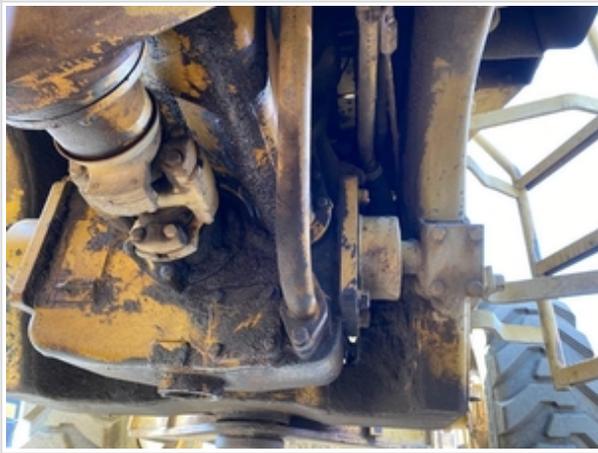
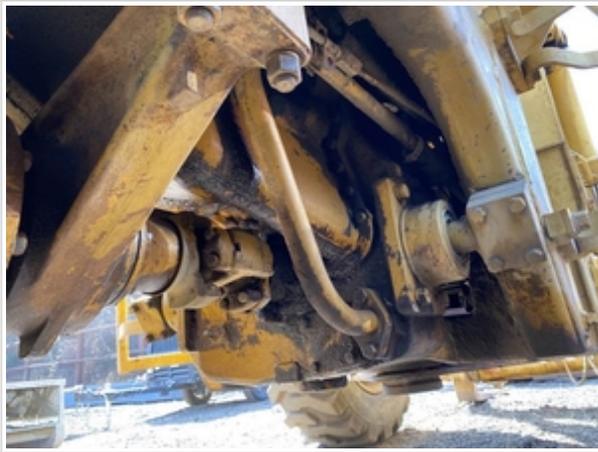
Hydrostatic Transmission?	No
Transmission Info (Make/Model/Speeds)	Powershift 4 speed
Transmission	3 - Normal Wear & Tear
Transmission Condition	No unusual noises or vibrations, Leaking transmission fluid observed, Other (see comments)
Comments	Active leaks see under trans
Transmission Photos

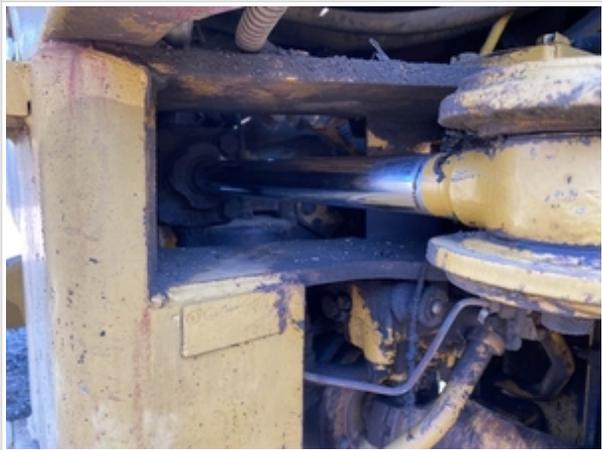
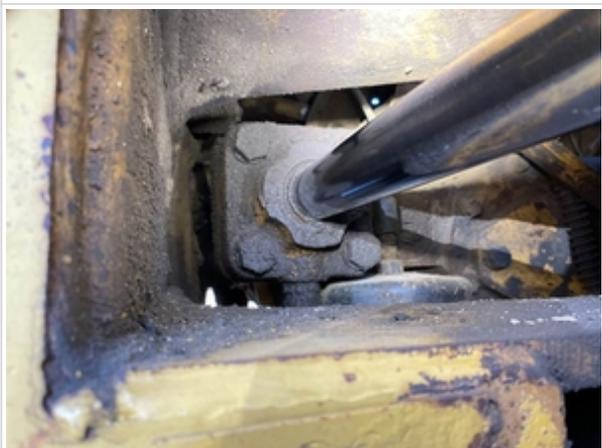
Steering Cylinder	Check the steering cylinder. Note any wear, pitting, discoloration, etc. Take photos.	
Steering Cylinder: Mounting Pin	3	
Steering Cylinder: Oil Leaks	Yes	
Comments	Minor seepage leaks from rod seals	
Steering Cylinder Photos
