Inspection Report (Wheel Loader)

| Make | CAT |
| Model | 930B unit 15-104 |
| Serial Number | 41K9005 |

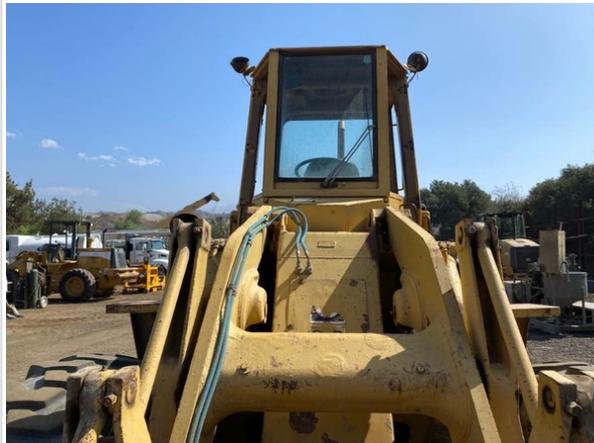
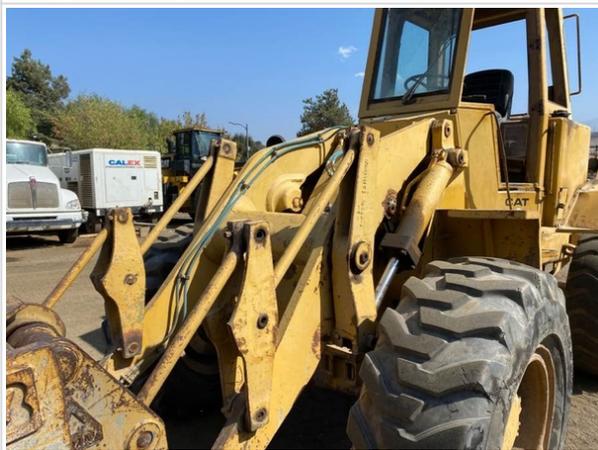
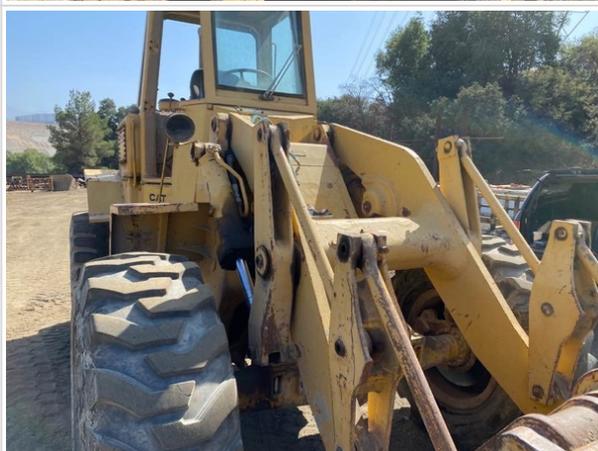
| Front Photos | |

| Front | 3 - Normal Wear & Tear |
| Front Condition | No visible damage |

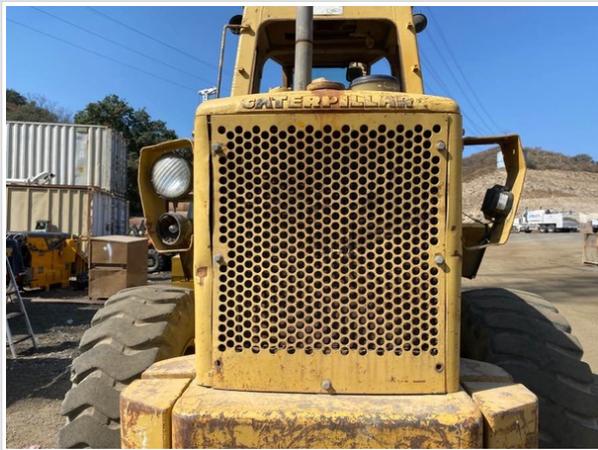
| Rear Photos | |

| Rear | 3 - Normal Wear & Tear |
| Rear Condition | No visible damage |

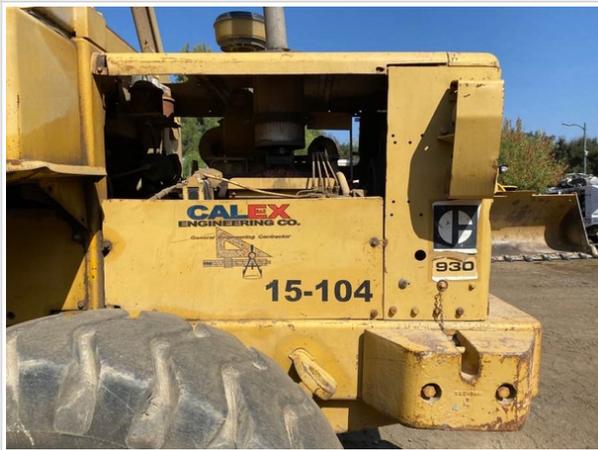
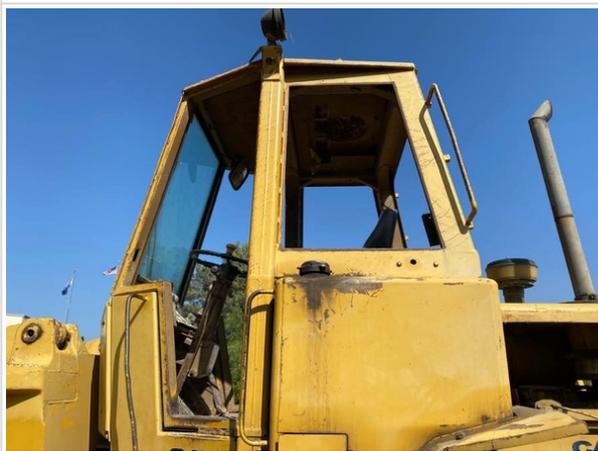
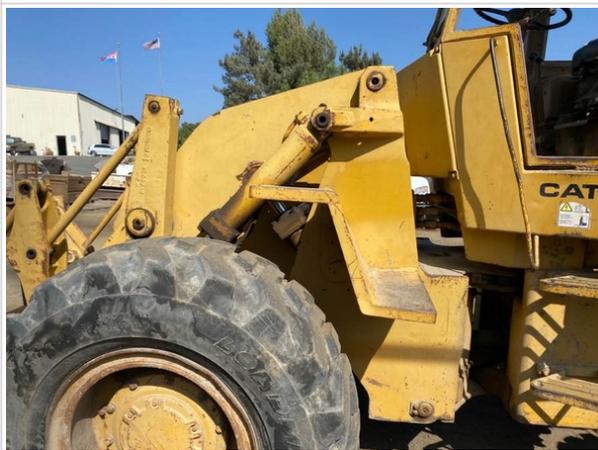
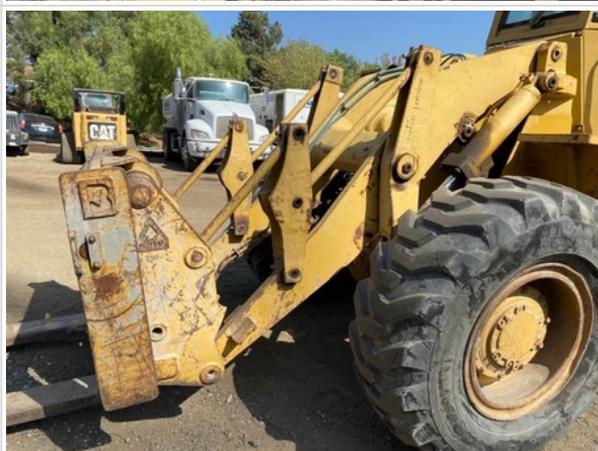
| Left Photos | |

| Left | 3 - Normal Wear & Tear |
| Left Condition | No visible damage |

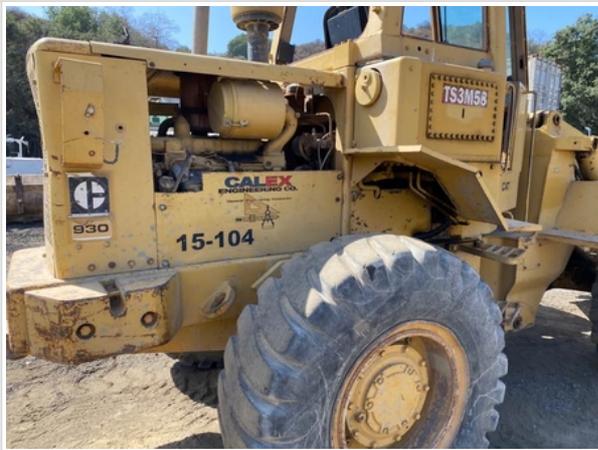
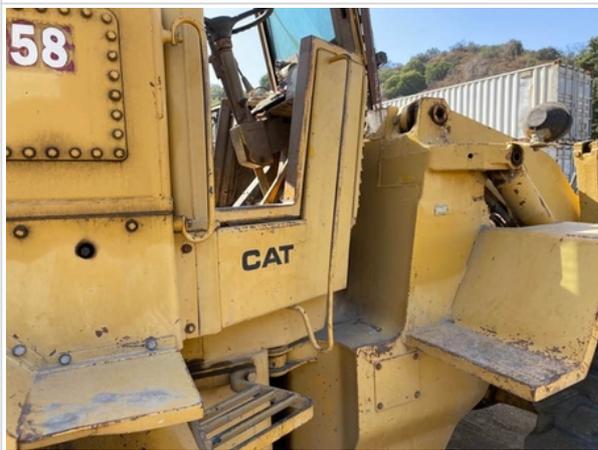
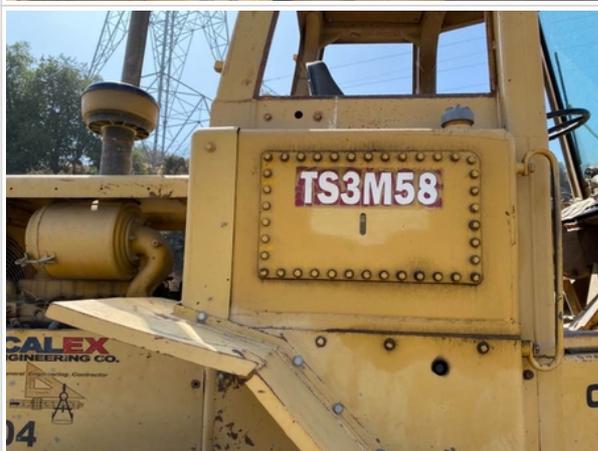
| Right Photos | |

| <p>Right</p> | <p>3 - Normal Wear & Tear</p> |
| <p>Right Condition</p> | <p>No visible damage</p> |

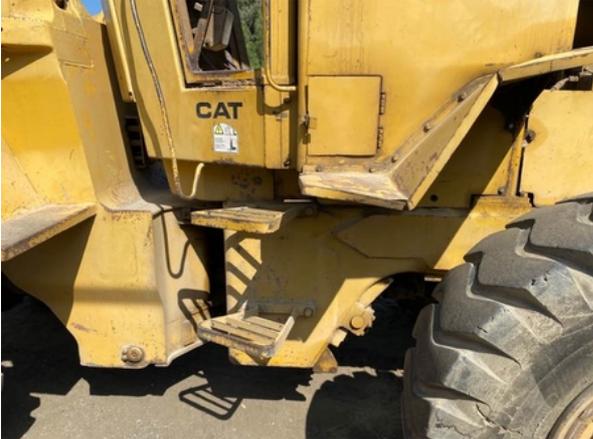
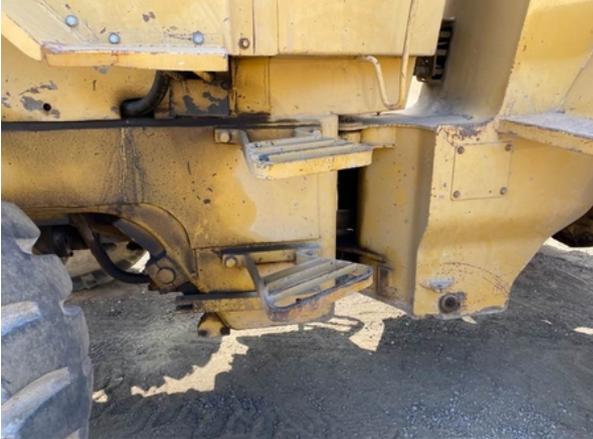
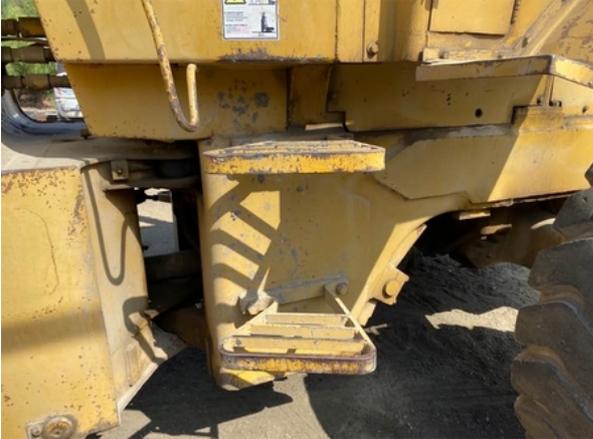
| Steps / Ladders Photos | |

| Steps / Ladders Condition | Steps/ladders are fully intact and appear structurally sound |

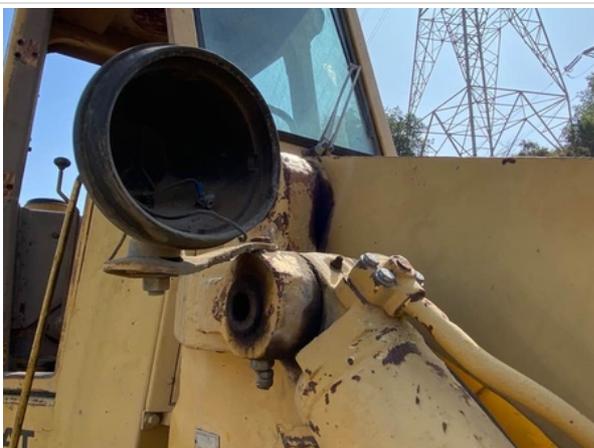
| Lighting System Photos | |

| Lighting System | 1 - Service Required |
| Lighting System Condition | Overall lighting system is non-operational |

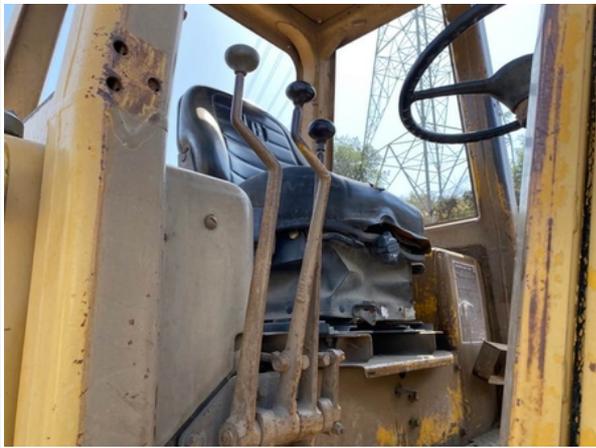
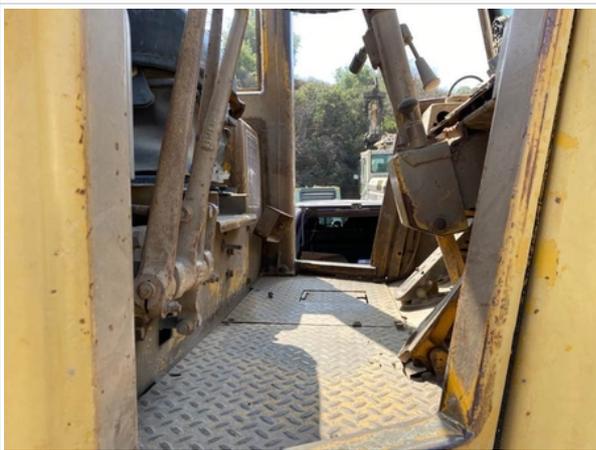
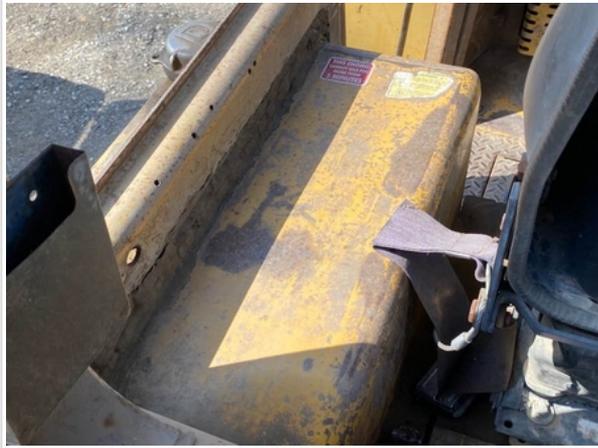
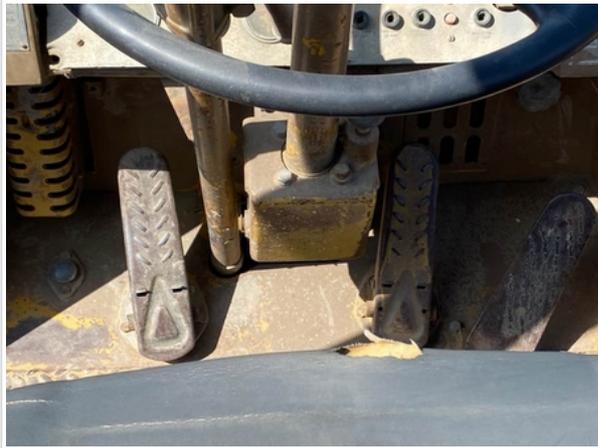
| Operator Cabin Photos | |

| Operator Cabin Overall Condition | Good cabin appearance, solid floors, panels, and ceiling |

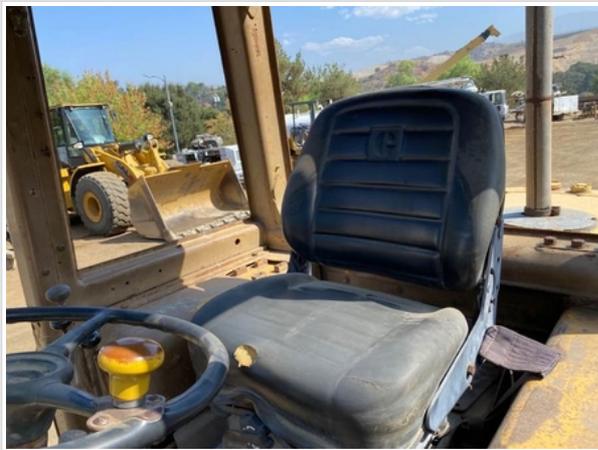
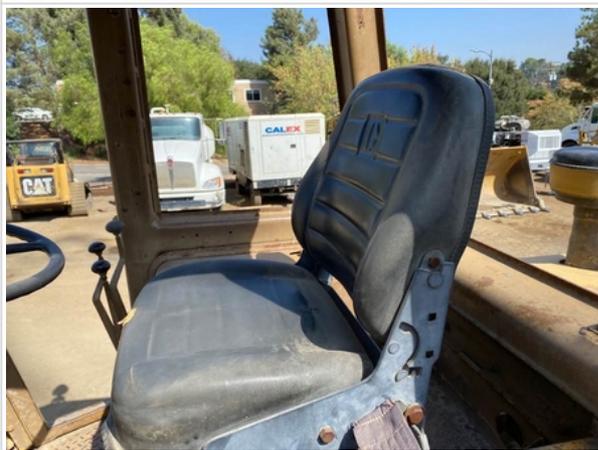
| <p>Operator's Seat & Arm Rests Photos</p> | |

| Operator's Seat & Arm Rests Condition | Seat(s) is damaged due to sun exposure; fading, cracking observed |

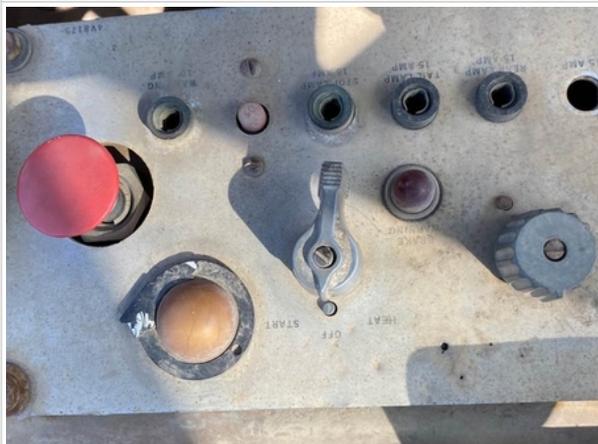
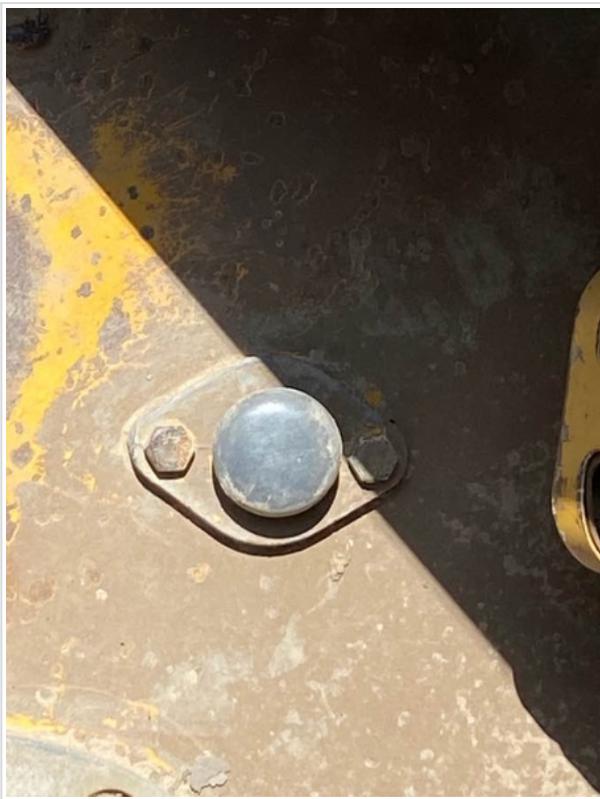
| <p>Controls & Switches Photos</p> | |

| <p>Controls & Switches</p> | <p>2 - Above Average Wear</p> |
| <p>Controls & Switches Condition</p> | <p>One or more switches are inoperative or missing</p> |

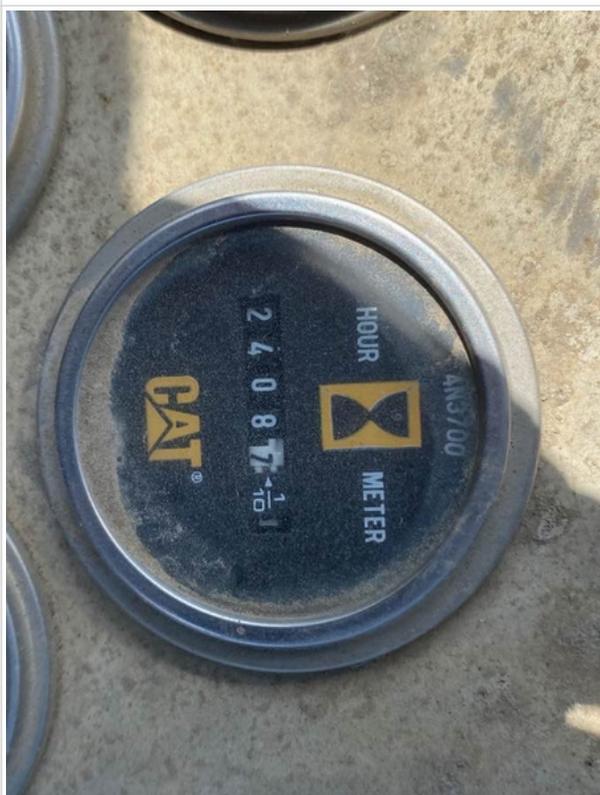
| Hour Meter Activity Photos | | |

| Hour Meter Condition | Hour meter is functional and in good condition, Other (see comments) | |
| Comments | Hour meter has been replaced (actual hours unknown) | |

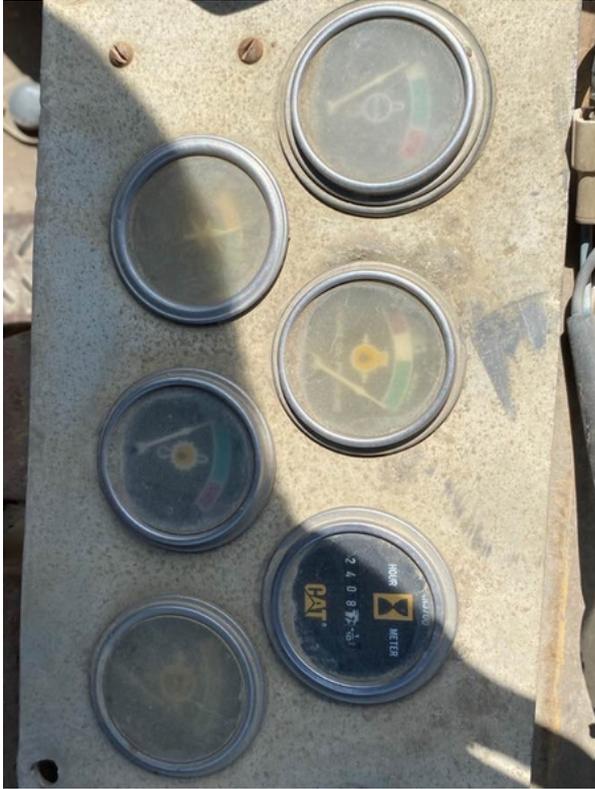
| Other Gauge Activity Photos | |

| Other Gauge Condition | All cockpit gauges are functional and in good condition |

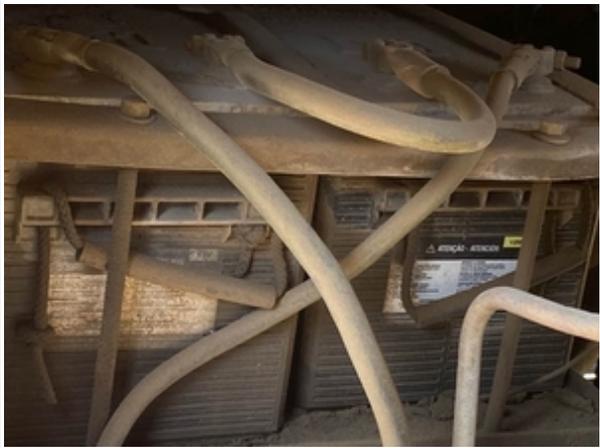
| Battery Condition Photos | | |

| Battery Condition | Clean & dry appearance, tight connections, Dusty & dirty appearance | |

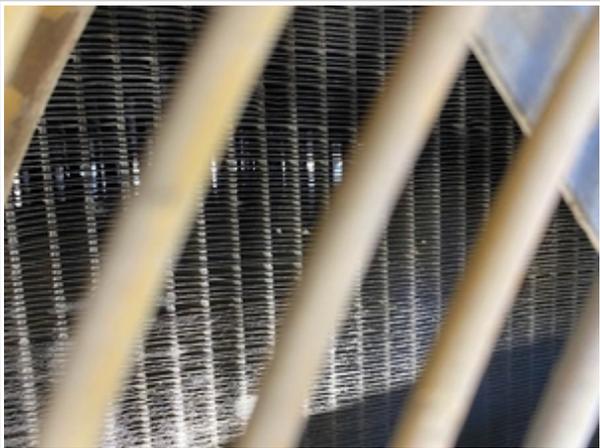
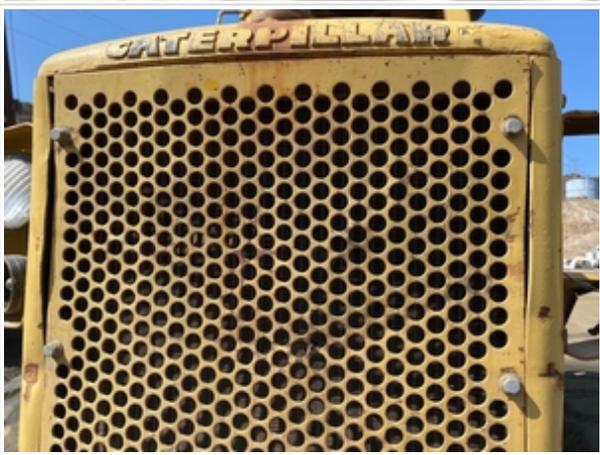
| Radiator Photos | | |

| Radiator Condition | Radiator fins & components appear to be in good working order, no signs of damage or leaks | |

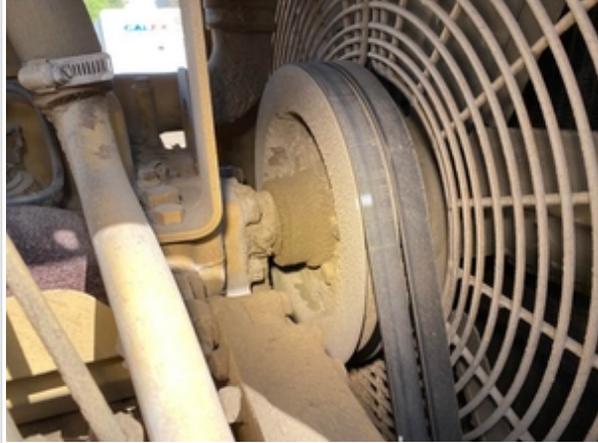
| Belt Photos | |

| Belt Condition | Belts appear in good condition & alignment with proper tension | |

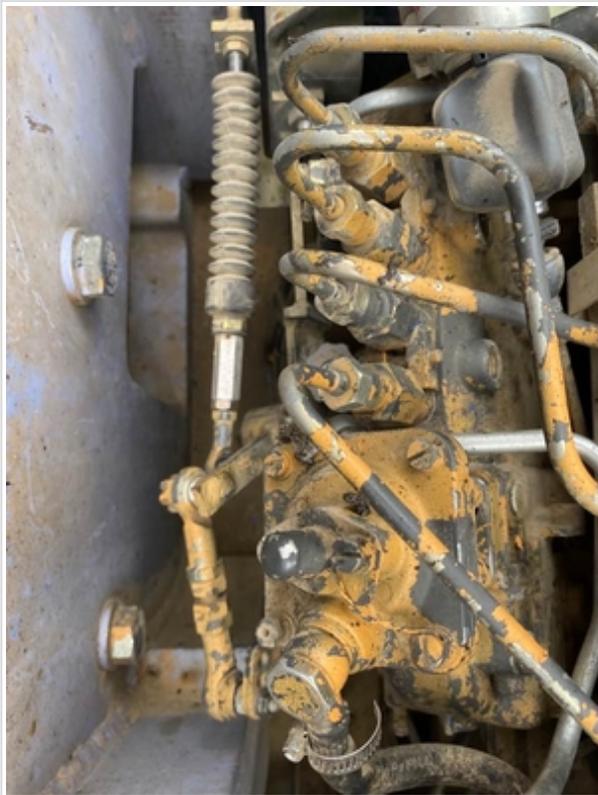
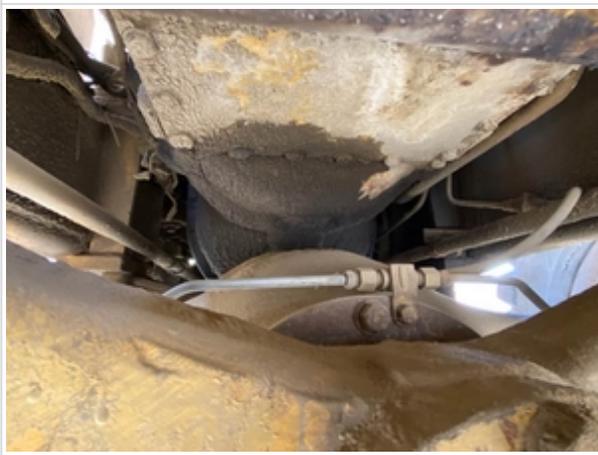
| <p>Oil Leak Photos</p> | |

| Oil Leak Notes | Dried oil seepages seen, Other (see comments) |
| Comments | Minor oil leak bottom left side of engine oil pan |

| <p>Overall Engine Comments</p> | <p>Overall engine well maintained and no obvious major leaks present. Minor oil leak at oil pan. Engine sounds healthy and works well.</p> |

| What Needs Work | Possible engine oil leak at l/s of oil pan. Most cylinders have seepage oil leaks at rod seals. |

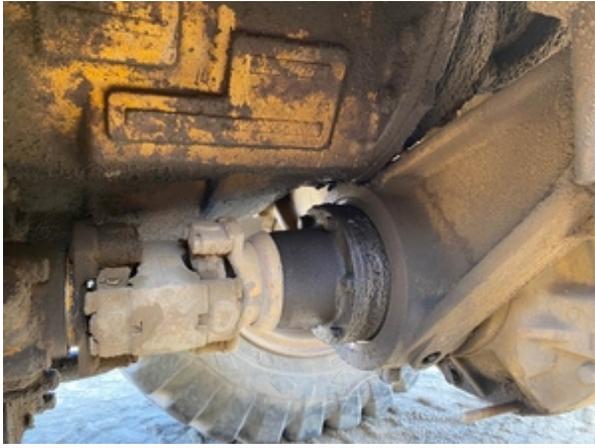
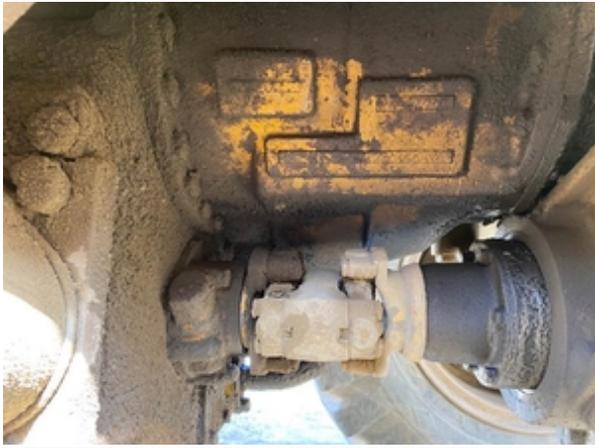
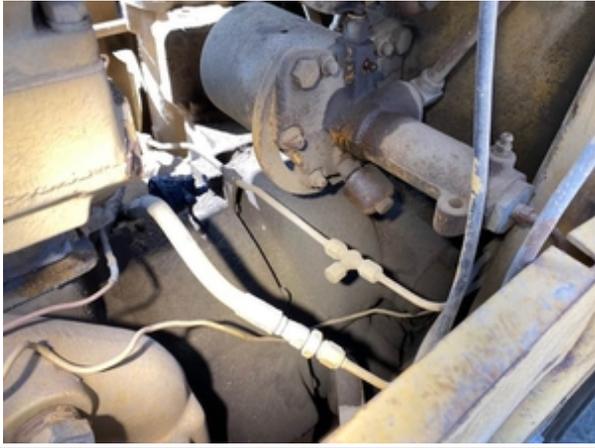
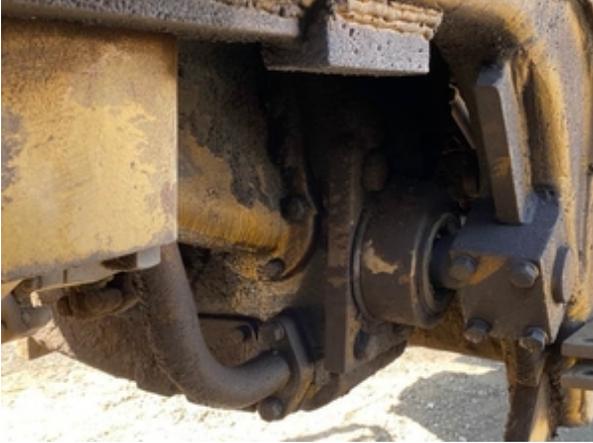
| Drivetrain | |
|---|---|
| Transmission Photos | |

| Drivetrain | |
|---|---|
| Transmission Condition | No unusual noises or vibrations, Leaking transmission fluid observed, Other (see comments) |
| Comments | Transmission showing signs of small leaks |

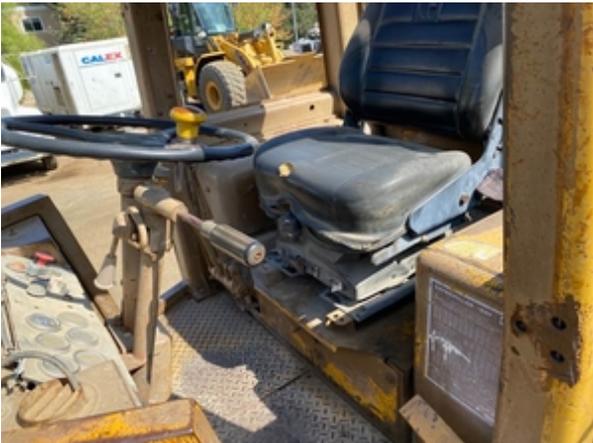
| Shift Level Photos | | |

| Shift Lever Condition | Good forward and reverse function | |

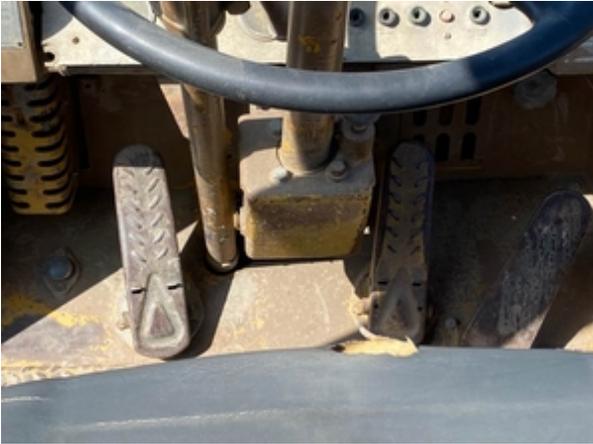
| Foot Brake Photos | | |

| Foot Brake Condition | Good brake function | |

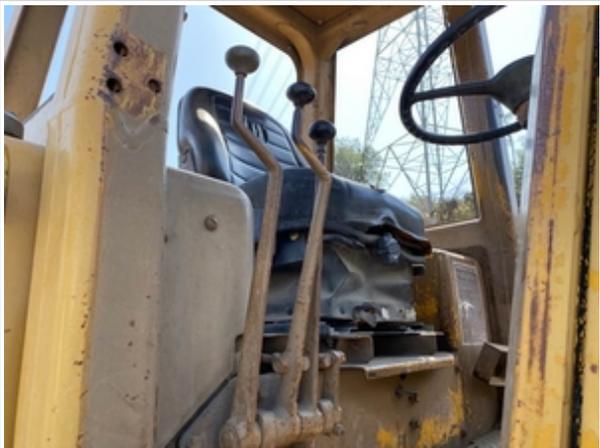
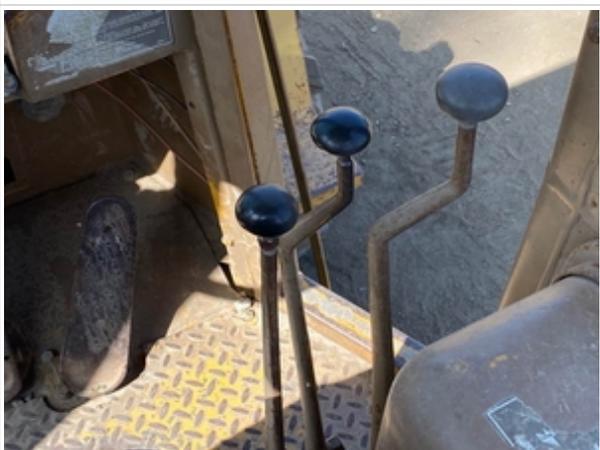
| External Controls / Levers Photos | | |

| External Controls / Levers Condition | Good function & condition of hydraulic controls | |

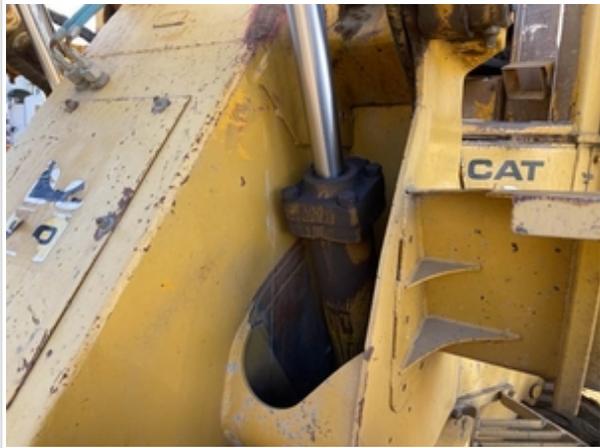
| Lift Cylinder: Oil Leaks | Yes |
| Comments | Seepage leaks at rod seal |

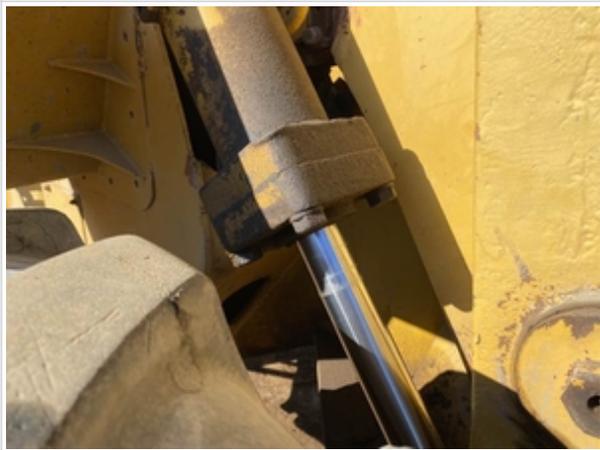
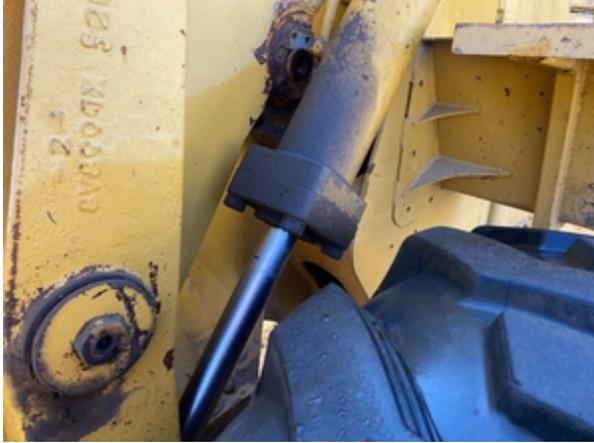
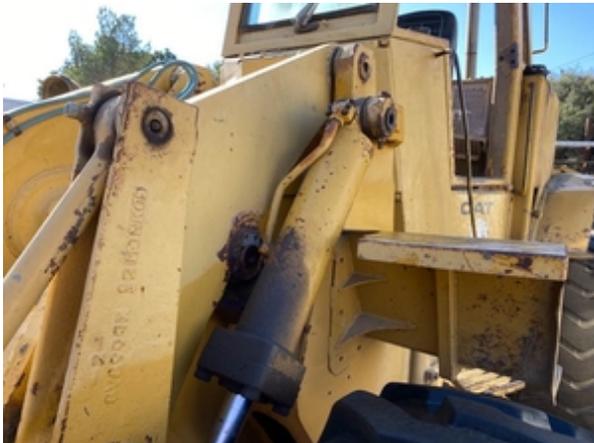
| Bucket Cylinder Photos | | |

| Bucket Cylinder: Oil Leaks | Yes | |
| Comments | Oil seepage at rod seals | |

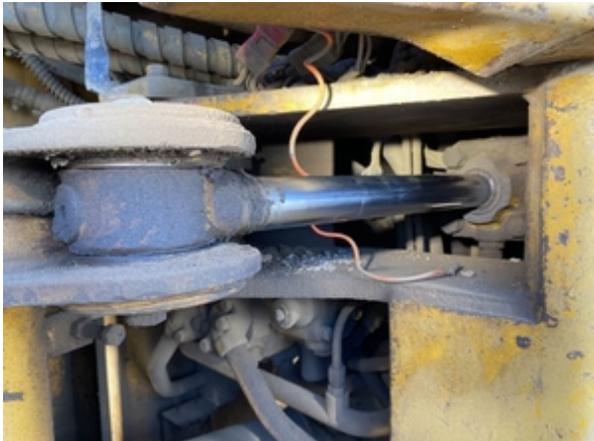
| Steering Cylinder Photos | | |

| Steering Cylinder: Oil Leaks | Yes | |
| Comments | Oil seepage at rod seals | |
