Inspection Report (Excavator)

Year	1997
Make	Komatsu
Model	PC 128UU
Serial Number	3267
Hour Meter Reading	10,607
Previous Application (e.g., earth moving, mining, demolition, etc)	General Construction

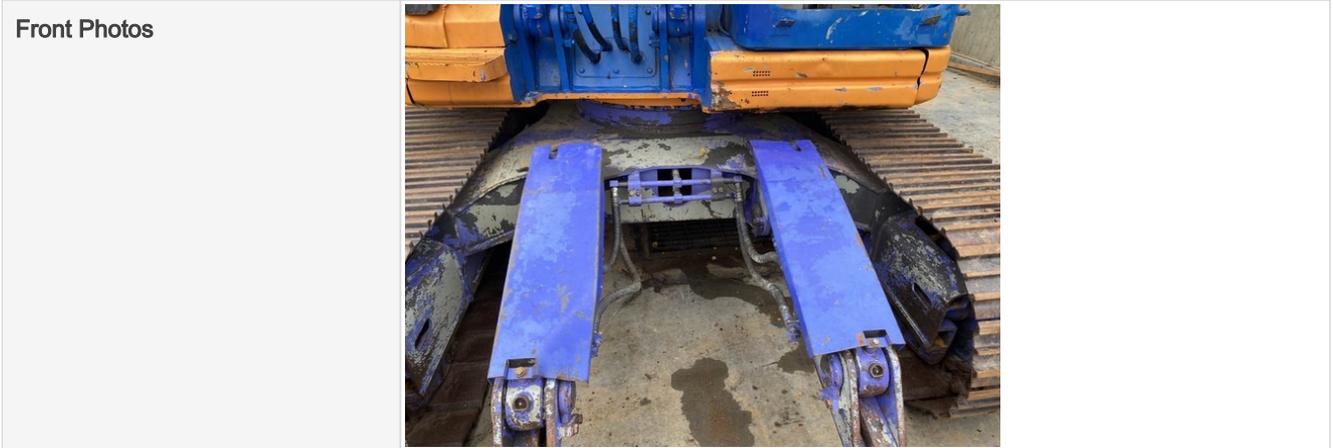
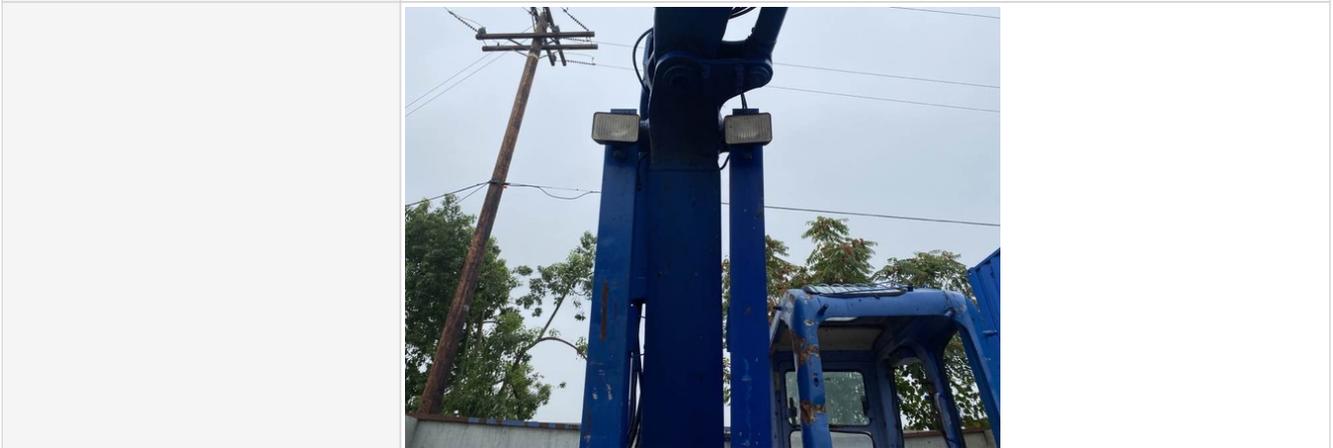
Front	3 - Normal Wear & Tear
Front Condition	Large dents or cracks, Other (see comments)
Comments	Front cab has dents, cylinder guards dented

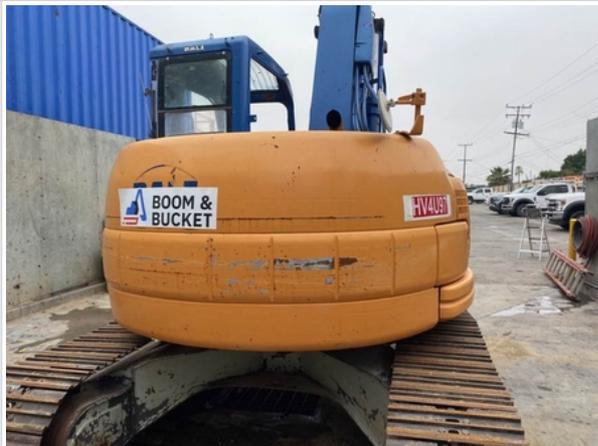
<p>Rear</p>	<p>3 - Normal Wear & Tear</p>	
<p>Rear Condition</p>	<p>Other (see comments)</p>	
<p>Comments</p>	<p>Normal wear and tear scuff marks</p>	
<p>Rear Photos</p>

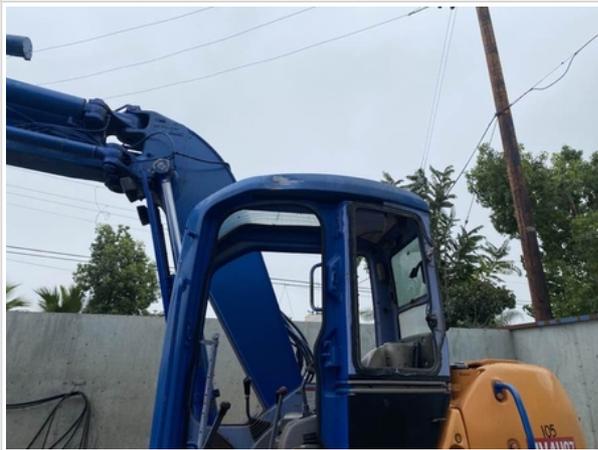
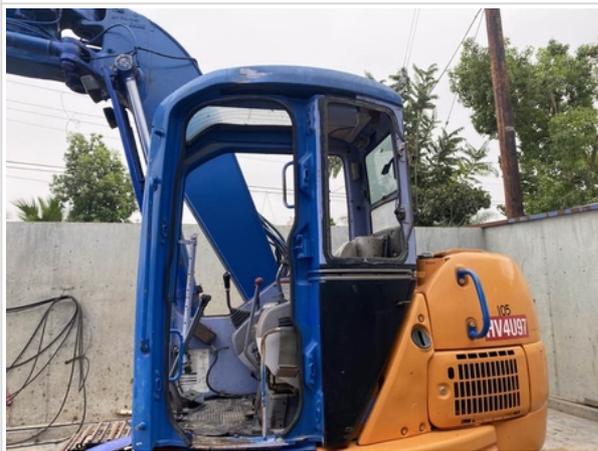
Left	3 - Normal Wear & Tear
Left Condition	Large dents or cracks, Other (see comments)
Left Photos

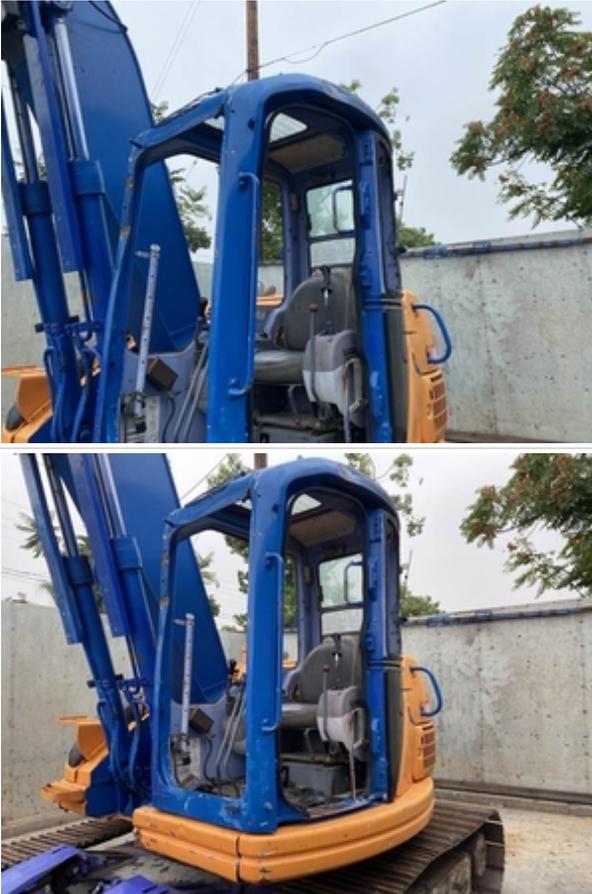
Doors / Canopy Latches	2 - Above Average Wear	
Doors / Canopy Latches Condition	Other (see comments)	
Comments	Door to cab removed	
Doors / Canopy Latches Photos

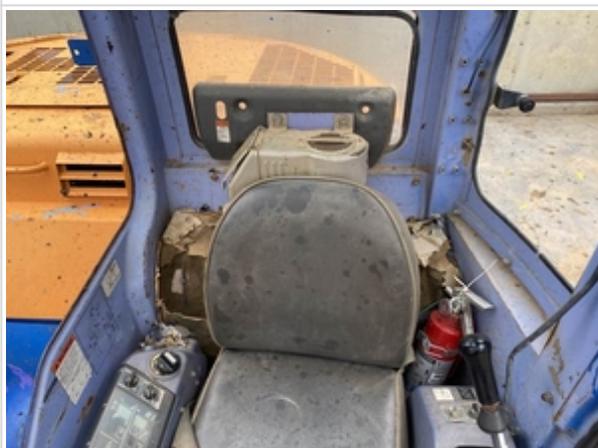
Operator Cabin Overall	2 - Above Average Wear
Operator Cabin Overall Condition	Significant wear and tear to cabin floor, panels, and ceiling
Operator Cabin Photos

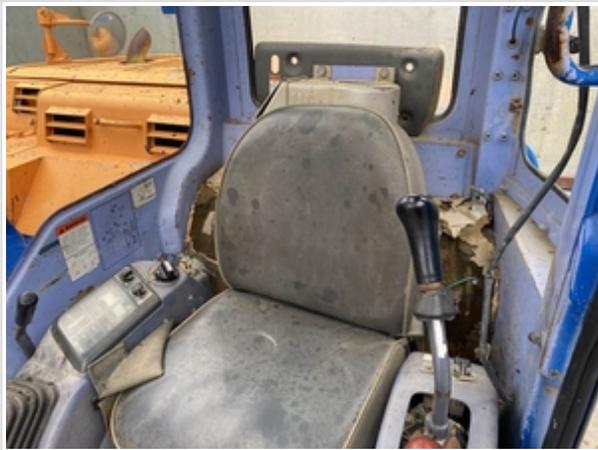
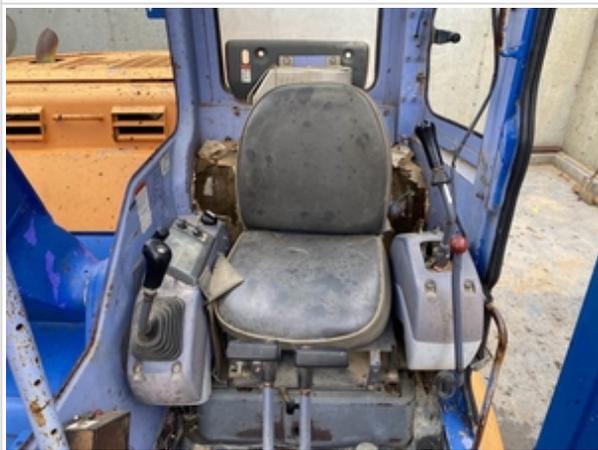
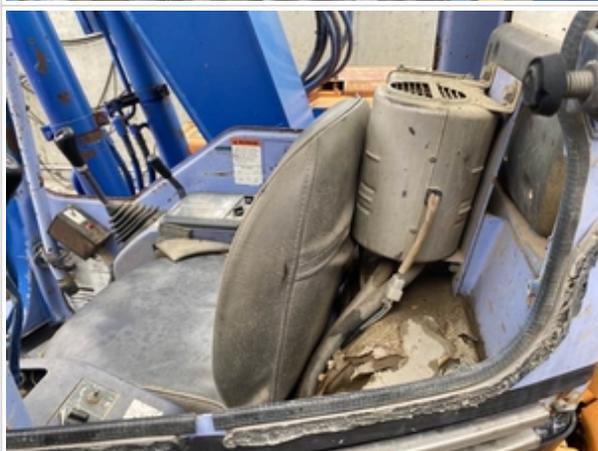
Operator's Seat & Arm Rests	2 - Above Average Wear
Operator's Seat & Arm Rests Condition	Seat(s) have minor surface staining or small tears
Comments	Seat sitting loose on frame (unbolted/unsecured)
Operator's Seat & Arm Rests Photos

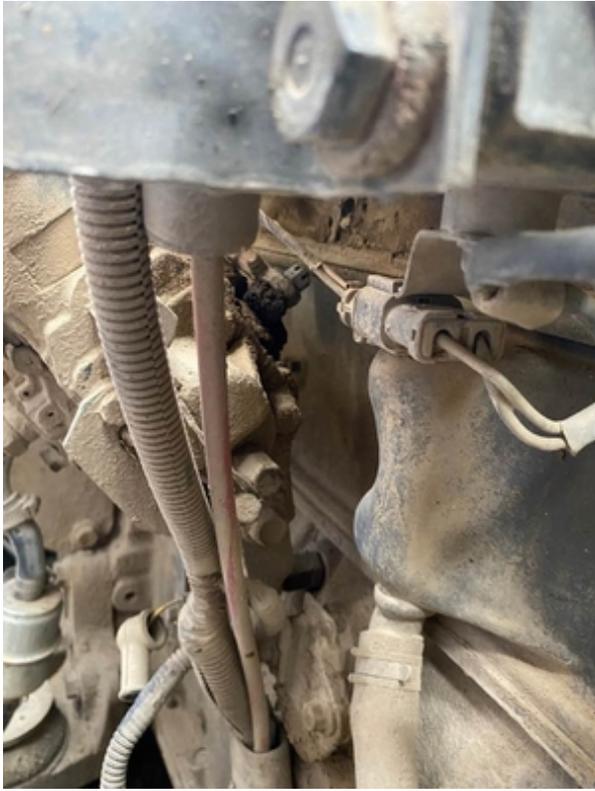
Comments	Minor oil buildup at r/s of engine block
Oil Leak Photos

Oil Color / Appearance	2 - Above Average Wear
Oil Color / Appearance Notes	Clean oil appearance, no signs of cross contamination, Low oil level, Other (see comments)
Comments	Recommend an oil change
Fuel Leaks	No
Equipped with DPF (Diesel Particulate Filter)	No
Requires DEF (Diesel Exhaust Fluid)	No
Overall Engine Appearance	Clean & dry
Overall Engine Comments	Overall, visually, engine in good condition externally with no active leaks found. I recommend getting a engine crankcase blowby test due to amount of combustion gasses from breather hose.

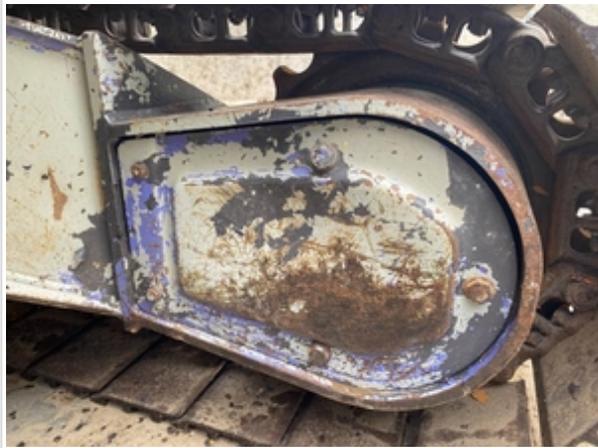
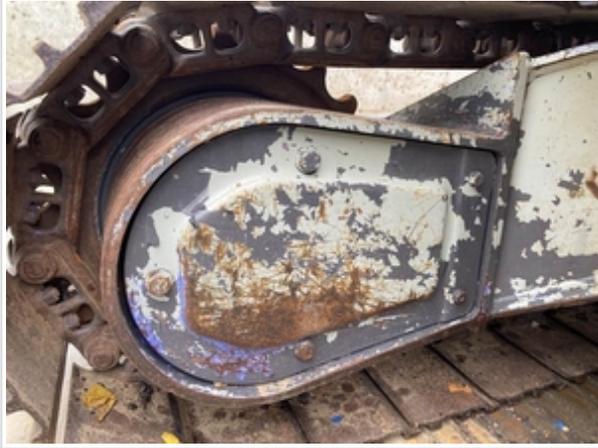
Hydrostatic Transmission?	Yes
2 Speed?	No
Hydrostatic Drive Configuration	Split Transmission
Drive Motors	2 - Above Average Wear
Comments	Drive motors are behind covers

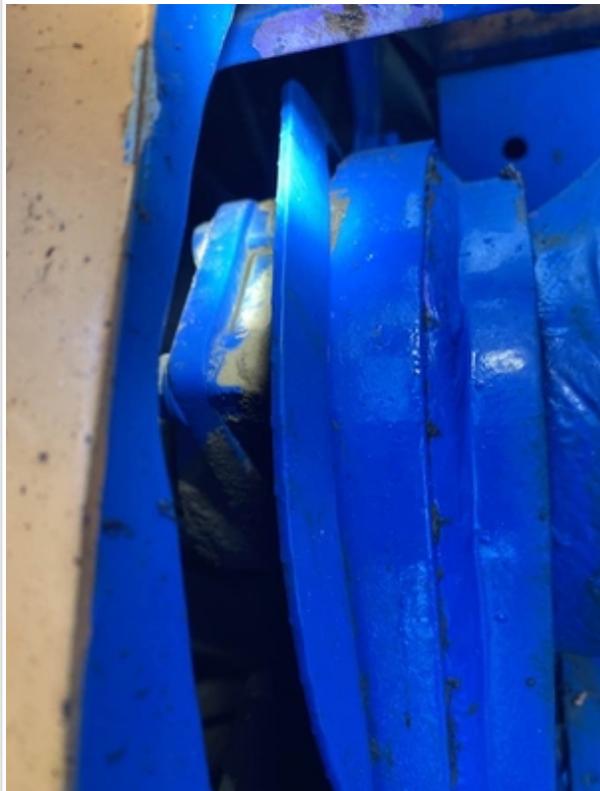
Boom to Stick Pin & Bushings	3 - Normal Wear & Tear
Stick to Bucket Pin & Bushings	3 - Normal Wear & Tear
Comments	Excessive play stick to Bucket coupler Pins connections
Stick to Bucket Pin & Bushings Photos

Overall Chassis	3 - Normal Wear & Tear	
Overall Chassis Comments	Stick to coupler and pins has excessive play. New bearings/bushings and or line boring may be needed

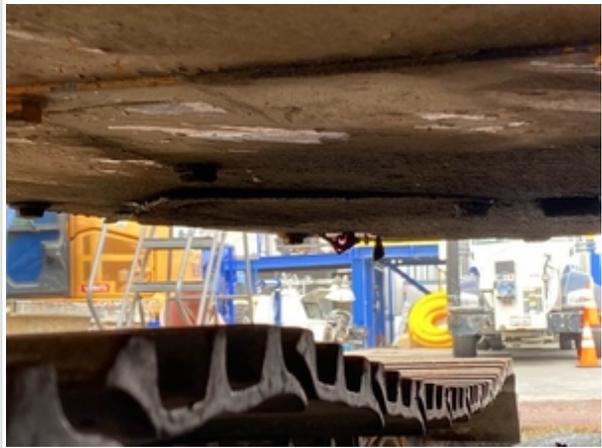
Bottom Covers	3 - Normal Wear & Tear	
Comments	Left side bottom cover slightly bent	
Bottom Covers Photos
