Inspection Report (Mini Excavator)

Year	2013
Make	Takeuchi
Model	TB016
Serial Number	116116151
Hour Meter Reading	1,754 Hours
Previous Application (e.g., earth moving, mining, demolition, etc)	Pipeline/Electrical Construction

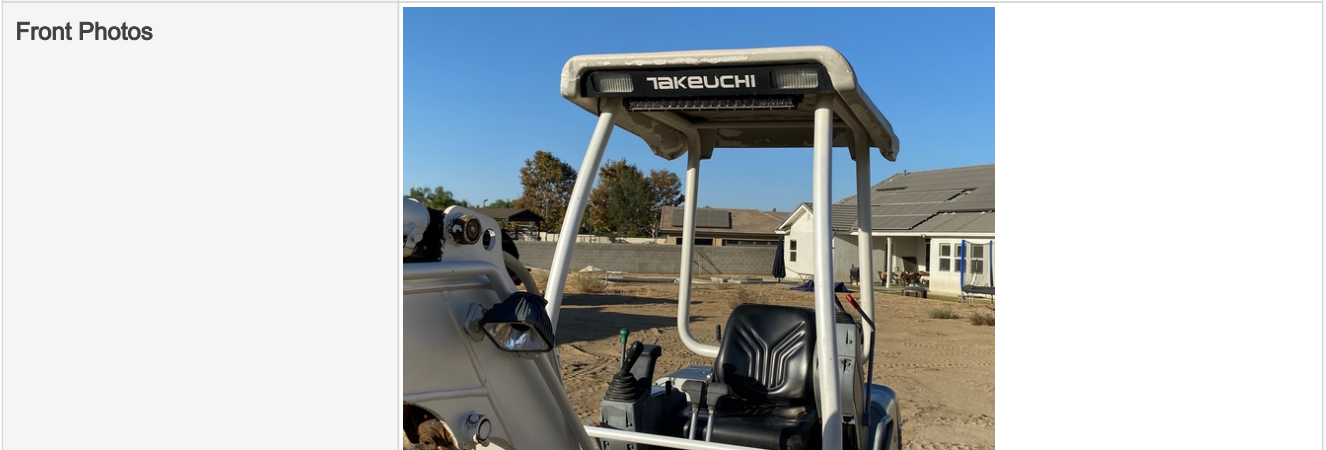
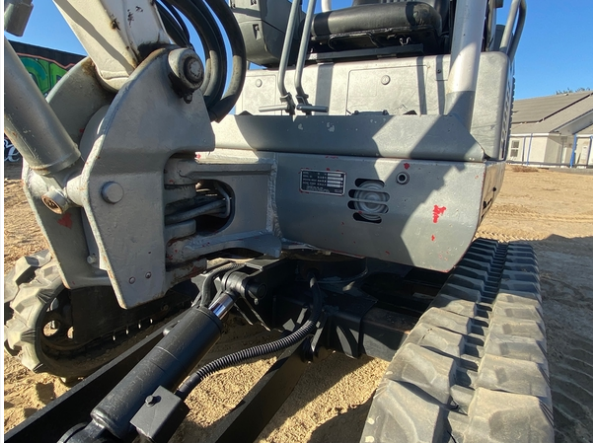
Front	3 - Normal Wear & Tear
Front Condition	Visible chipped paint or dents, Other (see comments)
Comments	Normal wear and tear

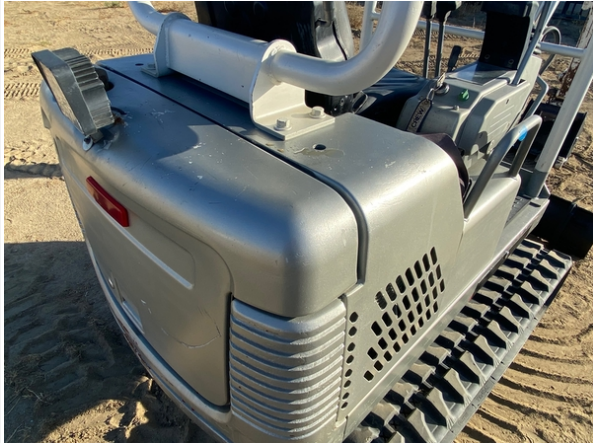
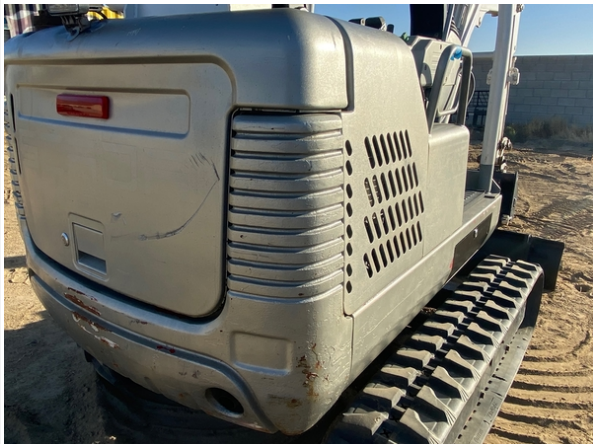
Rear	3 - Normal Wear & Tear	
Rear Condition	Visible chipped paint or dents, Other (see comments)	
Comments	Normal wear and tear	
Rear Photos

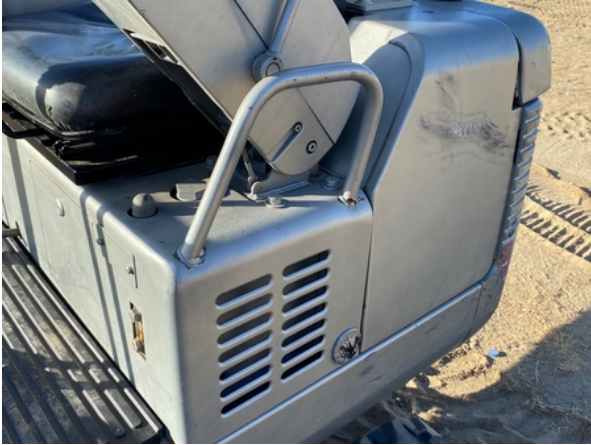
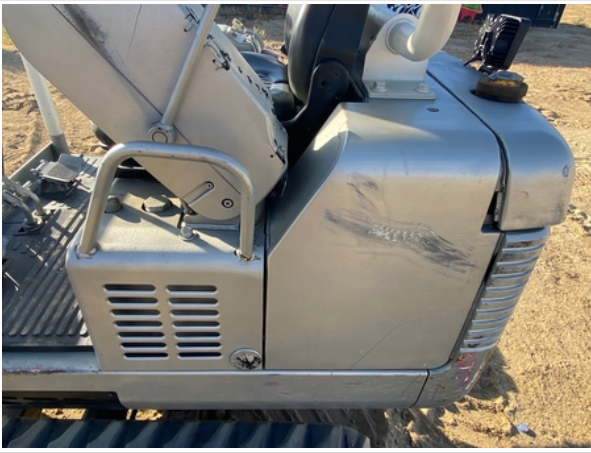
Left	3 - Normal Wear & Tear	
Left Condition	No visible damage, Other (see comments)

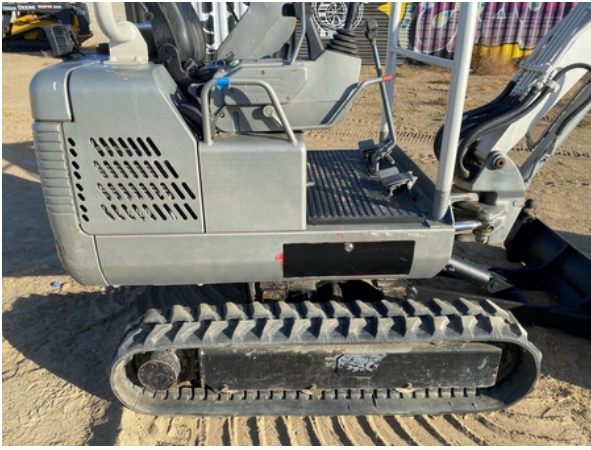
Right	3 - Normal Wear & Tear
Right Condition	No visible damage, Visible chipped paint or dents
Right Photos

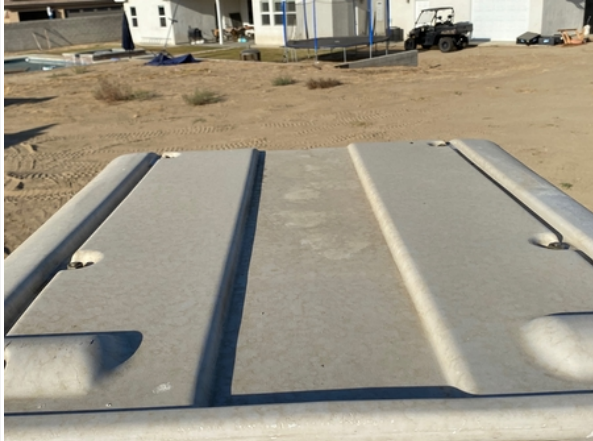
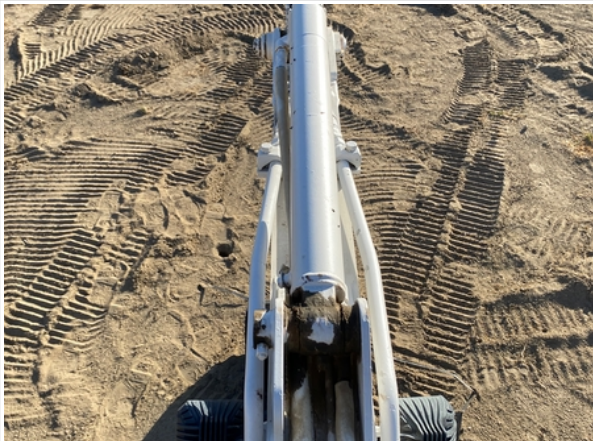
Upper	3 - Normal Wear & Tear
Upper Condition	No visible damage, Visible chipped paint or dents

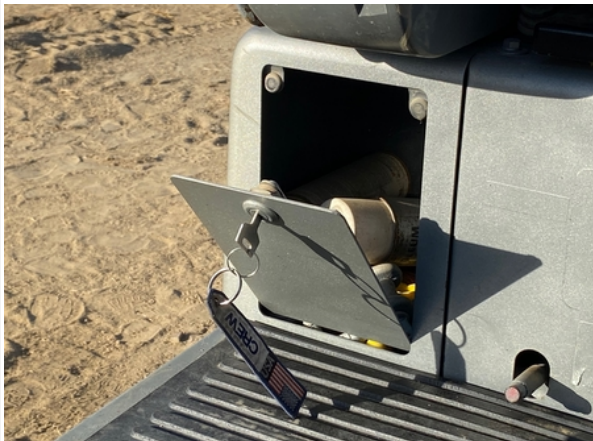
Body Panels (Any Rust Damage?)	3 - Normal Wear & Tear
Body Panel Condition	No visible damage, good paint condition and panel fitment, Other (see comments)
Comments	Normal wear and tear
Body Panels Photos

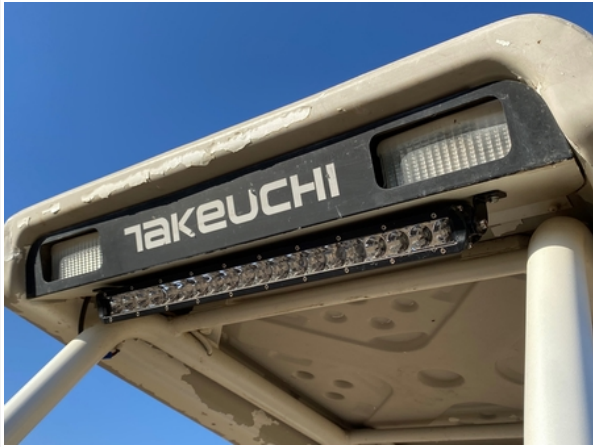
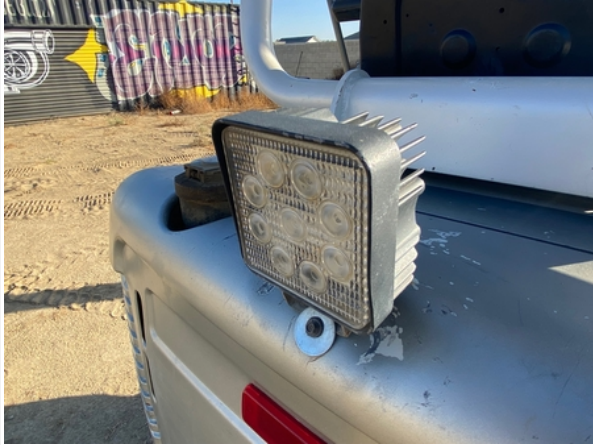
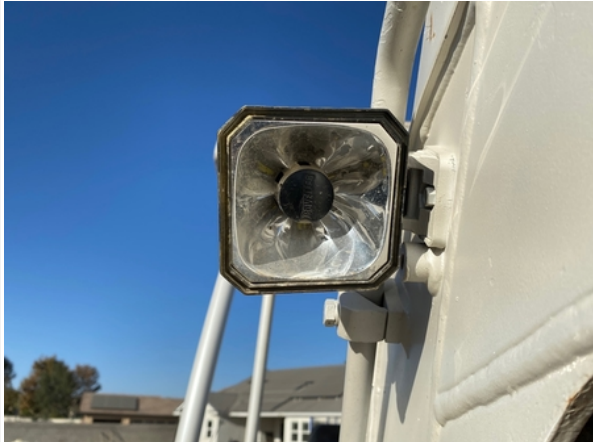
Glass Condition	0
Mirrors	0
Lighting System	3 - Normal Wear & Tear
Lighting System Condition	No visible damage, lighting system is operational
Lighting System Photos

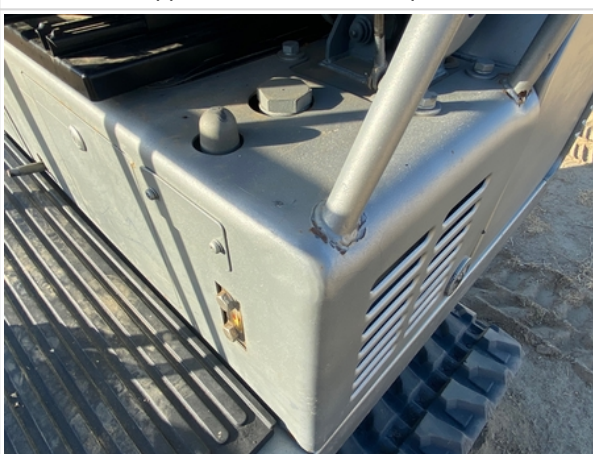
Operator Cabin Overall	3 - Normal Wear & Tear
Operator Cabin Overall Condition	Good cabin appearance, solid floors, panels, and ceiling
Operator Cabin Photos

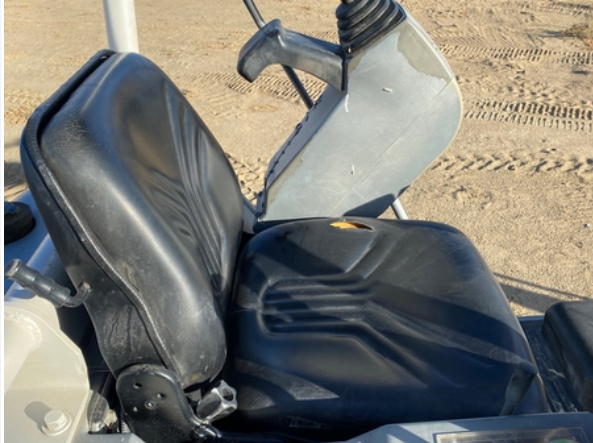
Operator's Seat & Arm Rests	3 - Normal Wear & Tear
Operator's Seat & Arm Rests Condition	Seat(s) in good condition, no stains or tears in upholstery, Seat(s) have minor surface staining or small tears

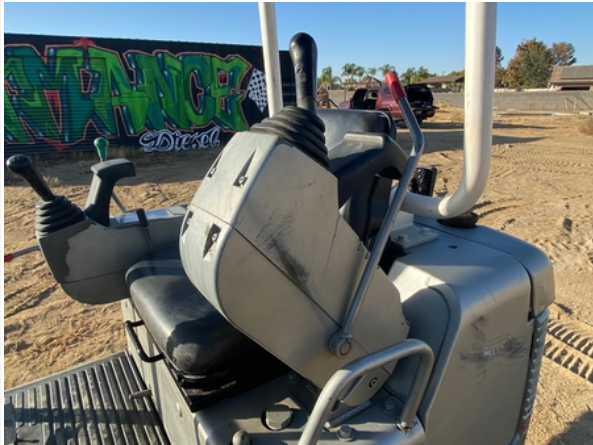
Seat Belt	2 - Above Average Wear
Seat Belt Condition	Seat belt shows limited functionality or does not secure properly
Cabin Lights	0
Safety Lock Out / Stop	3 - Normal Wear & Tear
Safety Lock Out / Stop Condition	Safety lock out device is present, in good condition, and functional, Other (see comments)
Comments	Hydraulic lockout mechanism may need to be adjusted (gets stuck once set to on/left side console down position)
Safety Lock Out / Stop Photos

Exterior Rating	3
Interior Rating	3
Safety Rating	3
Quality Rating	3
Functionality Rating	3
Overall Rating	3
What's Great About the Machine	Machine functions well with no obvious repairs needed. Rubber Tracks have low use. No engine or hydraulic issues found.
What Needs Work	Some cosmetic scrapes on display unit. Left side armrest/ hydraulic enable mechanism may need to be adjusted (sticking closed). Boom light fixtures missing lens cover.
Date/Time	10-27-2022

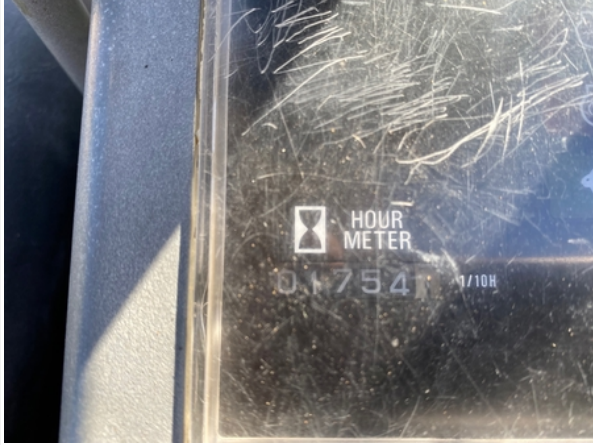
Hour Meter Activity	3 - Normal Wear & Tear
Hour Meter Condition	Hour meter is functional and in good condition

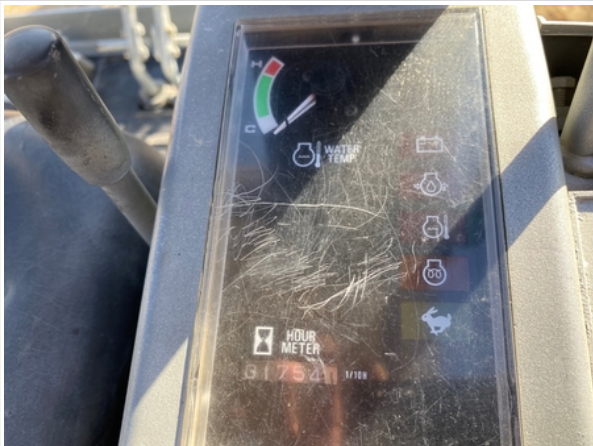
Other Gauge Activity	3 - Normal Wear & Tear
Other Gauge Condition	All cockpit gauges are functional and in good condition
Other Gauge Activity Photos

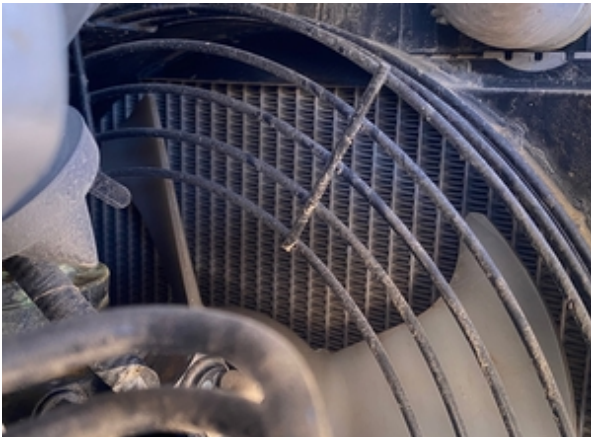
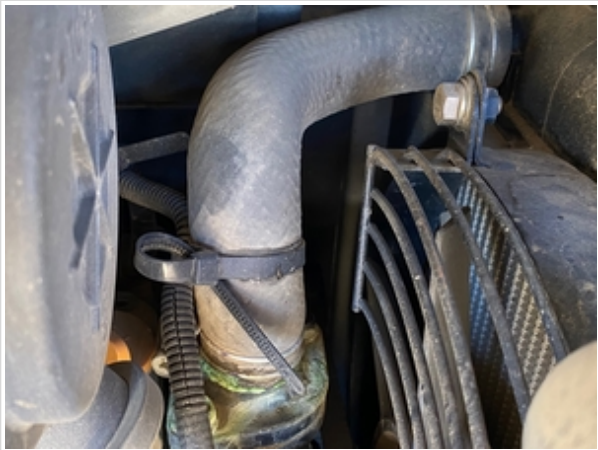
Radiator	3 - Normal Wear & Tear
Radiator Condition	Radiator fins & components appear to be in good working order, no signs of damage or leaks
Radiator Photos

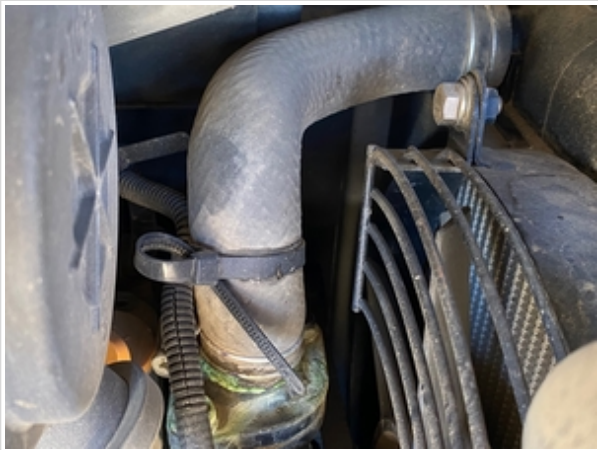
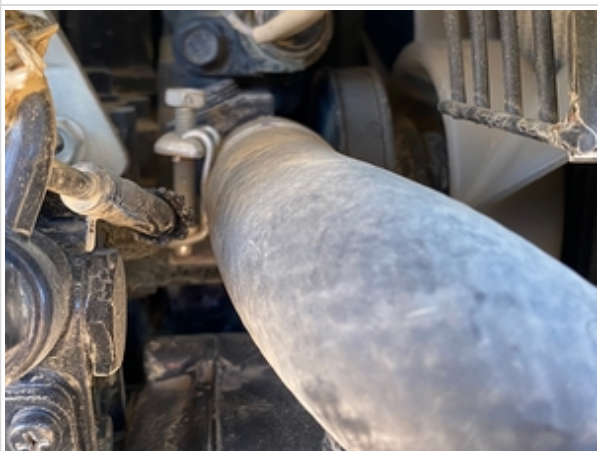
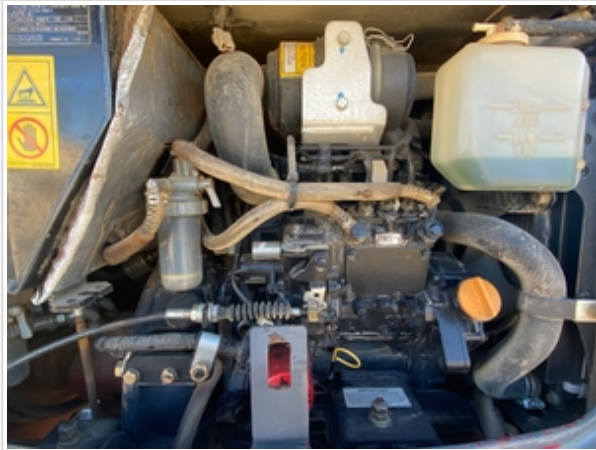
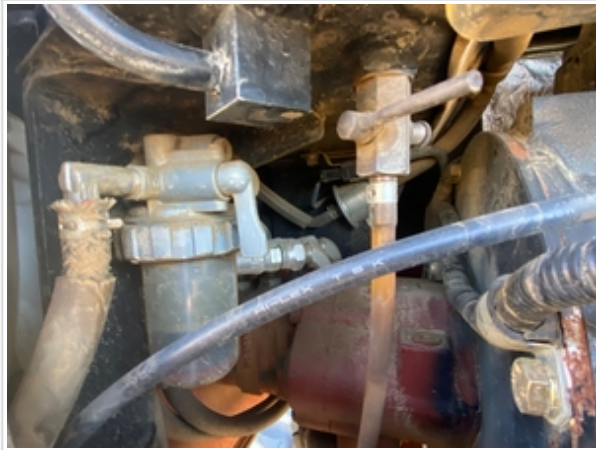
Belts	3 - Normal Wear & Tear	
Belt Condition	Belts appear in good condition & alignment with proper tension	
Hoses	3 - Normal Wear & Tear	
Hose Condition	Firm, pliant hoses with no signs of wear or leaks	
Hose Photos

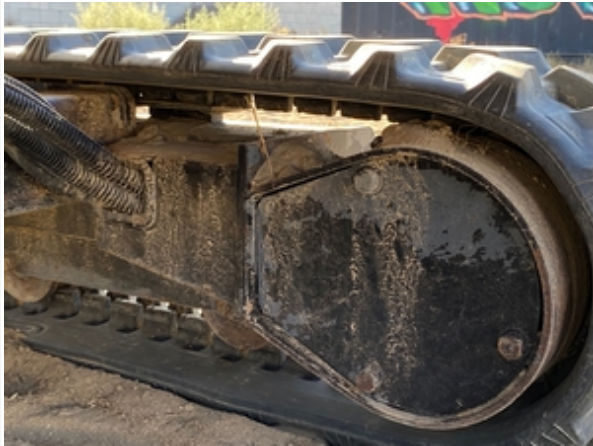
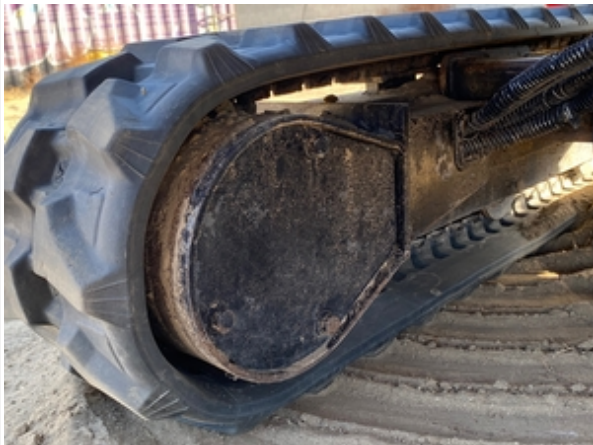
Hydrostatic Transmission?	Yes
2 Speed?	Yes
Hydrostatic Drive Configuration	Split Transmission
Drive Motors	2 - Above Average Wear
Comments	Drive motors inaccessible for photos, sound and work well
Drive Motor Photos

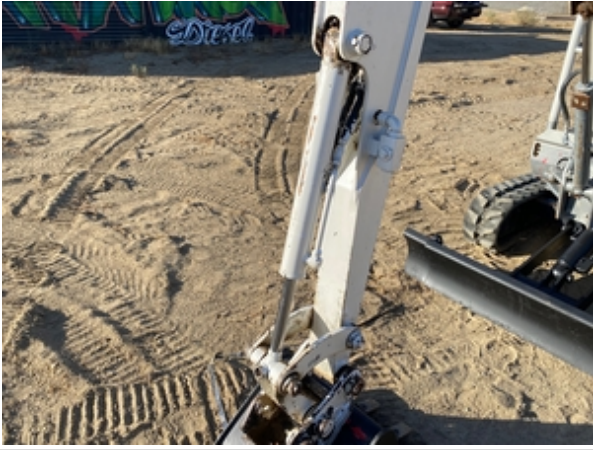
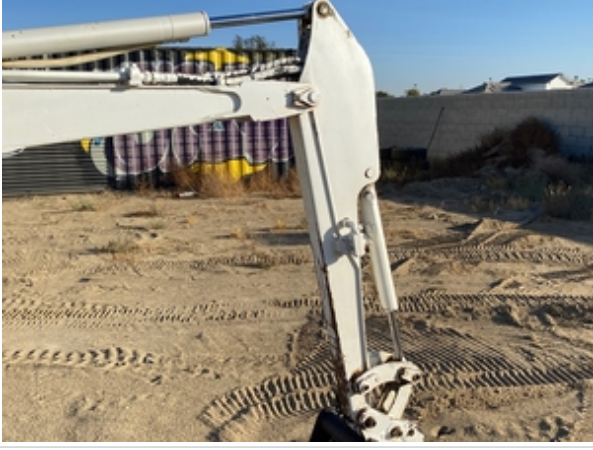
<p>Stick Condition</p>	<p>3 - Normal Wear & Tear</p>	
<p>Stick Photos</p>

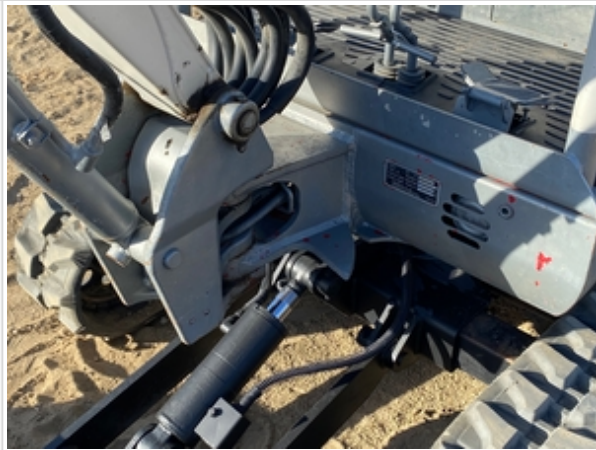
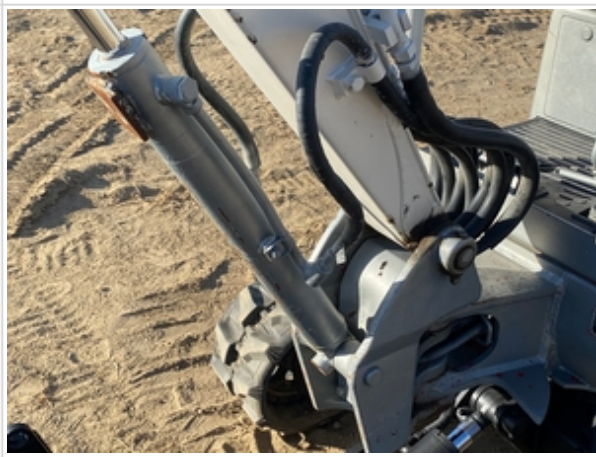
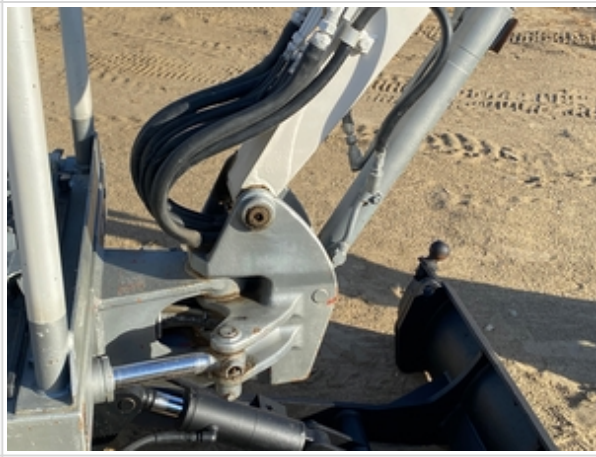
<p>Boom Base Pin & Bushings</p>	<p>3 - Normal Wear & Tear</p>

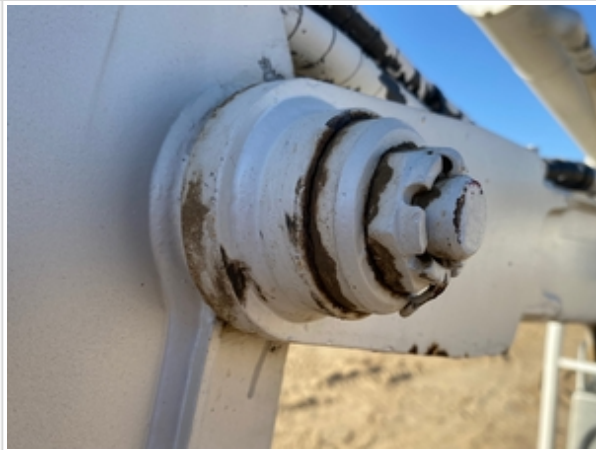
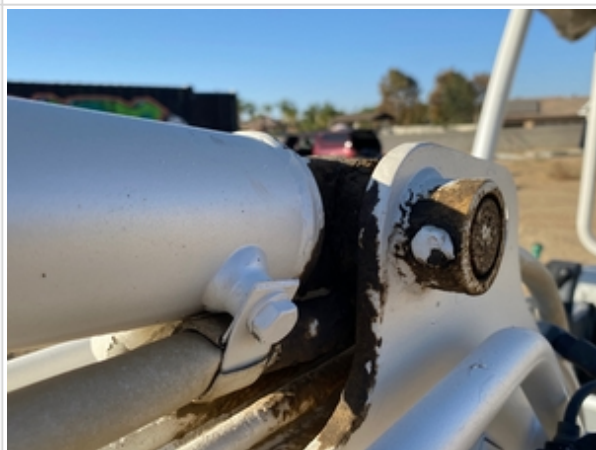
<p>Boom to Stick Pin & Bushings</p>	<p>3 - Normal Wear & Tear</p>

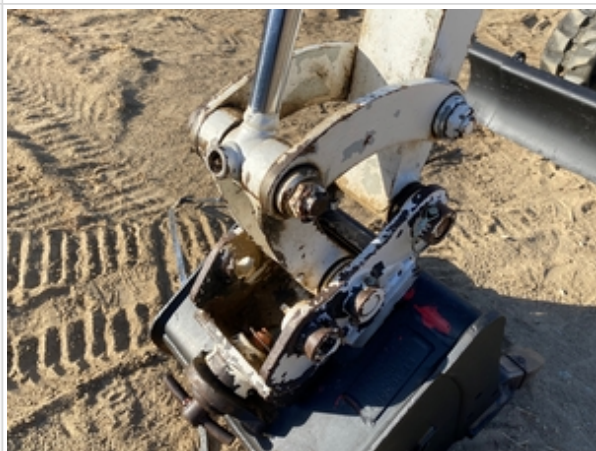
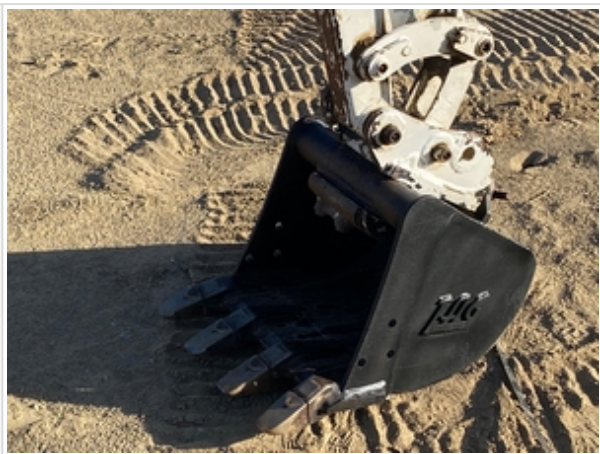
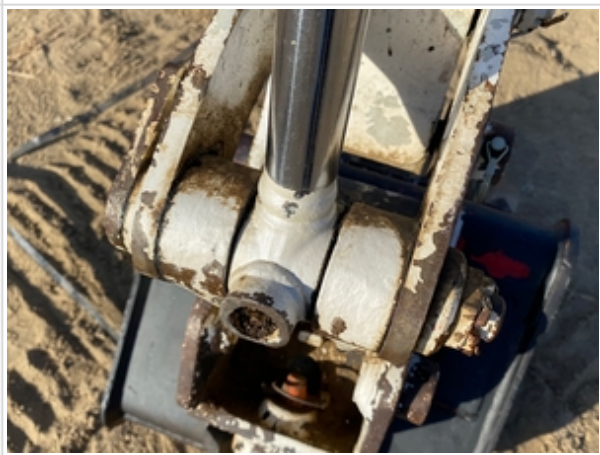
<p>Stick to Bucket Pin & Bushings</p>	<p>3 - Normal Wear & Tear</p>
<p>Stick to Bucket Pin & Bushings Photos</p>

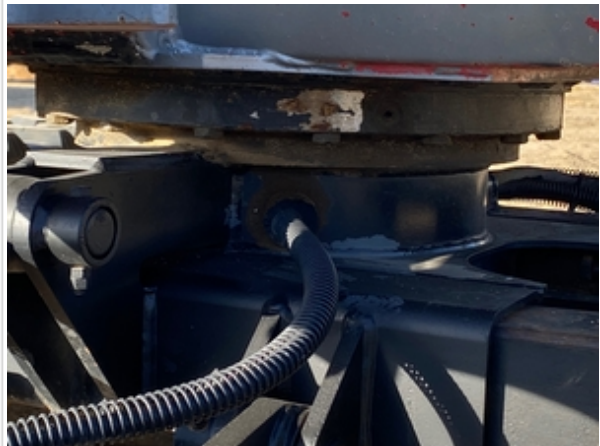
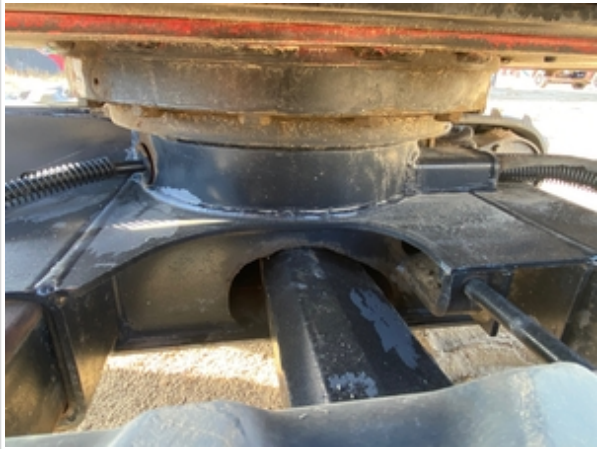
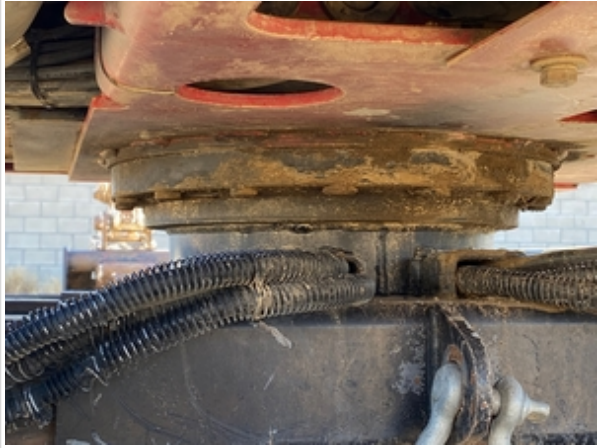
<p>Turntable Bearing</p>	<p>3 - Normal Wear & Tear</p>	
<p>Turntable Bearing Photos</p>

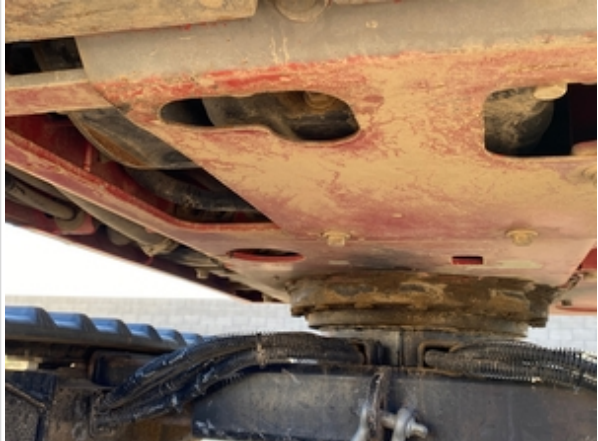
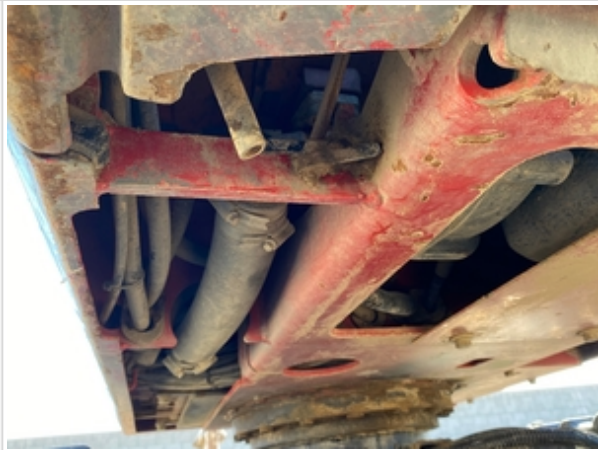
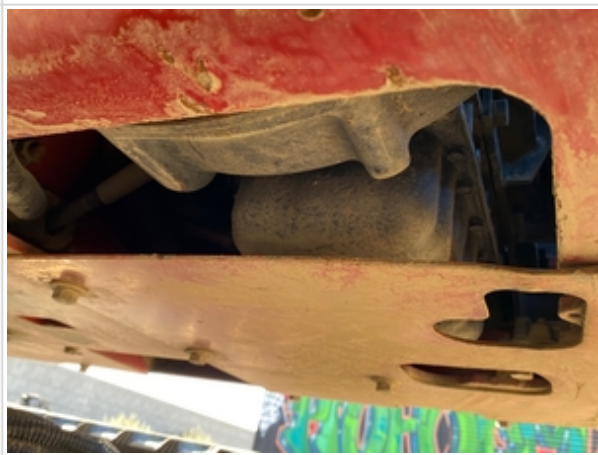
Bottom Covers	3 - Normal Wear & Tear	
Comments	Some bottom covers missing	
Bottom Covers Photos

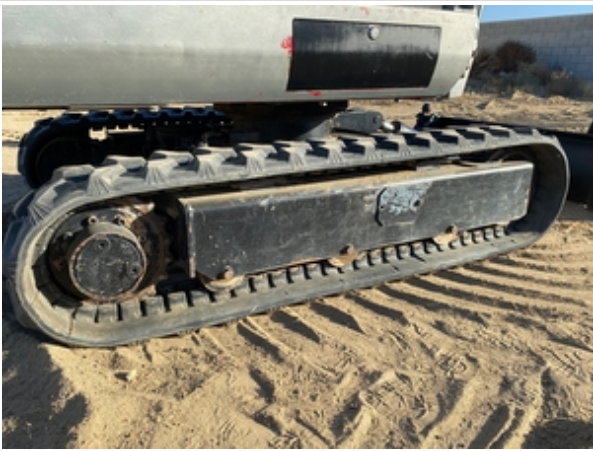
Roller Frames	3 - Normal Wear & Tear	
Roller Frames Photos

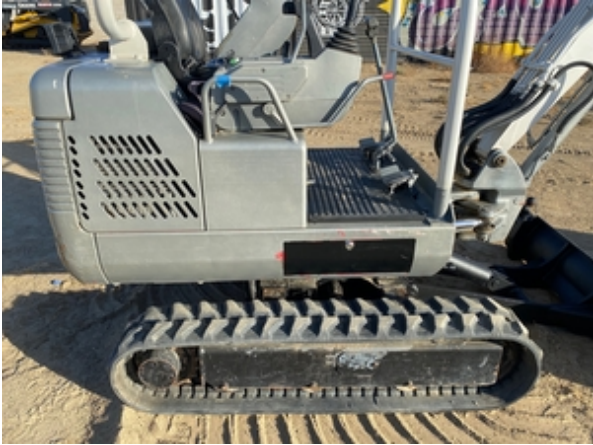
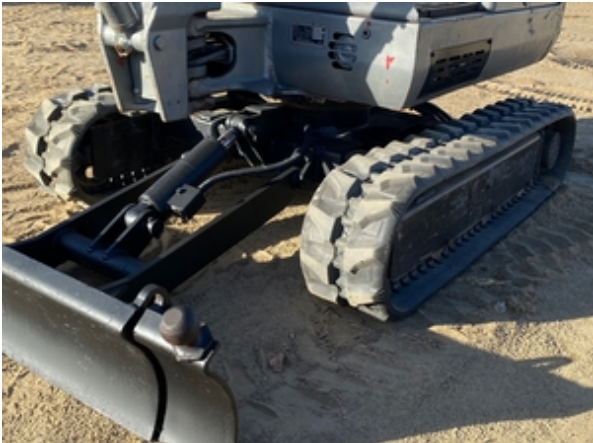
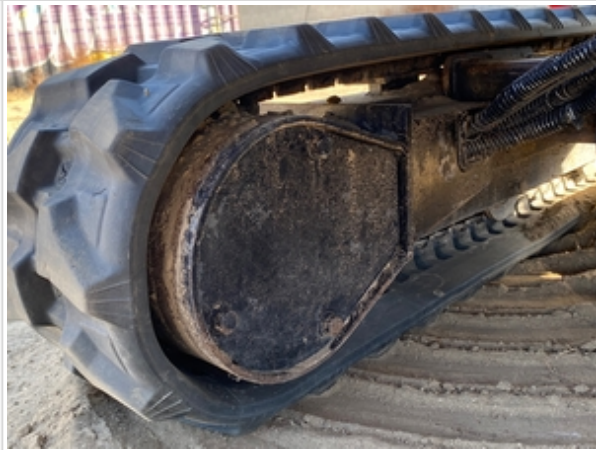
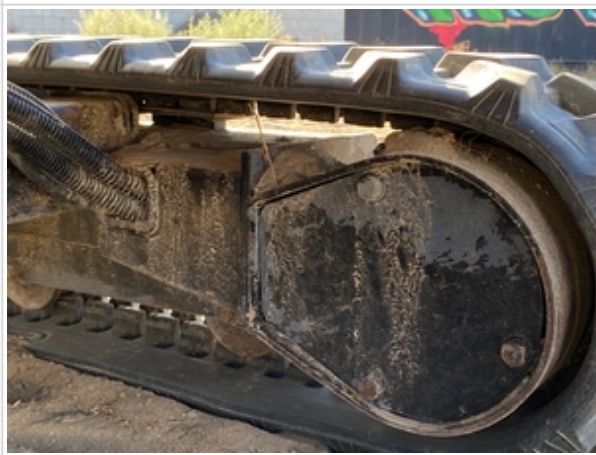
Track Belt	3 - Normal Wear & Tear	
Comments	In great condition	
Track Belt Photos

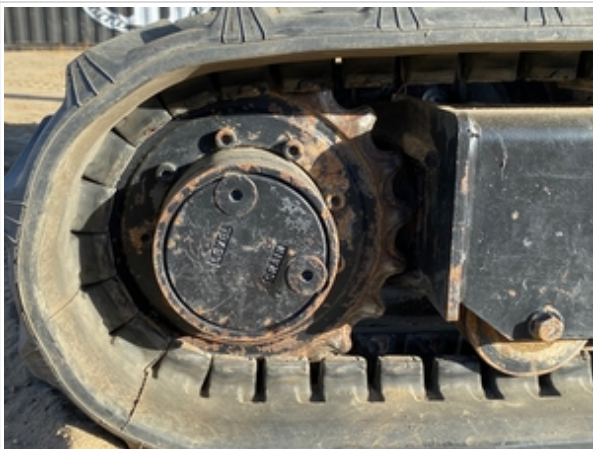
Rear Idlers	3 - Normal Wear & Tear
Track Rollers	3 - Normal Wear & Tear
Sprockets	3 - Normal Wear & Tear
Sprockets Photos

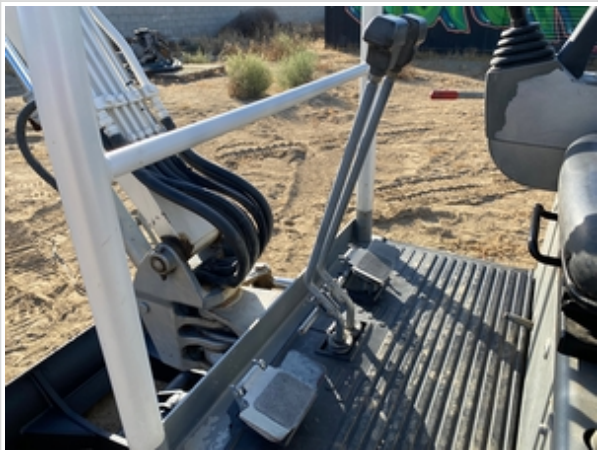
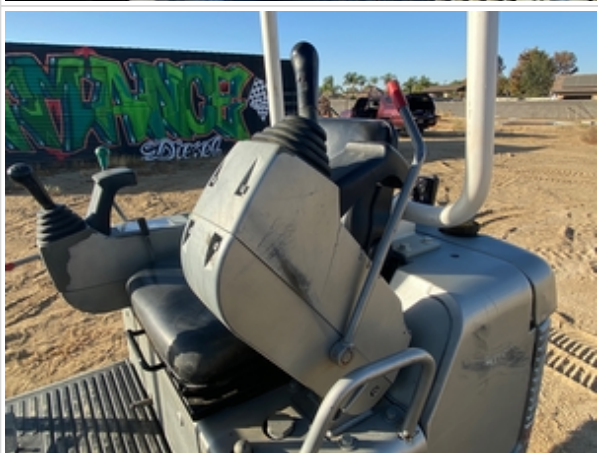
Unusual Noises (Hydraulic Pump)	No	
Hydraulic Pump Notes	No unusual noises heard during operation	
External Controls / Levers	3	
External Controls / Levers Condition	Good function & condition of hydraulic controls	
External Controls / Levers Photos

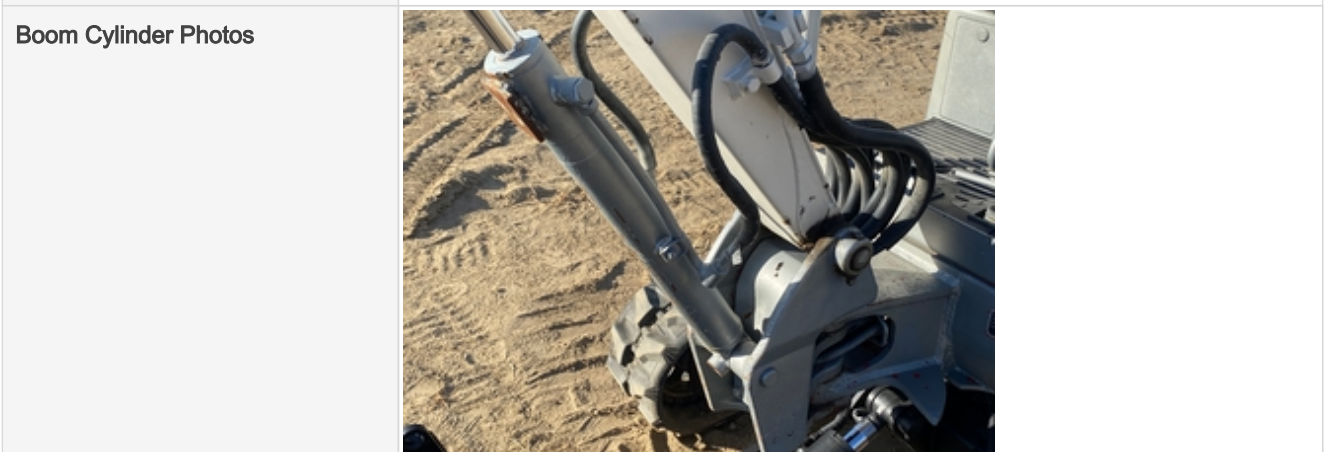
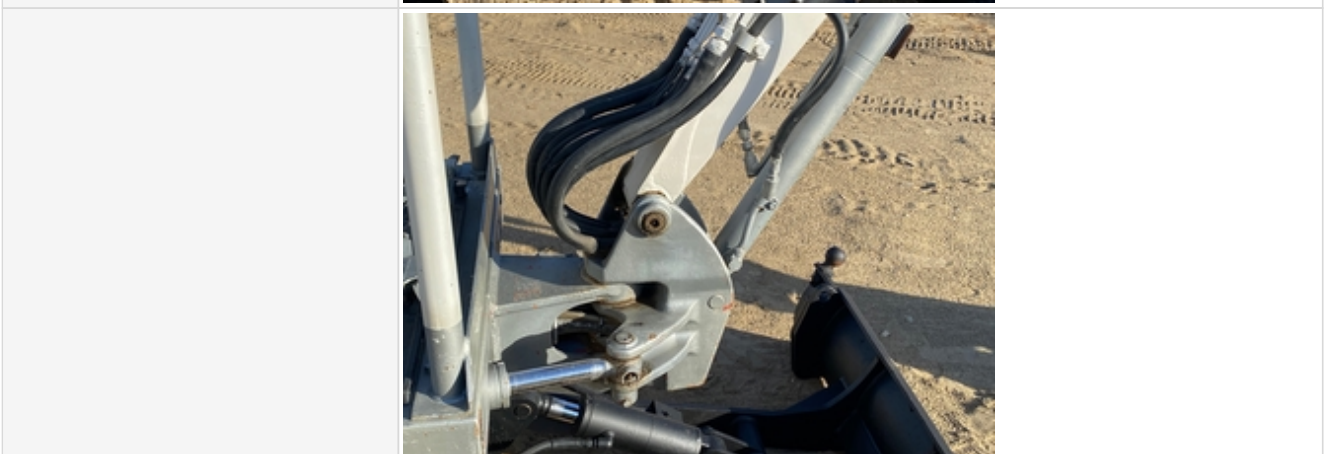
Boom Cylinder	Check the boom cylinder. Note any wear, pitting, discoloration, etc. Take photos.
Boom Cylinder: Mounting Pin	3
Boom Cylinder: Oil Leaks	No

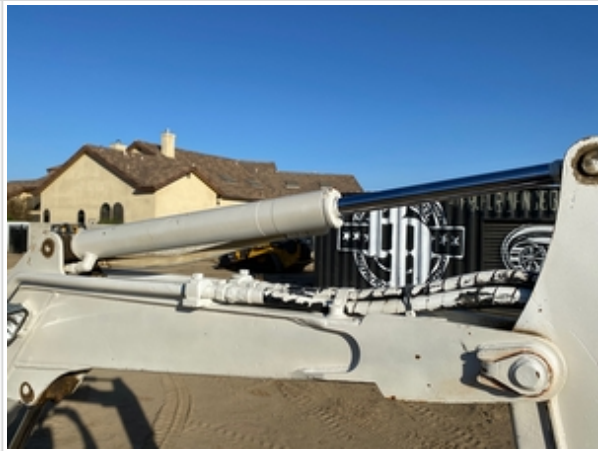
Stick Cylinder	Check the stick cylinder. Note any wear, pitting, discoloration, etc. Take photos.	
Stick Cylinder: Mounting Pin	3	
Stick Cylinder: Oil Leaks	No	
Stick Cylinder Photos

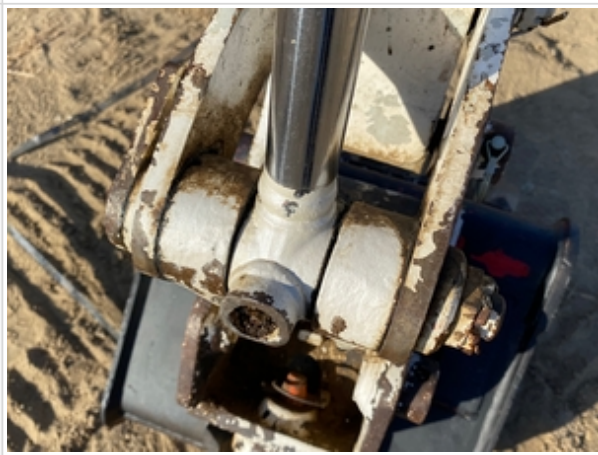
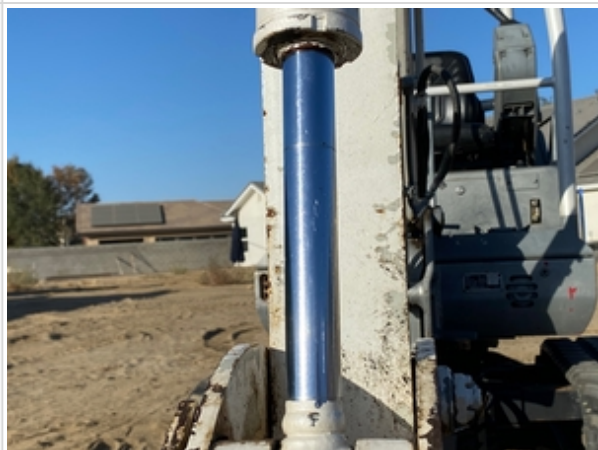
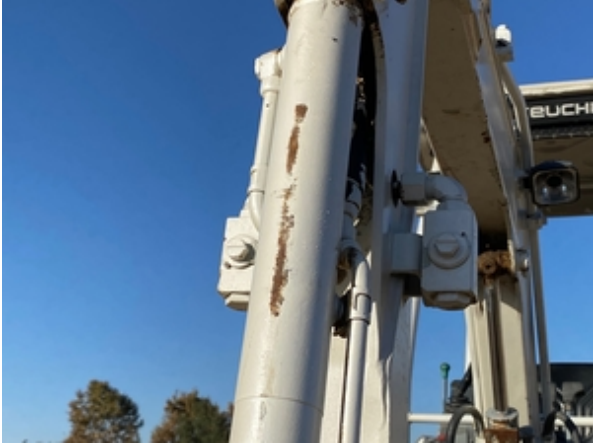
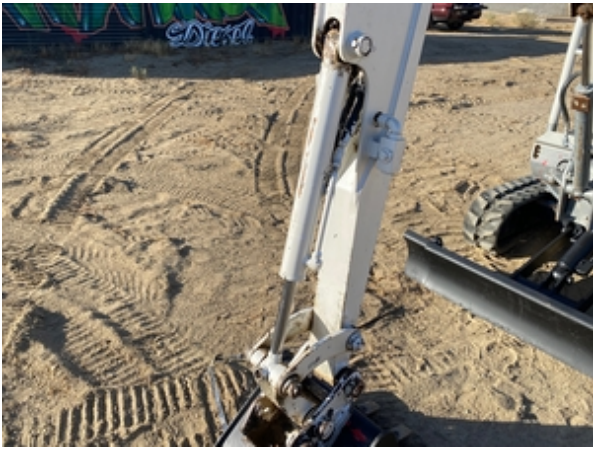
Bucket Cylinder	Check the bucket cylinder. Note any wear, pitting, discoloration, etc. Take photos.	
Bucket Cylinder: Mounting Pin	3	
Bucket Cylinder: Oil Leaks	No	
Bucket Cylinder Photos

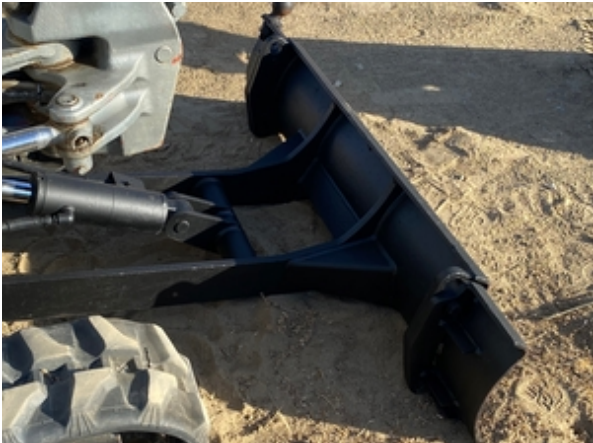
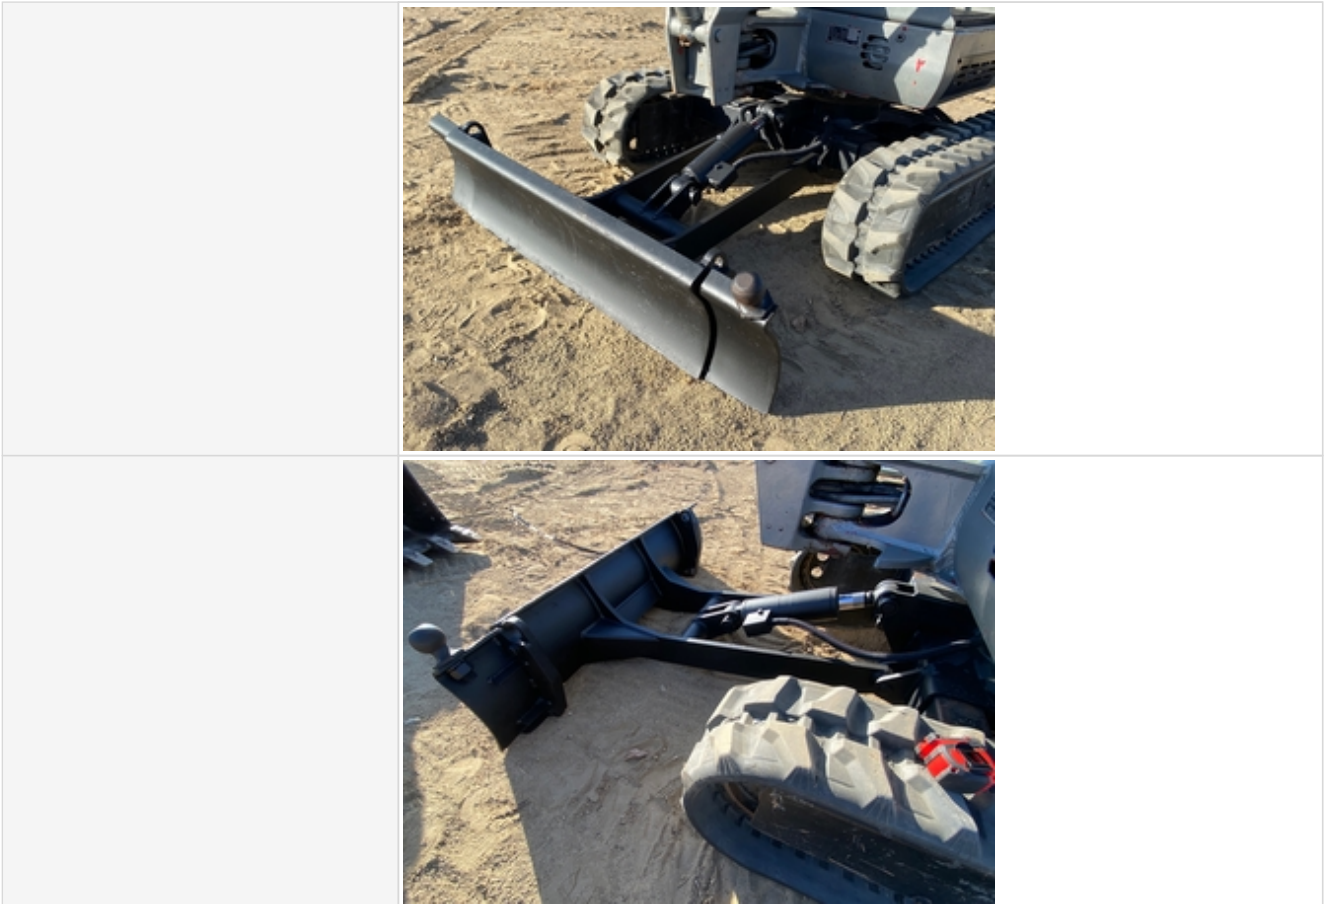
Blade	Check the blade. Note any wear, pitting, discoloration, etc. Take photos.
Blade	3
Blade Photos

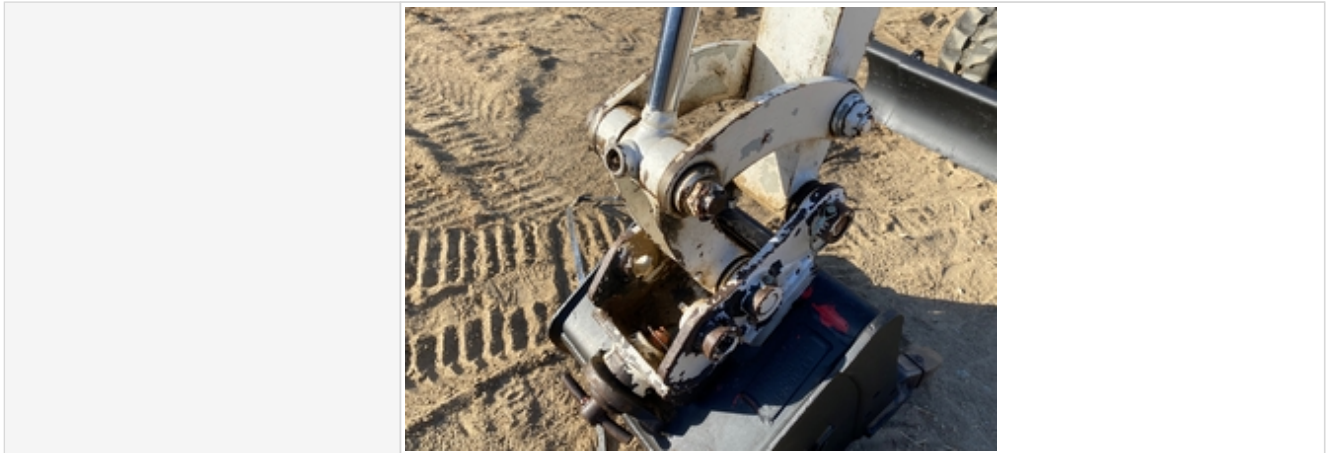
<p>Bucket Condition</p>	<p>3 - Normal Wear & Tear</p>
<p>Bucket Photos</p>
