Inspection Report (Compact Track Loader)

Year	2012
Make	CAT
Model	299D
Serial Number	NLC00387
Hour Meter Reading	5,567
Previous Application (e.g., earth moving, mining, demolition, etc)	Pipeline / Electrical Construction

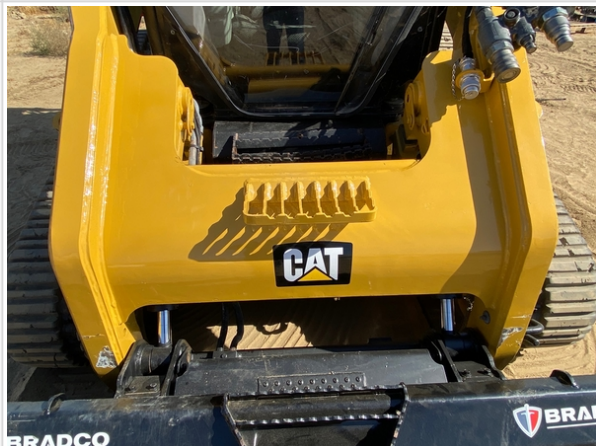
Front	3 - Normal Wear & Tear
Front Condition	No visible damage
Front Photos

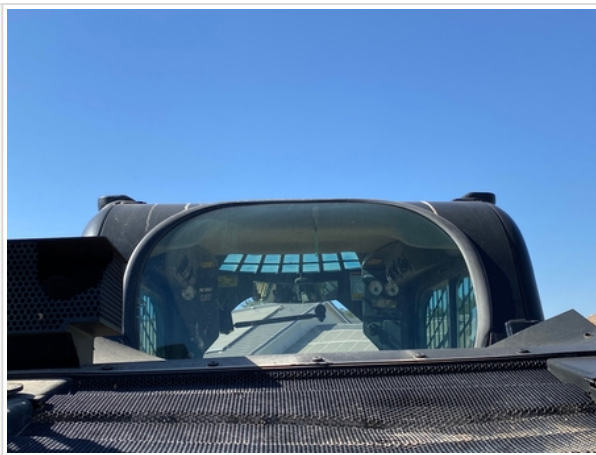
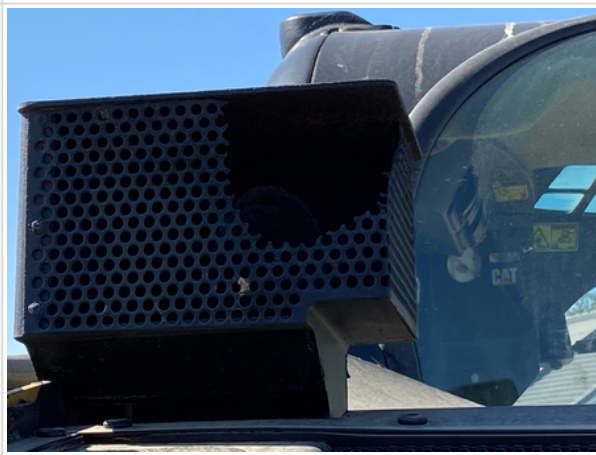
Rear	3 - Normal Wear & Tear
Rear Condition	No visible damage

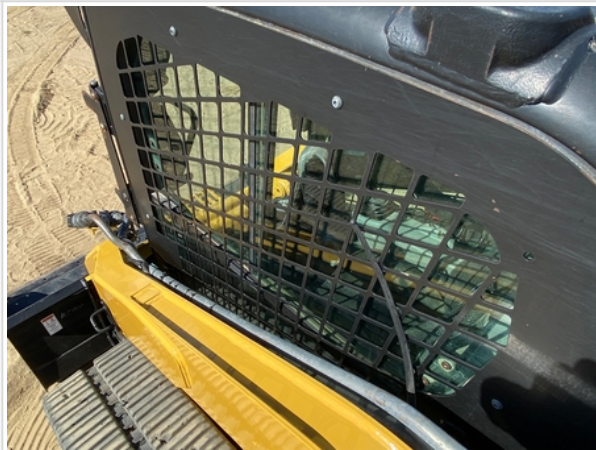
<p>Left</p>	<p>3 - Normal Wear & Tear</p>	
<p>Left Condition</p>	<p>No visible damage</p>	
<p>Left Photos</p>

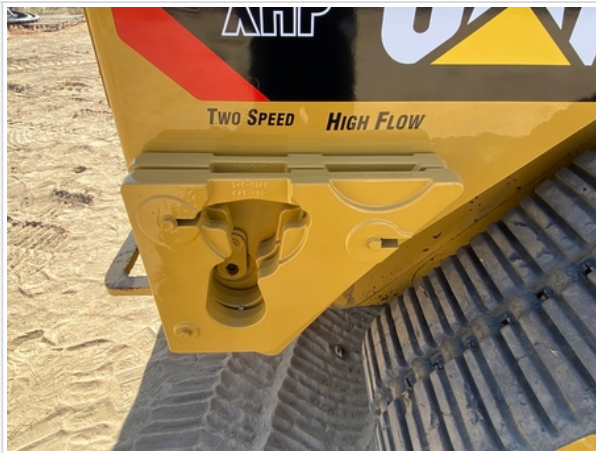
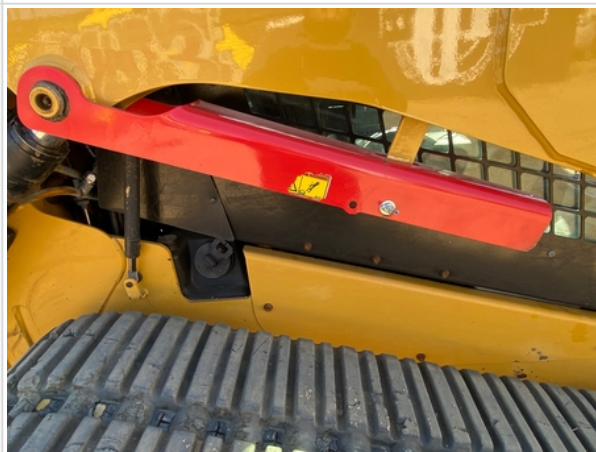
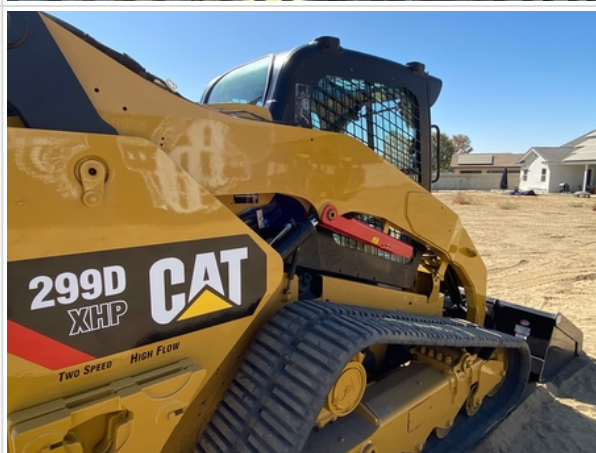
Right Photos

Right	3 - Normal Wear & Tear
Right Condition	No visible damage

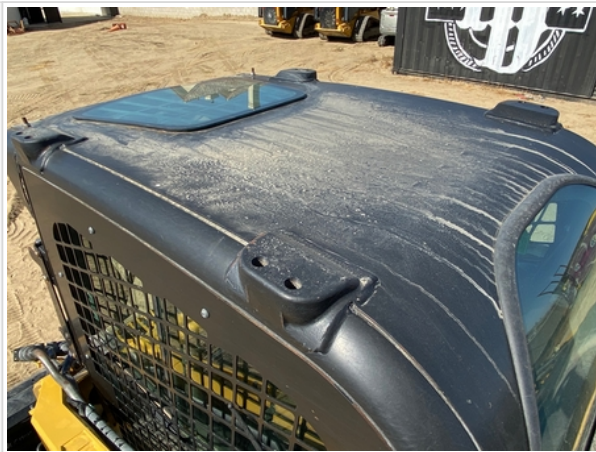
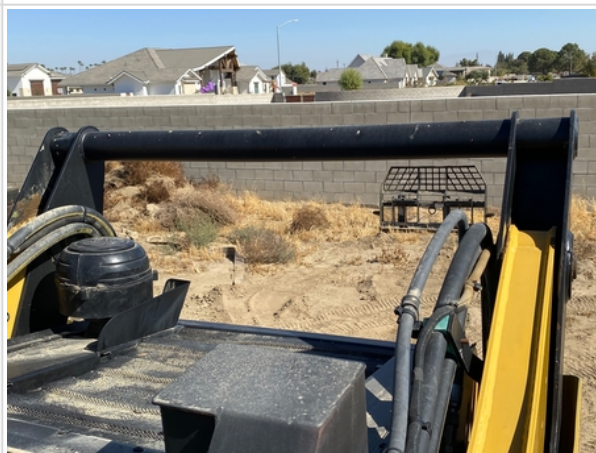
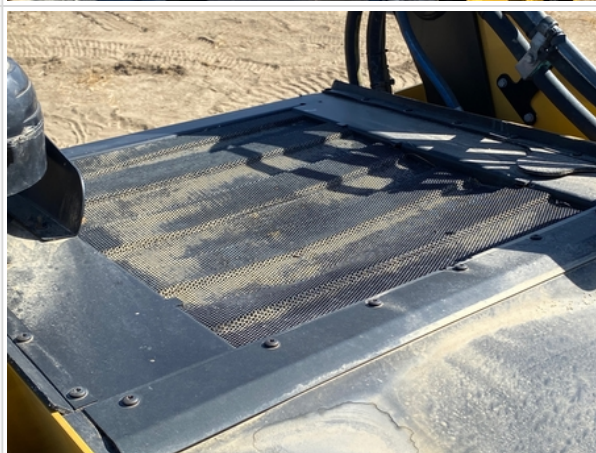
Upper Photos

Upper	3 - Normal Wear & Tear
Upper Condition	No visible damage

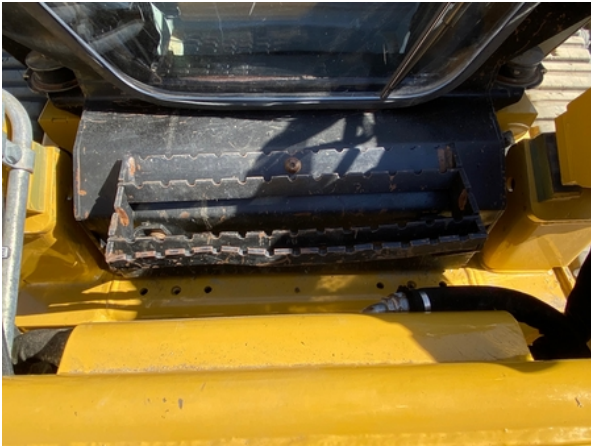
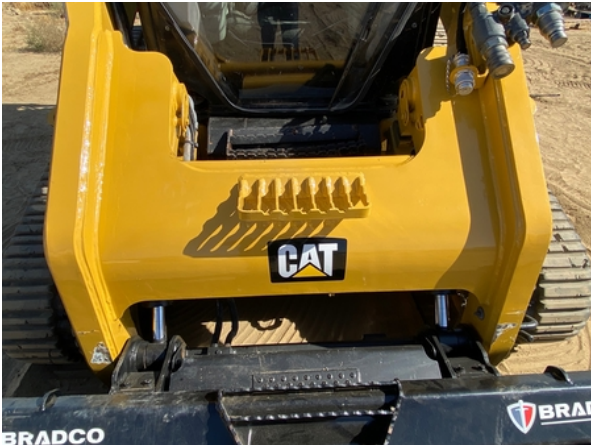
Steps / Ladders	3 - Normal Wear & Tear
Steps / Ladders Condition	Steps/ladders are fully intact and appear structurally sound, Other (see comments)
Comments	Front step slightly bent
Steps / Ladders Photos

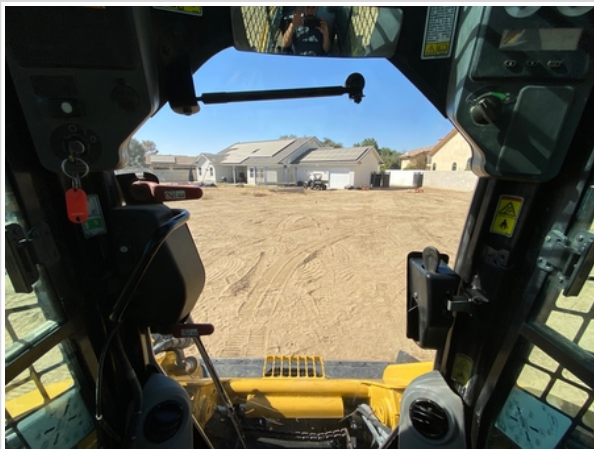
Glass Condition	3 - Normal Wear & Tear	
Glass Condition Notes	Glass intact, no visible damage	
Glass Condition Photos

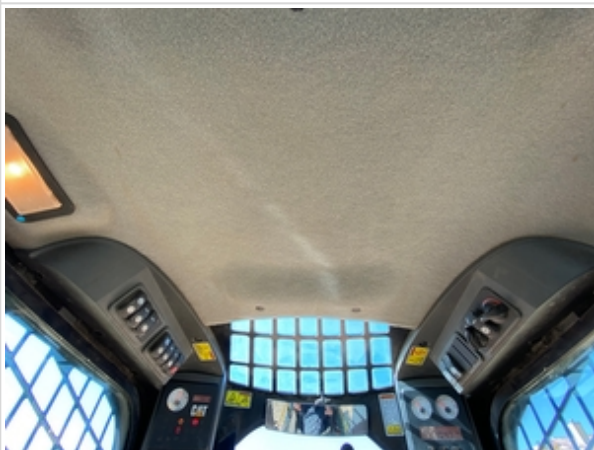
<p> MODEL NUMBER 299DXHP PRODUCT IDENTIFICATION NUMBER *CAT0299DKNLC00387* CATERPILLAR INC. PEORIA, IL 61659 USA </p>
Operator Cabin Overall	3 - Normal Wear & Tear
Operator Cabin Overall Condition	Good cabin appearance, solid floors, panels, and ceiling
Operator Cabin Photos

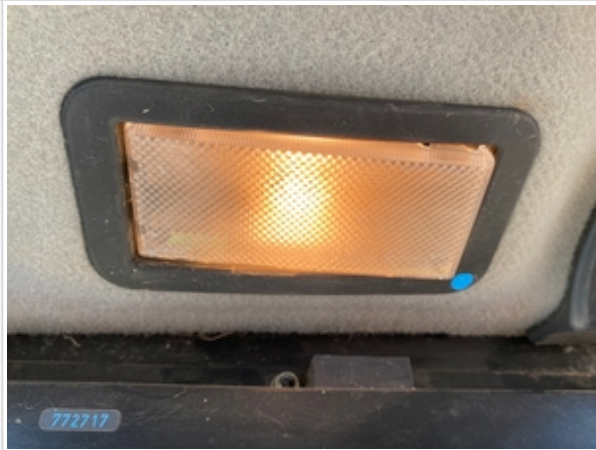
Cabin Lights Photos

Seat Belt	3 - Normal Wear & Tear
Seat Belt Condition	Seat belt secures properly. Belt is intact and in good condition
Cabin Lights	3 - Normal Wear & Tear
Cabin Lights Condition	Cabin lights are installed with all light covers in place, bulbs are installed and working properly

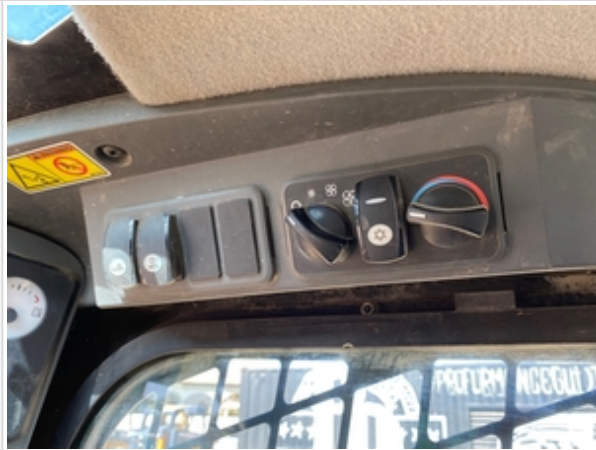
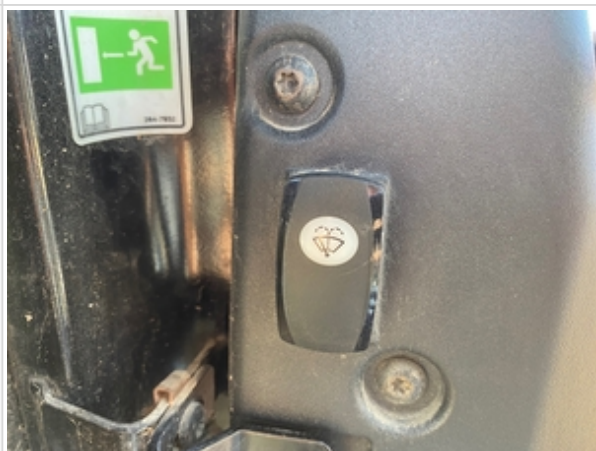
Safety Lock Out / Stop	3 - Normal Wear & Tear
Safety Lock Out / Stop Condition	Safety lock out device is present, in good condition, and functional
Controls & Switches	3 - Normal Wear & Tear
Controls & Switches Condition	All switches are installed and functional
Controls & Switches Photos

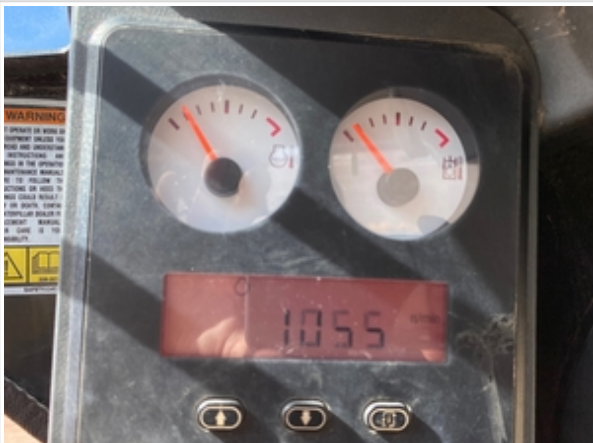
Other Gauge Activity	3 - Normal Wear & Tear
Other Gauge Condition	All cockpit gauges are functional and in good condition
Other Gauge Activity Photos

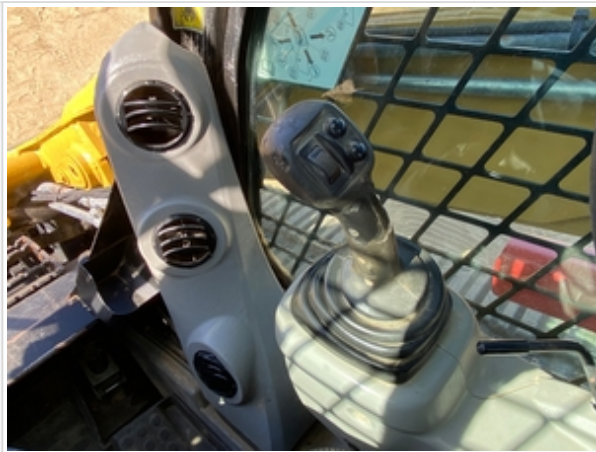
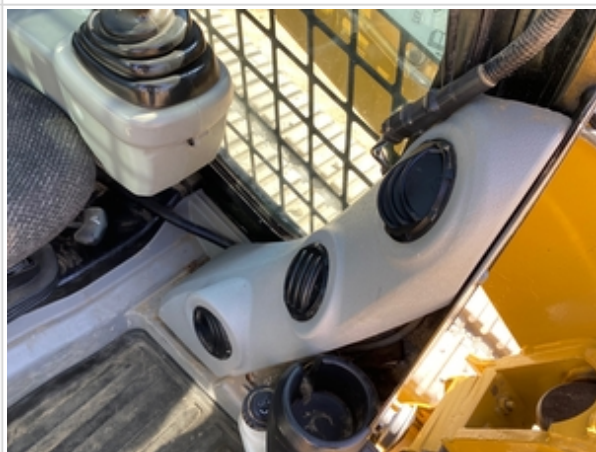
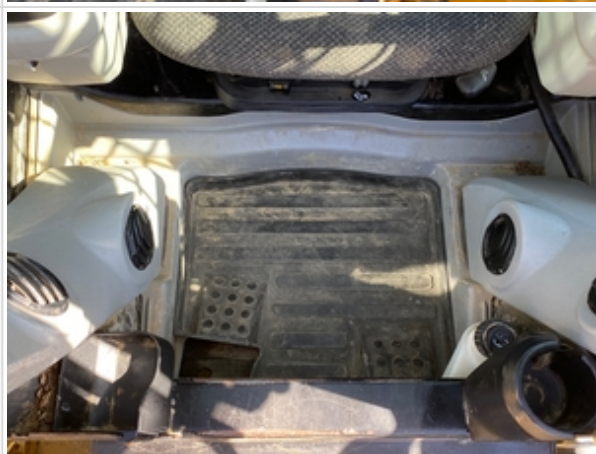
Fans / Vents Photos

Heater & A/C	3 - Normal Wear & Tear
Heater & A/C Condition	Heater and A/C work and transition through full temperature range
Fans / Vents	3 - Normal Wear & Tear
Fans / Vents Condition	Fan vents are functional, in good condition, and move through a full adjustable range of motion

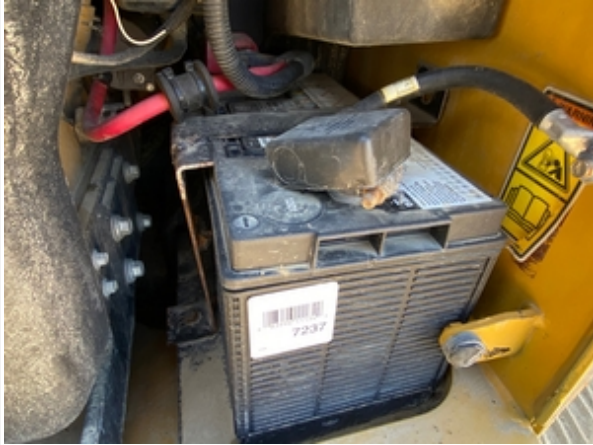
Blow-by (Visual Observation Check)	No
Unusual Noises (Upon Start-up, Idle, Shutdown)	No
Unusual Noise Notes	No unusual noises heard
Engine Smoke (Upon Start-up, Idle, Shutdown)	No
Engine Smoke Notes	No engine smoke issues observed
Engine Exhaust Color	Clear
Battery	3 - Normal Wear & Tear
Battery Condition	Clean & dry appearance, tight connections
Battery Condition Photos

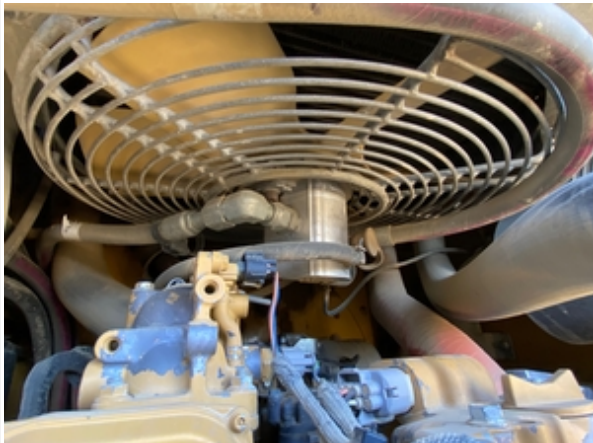
Radiator	3 - Normal Wear & Tear
Radiator Condition	Radiator fins & components appear to be in good working order, no signs of damage or leaks
Radiator Photos

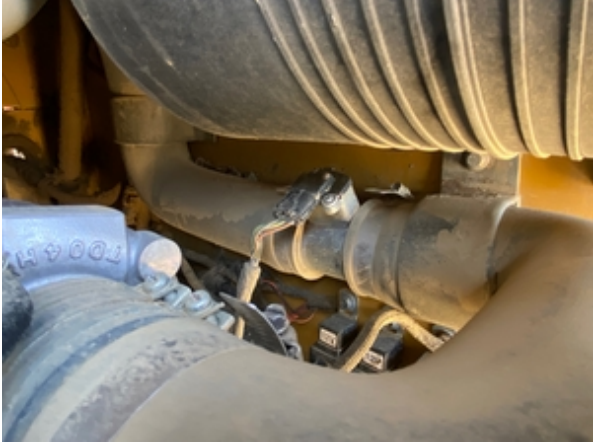
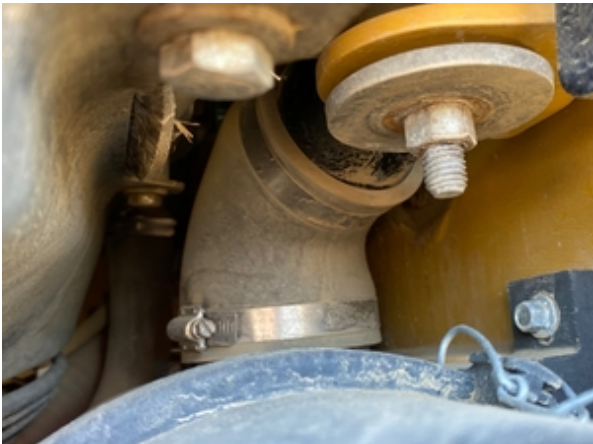
Belts	3 - Normal Wear & Tear	
Belt Condition	Belts appear in good condition & alignment with proper tension	
Hoses	3 - Normal Wear & Tear	
Hose Condition	Firm, pliant hoses with no signs of wear or leaks	
Hose Photos

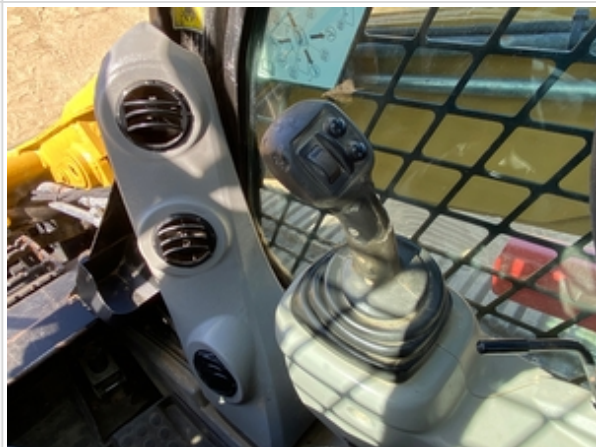
Unusual Noises (Hydraulic Pump)	No	
Hydraulic Pump Notes	No unusual noises heard during operation	
External Controls / Levers	3	
External Controls / Levers Condition	Good function & condition of hydraulic controls	
External Controls / Levers Photos
