Inspection Report (Compact Track Loader)

Year	2016
Make	John Deere
Model	333E
Serial Number	296619
Hour Meter Reading	1,335
Previous Application (e.g., earth moving, mining, demolition, etc)	Pipeline / Electrical Construction

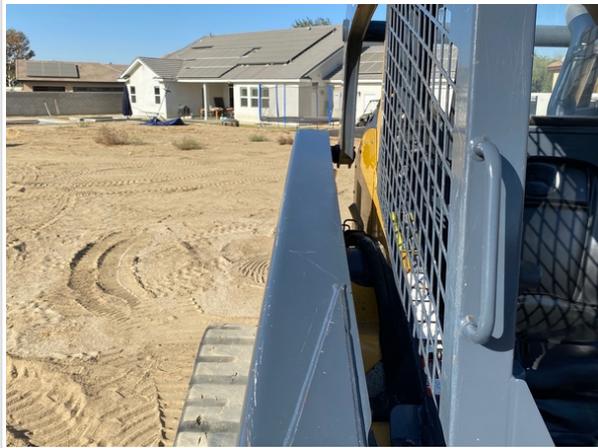
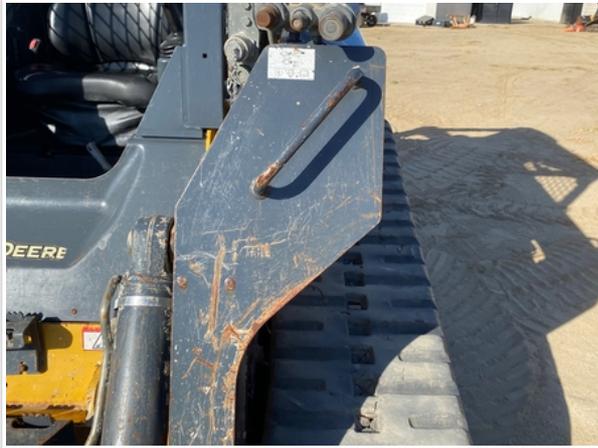
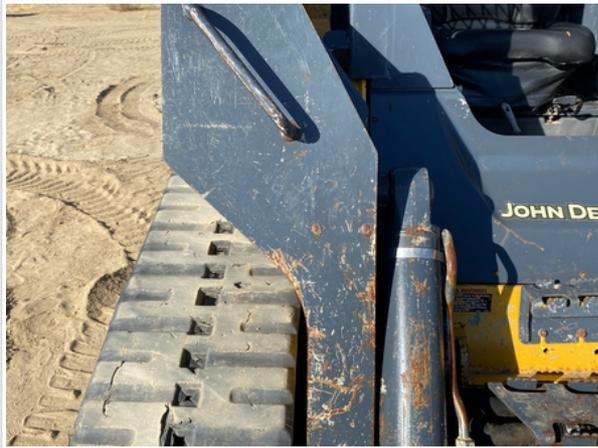
Front	3 - Normal Wear & Tear
Front Condition	No visible damage

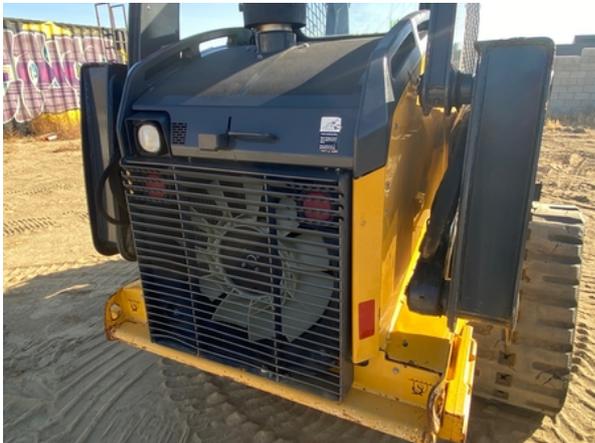
Rear	3 - Normal Wear & Tear
Rear Condition	No visible damage

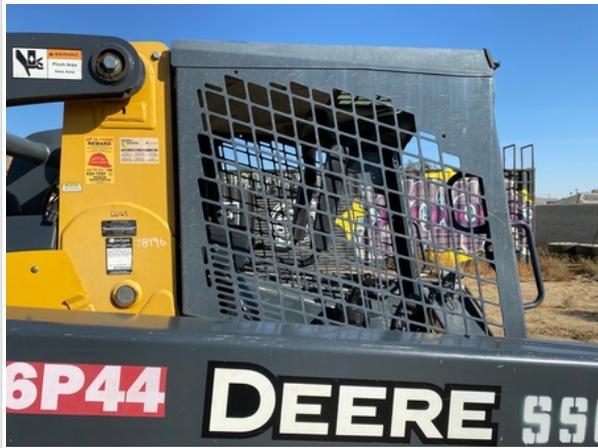
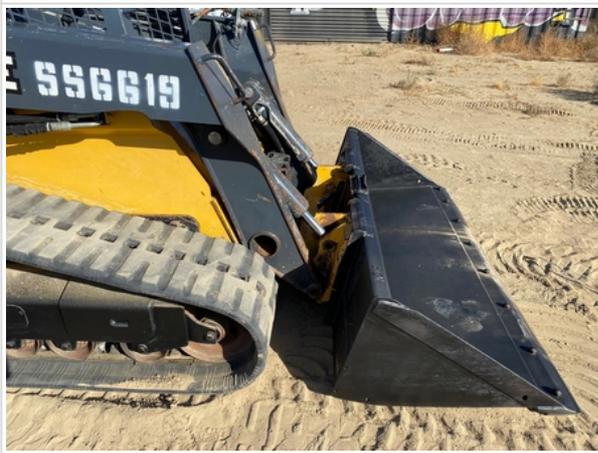
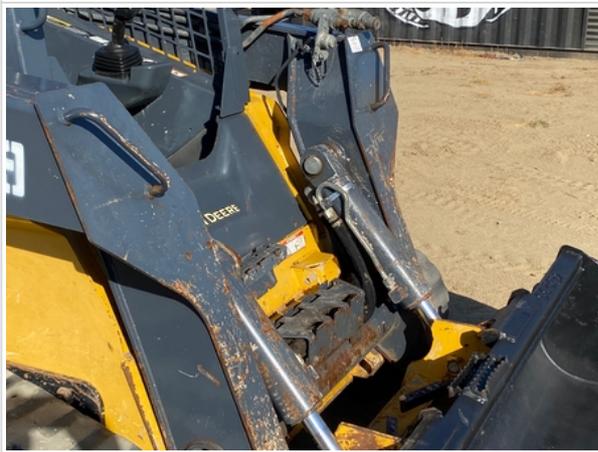
Right	3 - Normal Wear & Tear
Right Condition	No visible damage
Right Photos

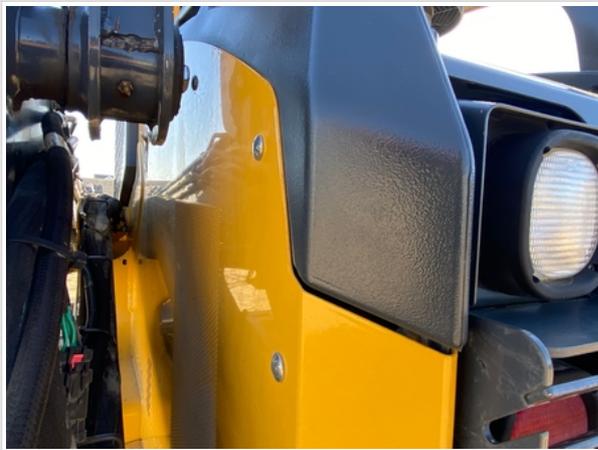
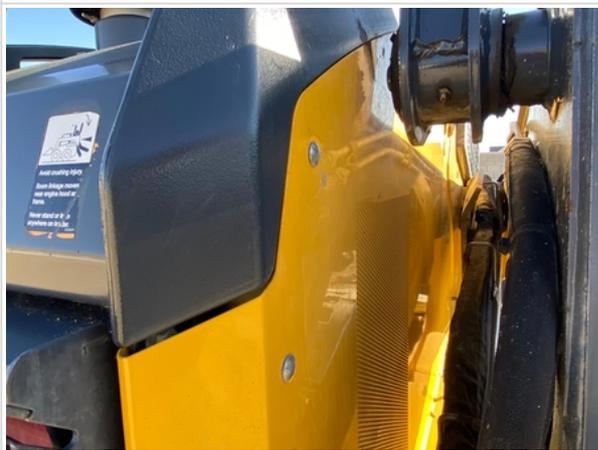
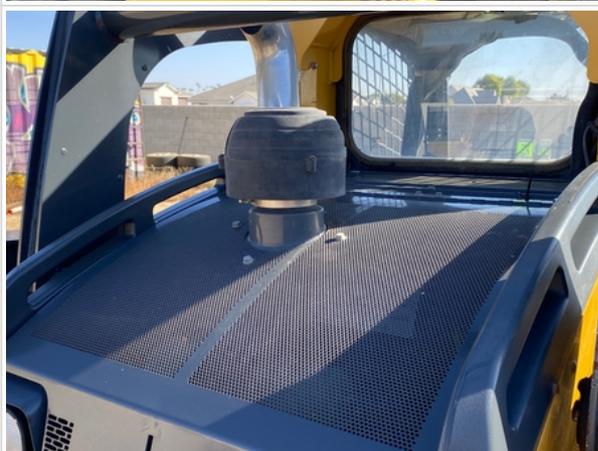
Body Panels Photos

Upper	3 - Normal Wear & Tear
Upper Condition	No visible damage
Body Panels (Any Rust Damage?)	3 - Normal Wear & Tear
Body Panel Condition	No visible damage, good paint condition and panel fitment

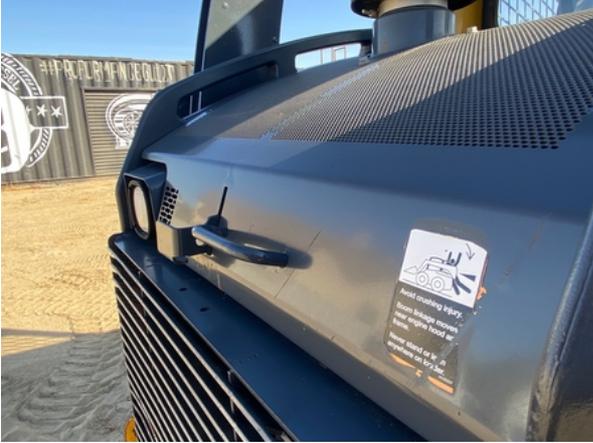
Doors / Canopy Latches Photos

Doors / Canopy Latches	3 - Normal Wear & Tear
Doors / Canopy Latches Condition	No visible damage

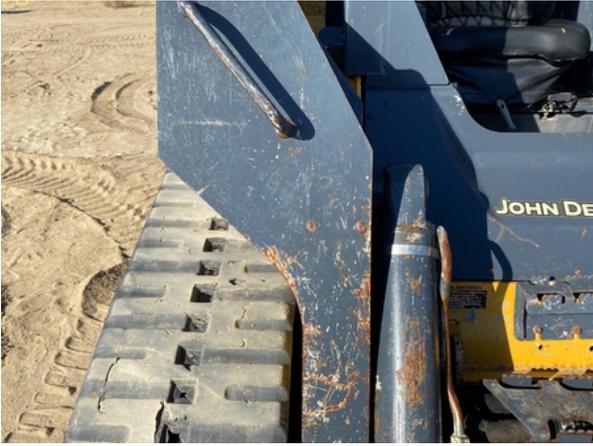
Steps / Ladders	0
Handrails	3 - Normal Wear & Tear
Handrails Condition	Handrails are fully intact and appear structurally sound
Handrail Photos

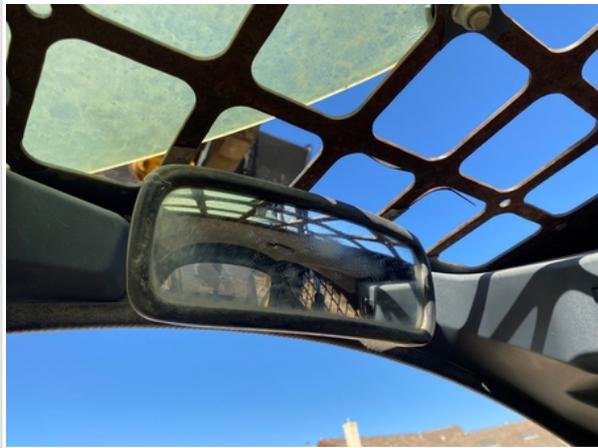
Mirrors Photos

Glass Condition	0
Mirrors	3 - Normal Wear & Tear
Mirror Condition Notes	Mirrors present and intact, no visible damage

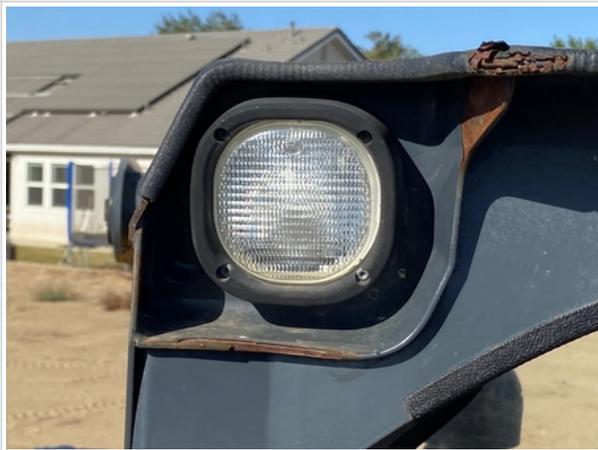
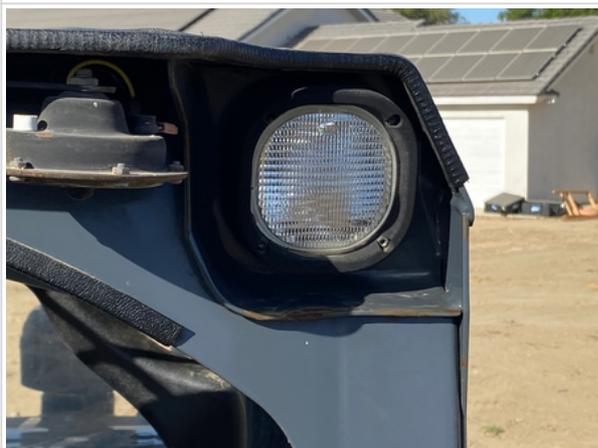
Lighting System	3 - Normal Wear & Tear
Lighting System Condition	No visible damage, lighting system is operational
Lighting System Photos

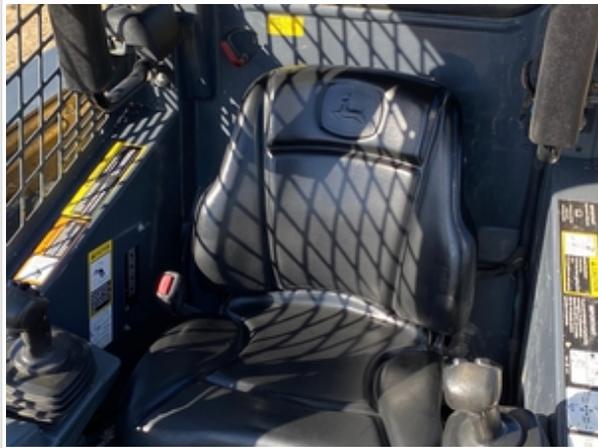
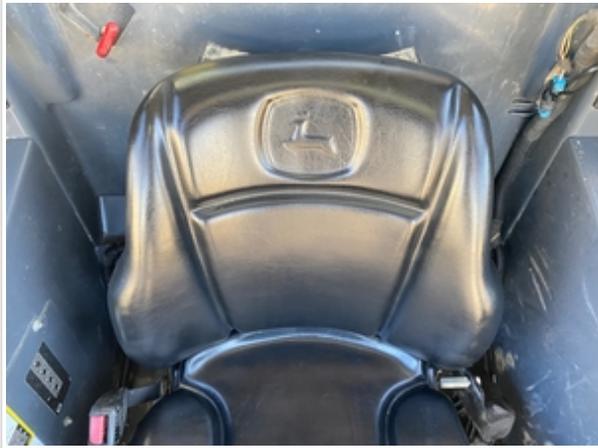
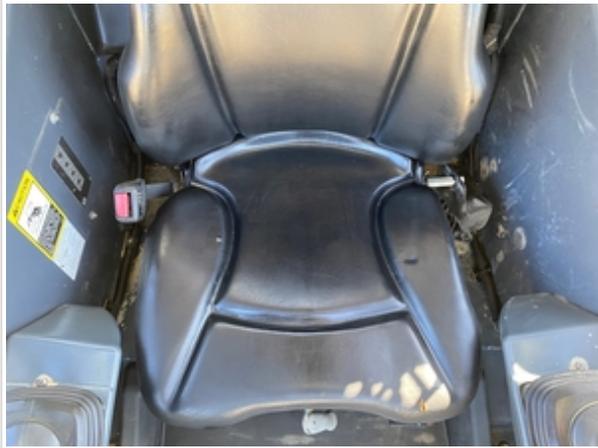
Operator's Seat & Arm Rests	3 - Normal Wear & Tear
Operator's Seat & Arm Rests Condition	Seat(s) have minor surface staining or small tears, Other (see comments)
Comments	Seat in good shape minor tear
Operator's Seat & Arm Rests Photos

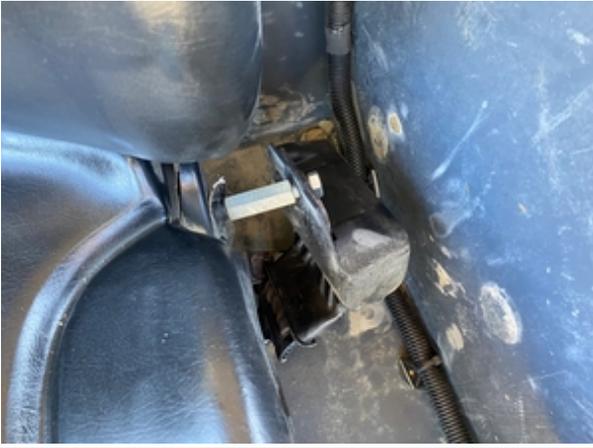
Seat Belt Photos

Seat Belt	3 - Normal Wear & Tear
Seat Belt Condition	Seat belt shows limited functionality or does not secure properly

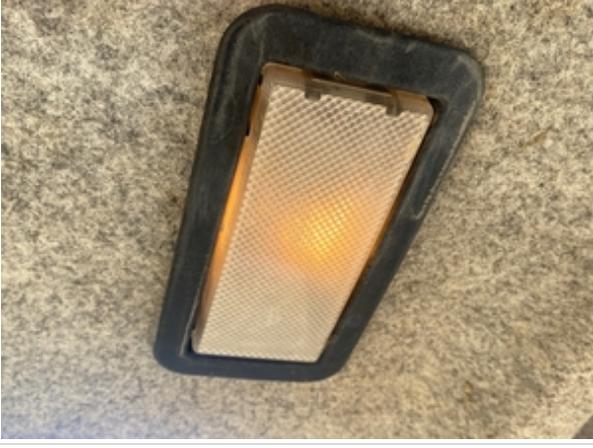
Cabin Lights	3 - Normal Wear & Tear
Cabin Lights Condition	Cabin lights are installed with all light covers in place, bulbs are installed and working properly
Cabin Lights Photos

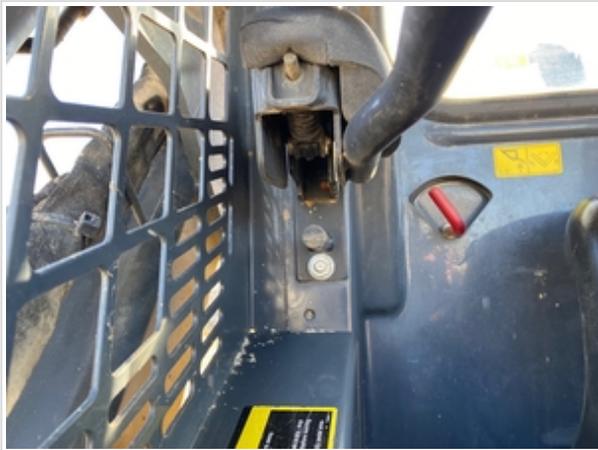
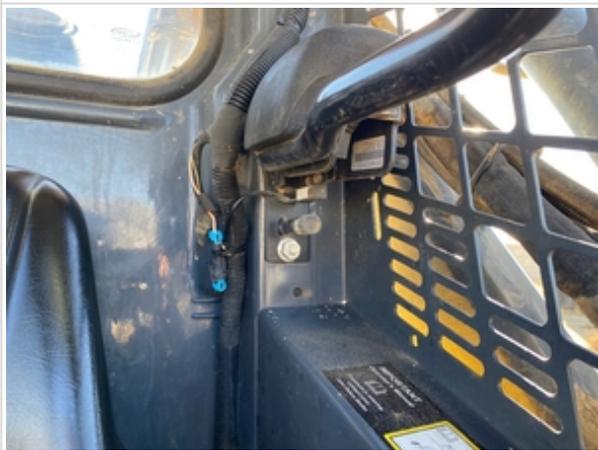
<p>Safety Lock Out / Stop Photos</p>

Safety Lock Out / Stop	3 - Normal Wear & Tear
Safety Lock Out / Stop Condition	Safety lock out device is present, in good condition, and functional, Other (see comments)
Comments	Electrical lockout switches functioning properly

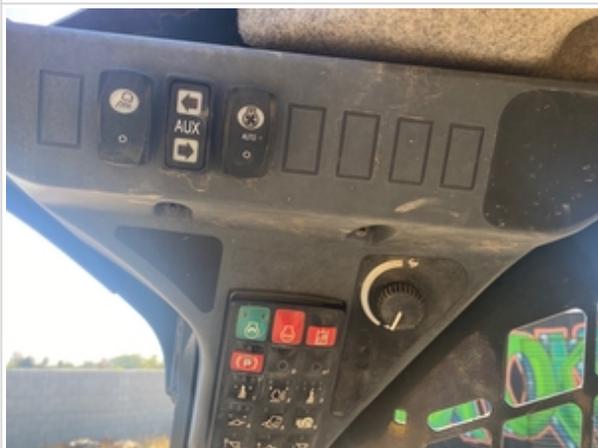
<p>Controls & Switches</p>	<p>3 - Normal Wear & Tear</p>
<p>Controls & Switches Condition</p>	<p>All switches are installed and functional</p>
<p>Controls & Switches Photos</p>

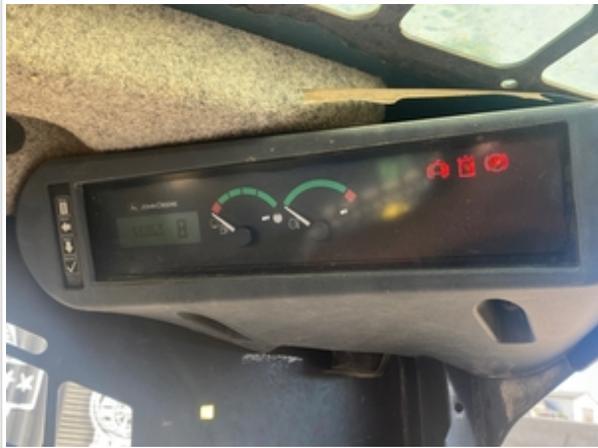
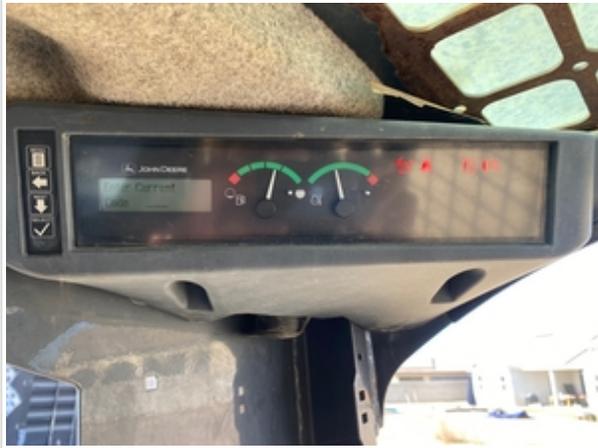
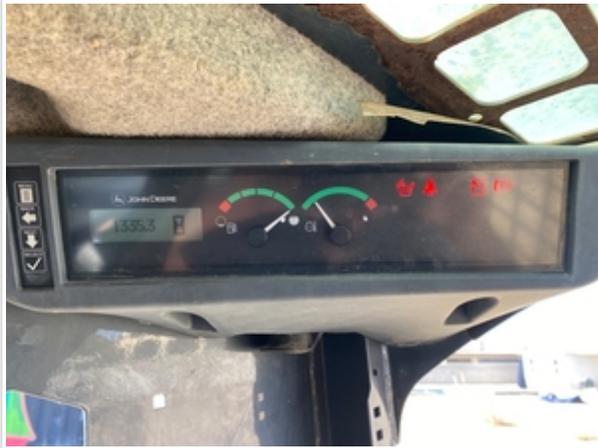
Other Gauge Activity Photos

Other Gauge Activity	3 - Normal Wear & Tear
Other Gauge Condition	All cockpit gauges are functional and in good condition

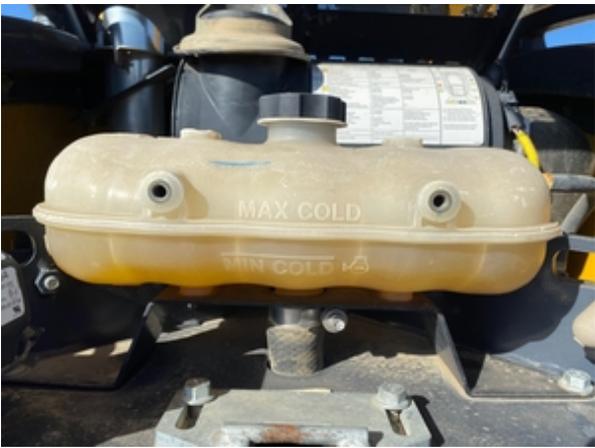
Radiator	3 - Normal Wear & Tear
Radiator Condition	Radiator fins & components appear to be in good working order, no signs of damage or leaks
Radiator Photos

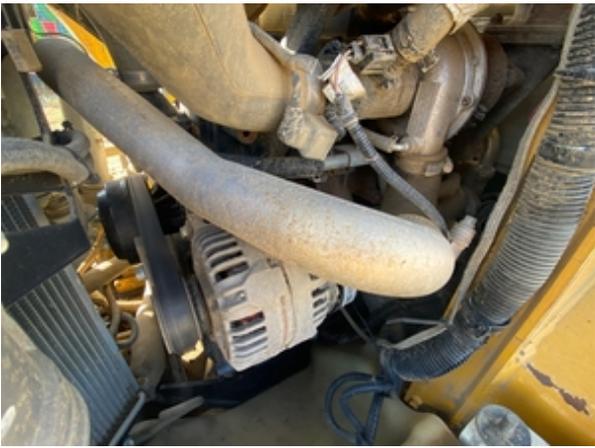
Belts	3 - Normal Wear & Tear	
Belt Condition	Belts appear in good condition & alignment with proper tension	
Belt Photos

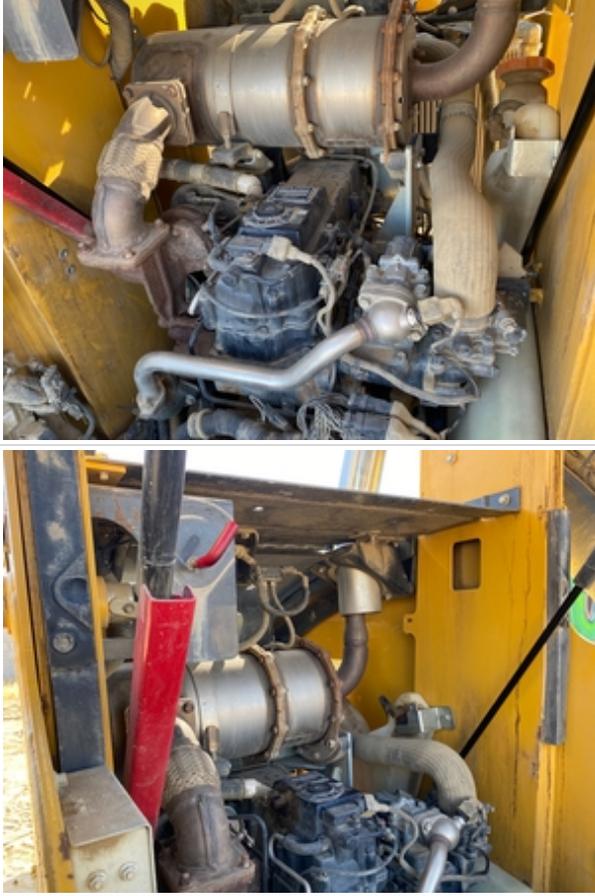
Oil Color / Appearance Notes	Clean oil appearance, no signs of cross contamination, Appropriate oil level
Fuel Leaks	No
Equipped with DPF (Diesel Particulate Filter)	Yes
DPF Condition	3 - Normal Wear & Tear
DPF Condition Notes	Filter housing is intact with no signs of damage or malfunction, DPF indicator is not illuminated
DPF Photos

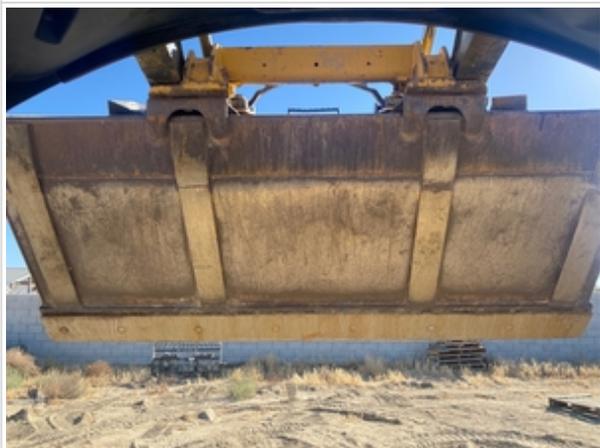
Quick Coupler	3 - Normal Wear & Tear	
Comments	Right side tilt cylinder pin to quick coupler loose	
Quick Coupler Photos

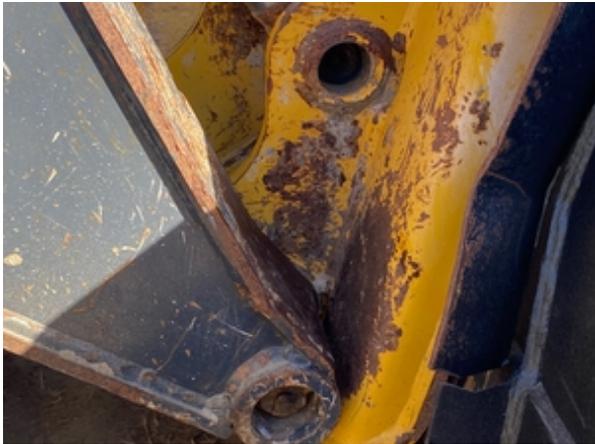
Quick Coupler to Arms Pins	2 - Above Average Wear
Comments	Right side pin needs attention
Quick Coupler to Arms Pins Photos

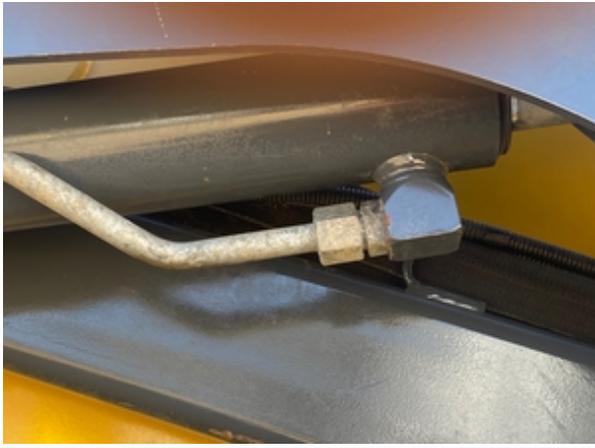
Wet or Damp Hydraulic Lines / Fittings	Yes
Appearance of Hydraulic Lines / Fittings	3
Hydraulic Lines / Fittings Condition	Hydraulic lines & fittings are clean and in good condition
Appearance of Hydraulic Lines / Fittings Photos

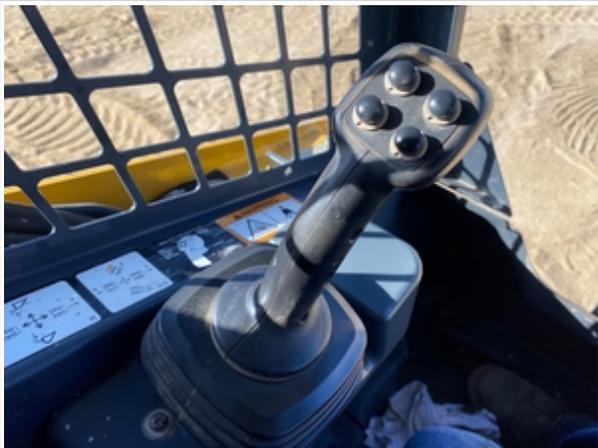
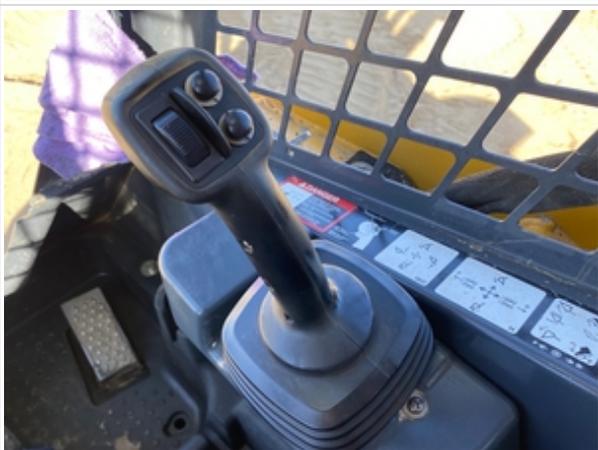
Unusual Noises (Hydraulic Pump)	No	
Hydraulic Pump Notes	No unusual noises heard during operation	
External Controls / Levers	3	
External Controls / Levers Condition	Good function & condition of hydraulic controls	
External Controls / Levers Photos

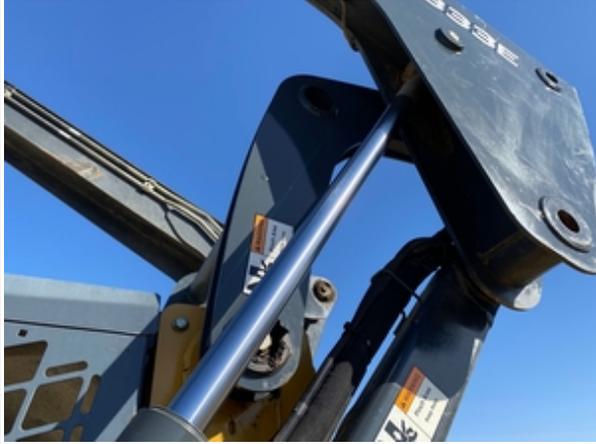
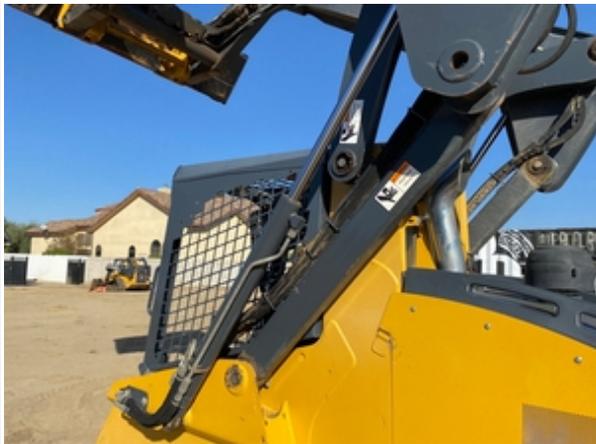
Lift Cylinder	Check the lift cylinder. Note any wear, pitting, discoloration, etc. Take photos.
Lift Cylinder: Mounting Pin	3
Lift Cylinder: Oil Leaks	Yes
Comments	Right side lift cylinder showing signs of seepage, oil dirt buildup, (no active leaks seen)
Lift Cylinder Photos
