## Inspection Report (Compact Track Loader)

Year	2015
Make	John Deere
Model	333E
Serial Number	279331
Hour Meter Reading	1,704
Previous Application (e.g., earth moving, mining, demolition, etc)	Pipeline / Electrical Construction

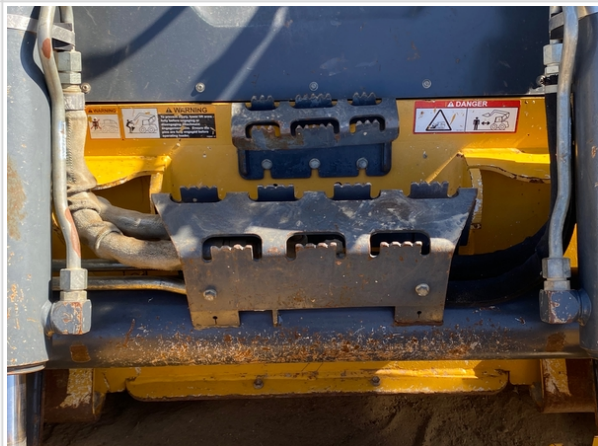
Front	3 - Normal Wear & Tear
Front Condition	No visible damage
Front Photos

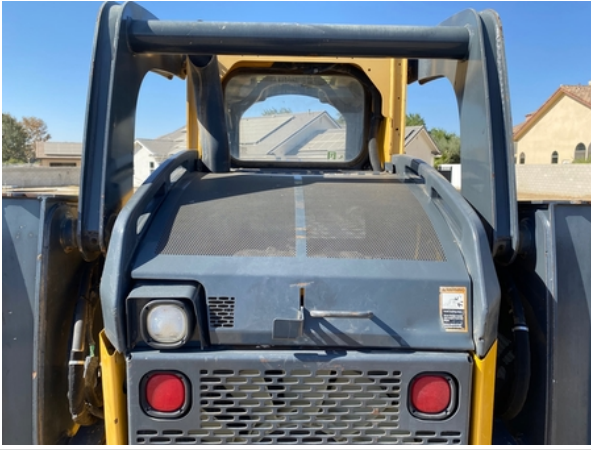
<b>Left</b>	3 - Normal Wear & Tear
<b>Left Condition</b>	No visible damage
<b>Left Photos</b>

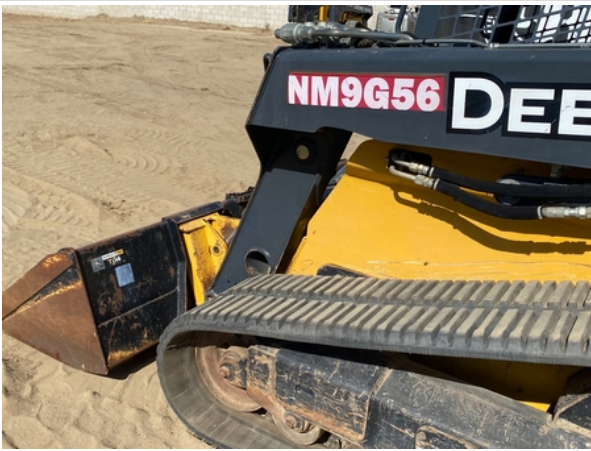
<b>Right</b>	3 - Normal Wear & Tear
<b>Right Condition</b>	No visible damage
<b>Right Photos</b>

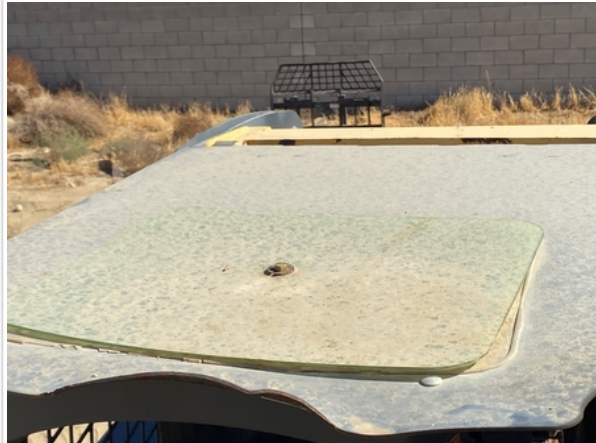
Upper	3 - Normal Wear & Tear
Upper Condition	No visible damage
Upper Photos

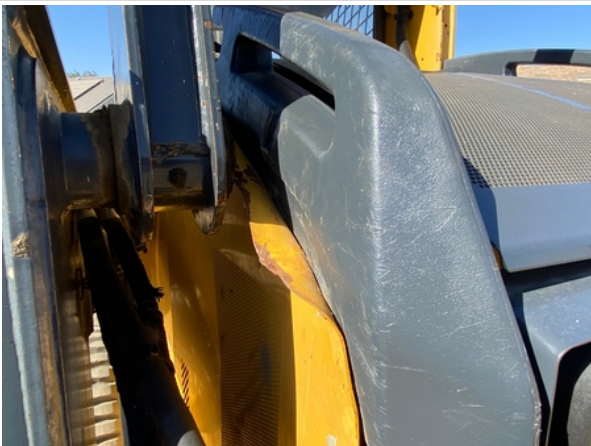
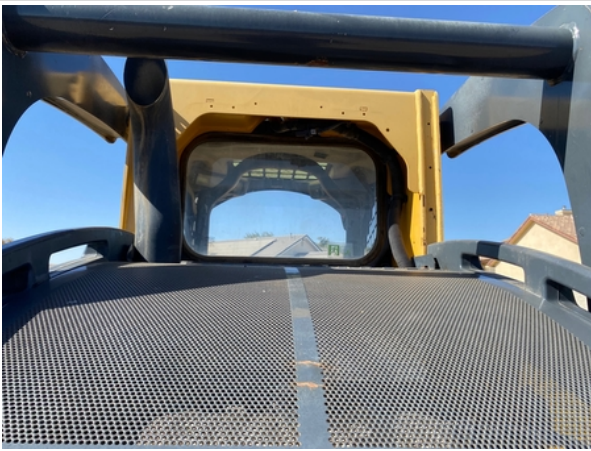
<b>Body Panels (Any Rust Damage?)</b>	3 - Normal Wear & Tear
<b>Body Panel Condition</b>	Some panel misalignment observed, Visible chipped paint or dents, Other (see comments)
<b>Comments</b>	Rear engine body panels bent on top side and slightly misaligned
<b>Body Panels Photos</b>

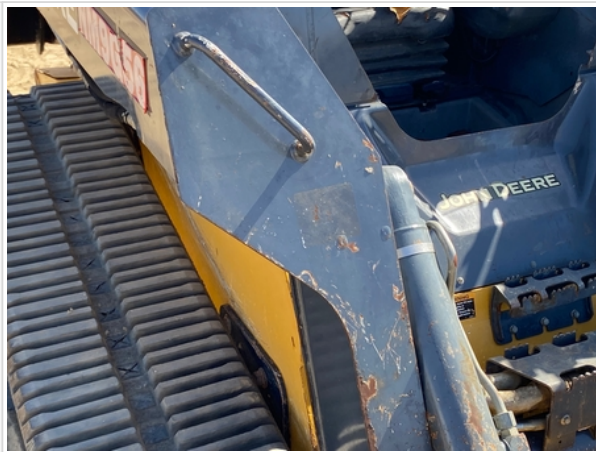
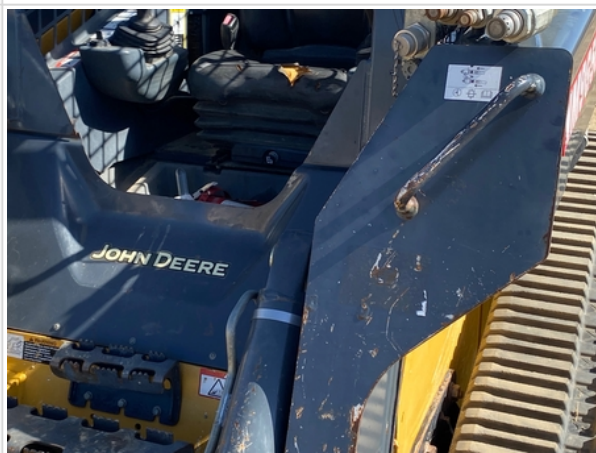
Handrail Photos

<b>Handrails</b>	3 - Normal Wear & Tear
<b>Handrails Condition</b>	Handrails are fully intact and appear structurally sound

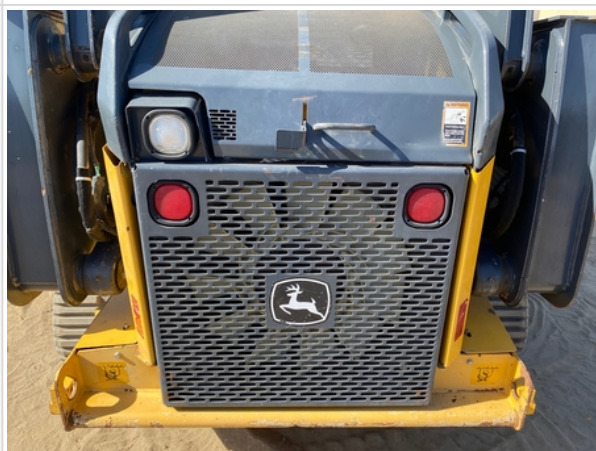
Glass Condition	0
Mirrors	0
Lighting System	3 - Normal Wear & Tear
Lighting System Condition	No visible damage, lighting system is operational
Lighting System Photos

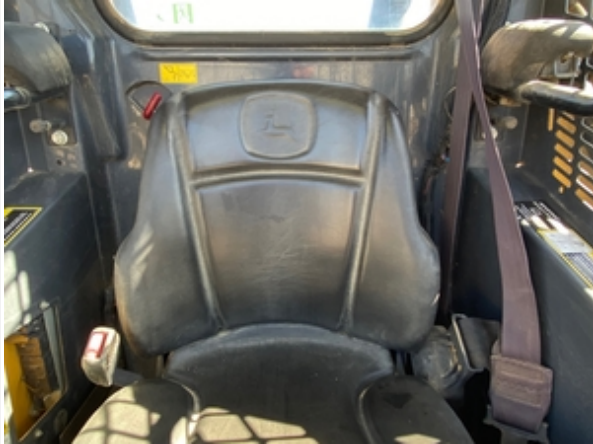
Operator's Seat & Arm Rests	3 - Normal Wear & Tear
Operator's Seat & Arm Rests Condition	Seat(s) have minor surface staining or small tears
Operator's Seat & Arm Rests Photos

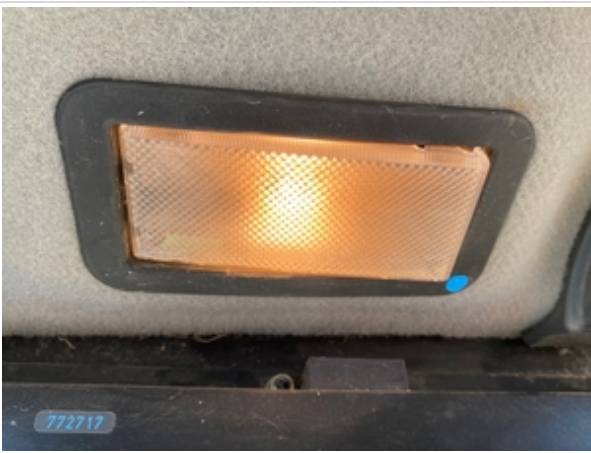
<b>Cabin Lights</b>	3 - Normal Wear & Tear
<b>Cabin Lights Condition</b>	Cabin lights are installed with all light covers in place, bulbs are installed and working properly
<b>Cabin Lights Photos</b>

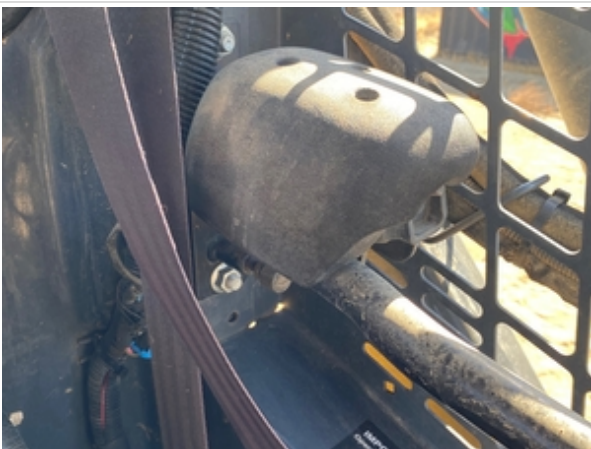
<b>Safety Lock Out / Stop</b>	3 - Normal Wear & Tear
<b>Safety Lock Out / Stop Condition</b>	Safety lock out device is present, in good condition, and functional
<b>Safety Lock Out / Stop Photos</b>

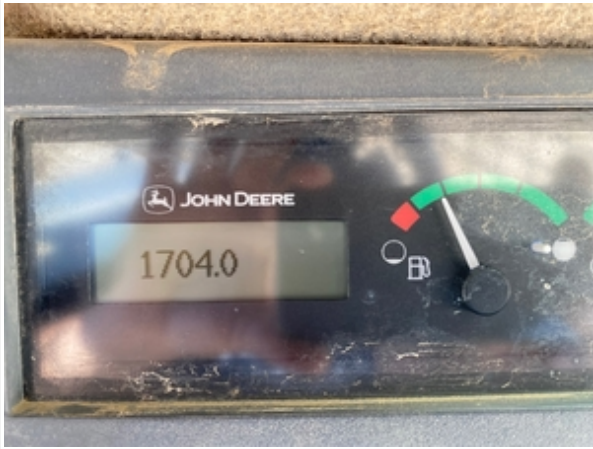
Hour Meter Activity Photos

<b>Hour Meter Activity</b>	3 - Normal Wear & Tear
<b>Hour Meter Condition</b>	Hour meter is functional and in good condition

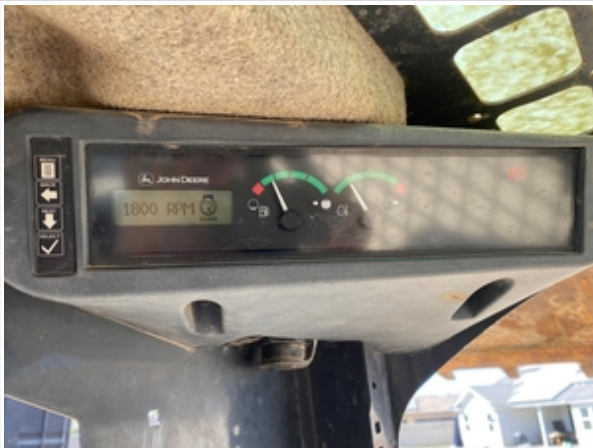
Other Gauge Activity	3 - Normal Wear & Tear
Other Gauge Condition	All cockpit gauges are functional and in good condition
Other Gauge Activity Photos

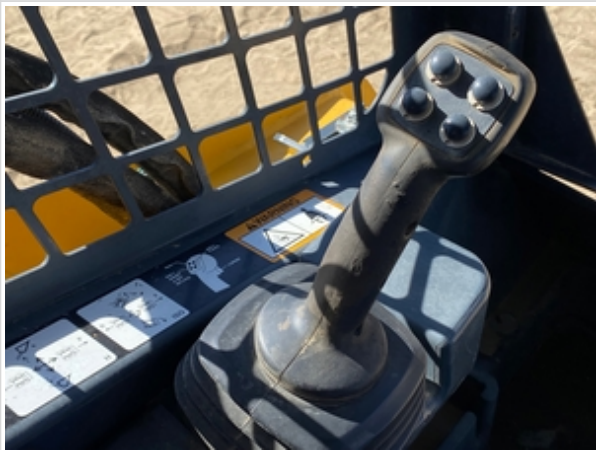
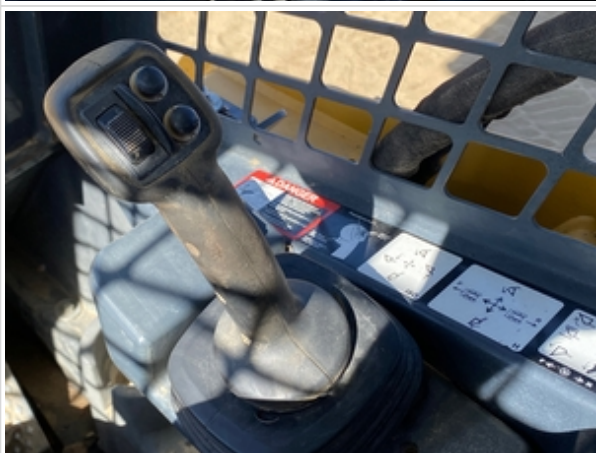
<b>Unusual Noises (Hydraulic Pump)</b>	No	
<b>Hydraulic Pump Notes</b>	No unusual noises heard during operation	
<b>External Controls / Levers</b>	3	
<b>External Controls / Levers Condition</b>	Good function & condition of hydraulic controls	
<b>External Controls / Levers Photos</b>
