Inspection Report (Excavator)

| Make | Komatsu |
| Model | PC128 UU |

| Date/Time | 11-01-2022 |

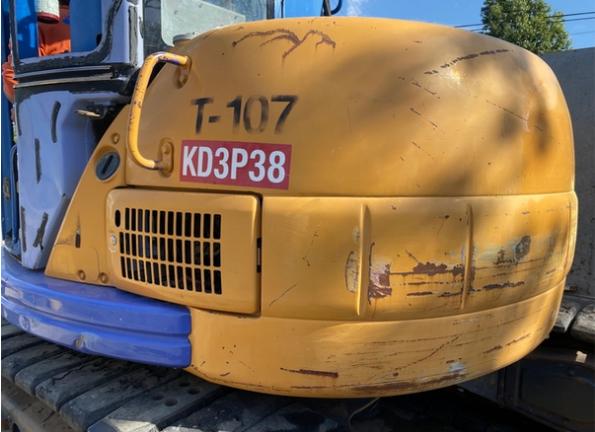
| Rear Photos | | |

| Rear | 3 - Normal Wear & Tear | |
| Rear Condition | Other (see comments), No visible damage | |
| Comments | Normal wear and tear scuff marks | |

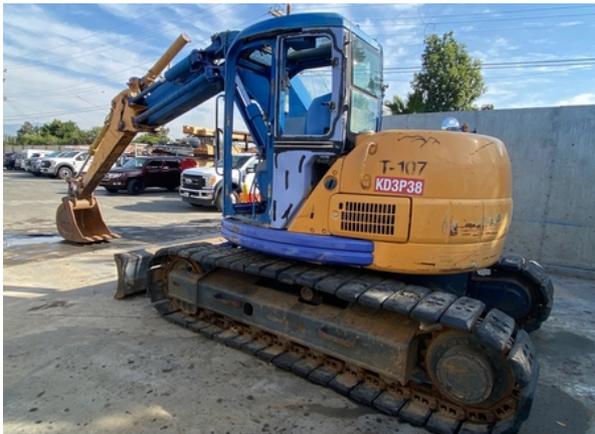
| Left Photos | |

| Left | 3 - Normal Wear & Tear |
| Left Condition | No visible damage |

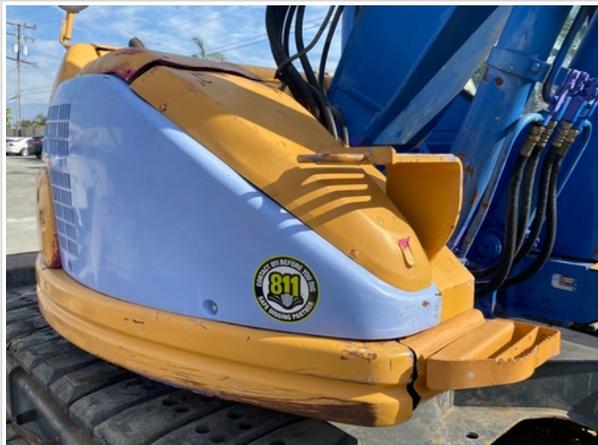
| <p>Right Photos</p> | | |

| <p>Right</p> | <p>3 - Normal Wear & Tear</p> | |
| <p>Right Condition</p> | <p>No visible damage</p> | |

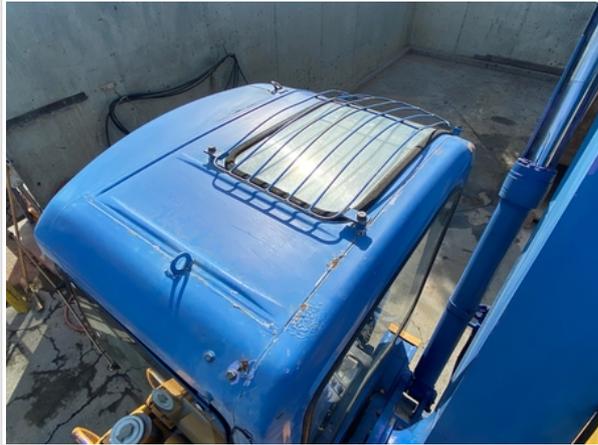
| Upper Photos | | |

| Upper | 3 - Normal Wear & Tear | |
| Upper Condition | No visible damage | |

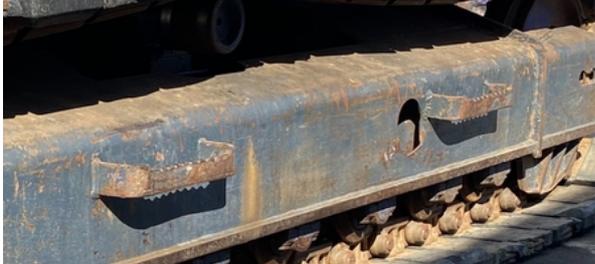
| Steps / Ladders Photos | | |

| Steps / Ladders | 3 - Normal Wear & Tear | |
| Steps / Ladders Condition | Bent or broken steps or rungs, Other (see comments) | |
| Comments | Left side track frame step bent | |

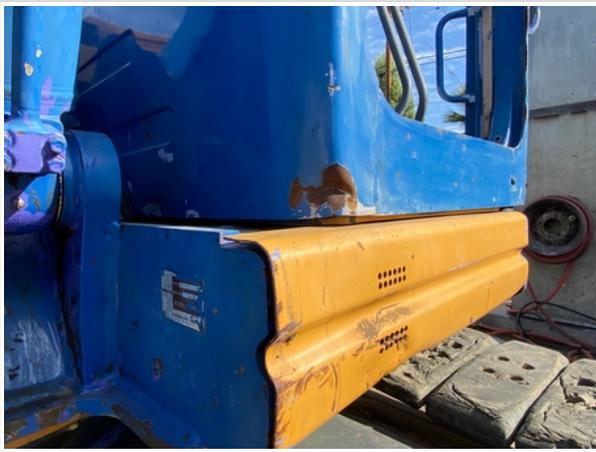
| Handrail Photos | | |

| Handrails | 3 - Normal Wear & Tear | |
| Handrails Condition | Handrails are fully intact and appear structurally sound | |

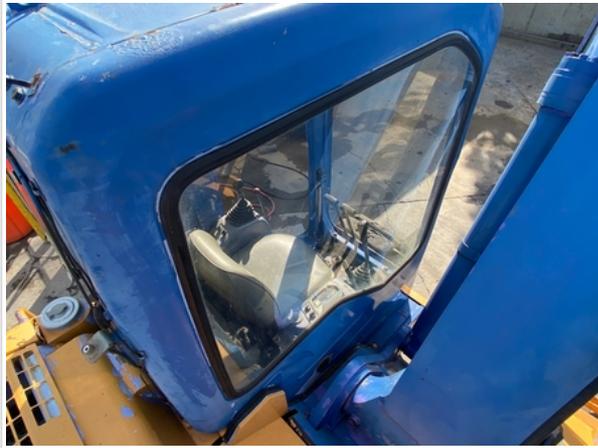
| Glass Condition Photos | |

| Glass Condition | 2 - Above Average Wear |
| Glass Condition Notes | Other (see comments) |
| Comments | Front glass missing, door also removed |

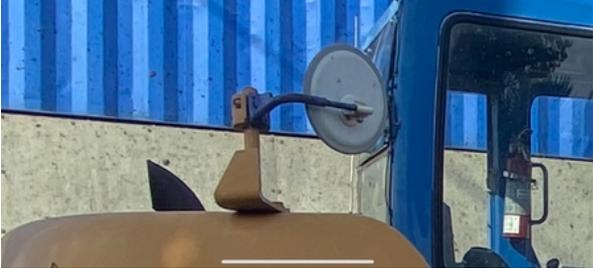
| Mirrors Photos | | |

| Mirrors | 3 - Normal Wear & Tear | |
| Mirror Condition Notes | Mirrors present and intact, no visible damage | |

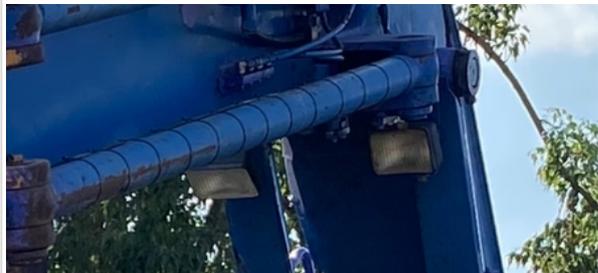
| Lighting System Photos | |

| Lighting System | 3 - Normal Wear & Tear | |
| Lighting System Condition | No visible damage, lighting system is operational | |

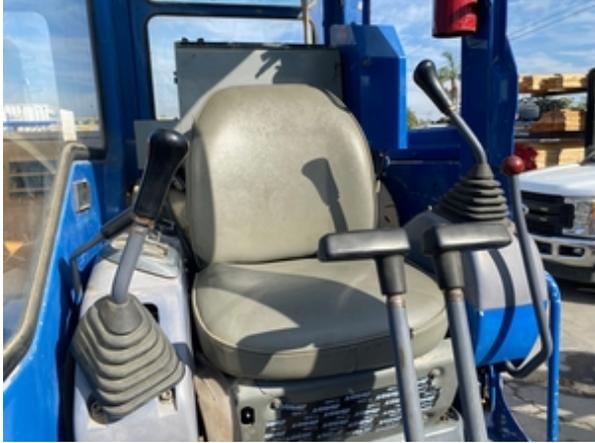
| Operator's Seat & Arm Rests Photos | |

| Operator's Seat & Arm Rests | 3 - Normal Wear & Tear |
| Operator's Seat & Arm Rests Condition | Seat(s) have minor surface staining or small tears |

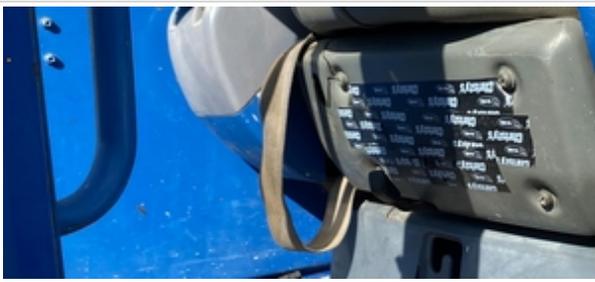
| Seat Belt Photos | |

| Seat Belt | 2 - Above Average Wear |
| Seat Belt Condition | Seat belt shows limited functionality or does not secure properly |

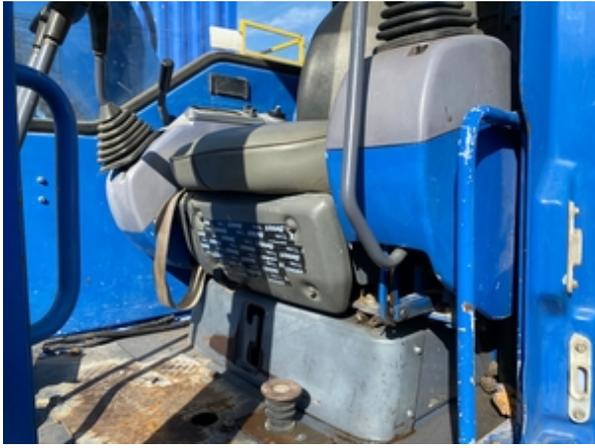
| Safety Lock Out / Stop Photos | |

| Safety Lock Out / Stop | 3 - Normal Wear & Tear |
| Safety Lock Out / Stop Condition | Safety lock out device is present, in good condition, and functional |

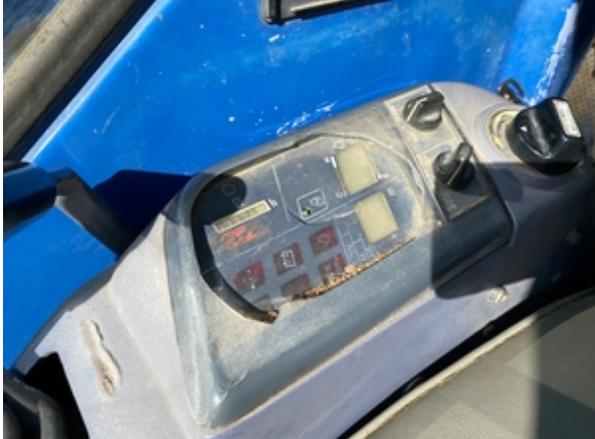
| Controls & Switches Photos | |

| Controls & Switches | 3 - Normal Wear & Tear |
| Controls & Switches Condition | All switches are installed and functional |

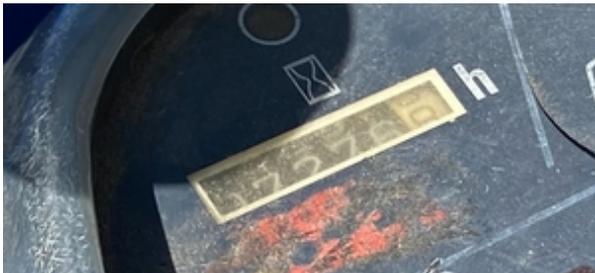
| Hour Meter Activity Photos | |

| Hour Meter Activity | 3 - Normal Wear & Tear |
| Hour Meter Condition | Hour meter is functional, with some minor wear and/or cosmetic damage |

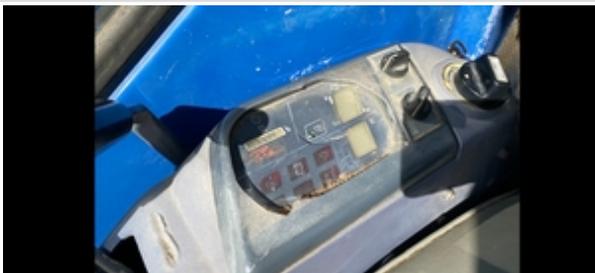
| Other Gauge Activity Photos | |

| Other Gauge Activity | 3 - Normal Wear & Tear |
| Other Gauge Condition | All cockpit gauges are functional and in good condition |

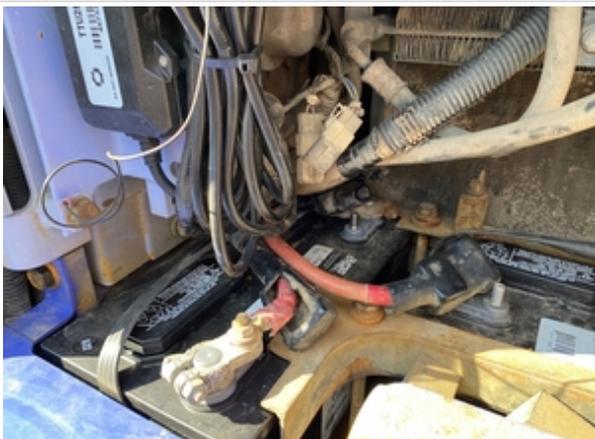
| Battery Condition Photos | |

| Battery | 3 - Normal Wear & Tear |
| Battery Condition | Other (see comments) |
| Comments | Customer installed new starter |

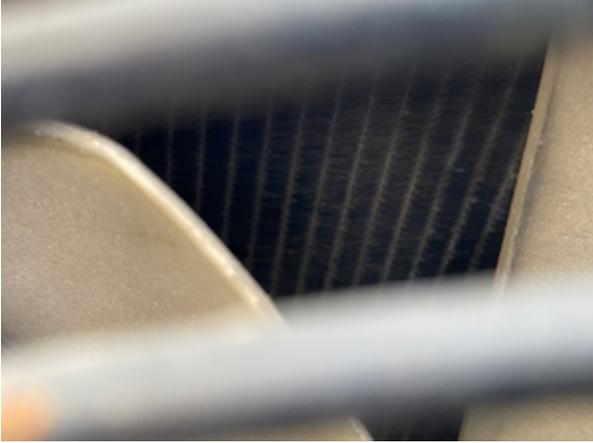
| Radiator Photos | |

| Radiator | 3 - Normal Wear & Tear |
| Radiator Condition | Radiator fins & components appear to be in good working order, no signs of damage or leaks |

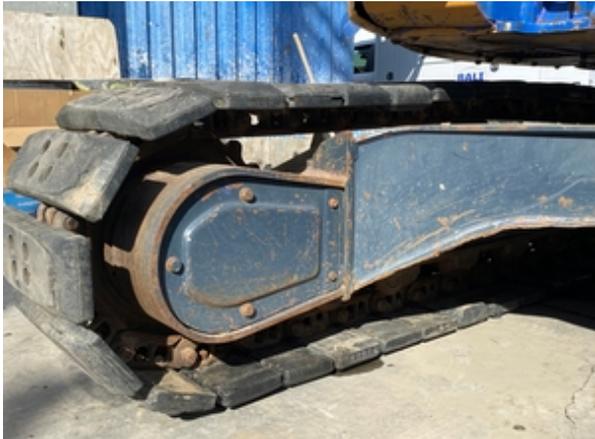
| Drive Motor Photos | |

| Drive Motors | 2 - Above Average Wear |
| Comments | Drive motors sound and work well (behind covers) |

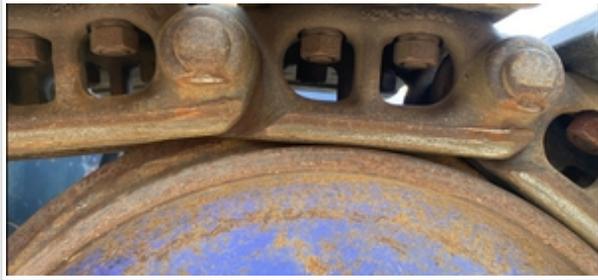
| Pin & Bushings Photos | | |

| Pin & Bushings | 3 - Normal Wear & Tear | |

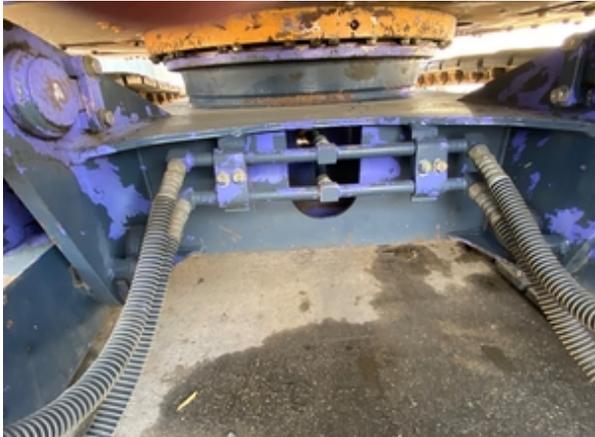
| Appearance of Hydraulic Lines / Fittings Photos | |

| Wet or Damp Hydraulic Lines / Fittings | No |
| Appearance of Hydraulic Lines / Fittings | 3 |
| Hydraulic Lines / Fittings Condition | Hydraulic lines & fittings are clean and in good condition |

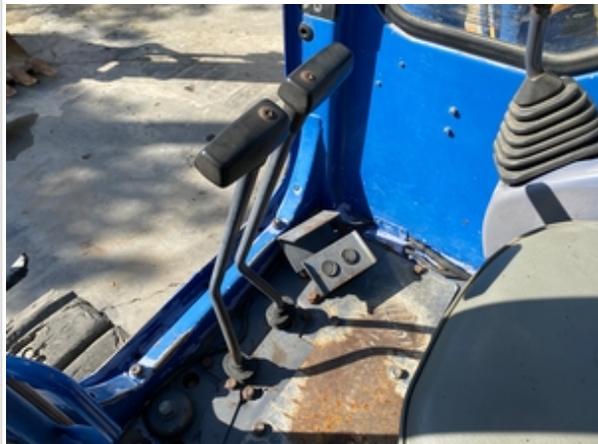
| External Controls / Levers Photos | |

| External Controls / Levers | 3 |
| External Controls / Levers Condition | Good function & condition of hydraulic controls |

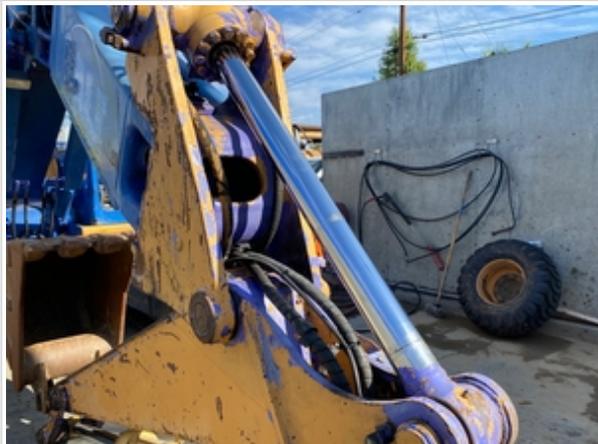
| Stick Cylinder Photos | | |

| Stick Cylinder | Check the stick cylinder. Note any wear, pitting, discoloration, etc. Take photos. | |
| Stick Cylinder: Mounting Pin | 3 | |
| Stick Cylinder: Oil Leaks | No | |

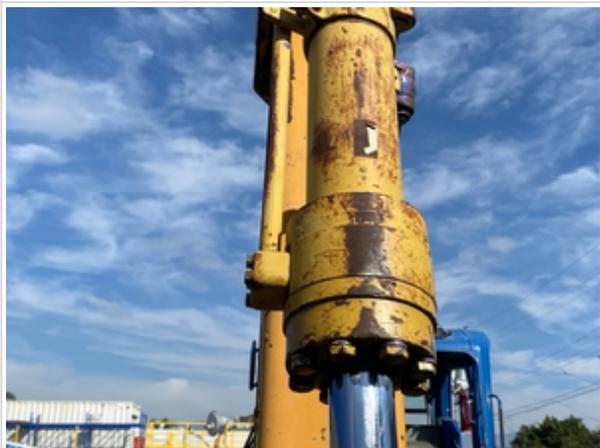
| Bucket Cylinder Photos | | |

| Bucket Cylinder | Check the bucket cylinder. Note any wear, pitting, discoloration, etc. Take photos. | |
| Bucket Cylinder: Mounting Pin | 3 | |
| Bucket Cylinder: Oil Leaks | No | |

| Comments | Bucket curl out drifting when operating temperature reached |

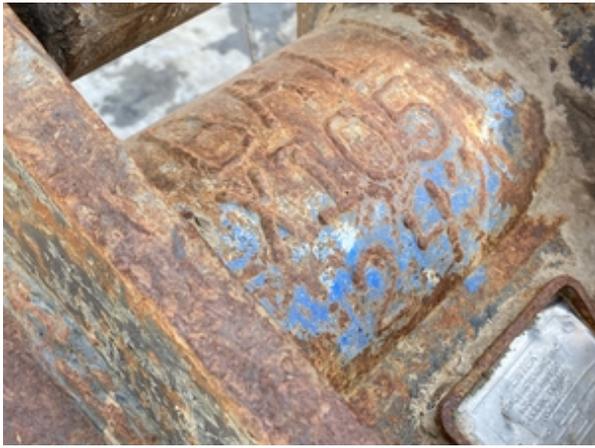
| Bucket Photos | |

| Bucket Condition | 3 - Normal Wear & Tear |

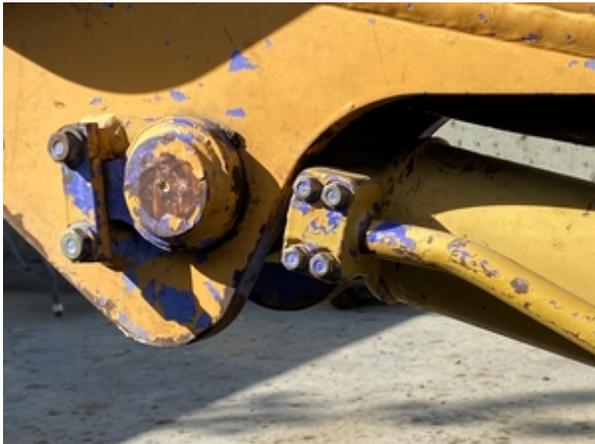
| Bucket Hose & Fittings Photos | | |

| Bucket Hose & Fittings | 3 - Normal Wear & Tear | |

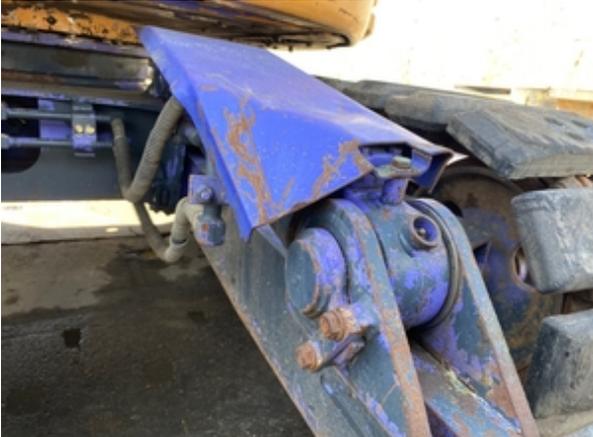
| Blade Hose & Fittings Photos | |

| Blade Hose & Fittings | 3 - Normal Wear & Tear |
| Comments | Hoses in good condition |

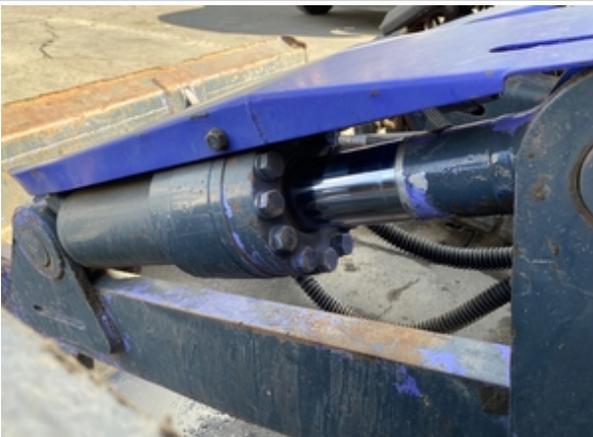
| Blade Cylinder Photos | |

| Blade Cylinder | 3 - Normal Wear & Tear |

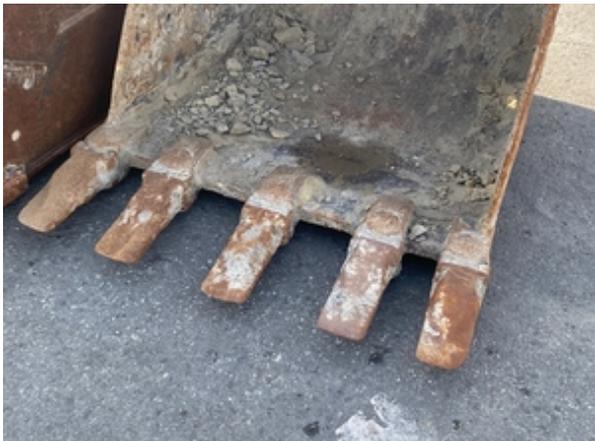
| Attachment Photos | |

| Attachment Type | Bucket and compaction wheel |
| Attachment Size / Specs | Bucket 36" - American Compaction Wheel |
| Attachment Condition | 3 - Normal Wear & Tear |
| Comments | Machine will come with 1 extra bucket and 1 compaction wheel |
