## Inspection Report (Generator)

Year	2001
Make	Weber
Model	177KW Studio Generator
Serial Number	101113177A39824
Hour Meter Reading	8,976
Previous Application (e.g., earth moving, mining, demolition, etc)	Generator Rentals

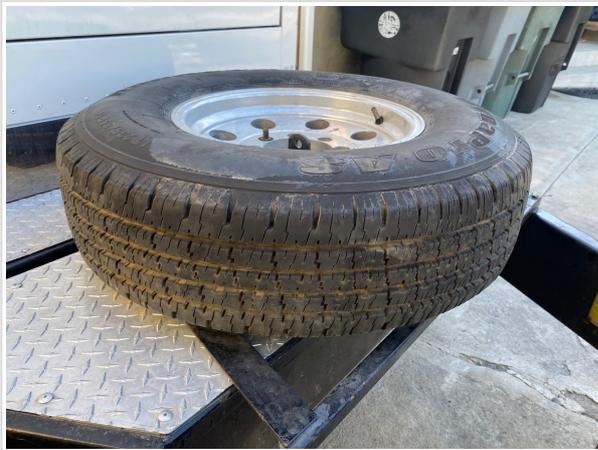
Front	3 - Normal Wear & Tear
Front Condition	No visible damage, Other (see comments)

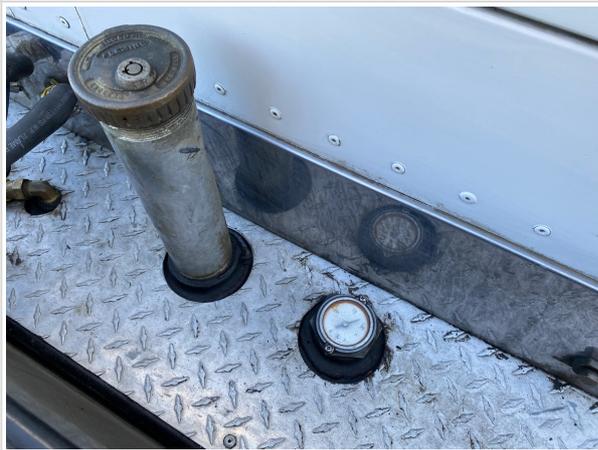
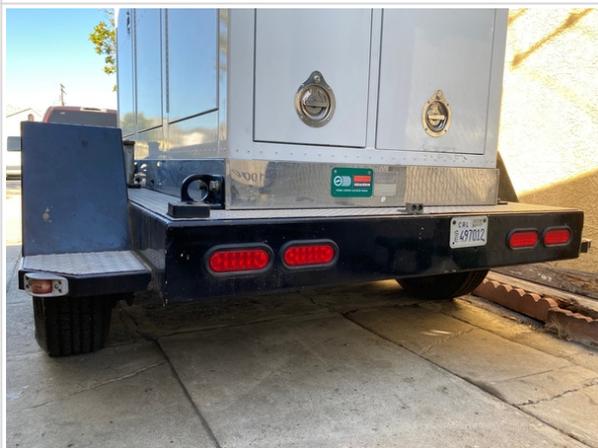
<p>Rear</p>	<p>3 - Normal Wear &amp; Tear</p>
<p>Rear Condition</p>	<p>No visible damage</p>
<p>Rear Photos</p>

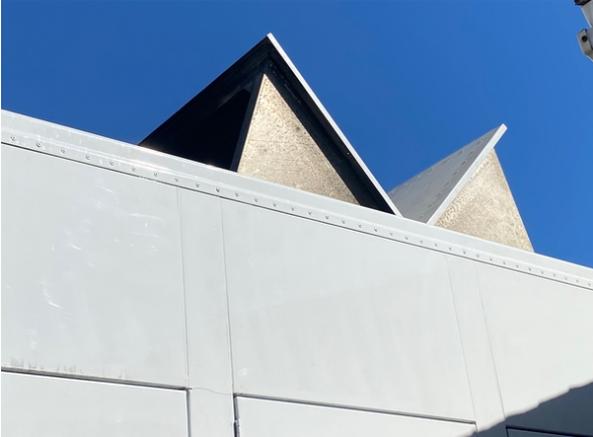
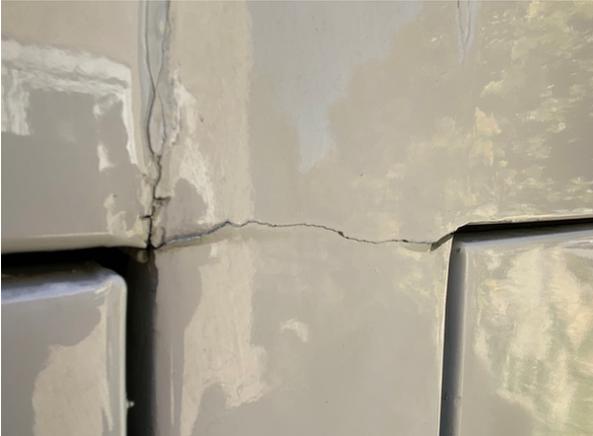
<b>Left</b>	3 - Normal Wear & Tear
<b>Left Condition</b>	No visible damage, Other (see comments)
<b>Comments</b>	Small crack between doors
<b>Left Photos</b>

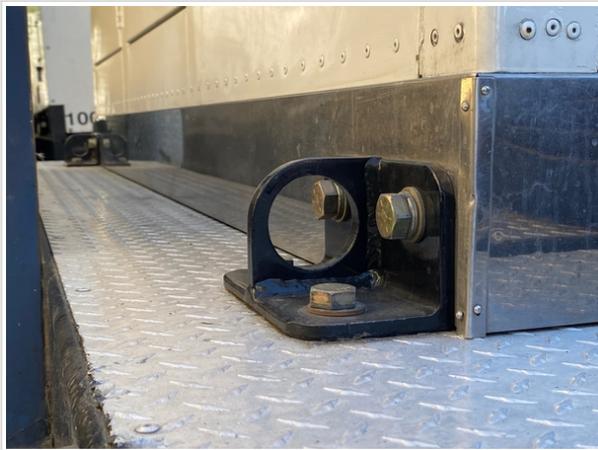
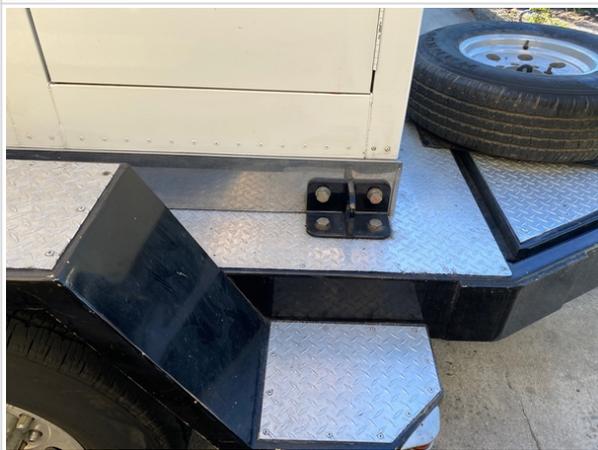
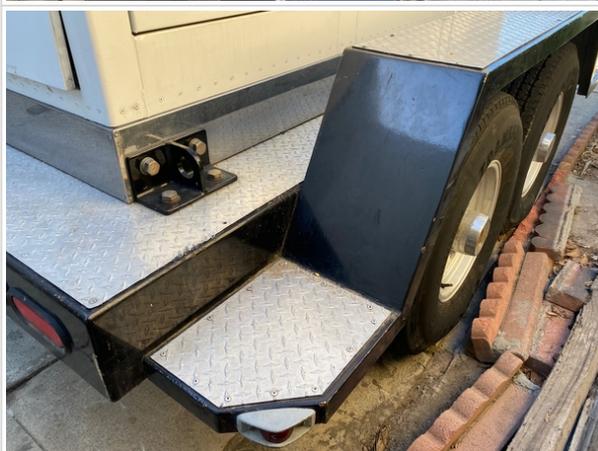
<b>Right</b>	3 - Normal Wear & Tear
<b>Right Condition</b>	No visible damage

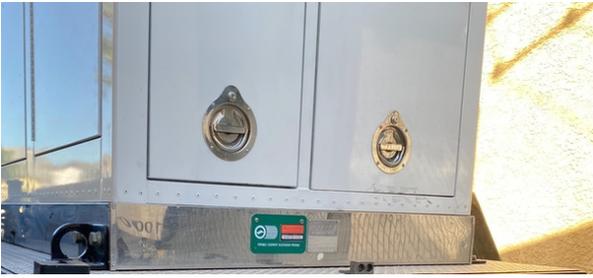
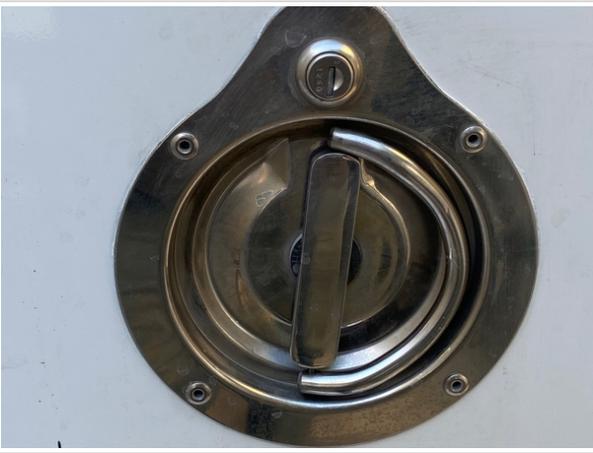
Doors / Canopy Latches Photos

<b>Upper</b>	3 - Normal Wear & Tear
<b>Upper Condition</b>	No visible damage
<b>Body Panels (Any Rust Damage?)</b>	3 - Normal Wear & Tear
<b>Body Panel Condition</b>	No visible damage, good paint condition and panel fitment, Other (see comments)
<b>Comments</b>	Minor surface cracks
<b>Doors / Canopy Latches</b>	3 - Normal Wear & Tear
<b>Doors / Canopy Latches Condition</b>	No visible damage

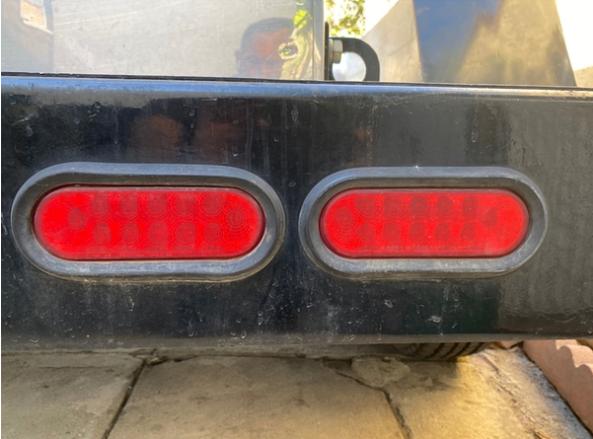
Steps / Ladders	0	
Handrails	0	
Glass Condition	0	
Mirrors	0	
Lighting System	3 - Normal Wear & Tear	
Lighting System Condition	No visible damage, lighting system is operational, Other (see comments)	
Comments	Unable to test but light fixtures in good looking condition	
Lighting System Photos

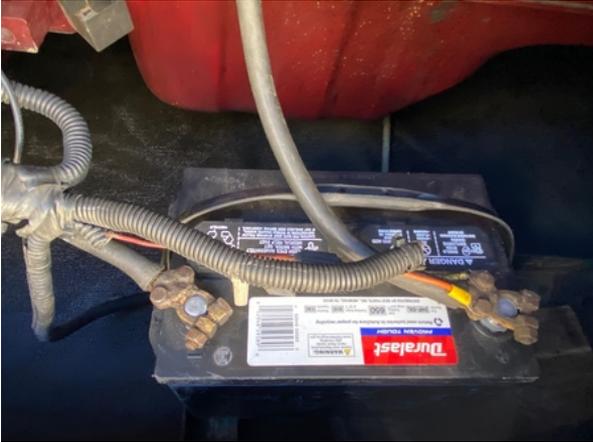
Battery	3 - Normal Wear & Tear
Battery Condition	Like new, recently replaced
Battery Condition Photos

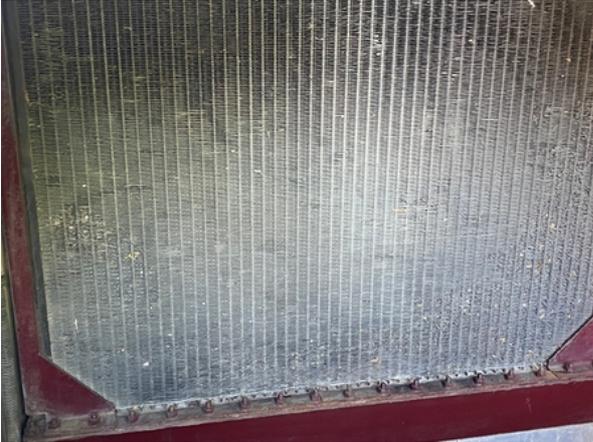
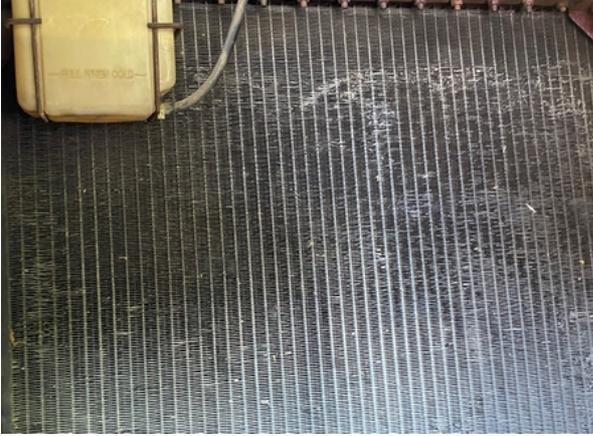
Radiator	3 - Normal Wear & Tear
Radiator Condition	Radiator fins & components appear to be in good working order, no signs of damage or leaks
Radiator Photos

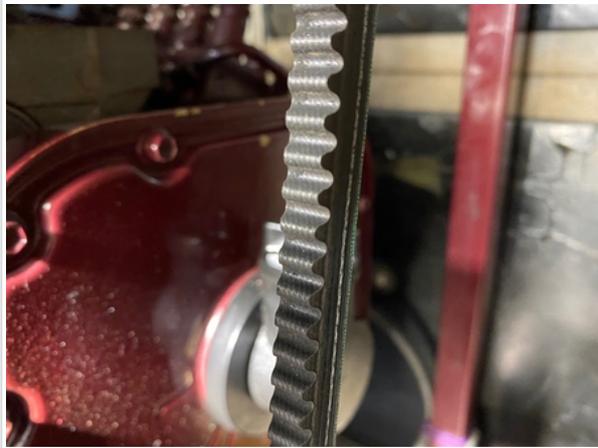
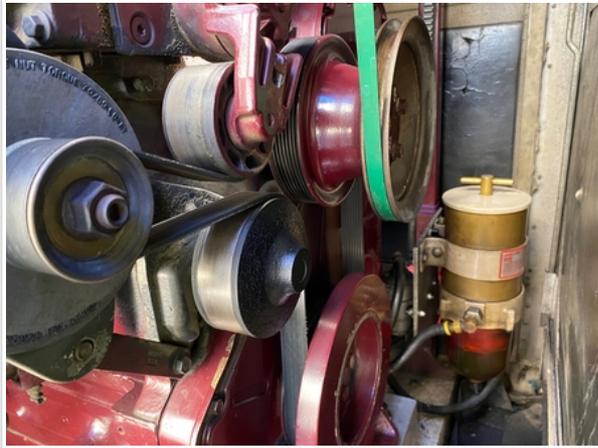
<b>Belt Photos</b>

Belts	3 - Normal Wear & Tear
Belt Condition	Belts appear in good condition & alignment with proper tension

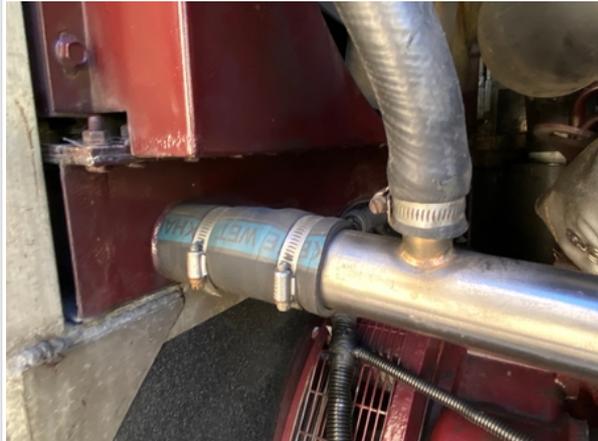
<b>Hoses</b>	3 - Normal Wear & Tear
<b>Hose Condition</b>	Firm, pliant hoses with no signs of wear or leaks
<b>Hose Photos</b>

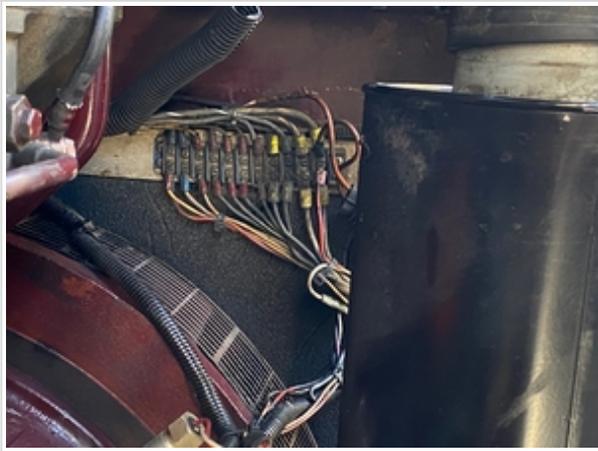
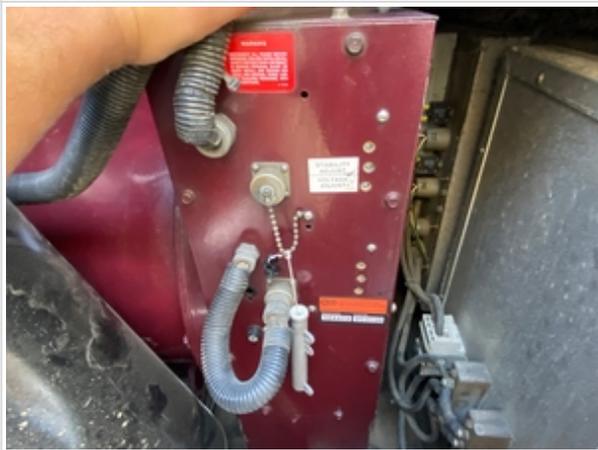
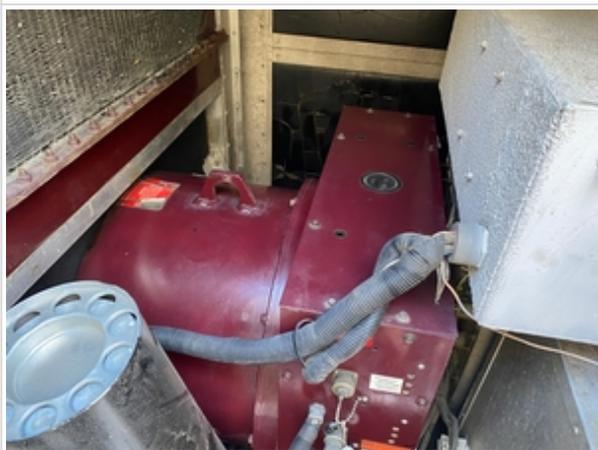
<p>Comments</p>	<p>Wire harness has been repaired in some areas</p>
<p>Wire Harness Photos</p>

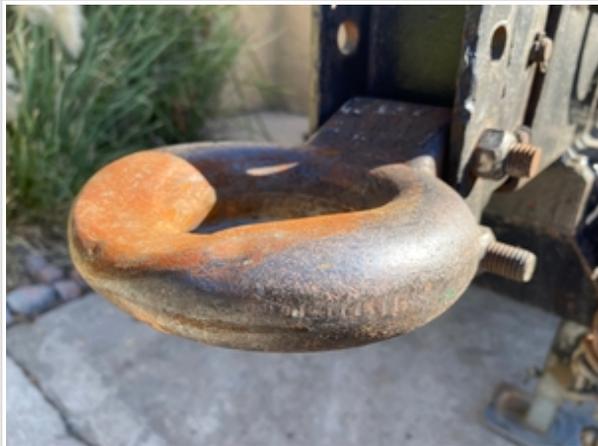
Hitch Type	Pintle
Hitch Condition	2 - Above Average Wear
Comments	Pintle hitch needs to be replaced (worn)
Hitch Photos

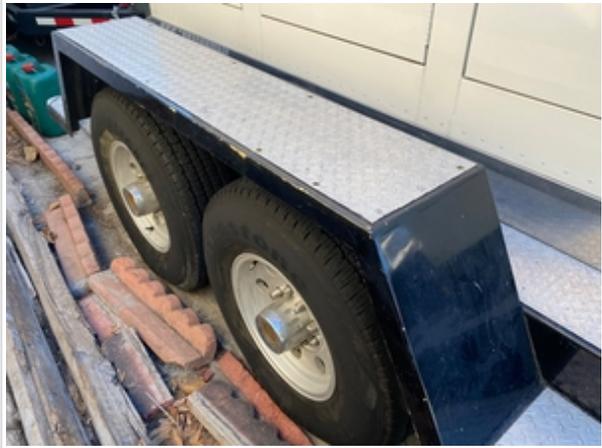
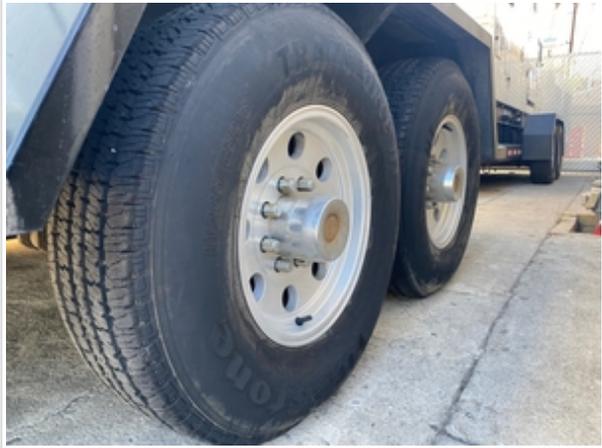
Wheels & Hub Condition	3 - Normal Wear & Tear	
Comments	Wheels in nice shape	
Wheels & Hub Photos

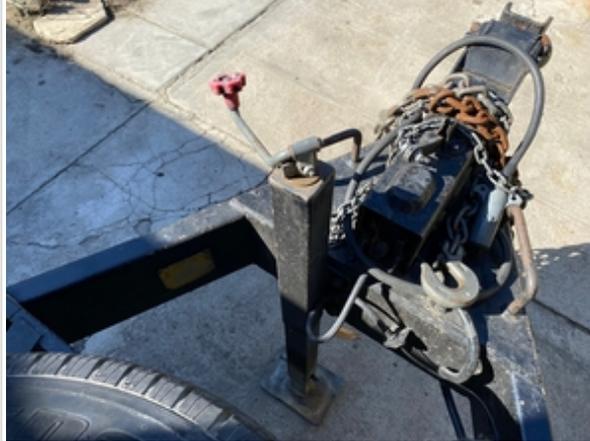
Emergency Brake/Break-Away  
Photos

Brake Type	Surge Brakes
Brake Controller	No
Emergency Brake/Break-Away	3 - Normal Wear & Tear
Comments	Emergency Breakaway system inoperable (missing cable)

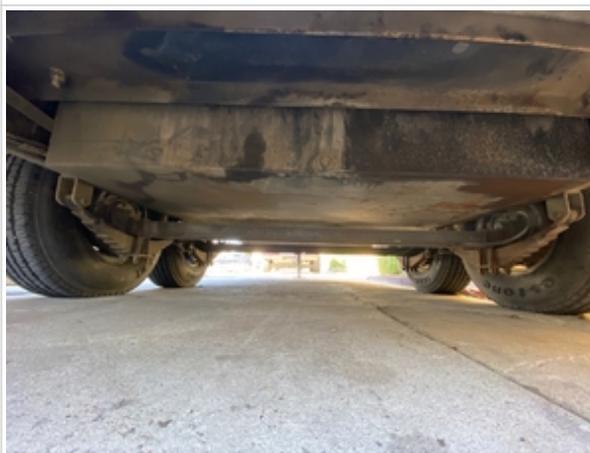
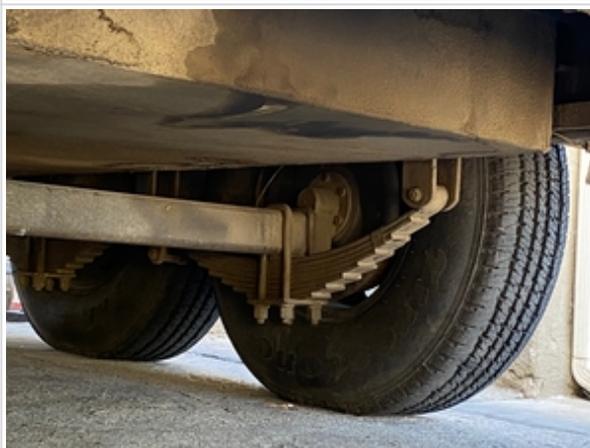
Overall Trailer	3 - Normal Wear & Tear
Overall Trailer Comments	Overall, visually, the trailer in good condition. Brakes need to be tested for proper operation. Covers on and unable to see brake shoes.
Overall Trailer & Undercarriage Photos
