Inspection Report (Telehandler)

Year	2014
Make	Genie
Model	GTH-5519
Serial Number	2237
Hour Meter Reading	1,416
Previous Application (e.g., earth moving, mining, demolition, etc)	Equipment Rentals

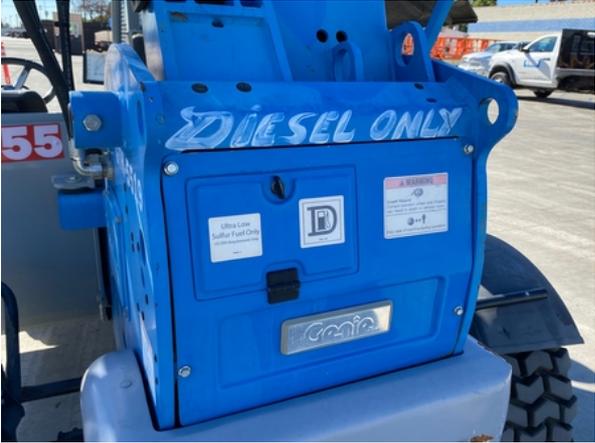
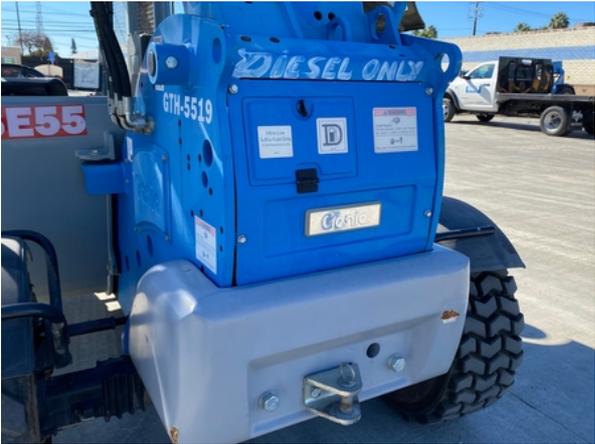
Rear	3 - Normal Wear & Tear	
Rear Condition	No visible damage	
Rear Photos

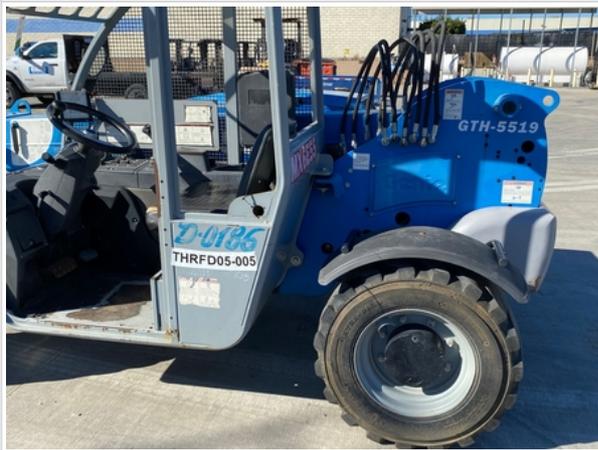
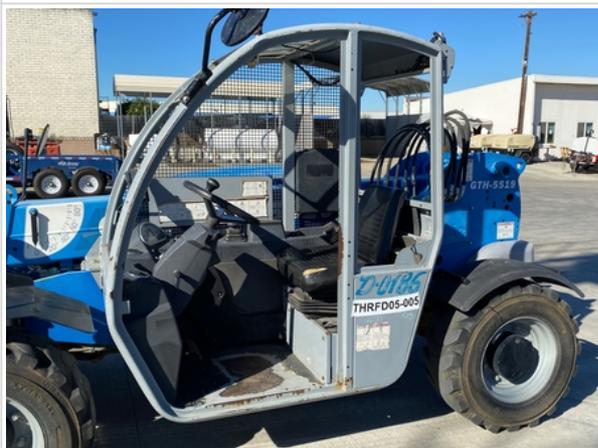
Left	3 - Normal Wear & Tear
Left Condition	No visible damage
Left Photos

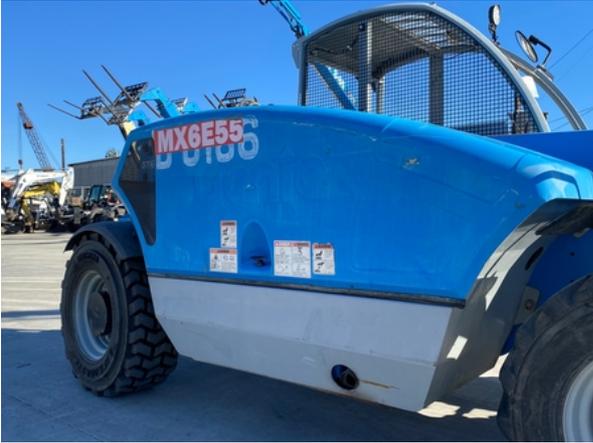
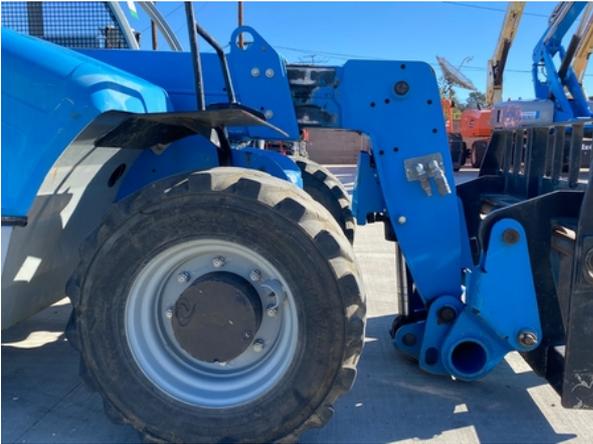
Right	3 - Normal Wear & Tear	
Right Condition	No visible damage	
Right Photos

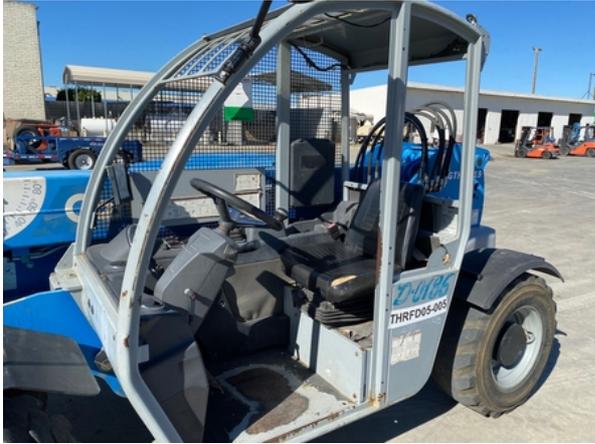
Steps / Ladders Condition	Steps/ladders are fully intact and appear structurally sound
Handrails	3 - Normal Wear & Tear
Handrails Condition	Handrails are fully intact and appear structurally sound
Glass Condition	0
Mirrors	3 - Normal Wear & Tear
Mirror Condition Notes	Mirrors present and intact, no visible damage
Mirrors Photos

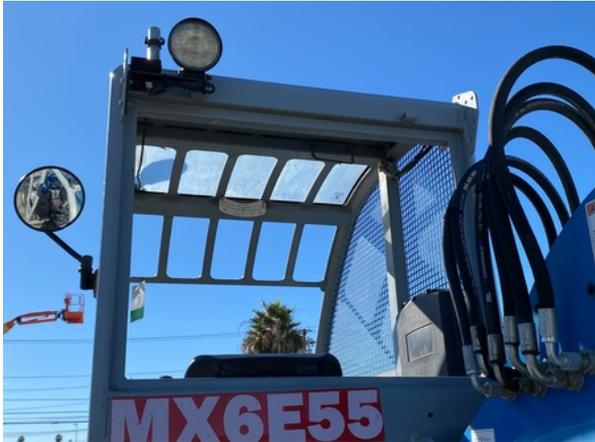
Lighting System	3 - Normal Wear & Tear
Lighting System Condition	No visible damage, lighting system is operational
Lighting System Photos

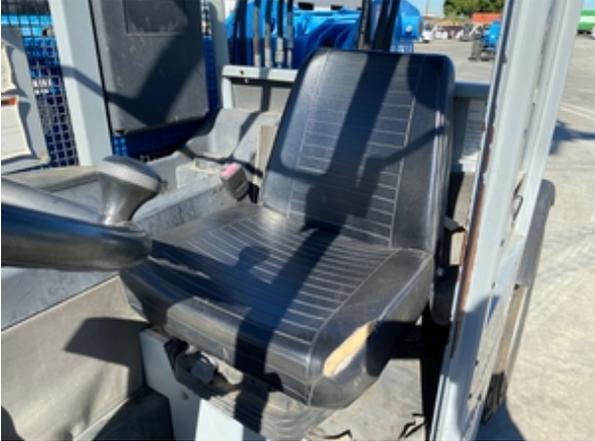
Operator's Seat & Arm Rests	3 - Normal Wear & Tear
Operator's Seat & Arm Rests Condition	Seat(s) have minor surface staining or small tears
Operator's Seat & Arm Rests Photos

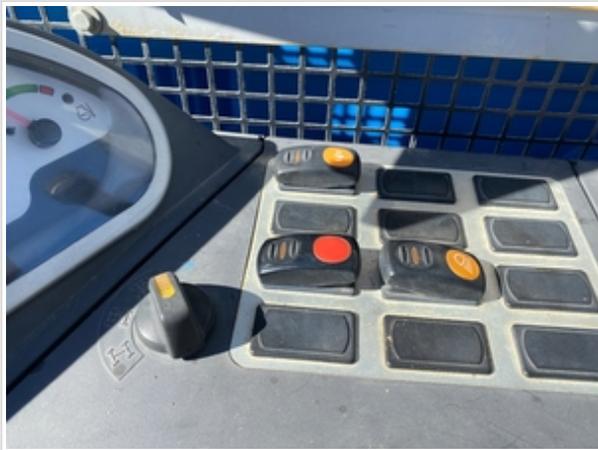
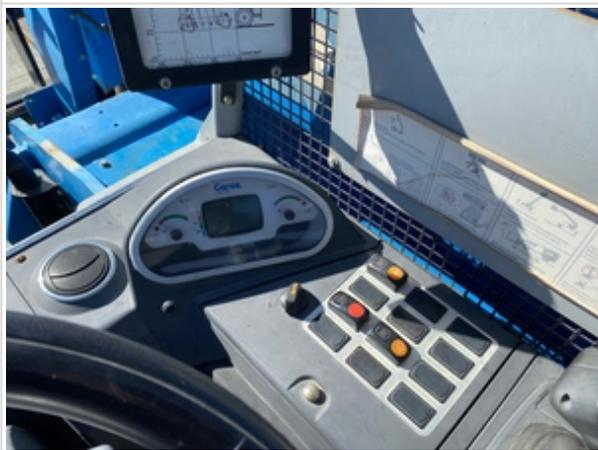
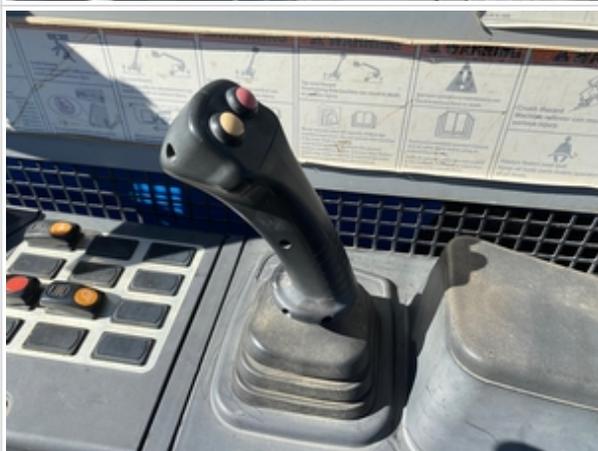
Seat Belt	3 - Normal Wear & Tear
Seat Belt Condition	Seat belt secures properly. Belt is intact and in good condition
Cabin Lights	0
Safety Lock Out / Stop	0
Controls & Switches	3 - Normal Wear & Tear
Controls & Switches Condition	All switches are installed and functional, Other (see comments)
Comments	Some decals on switches worn and unable to distinguish

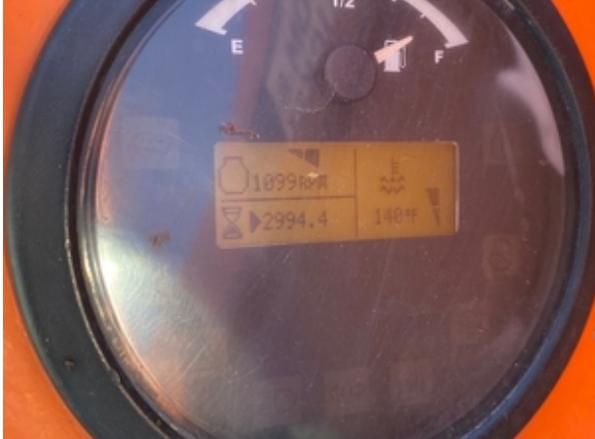
Hour Meter Activity	3 - Normal Wear & Tear
Hour Meter Condition	Hour meter is functional and in good condition

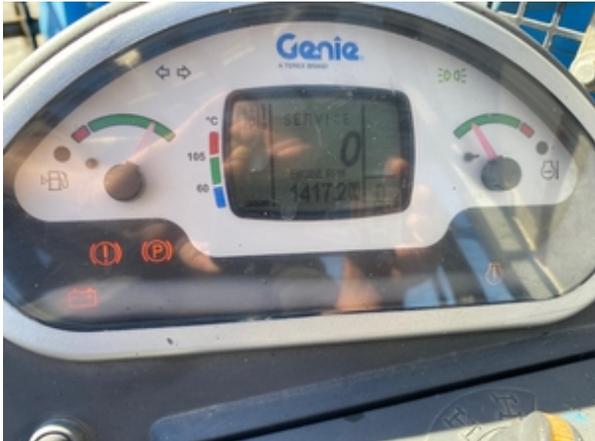
Other Gauge Activity	3 - Normal Wear & Tear
Other Gauge Condition	All cockpit gauges are functional and in good condition
Other Gauge Activity Photos

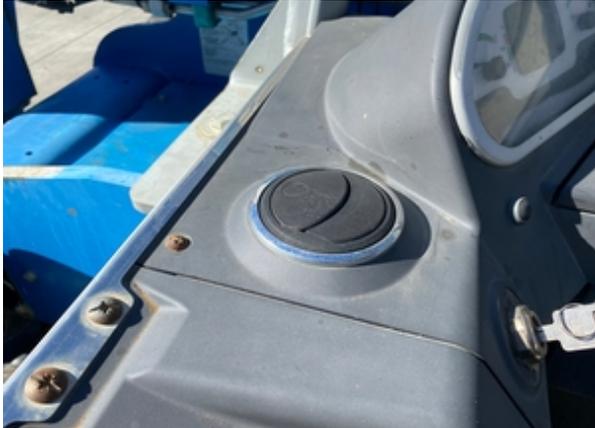
Heater & A/C	0
Fans / Vents	2 - Above Average Wear
Fans / Vents Condition	Fan vents are installed but one or more is restricted in movement or functionality
Comments	Fan inoperable
Fans / Vents Photos

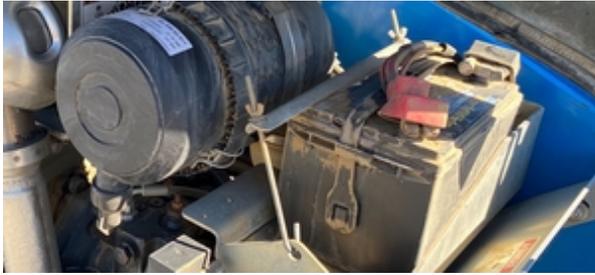
Battery	2 - Above Average Wear
Battery Condition	Other (see comments)
Comments	Battery may need to be replaced (hard start)
Battery Condition Photos

Overall Assessment	
Exterior Rating	3
Interior Rating	3
Safety Rating	3
Quality Rating	3
Functionality Rating	3
Overall Rating	3
What's Great About the Machine	Machine has been well maintained and no obvious major defects found. All main implement functions operate well.
What Needs Work	3 of the 4 tires will need to be replaced soon. Operator decals in cab worn and should be replaced. Battery should be tested or replaced (hard start).
Date/Time	11-10-2022

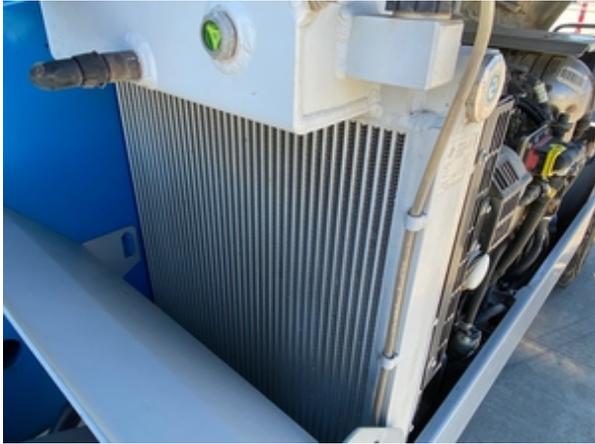
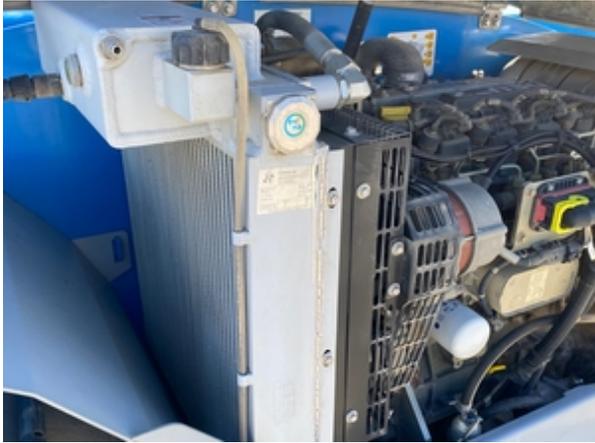
Radiator	3 - Normal Wear & Tear
Radiator Condition	Radiator fins & components appear to be in good working order, no signs of damage or leaks
Radiator Photos

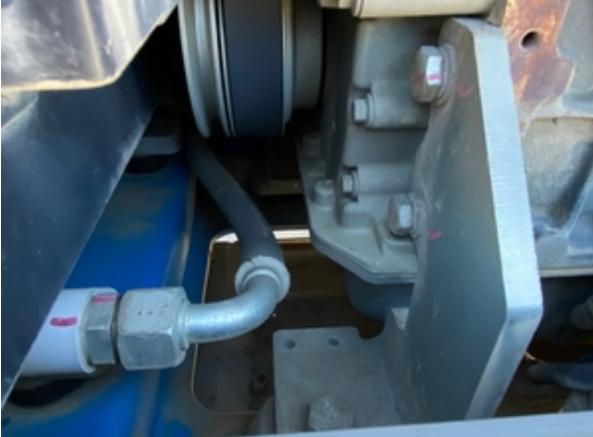
Belts	3 - Normal Wear & Tear
Belt Condition	Belts appear in good condition & alignment with proper tension

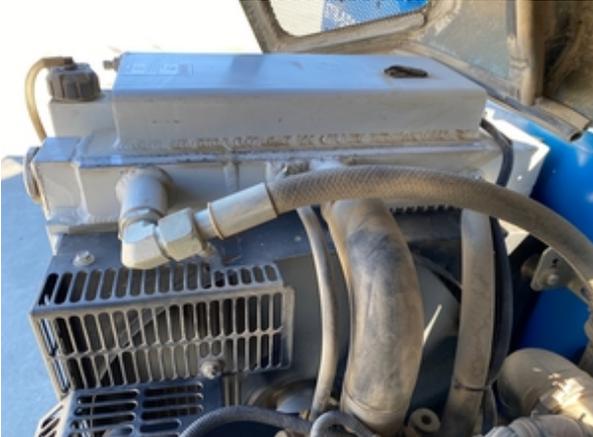
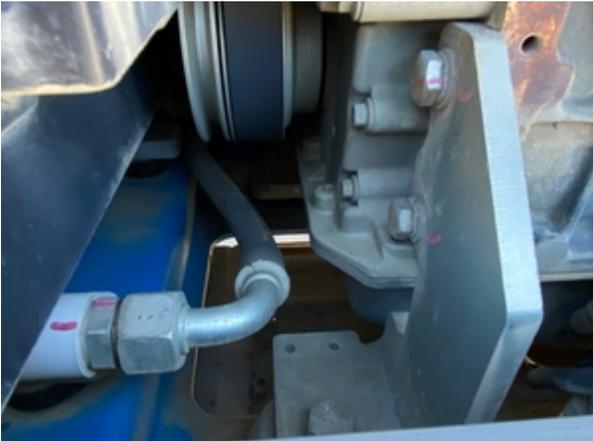
Hoses	3 - Normal Wear & Tear
Hose Condition	Firm, pliant hoses with no signs of wear or leaks
Hose Photos

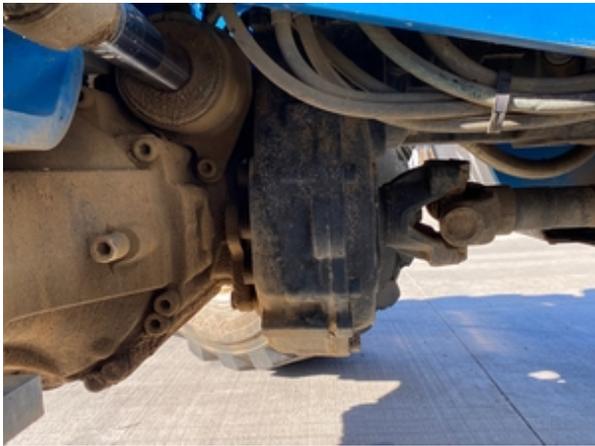
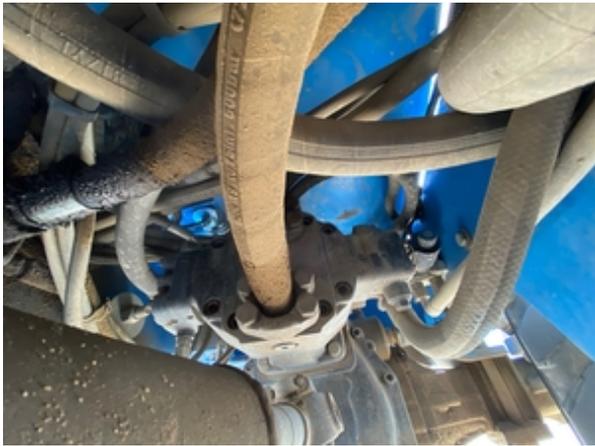
Hydrostatic Transmission?	Yes
2 Speed?	No
Hydrostatic Drive Configuration	Other (see comments)
Comments	Hydraulic drive unit directly bolted to engine
Drive Motors	1 - Service Required
Drive Motor Photos

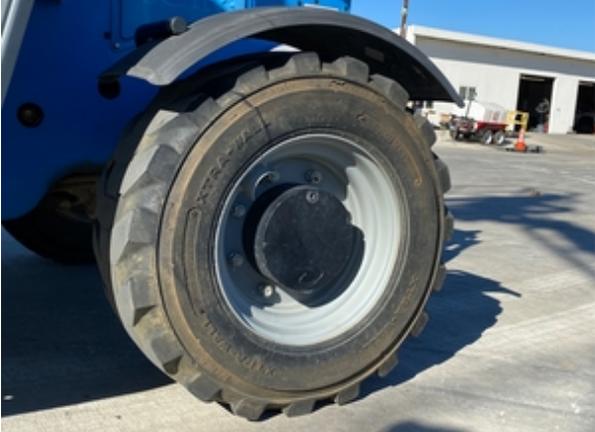
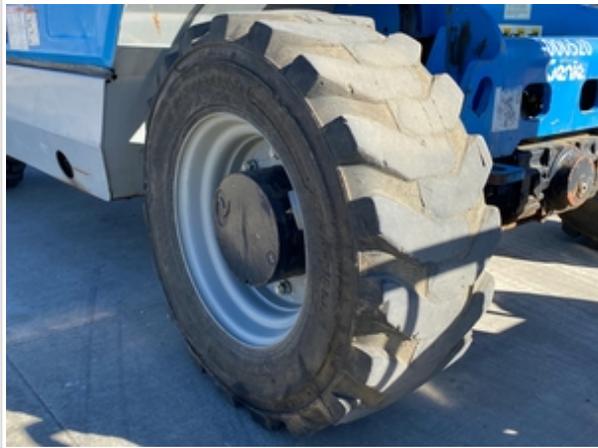
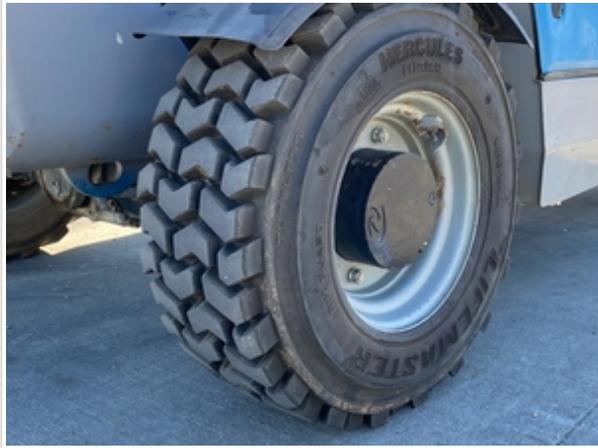
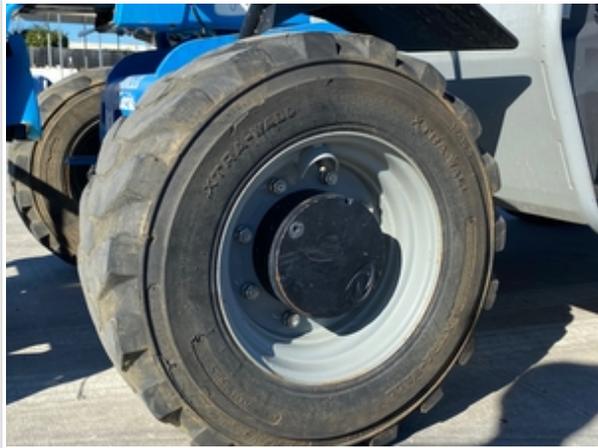
Tire Brand	Hercules life master
Tire Size	12 - 16.5
Front Left Tire - Ratio Remaining	30%
Rear Left Tire - Ratio Remaining	30%
Front Right Tire - Ratio Remaining	30%
Rear Right Tire - Ratio Remaining	90%
Boom Condition	3 - Normal Wear & Tear

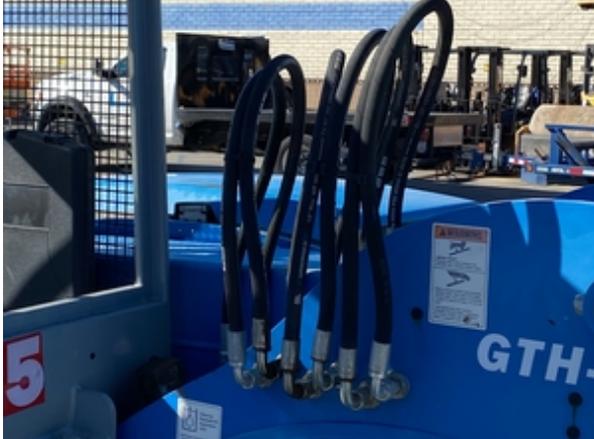
<h3>Hydraulics Overall</h3>	
Wet or Damp Hydraulic Lines / Fittings	Yes
Appearance of Hydraulic Lines / Fittings	3
Hydraulic Lines / Fittings Condition	Hydraulic lines & fittings are clean and in good condition, Active leaks in hoses or fittings observed, Other (see comments)
Comments	Some hydraulic hoses starting to leak. No active fluid drips seen only wet hoses

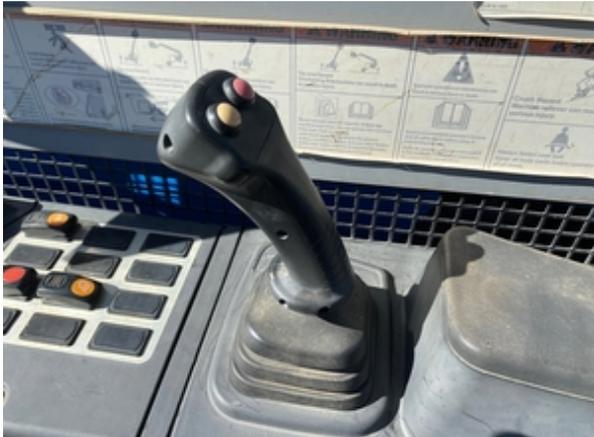
Unusual Noises (Hydraulic Pump)	No	
Hydraulic Pump Notes	No unusual noises heard during operation	
External Controls / Levers	3	
External Controls / Levers Condition	Good function & condition of hydraulic controls	
External Controls / Levers Photos
