Inspection Report (On-Highway Dump Truck)

Year	2011
Make	Peterbilt
Model	367
Serial Number	1NP - TLUOX - 6 - BD127980
Truck Odometer Reading	408,807
Previous Application (e.g., earth moving, mining, demolition, etc)	Asphalt Construction

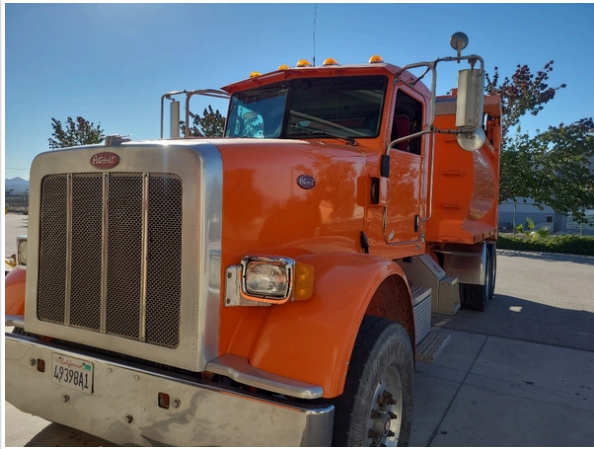
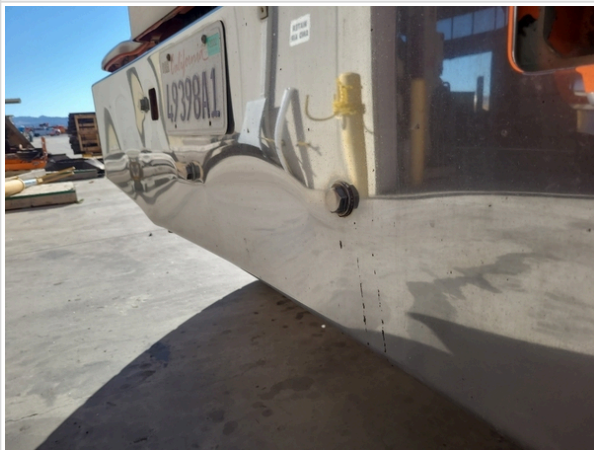
Front	3 - Normal Wear & Tear
Front Condition	No visible damage, Other (see comments)
Comments	Small front bumper dent at center

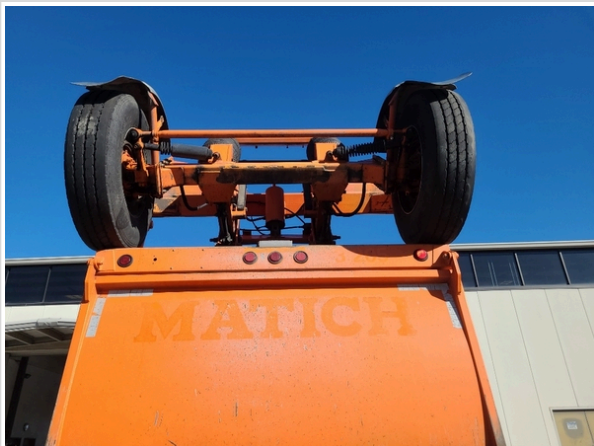
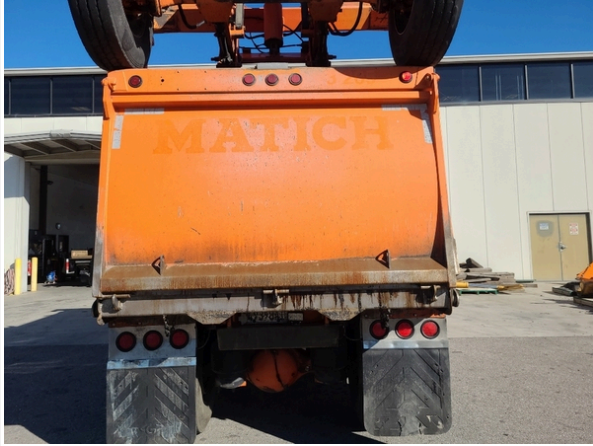
Rear	3 - Normal Wear & Tear	
Rear Condition	No visible damage, Other (see comments)	
Comments	normal wear and tear	
Rear Photos

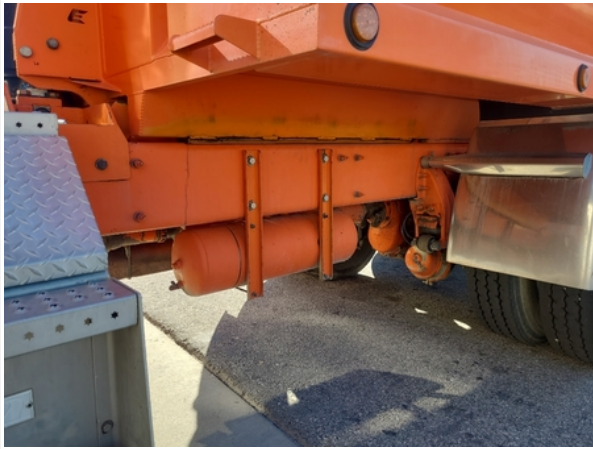
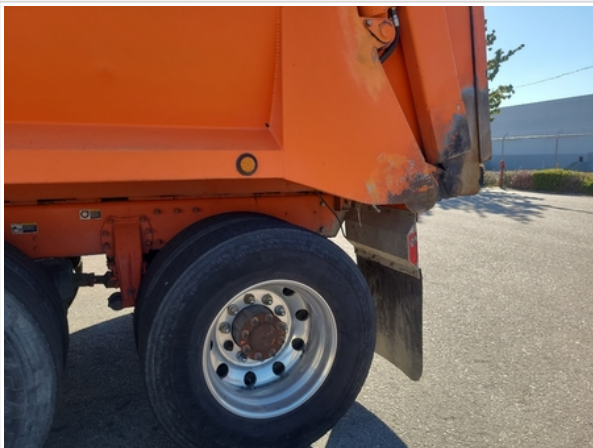
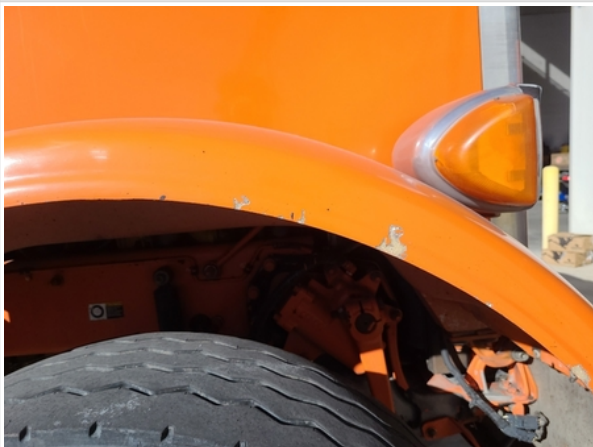
Left	3 - Normal Wear & Tear	
Left Condition	No visible damage, Other (see comments)	
Comments	a few paint chipping at front fender

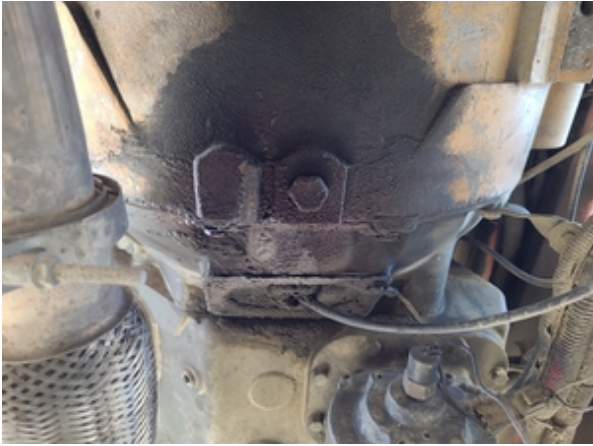
Cooling System Leaks	No
Coolant Color / Appearance	3 - Normal Wear & Tear
Coolant Color/Appearance Notes	Normal Translucent appearance, no visual signs of contamination
Oil Leaks	Yes
Oil Leak Notes	Wet areas with drops forming due to oil leakage, Other (see comments)
Comments	small oil leak observed around bell housing & Small oil leak at front left side of engine
Oil Leak Photos

Requires DEF (Diesel Exhaust Fluid)	No
Overall Engine Appearance	Clean & dry, Areas of dried seepage seen on engine hoses & components
Overall Engine Comments	Overall engine well maintained. A few small leaks observed.

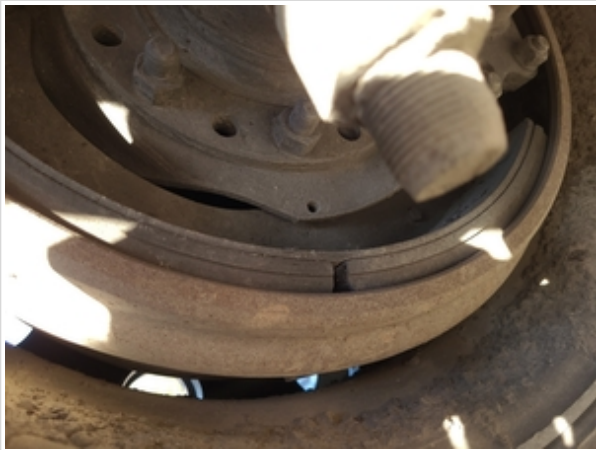
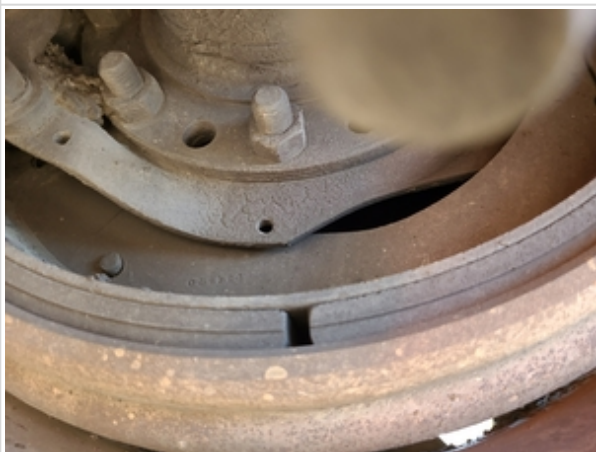
Brake Shoe Thickness	50%
Comments	front left side low rest okay
Brake Shoe Photos
