Inspection Report (On-Highway Dump Truck)

Year	2011
Make	Peterbilt
Model	367
Serial Number	1NP - TLUOX - 2 - BD127975
Truck Odometer Reading	423,441
Previous Application (e.g., earth moving, mining, demolition, etc)	Asphalt Construction

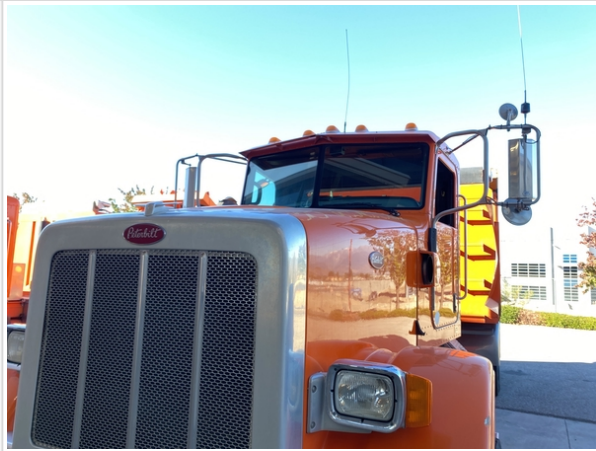
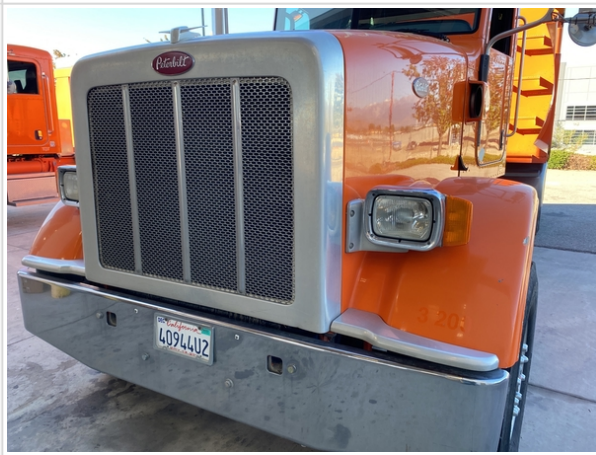
Front	3 - Normal Wear & Tear
Front Condition	No visible damage
Front Photos

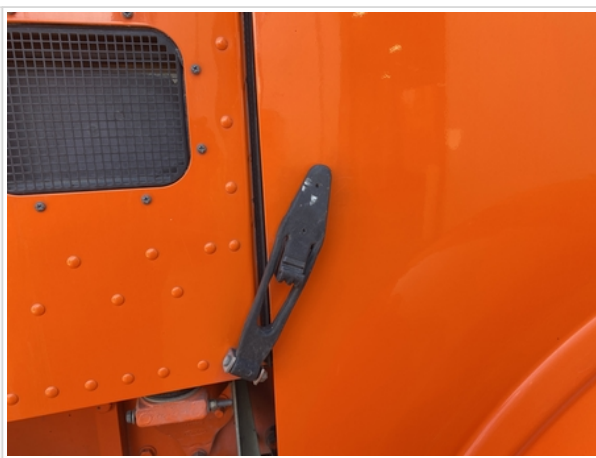
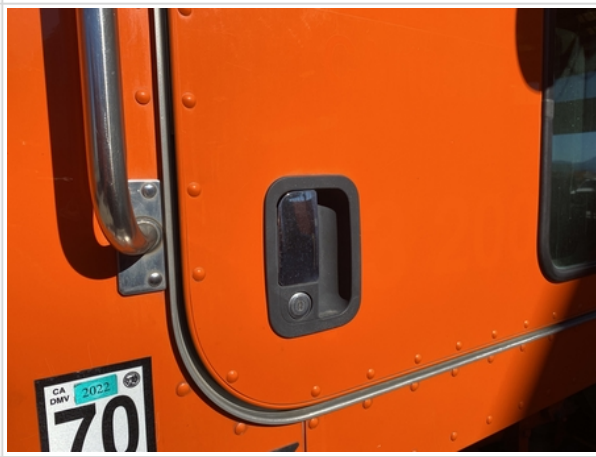
Body Panels (Any Rust Damage?)	3 - Normal Wear & Tear	
Body Panel Condition	No visible damage, good paint condition and panel fitment, Other (see comments)	
Doors / Canopy Latches	3 - Normal Wear & Tear	
Doors / Canopy Latches Condition	No visible damage	
Doors / Canopy Latches Photos

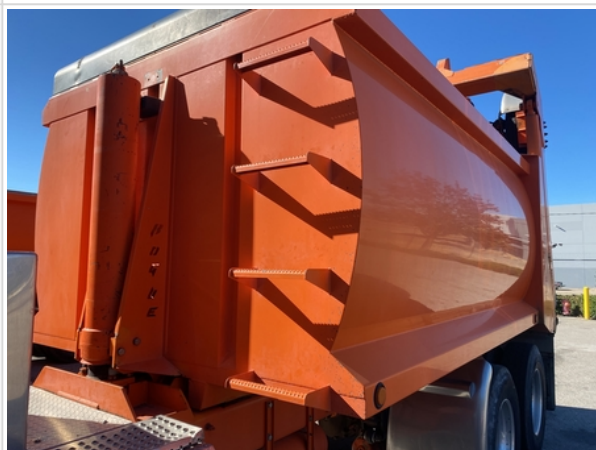
Steps / Ladders	3 - Normal Wear & Tear	
Steps / Ladders Condition	Steps/ladders are fully intact and appear structurally sound	
Steps / Ladders Photos

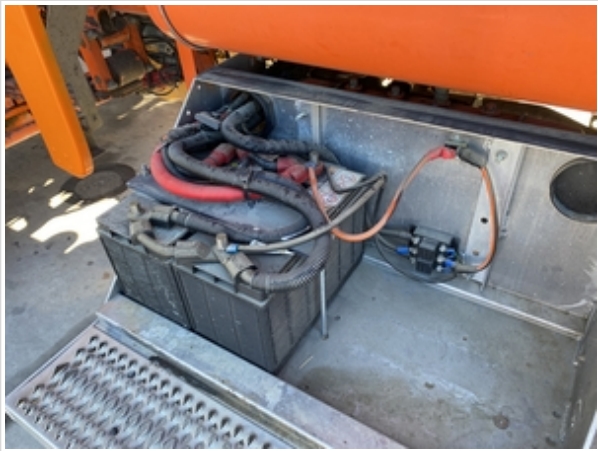
Blow-by (Visual Observation Check)	No	
Unusual Noises (Upon Start-up, Idle, Shutdown)	No	
Unusual Noise Notes	No unusual noises heard	
Engine Smoke (Upon Start-up, Idle, Shutdown)	No	
Engine Smoke Notes	No engine smoke issues observed	
Engine Exhaust Color	Clear	
Battery	2 - Above Average Wear	
Battery Condition	Needs charge or replacement	
Comments	Engine starter hesitation observed	
Battery Condition Photos

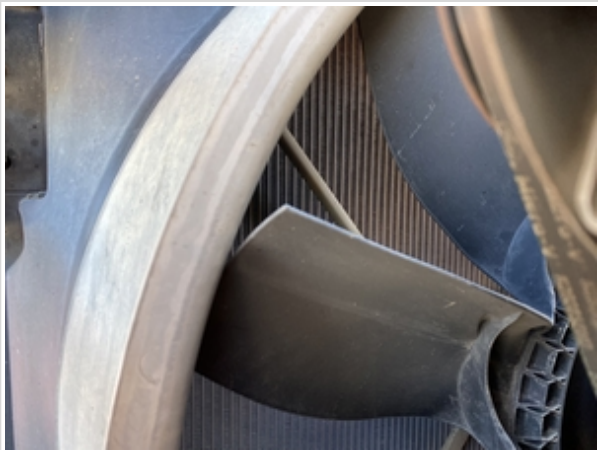
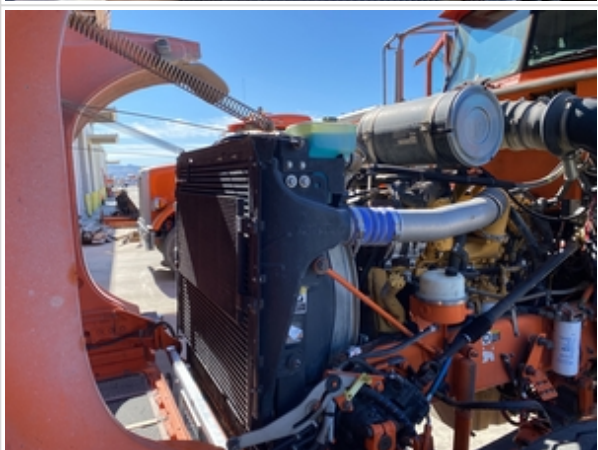
Radiator	3 - Normal Wear & Tear	
Radiator Condition	Radiator fins & components appear to be in good working order, no signs of damage or leaks	
Radiator Photos

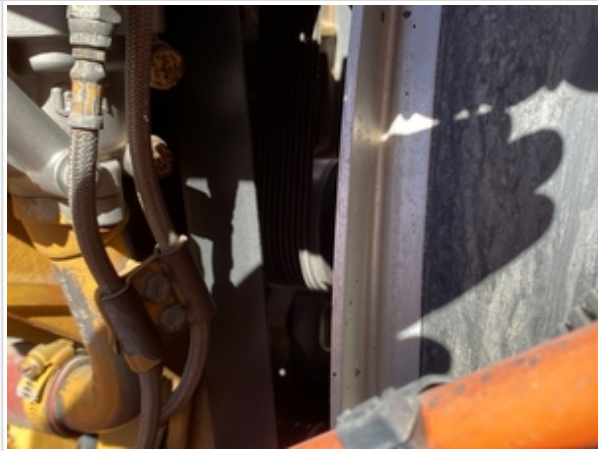
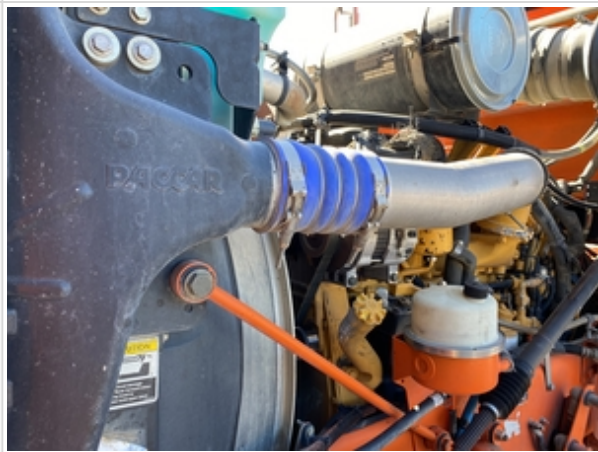
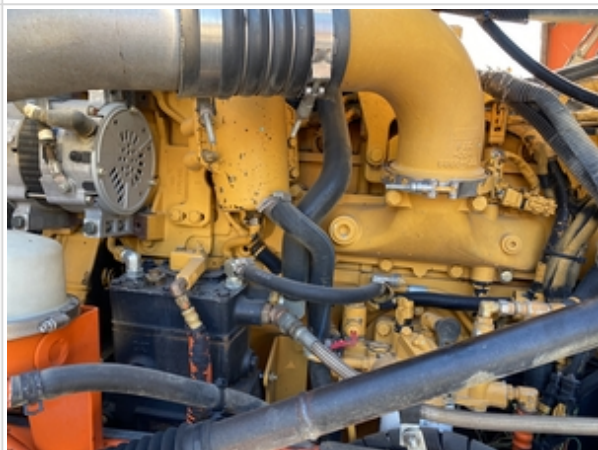
Hoses	3 - Normal Wear & Tear	
Hose Condition	Firm, pliant hoses with no signs of wear or leaks	
Hose Photos

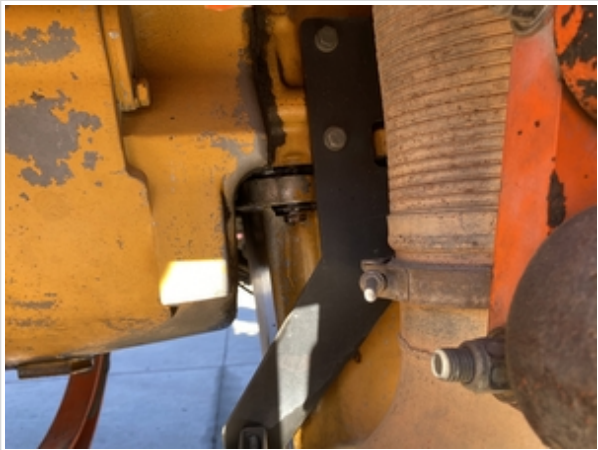
Cooling System Leaks	No
Coolant Color / Appearance	3 - Normal Wear & Tear
Coolant Color/Appearance Notes	Normal Translucent appearance, no visual signs of contamination
Oil Leaks	Yes
Oil Leak Notes	Wet areas with drops forming due to oil leakage, Other (see comments)
Comments	Oil leak at rear top side of oil pan and around bell housing
Oil Leak Photos

Requires DEF (Diesel Exhaust Fluid)	No
Overall Engine Appearance	Clean & dry, Areas of dried seepage seen on engine hoses & components
Overall Engine Comments	Minor oil leak may be coming from engine oil pan and around bell housing.

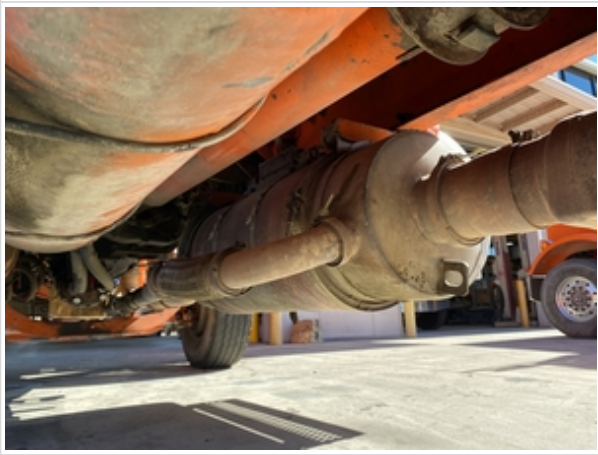
Oil Color / Appearance	3 - Normal Wear & Tear	
Oil Color / Appearance Notes	Clean oil appearance, no signs of cross contamination, Appropriate oil level	
Fuel Leaks	No	
Equipped with DPF (Diesel Particulate Filter)	Yes	
DPF Condition	3 - Normal Wear & Tear	
DPF Condition Notes	Filter housing is intact with no signs of damage or malfunction, DPF indicator is not illuminated	
DPF Photos

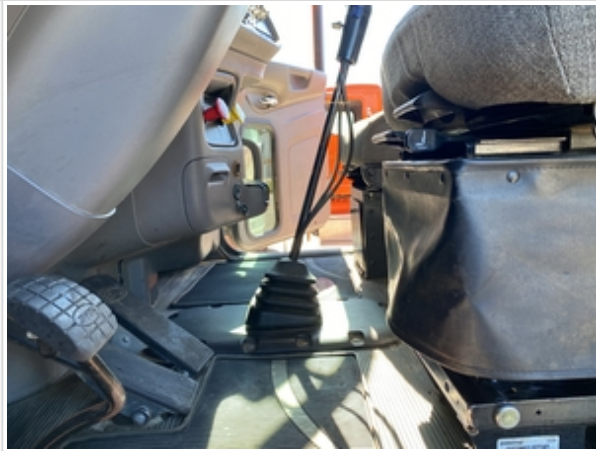
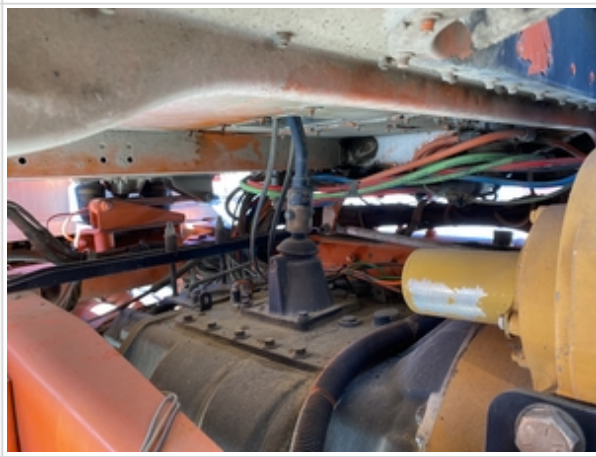
Clutch	3 - Normal Wear & Tear	
Clutch Condition	Clutch is functioning as expected	
Shift Lever	3 - Normal Wear & Tear	
Shift Lever Condition	Good forward and reverse function	
Shift Lever Photos

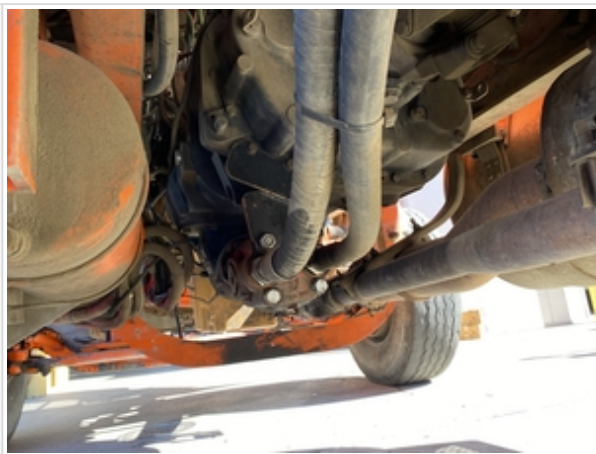
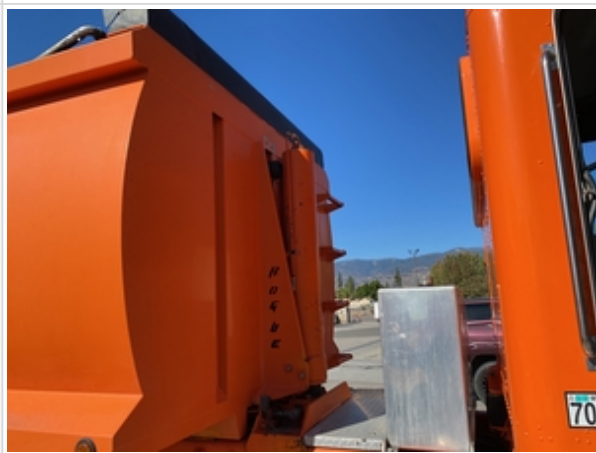
<p>Hydraulic Cylinders</p>	<p>3 - Normal Wear & Tear</p>
<p>Hydraulic Cylinder Photos</p>

Hydraulic Function	3 - Normal Wear & Tear
Comments	Cylinder functions well
