## Inspection Report (On-Highway Dump Truck)

Year	2011
Make	Peterbilt
Model	367
Serial Number	1NP - TLUOX - 6 - BD127977
Truck Odometer Reading	443,015
Previous Application (e.g., earth moving, mining, demolition, etc)	Asphalt Construction

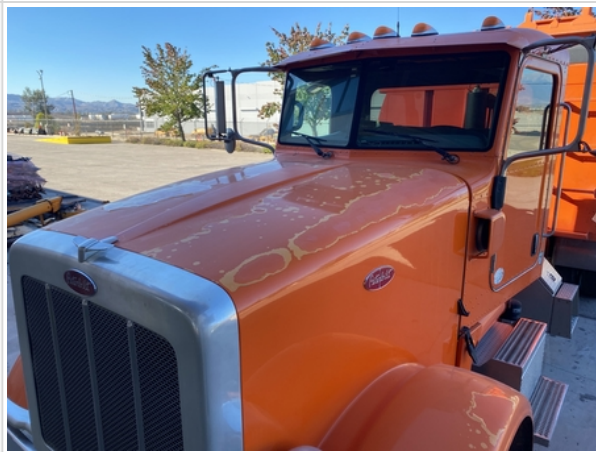
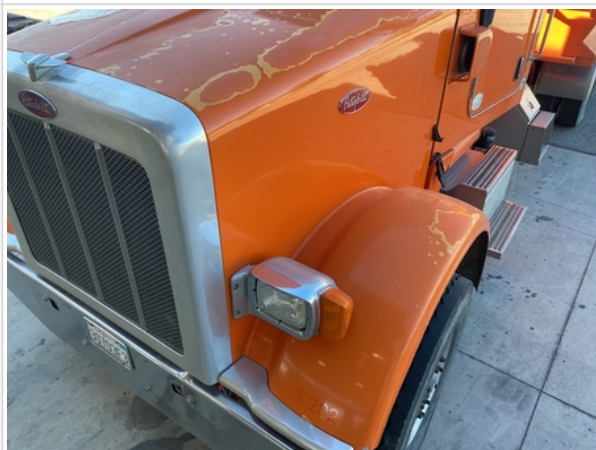
Upper	3 - Normal Wear & Tear
Upper Condition	No visible damage
Upper Photos

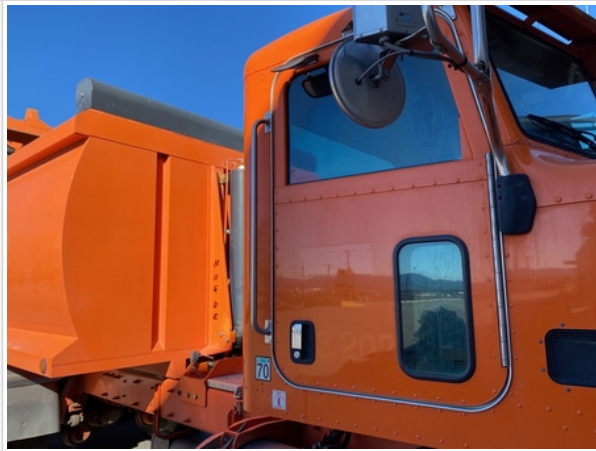
<b>Handrails</b>	3 - Normal Wear & Tear
<b>Handrails Condition</b>	Handrails are fully intact and appear structurally sound
<b>Handrail Photos</b>

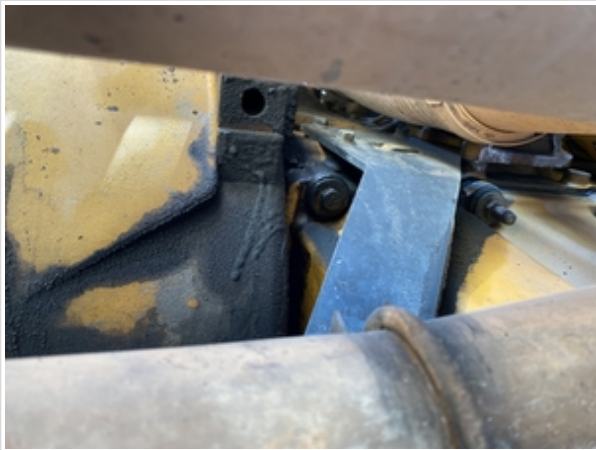
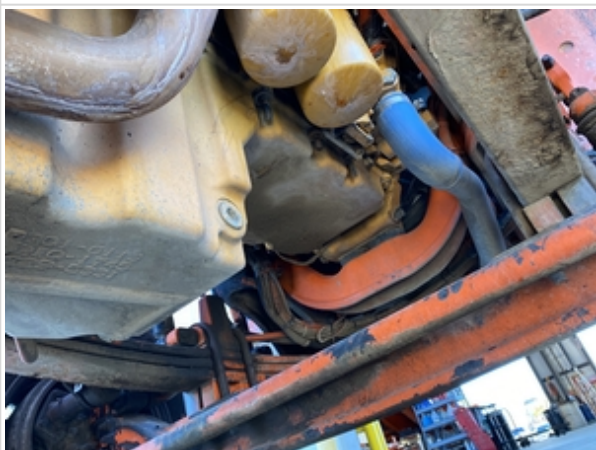
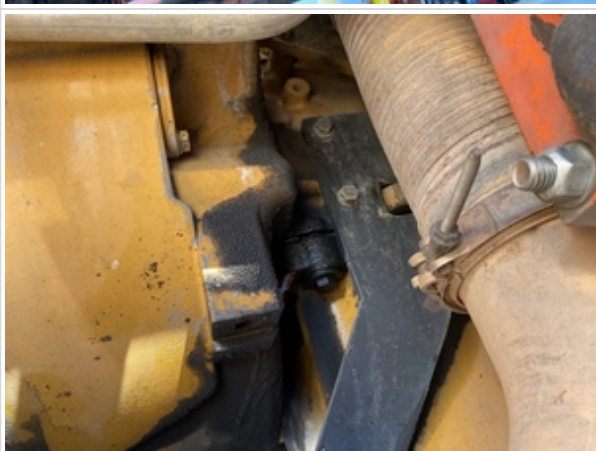
<b>Cooling System Leaks</b>	No
<b>Coolant Color / Appearance</b>	3 - Normal Wear & Tear
<b>Coolant Color/Appearance Notes</b>	Normal Translucent appearance, no visual signs of contamination
<b>Oil Leaks</b>	Yes
<b>Oil Leak Notes</b>	No oil leaks seen, Dried oil seepages seen
<b>Oil Leak Photos</b>

Requires DEF (Diesel Exhaust Fluid)	No
Overall Engine Appearance	Clean & dry, Areas of dried seepage seen on engine hoses & components
Overall Engine Comments	Engine clean, minor leakage at oil pan, rear housing area

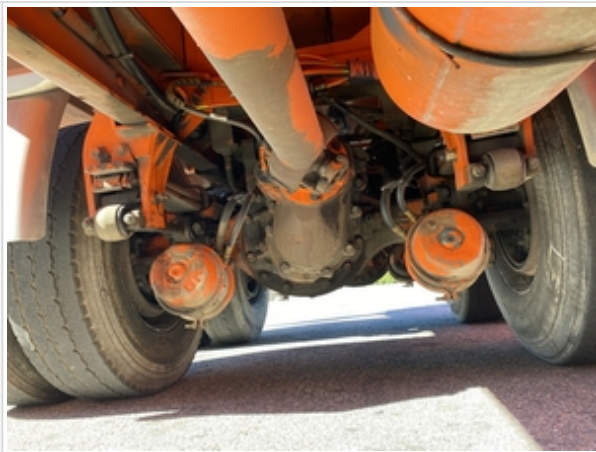
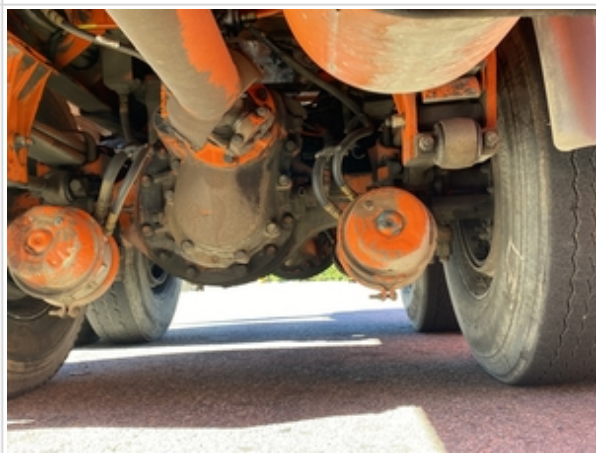
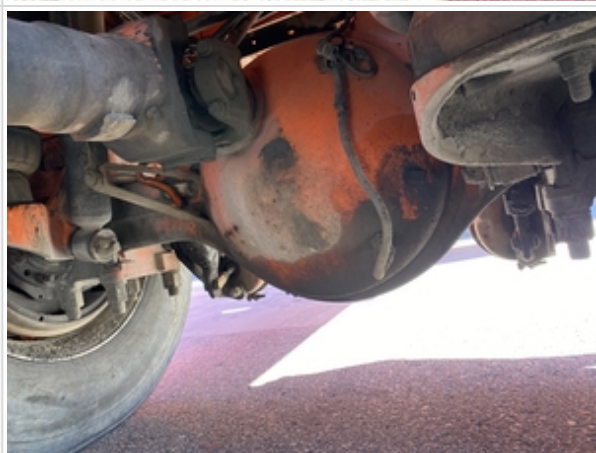
<b>Front Differential Photos</b>

<b>Front Differential</b>	3 - Normal Wear & Tear
<b>Front Differential Condition</b>	Dry housing appearance, no unusual noises heard during operation

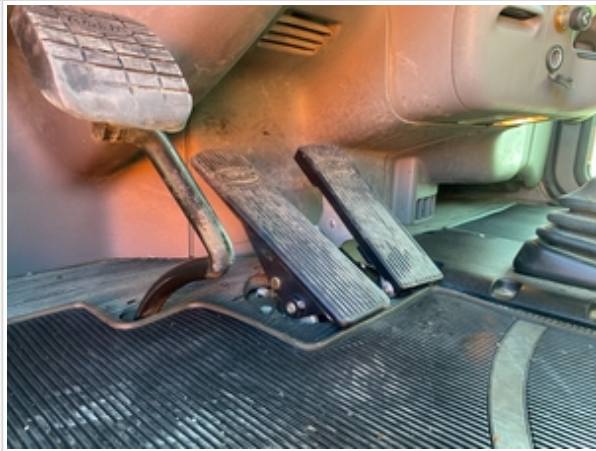
Foot Brake Photos

<b>Foot Brake</b>	3 - Normal Wear & Tear
<b>Foot Brake Condition</b>	Good brake function
