## Inspection Report (Boom Lift)

Year	2008
Make	JLG
Model	AJ 800
Serial Number	0300119325
Hour Meter Reading	3,827
Previous Application (e.g., earth moving, mining, demolition, etc)	Equipment Rental

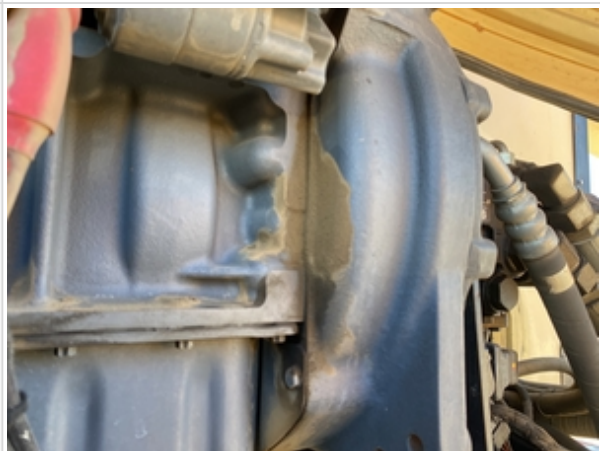
<b>Water Pump</b>	3 - Normal Wear & Tear	
<b>Water Pump Condition</b>	No unusual pump noises heard	
<b>Cooling System Leaks</b>	No	
<b>Coolant Color / Appearance</b>	3 - Normal Wear & Tear	
<b>Coolant Color/Appearance Notes</b>	Normal Translucent appearance, no visual signs of contamination	
<b>Oil Leaks</b>	Yes	
<b>Oil Leak Notes</b>	Dried oil seepages seen	
<b>Comments</b>	Dried oil seepage/dirt buildup around bell housing and oil filter base	
<b>Oil Leak Photos</b>

Oil Color / Appearance	3 - Normal Wear & Tear
Oil Color / Appearance Notes	Clean oil appearance, no signs of cross contamination, Appropriate oil level
Fuel Leaks	No
Equipped with DPF (Diesel Particulate Filter)	No
Requires DEF (Diesel Exhaust Fluid)	No
Overall Engine Appearance	Clean & dry, Areas of dried seepage seen on engine hoses & components
Overall Engine Comments	Engine in solid condition. This engine has been well maintained and no active leaks found. Dried seepage leaks with oil/dirt buildup around bell housing and oil filter base. No Aftertreatment needed due to under 75 HP.

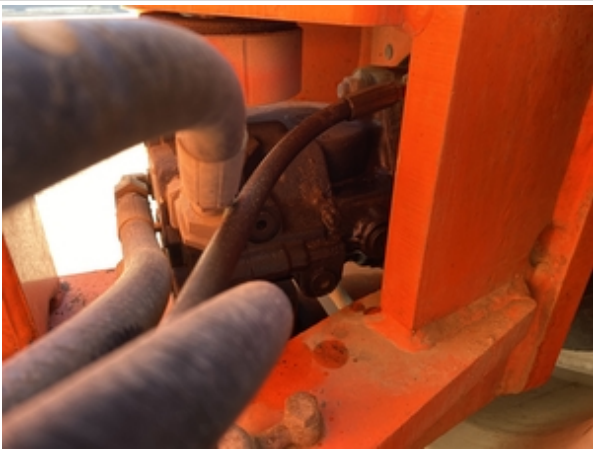
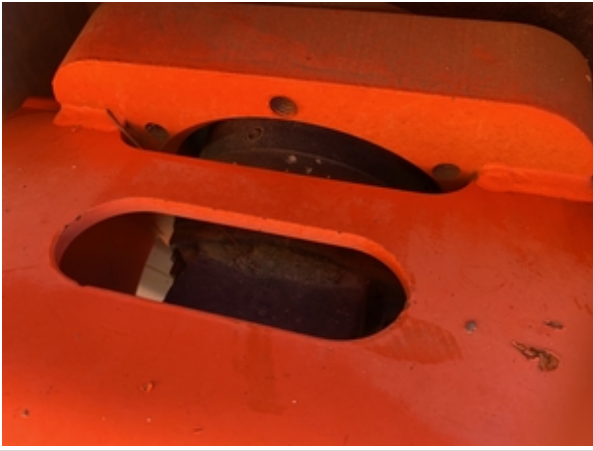
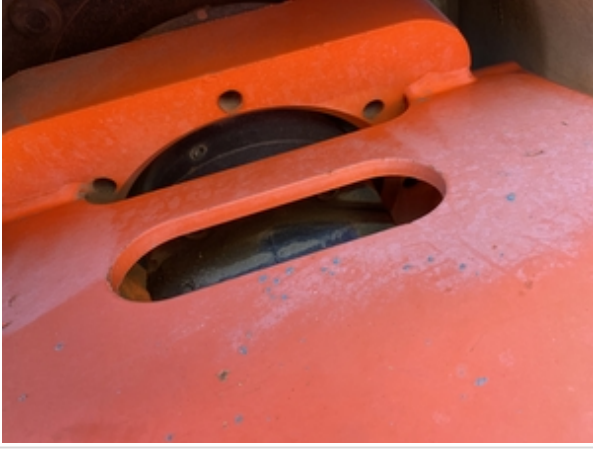
Hydrostatic Transmission?	Yes
2 Speed?	Yes
Hydrostatic Drive Configuration	Split Transmission
Drive Motors	4 - Like New, Recently Replaced
Comments	Rear left drive motor showing signs of active leak
Drive Motor Photos

<b>Hydrostatic Parking Brake</b>	3 - Normal Wear & Tear	
<b>Hydrostatic Parking Brake Condition</b>	Good brake function	
<b>Overall Drivetrain Comments</b>	Overall drivetrain in great condition. Left side rear hydraulic motor showing signs of active hydraulic leak.

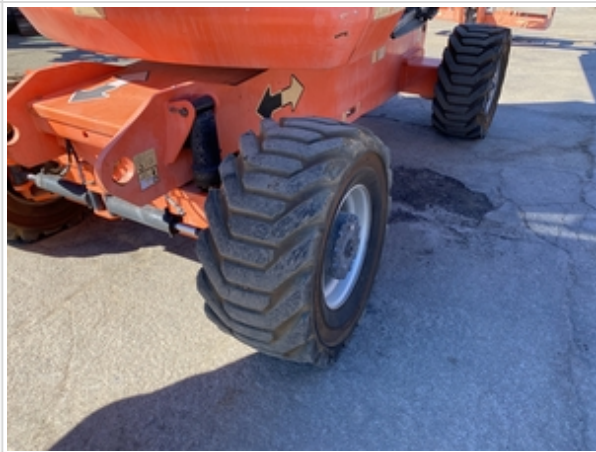
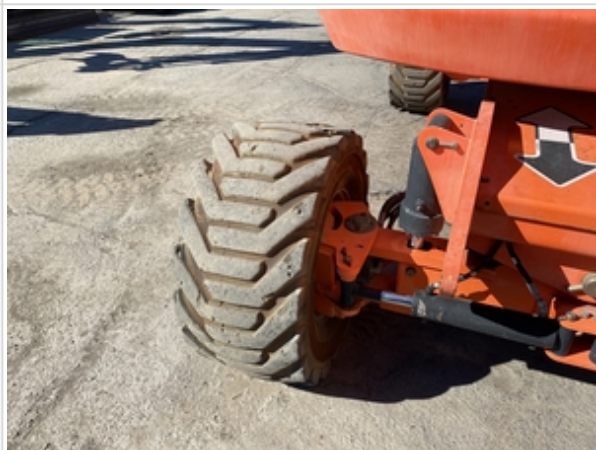
<b>Wheels &amp; Tires</b>	3 - Normal Wear & Tear
<b>Comments</b>	Tires foam filled and in good condition
<b>Wheels &amp; Tires Photos</b>

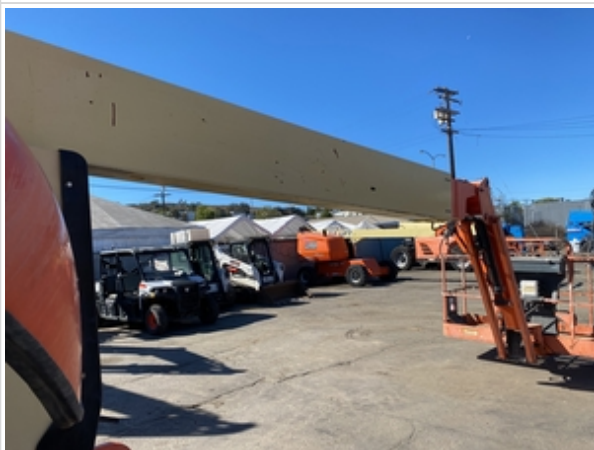
Boom Condition	3 - Normal Wear & Tear
Comments	Really good condition, wear pads like new
Boom Condition Photos

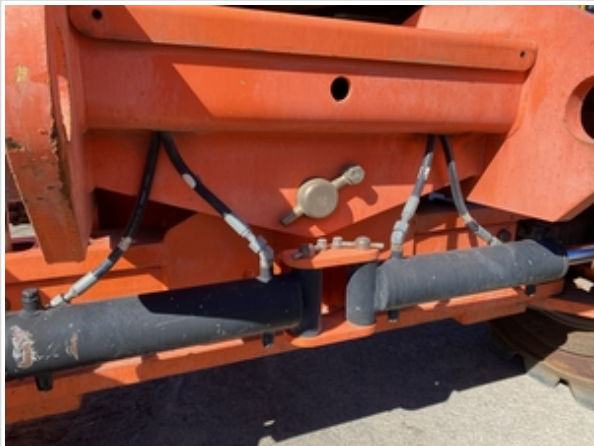
<b>Wet or Damp Hydraulic Lines / Fittings</b>	No
<b>Appearance of Hydraulic Lines / Fittings</b>	3
<b>Hydraulic Lines / Fittings Condition</b>	Hydraulic lines & fittings are clean and in good condition, Active leaks in hoses or fittings observed
<b>Comments</b>	Active leaks seen coming from rear hoses under boom cylinder and possibly from underneath front body
<b>Appearance of Hydraulic Lines / Fittings Photos</b>

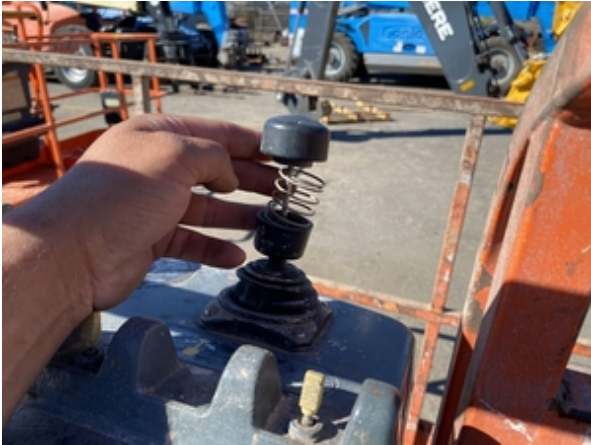
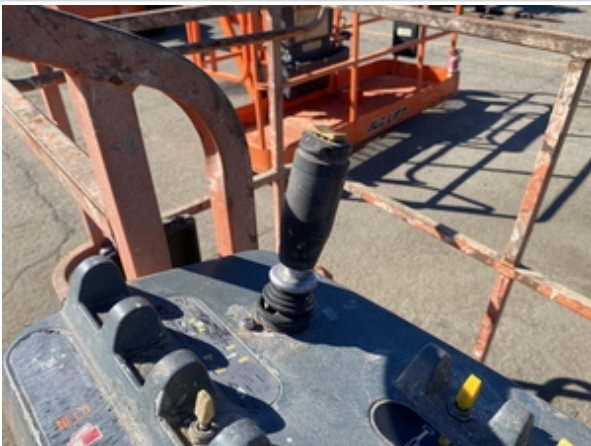
<b>Unusual Noises (Hydraulic Pump)</b>	No
<b>Hydraulic Pump Notes</b>	No unusual noises heard during operation
<b>External Controls / Levers</b>	2
<b>External Controls / Levers Condition</b>	Good function & condition of hydraulic controls, Other (see comments)
<b>Comments</b>	Hydraulic levers worn
<b>External Controls / Levers Photos</b>

Exterior Rating	3
Interior Rating	3
Safety Rating	3
Quality Rating	3
Functionality Rating	3
Overall Rating	3
What's Great About the Machine	Machine operates well and hydraulic pump sounds healthy. Engine fires right up and also sound healthy. Frame and implements in great condition. No obvious major repairs needed with engine, hydraulics and main implements. Tires are foam filled and have plenty of life left. Boom wear pads like new.
What Needs Work	Operator platform and ground controls should be relabeled for easy function indication as to what they do. Leaks at rear left drive motor, rear hydraulic hoses and leak underneath front body should be addressed. Operator manual missing. Travel alarm inoperable. Joystick controls should be repaired or addressed.
Date/Time	11-16-2022
