Inspection Report (Skid Steer)

Year	2017
Make	Bobcat
Model	T 450
Serial Number	AUVP13415
Hour Meter Reading	2,811
Previous Application (e.g., earth moving, mining, demolition, etc)	Demolition Work

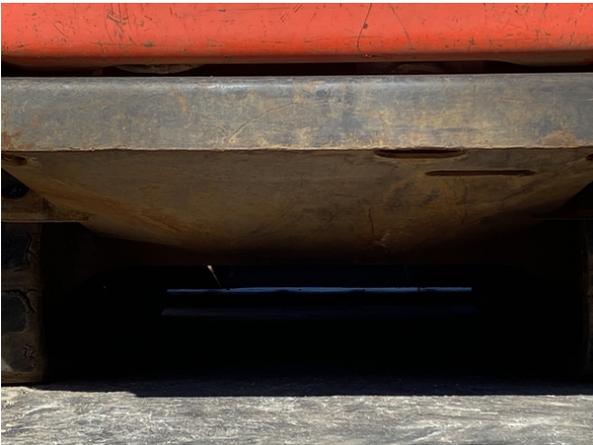
Left	3 - Normal Wear & Tear	
Left Condition	No visible damage, Other (see comments)	
Left Photos

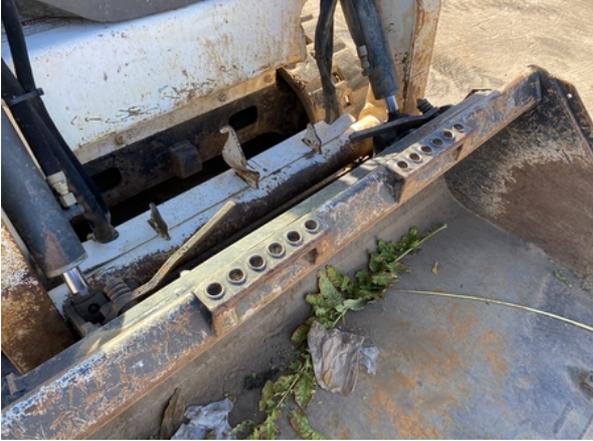
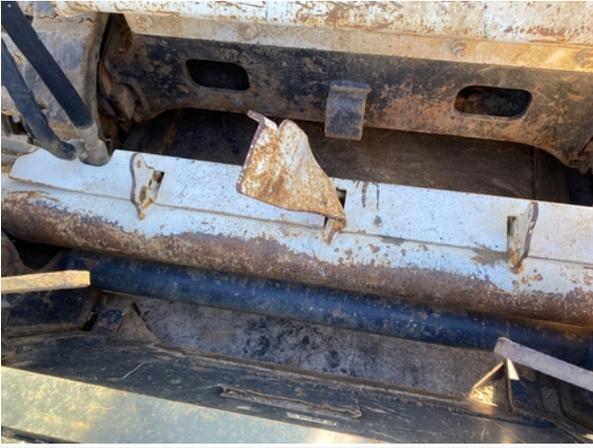
Steps / Ladders	3 - Normal Wear & Tear
Steps / Ladders Condition	Steps/ladders are fully intact and appear structurally sound, Other (see comments)
Comments	Front step broken

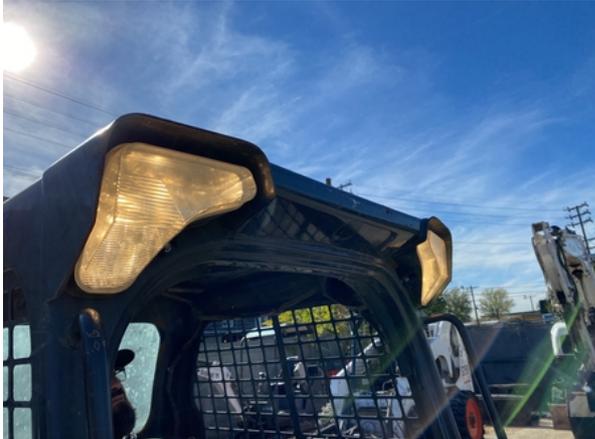
Mirrors	0
Lighting System	3 - Normal Wear & Tear
Lighting System Condition	One or more exterior lights are non-operational, Other (see comments)
Comments	Rear left side light inop. (Missing)
Lighting System Photos

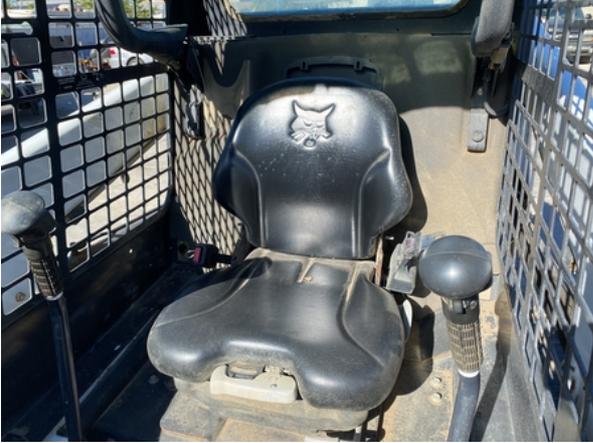
Operator's Seat & Arm Rests	3 - Normal Wear & Tear
Operator's Seat & Arm Rests Condition	Seat(s) in good condition, no stains or tears in upholstery, Seat(s) have minor surface staining or small tears
Comments	Small tear on bottom part of seat

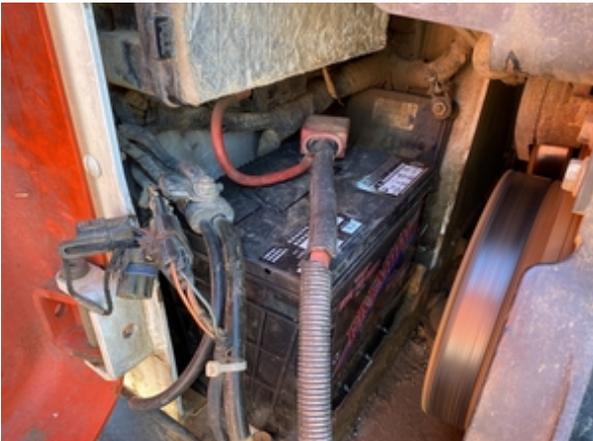
Blow-by (Visual Observation Check)	No
Unusual Noises (Upon Start-up, Idle, Shutdown)	No
Unusual Noise Notes	No unusual noises heard
Engine Smoke (Upon Start-up, Idle, Shutdown)	No
Engine Smoke Notes	No engine smoke issues observed
Engine Exhaust Color	Clear
Battery	3 - Normal Wear & Tear
Battery Condition	Like new, recently replaced
Battery Condition Photos

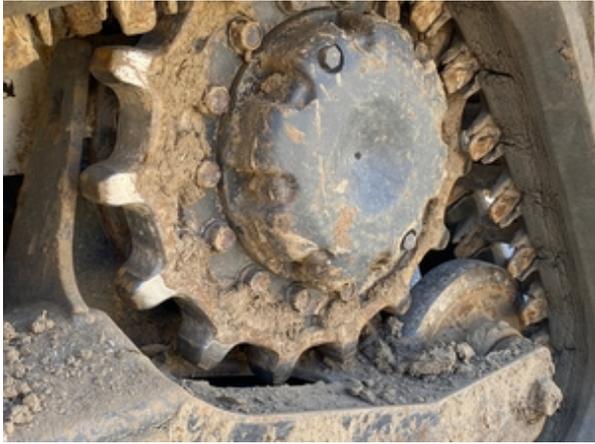
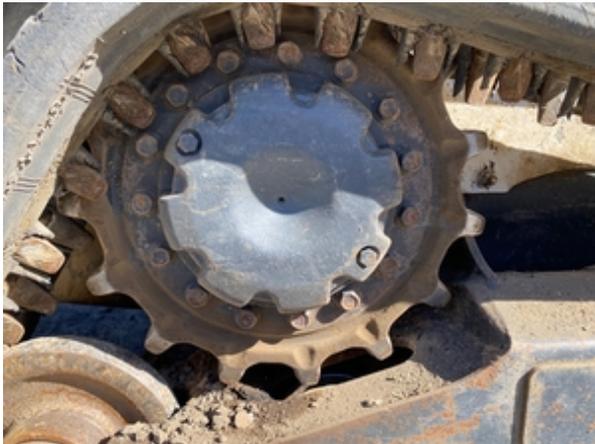
Hydrostatic Transmission?	Yes
2 Speed?	Yes
Hydrostatic Drive Configuration	Split Transmission
Drive Motors	2 - Above Average Wear
Drive Motor Photos

Hydrostatic Parking Brake	3 - Normal Wear & Tear
Hydrostatic Parking Brake Condition	Good brake function
Overall Drivetrain Comments	Overall besides tracks being worn (below 20% track tread left) the powertrain/drivetrain works well. Hydrostatic systems sounds healthy and undercarriage has normal wear and tear.

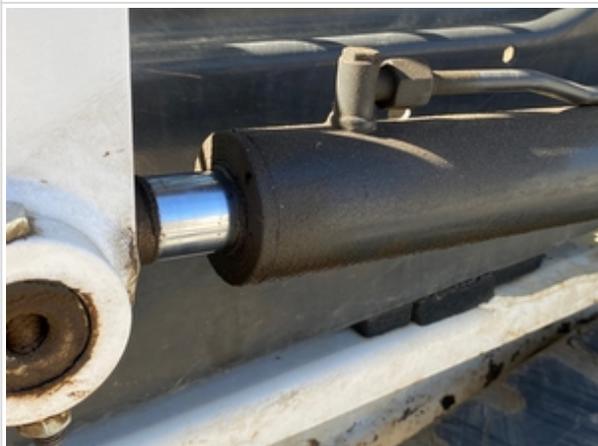
Lift Cylinder	Check the lift cylinder. Note any wear, pitting, discoloration, etc. Take photos.
Lift Cylinder: Mounting Pin	3
Lift Cylinder: Oil Leaks	No
Comments	Left side lift cylinder has residual oil buildup (possible cylinder reseal may be needed soon)
Lift Cylinder Photos

Exterior Rating	3
Interior Rating	3
Safety Rating	3
Quality Rating	3
Functionality Rating	3
Overall Rating	3
What's Great About the Machine	Machine is in good condition all the way around. All powertrain components healthy and no major active leaks observed. Engine compartment in good shape. Hydraulic compartment also in good shape.
What Needs Work	Minor seepage leaks may be coming from hydraulic lines underneath cab. Pressure wash recommended to find out if small leak present underneath cab. Tracks need to be replaced soon. Left side cylinder should be clean and tested to see if small leak exist.
Date/Time	11-17-2022
