Inspection Report (Generator)

Year	2021
Make	G-Energy Gen. Set
Model	SVF60 - 160
Serial Number	5312637944
Hour Meter Reading	4,042
Previous Application (e.g., earth moving, mining, demolition, etc)	Generator Rentals

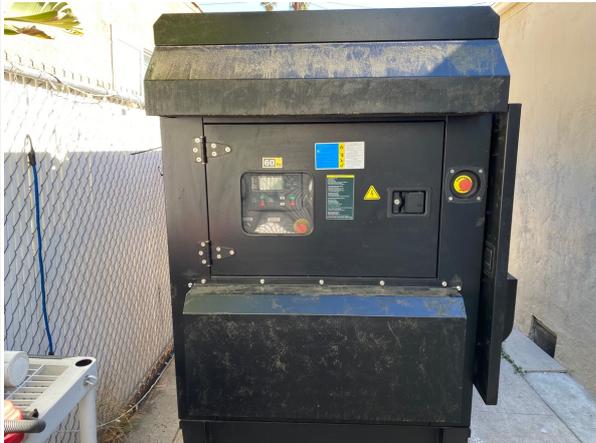
Front	3 - Normal Wear & Tear
Front Photos

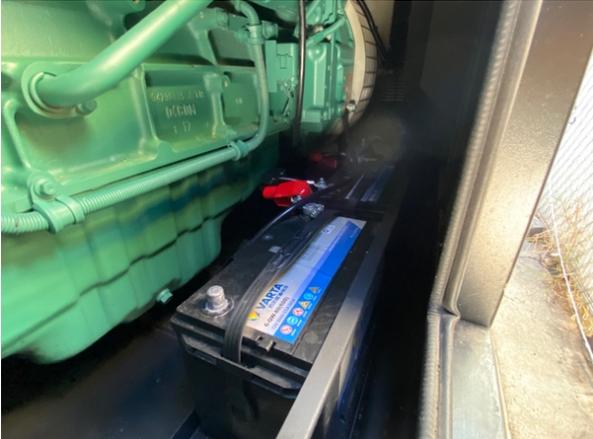
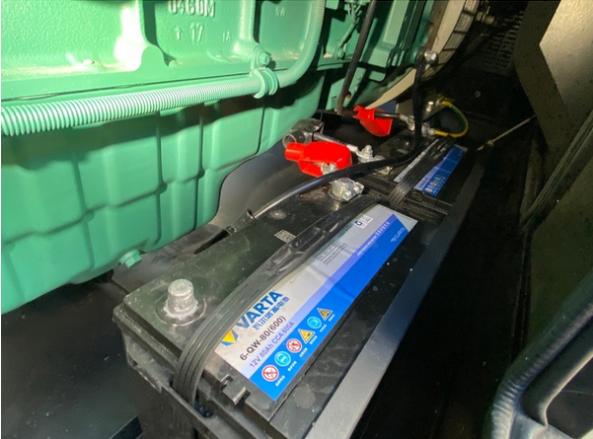
Battery	3 - Normal Wear & Tear
Battery Condition	Like new, recently replaced
Battery Condition Photos

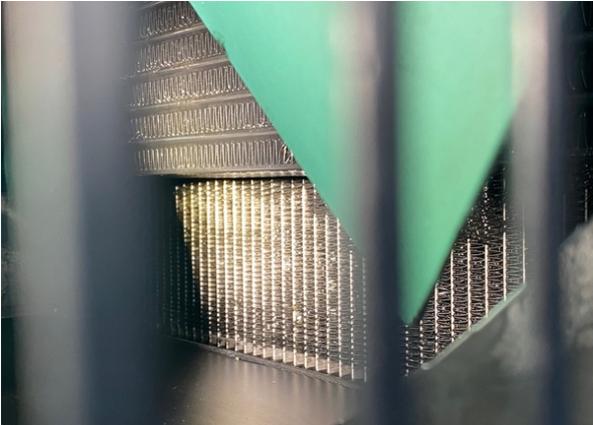
Radiator	3 - Normal Wear & Tear
Radiator Condition	Radiator fins & components appear to be in good working order, no signs of damage or leaks
Radiator Photos

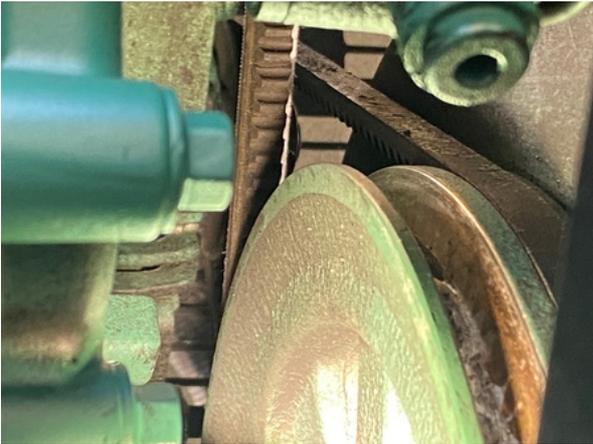
Belts	3 - Normal Wear & Tear
Belt Condition	Belts appear in good condition & alignment with proper tension
Belt Photos

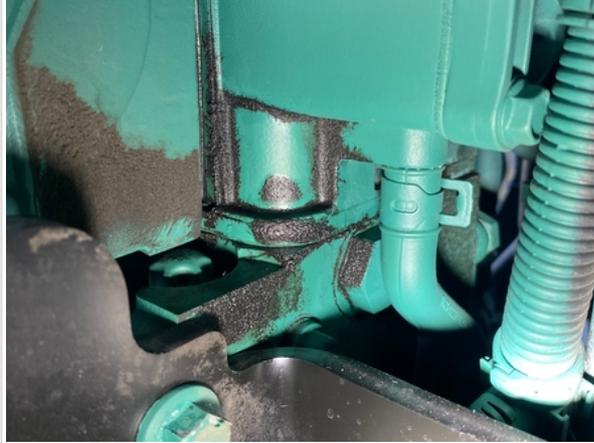
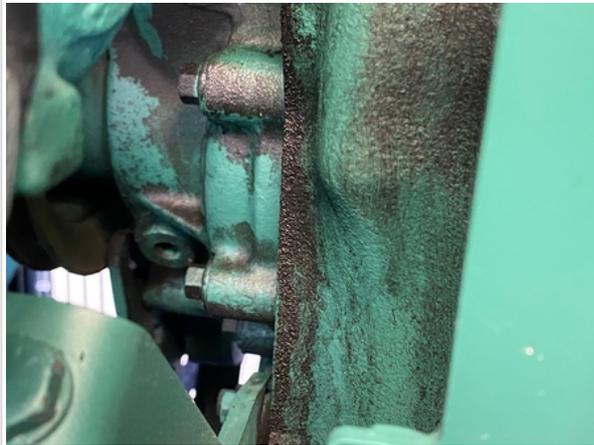
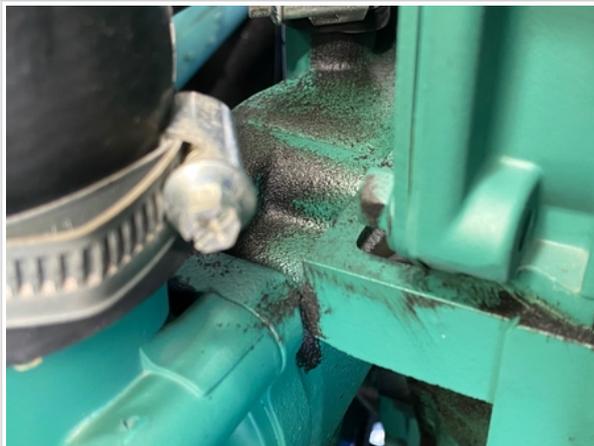
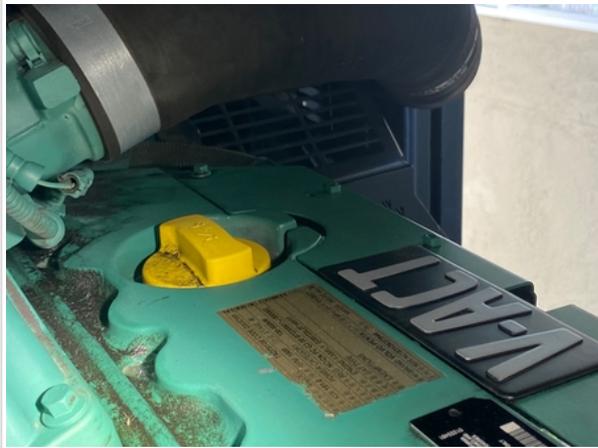
Oil Leak Photos

Water Pump	3 - Normal Wear & Tear
Water Pump Condition	No unusual pump noises heard
Cooling System Leaks	No
Coolant Color / Appearance	3 - Normal Wear & Tear
Coolant Color/Appearance Notes	Normal Translucent appearance, no visual signs of contamination
Oil Leaks	Yes
Oil Leak Notes	Other (see comments)
Comments	Residual oil leak observed at top of engine (possibly from engine oil serviced performed)

Oil Color / Appearance	3 - Normal Wear & Tear
Oil Color / Appearance Notes	Clean oil appearance, no signs of cross contamination, Appropriate oil level
Fuel Leaks	No
Equipped with DPF (Diesel Particulate Filter)	No
Requires DEF (Diesel Exhaust Fluid)	No
Overall Engine Appearance	Clean & dry
Overall Engine Comments	Overall engine looks to be in great condition. Residual oil seen around valve cover and around top of engine. (May be spillover engine oil from service performed or may be a small engine oil leak)

What's Great About the Machine	The generator is well maintained and sounds healthy. Monitor display unit showing Generator working well with all outputs. Engine/generator compartment well kept and clean.
What Needs Work	Residual oil on top of engine should be cleaned and inspected further for possible small leak.
Date/Time	11-09-2022

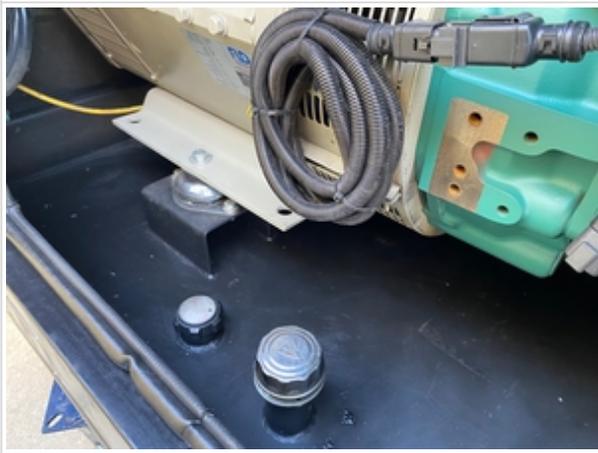
Bottom Surface	3 - Normal Wear & Tear
Bottom Surface Photos
