Inspection Report (Mini Excavator)

Year	2015
Make	Kubota
Model	U25
Serial Number	50812
Hour Meter Reading	1,827
Previous Application (e.g., earth moving, mining, demolition, etc)	Equipment Rental

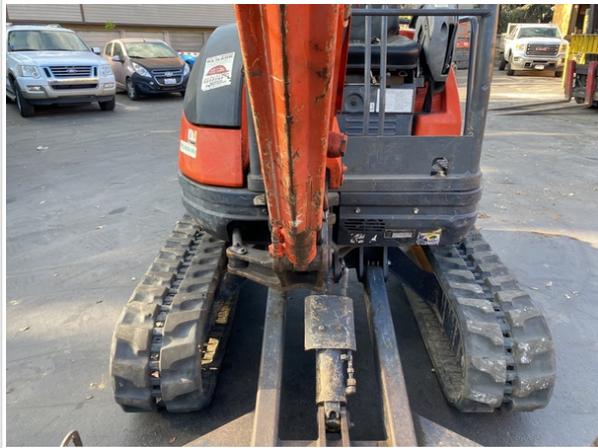
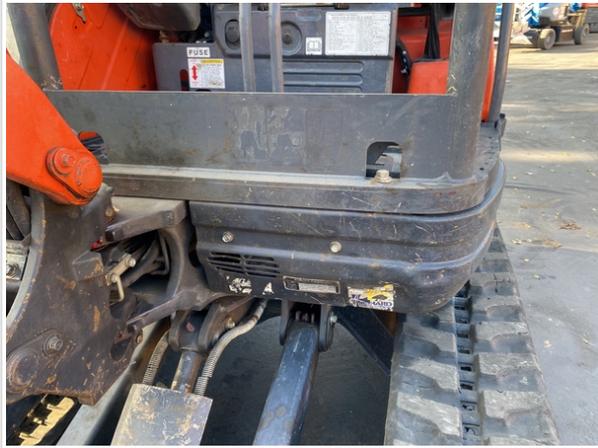
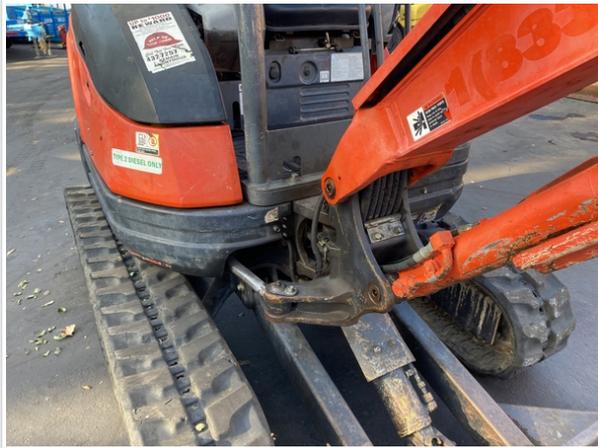
Front	3 - Normal Wear & Tear
Front Condition	No visible damage, Other (see comments)
Comments	Normal wear and tear scuff marks

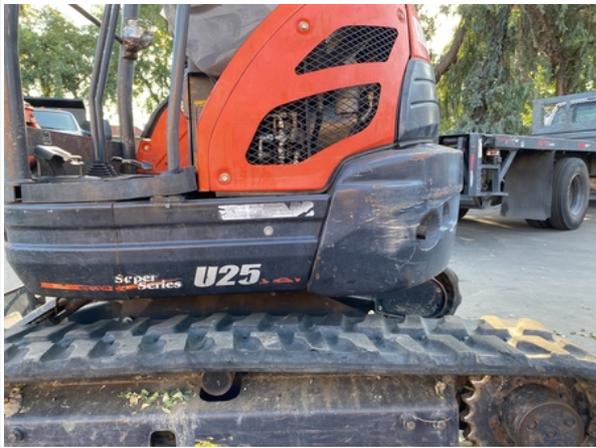
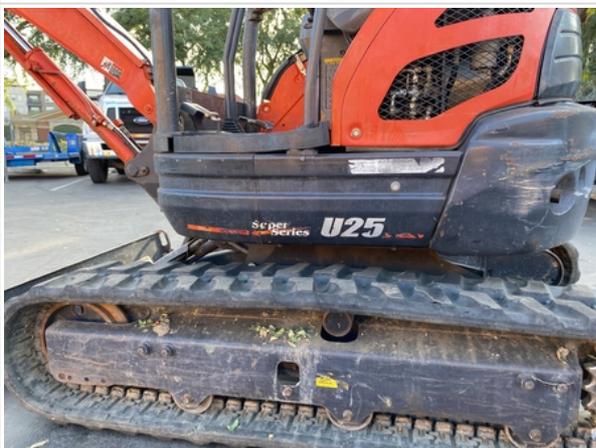
Left	3 - Normal Wear & Tear
Left Condition	No visible damage, Other (see comments)
Comments	Normal wear and tear scuff marks
Left Photos

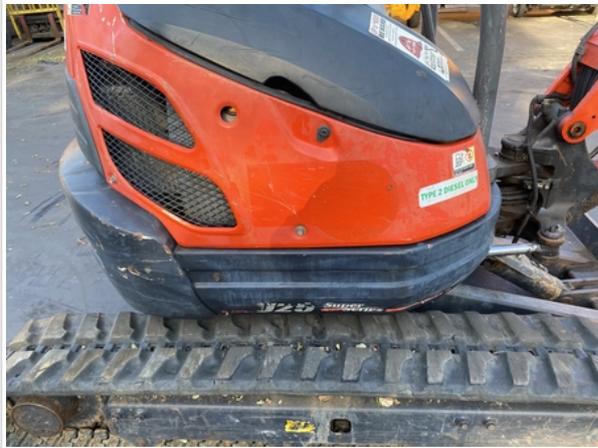
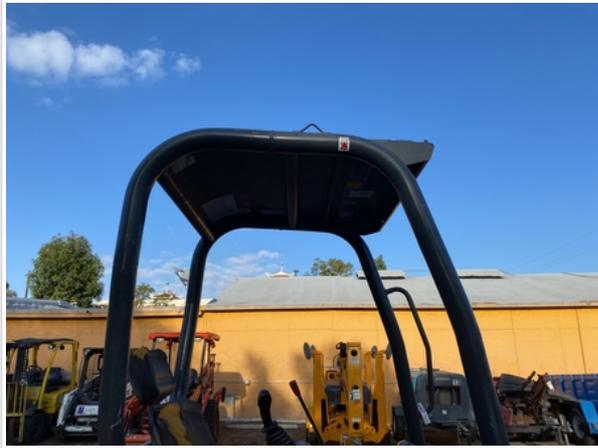
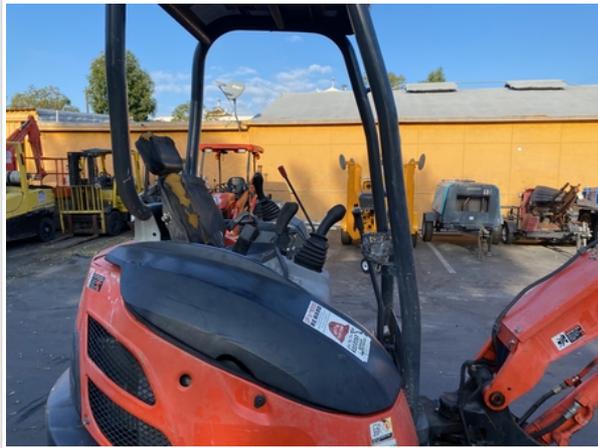
Right	3 - Normal Wear & Tear	
Right Condition	No visible damage, Other (see comments)	
Comments	Normal wear and tear scuff marks	
Right Photos

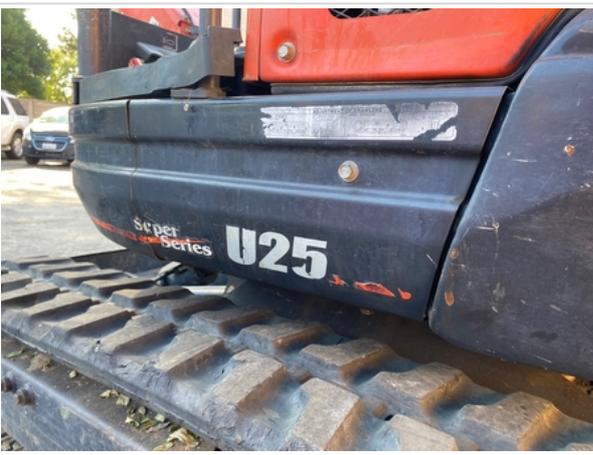
Body Panels (Any Rust Damage?)	3 - Normal Wear & Tear
Body Panel Condition	Other (see comments), Visible chipped paint or dents
Body Panels Photos

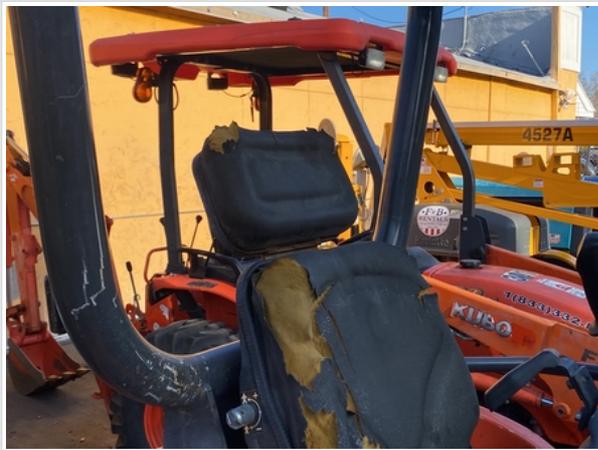
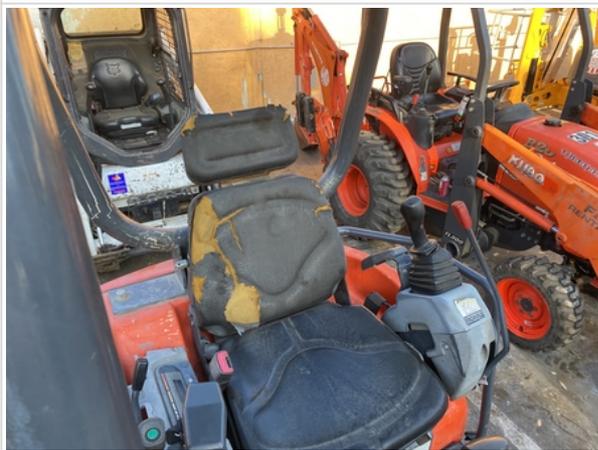
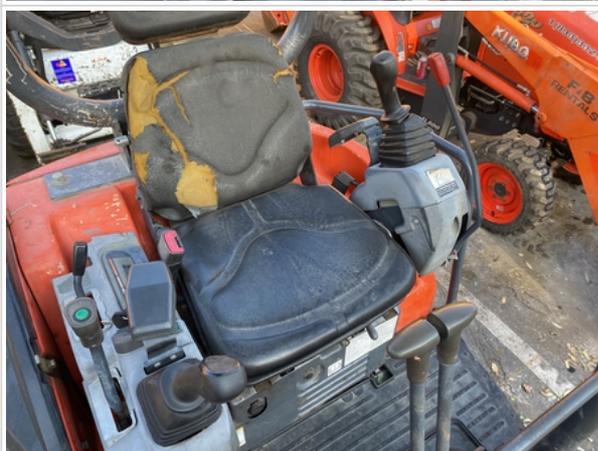
<p>Operator's Seat & Arm Rests Photos</p>

Operator's Seat & Arm Rests	3 - Normal Wear & Tear
Operator's Seat & Arm Rests Condition	Seat(s) is damaged due to sun exposure; fading, cracking observed, Seat(s) has major surface staining or tears

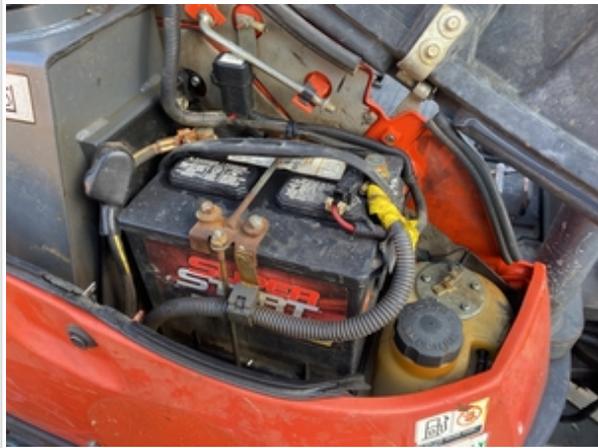
Battery Condition Photos

Blow-by (Visual Observation Check)	No
Unusual Noises (Upon Start-up, Idle, Shutdown)	No
Unusual Noise Notes	No unusual noises heard
Engine Smoke (Upon Start-up, Idle, Shutdown)	No
Engine Smoke Notes	No engine smoke issues observed
Engine Exhaust Color	Clear
Battery	3 - Normal Wear & Tear
Battery Condition	Like new, recently replaced, Other (see comments)
Comments	Minor corrosion buildup on positive terminal

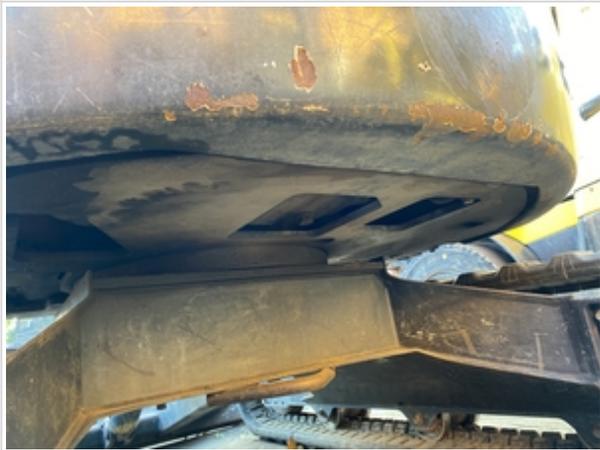
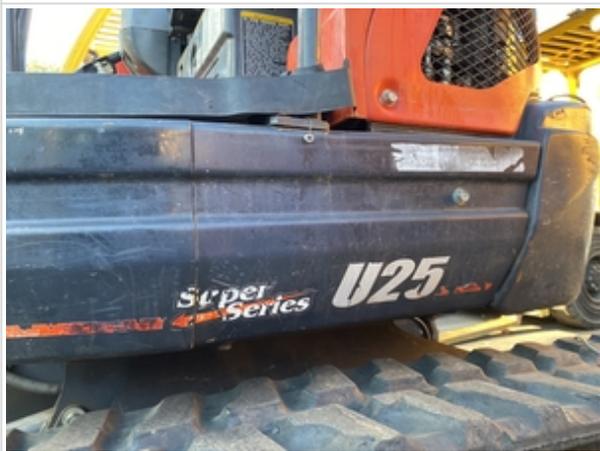
<p>Bottom Covers</p>	<p>3 - Normal Wear & Tear</p>	
<p>Comments</p>	<p>Small dent front lower panel</p>	
<p>Bottom Covers Photos</p>

What's Great About the Machine	Overall machine functions well. All implements tight and well lubricated at pins. Powertrain works and sounds healthy. No active leaks found & no obvious major repairs required.
What Needs Work	Minor dent bottom front left panel. Possible seepage at hydraulic hoses coming from hydraulic pump. (No active leaks). No bucket with machine.
Date/Time	11-29-2022

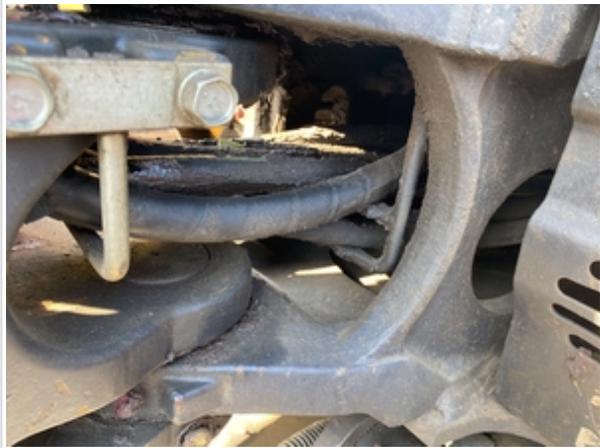
Hydraulics Overall	
Wet or Damp Hydraulic Lines / Fittings	Yes
Appearance of Hydraulic Lines / Fittings	3
Hydraulic Lines / Fittings Condition	Hydraulic lines & fittings are clean and in good condition
Appearance of Hydraulic Lines / Fittings Photos
