Inspection Report (Skip Loader)

Year	2004
Make	Case
Model	570MXT
Serial Number	JJG0301527
Hour Meter Reading	800.00 + 5,090 = both hour meters
Previous Application (e.g., earth moving, mining, demolition, etc)	General Construction

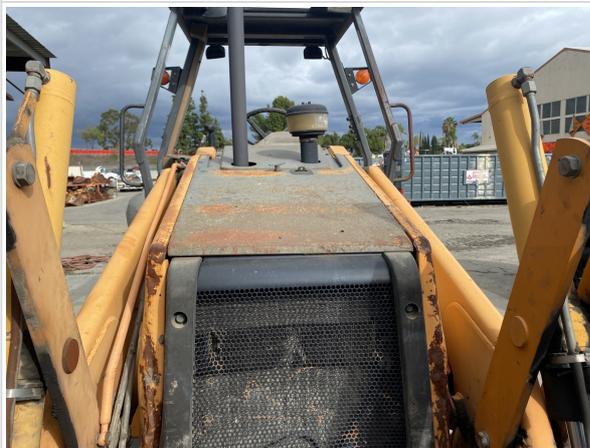
Front	3 - Normal Wear & Tear
Front Condition	Other (see comments), Large dents or cracks
Comments	Front outside of hood damaged on both sides

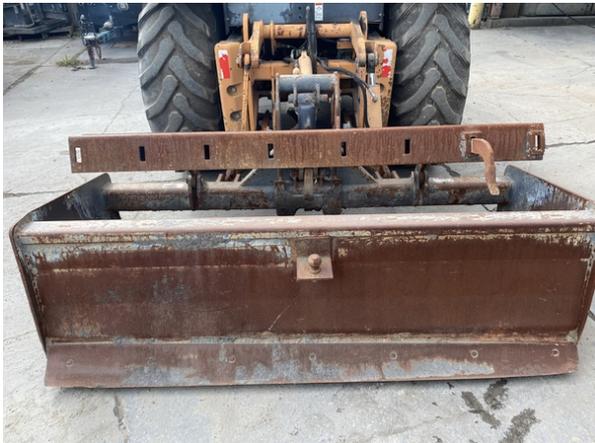
Rear	3 - Normal Wear & Tear
Rear Condition	Other (see comments)
Comments	Normal scuff marks, small crack at left fender, rear panel bent
Rear Photos

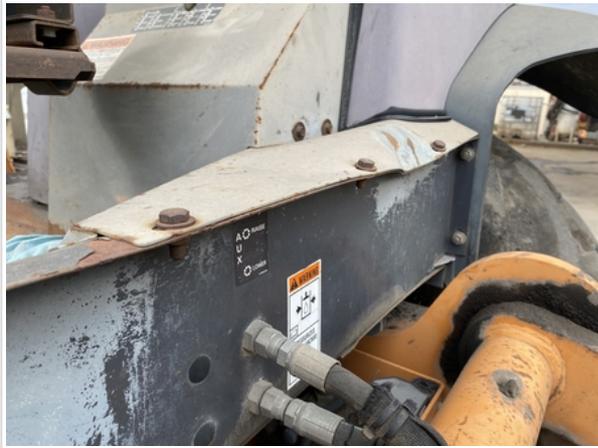
Body Panels (Any Rust Damage?)	3 - Normal Wear & Tear
Body Panel Condition	Other (see comments)
Comments	Body damage to front hood and rear operator platform panel
Body Panels Photos

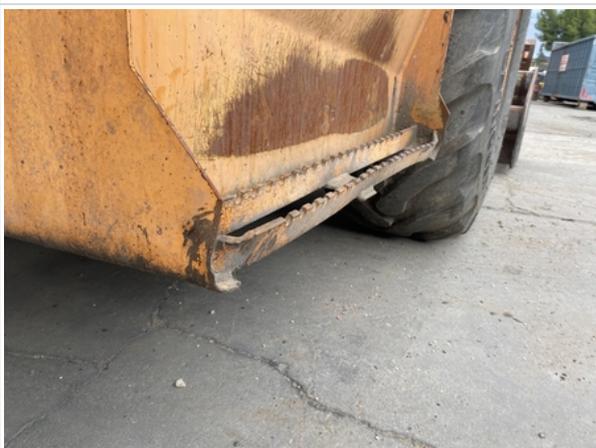
Steps / Ladders	3 - Normal Wear & Tear
Steps / Ladders Condition	Steps/ladders are fully intact and appear structurally sound, Bent or broken steps or rungs, Other (see comments)
Comments	Steps bent slightly
Steps / Ladders Photos

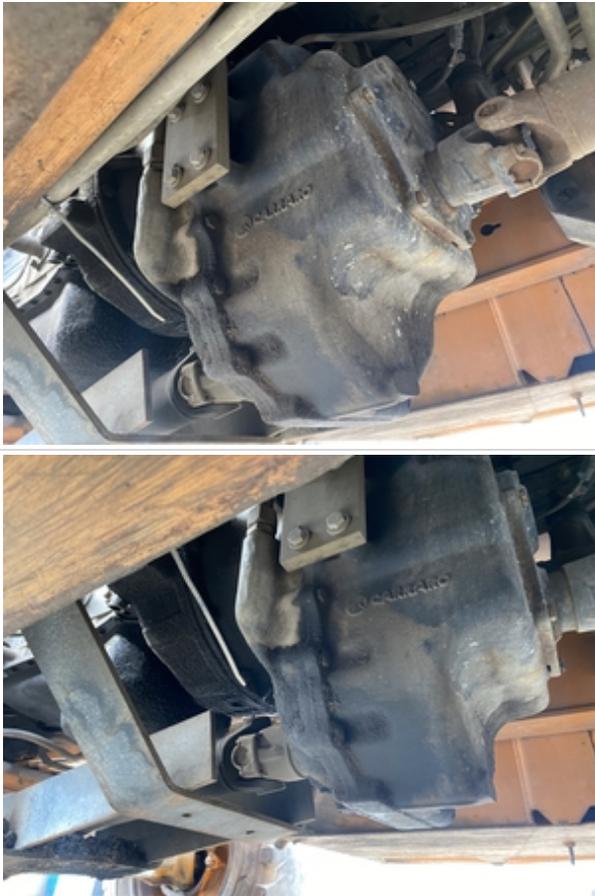
Drivetrain	
Hydrostatic Transmission?	No
Transmission Info (Make/Model/Speeds)	Carraro - All wheel drive - 4 speed - Powershift transmission
Transmission	3 - Normal Wear & Tear
Transmission Condition	No unusual noises or vibrations, Other (see comments)
Comments	Small seepage buildup around bottom of transmission
Transmission Photos

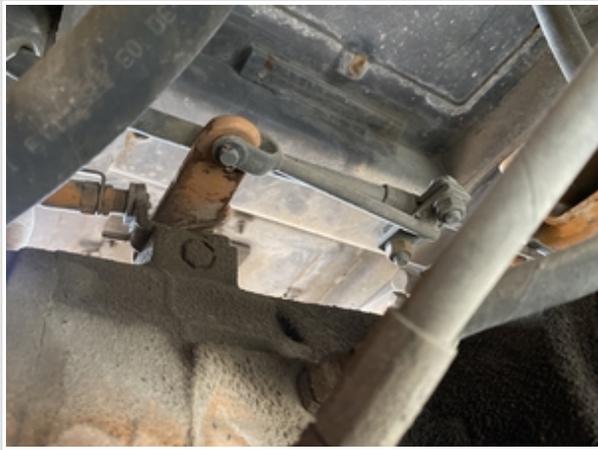
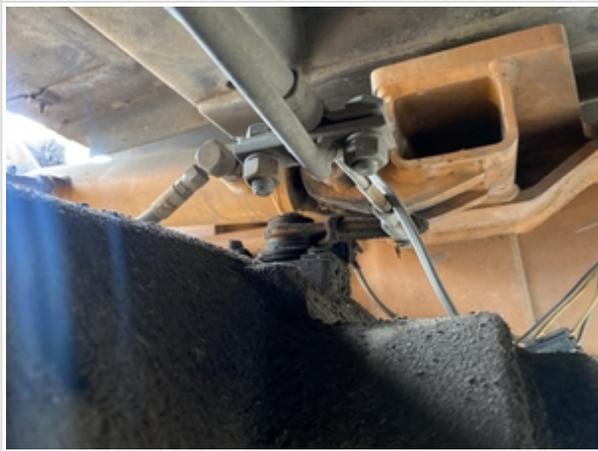
Clutch	0
Shift Lever	3 - Normal Wear & Tear
Shift Lever Condition	Good forward and reverse function
Foot Brake	3 - Normal Wear & Tear
Foot Brake Condition	Good brake function
Inching Brake	0
Parking Brake	3 - Normal Wear & Tear
Parking Brake Condition	Good brake function, Other (see comments)

Comments	Parking brake works (holds in third gear forward) but should be adjusted for proper functionality
Parking Brake Photos

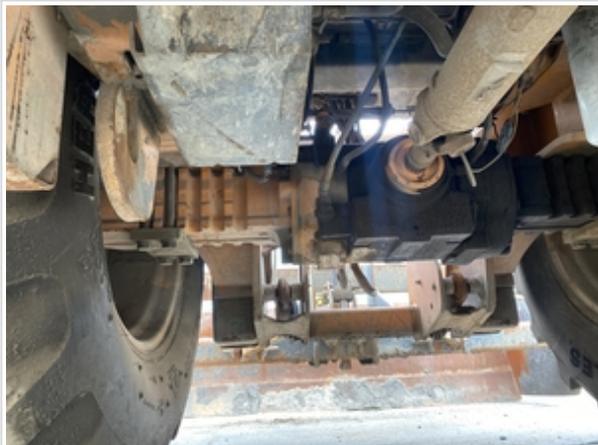
Rear Axle Appearance	3 - Normal Wear & Tear	
Comments	Signs of oil leaks/seepage buildup may have started from top of axle	
Rear Axle Appearance Photos

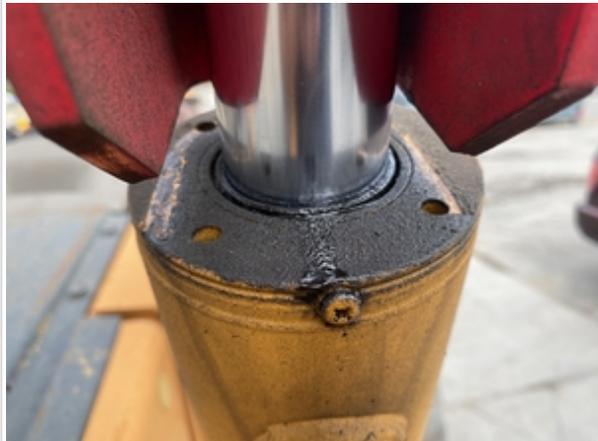
Bucket Lift / Tilt Cylinders	Check the bucket lift and tilt cylinders. Note any wear, pitting, discoloration, etc. Take photos.
Bucket Lift / Tilt Cylinders: Mounting Pin	3
Bucket Lift / Tilt Cylinders: Oil Leaks	Yes
Comments	Minor seepage out of L/S lift cylinder, Left side tilt cylinder has dried seepage buildup but no active leak seen
Bucket Lift / Tilt Cylinders Photos

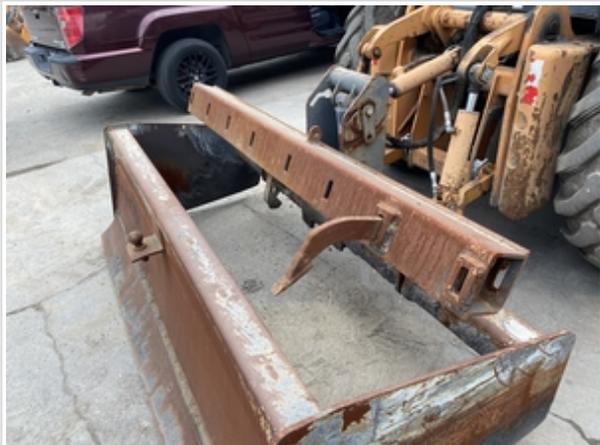
Scarifier	3 - Normal Wear & Tear	
Comments	Missing 7 from Gannon Box	
Scarifier Photos
