Inspection Report (Mini Excavator)

Year	2005
Make	Bobcat
Model	435 HAG
Serial Number	563211071
Hour Meter Reading	3,070
Previous Application (e.g., earth moving, mining, demolition, etc)	General Construction

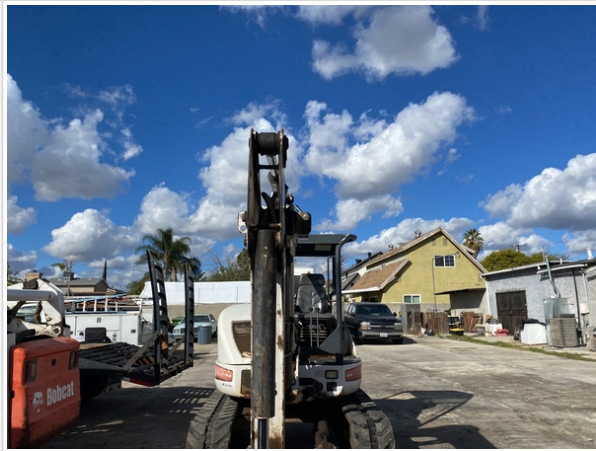
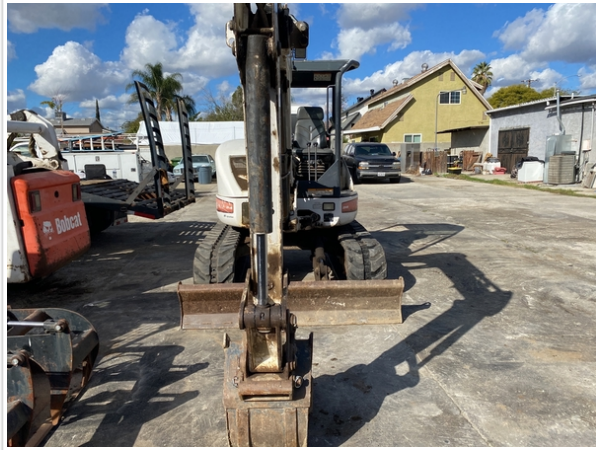
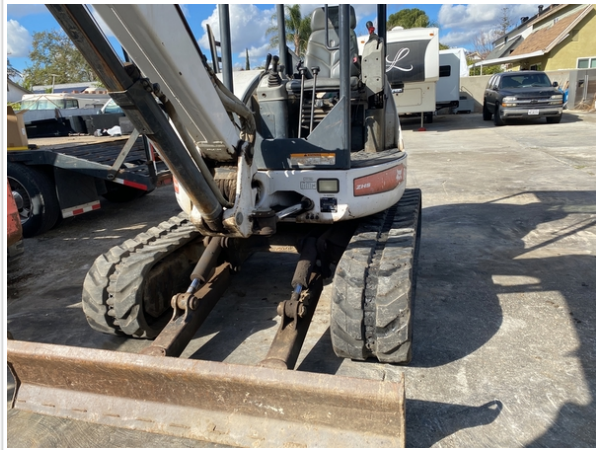
Front	3 - Normal Wear & Tear
Front Condition	No visible damage

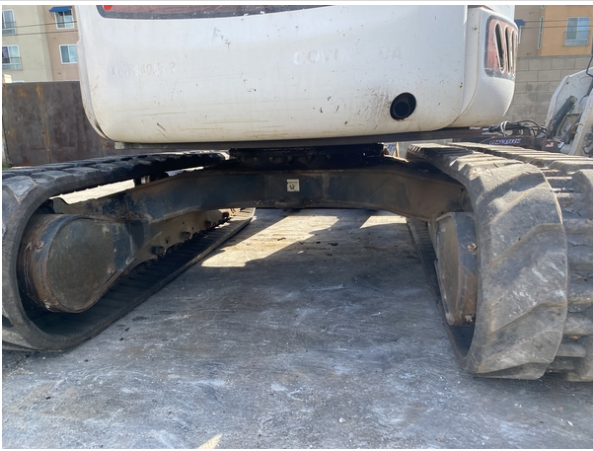
Rear	3 - Normal Wear & Tear
Rear Condition	No visible damage

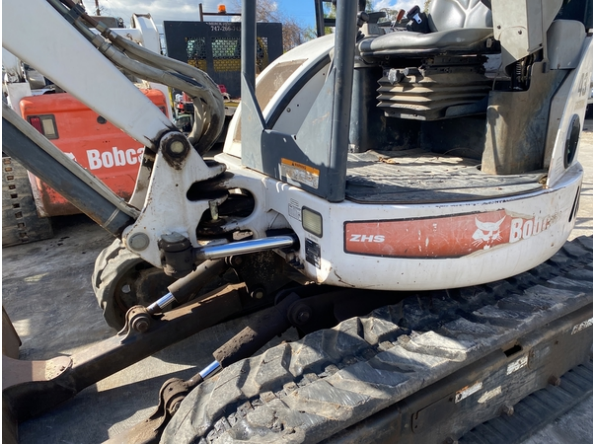
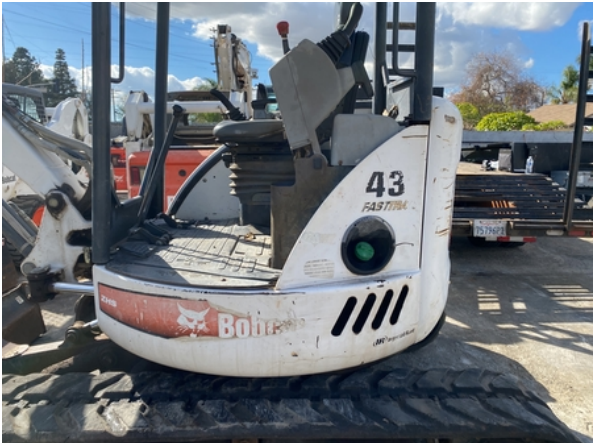
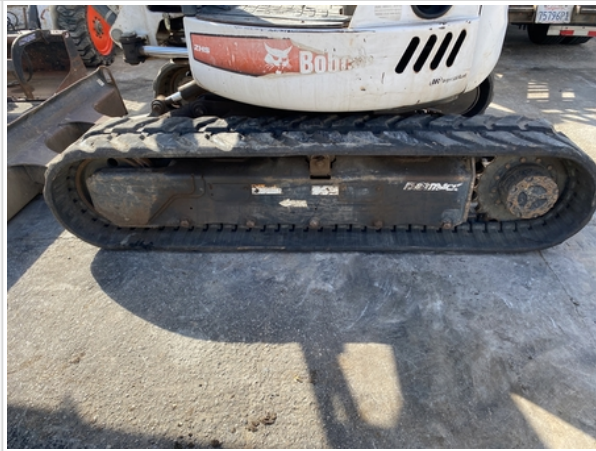
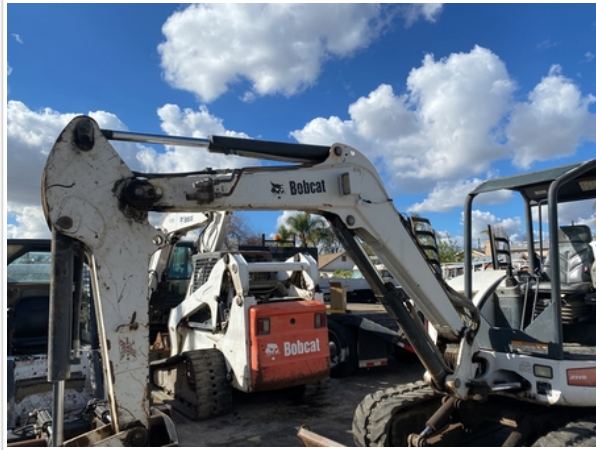
Left	3 - Normal Wear & Tear	
Left Condition	No visible damage	
Left Photos

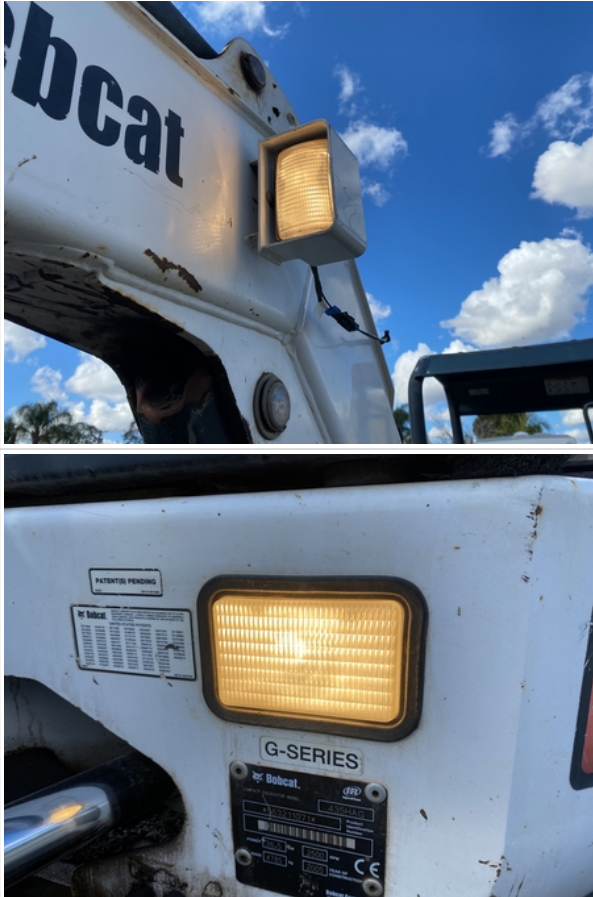
Glass Condition	0
Mirrors	0
Lighting System	3 - Normal Wear & Tear
Lighting System Condition	No visible damage, lighting system is operational
Lighting System Photos

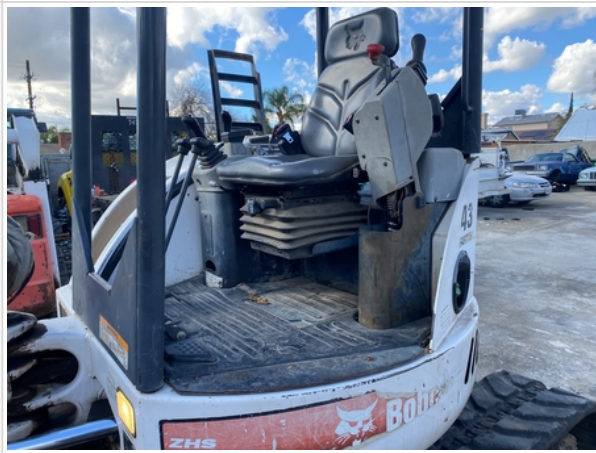
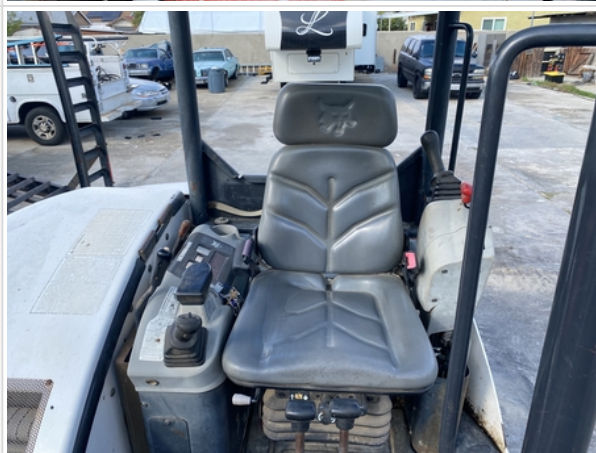
Operator Cabin Overall Condition	Good cabin appearance, solid floors, panels, and ceiling
Operator Cabin Photos

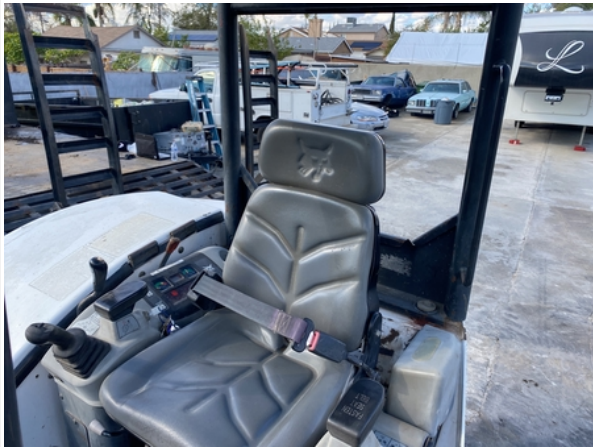
Operator's Seat & Arm Rests	3 - Normal Wear & Tear
Operator's Seat & Arm Rests Condition	Seat(s) in good condition, no stains or tears in upholstery
Operator's Seat & Arm Rests Photos

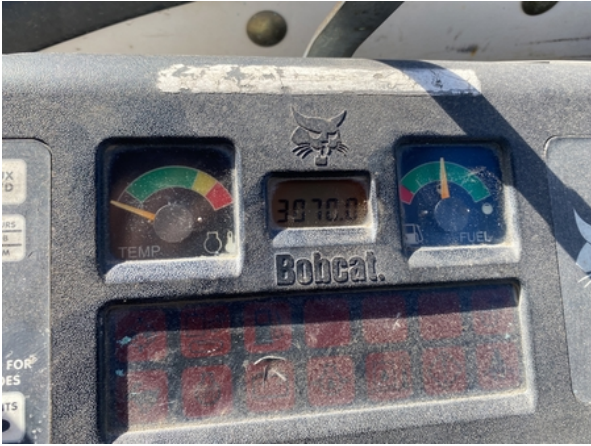
Hour Meter Activity	3 - Normal Wear & Tear	
Hour Meter Condition	Hour meter is functional and in good condition	
Hour Meter Activity Photos	 	
Other Gauge Activity	3 - Normal Wear & Tear	
Other Gauge Condition	All cockpit gauges are functional and in good condition	
Other Gauge Activity Photos

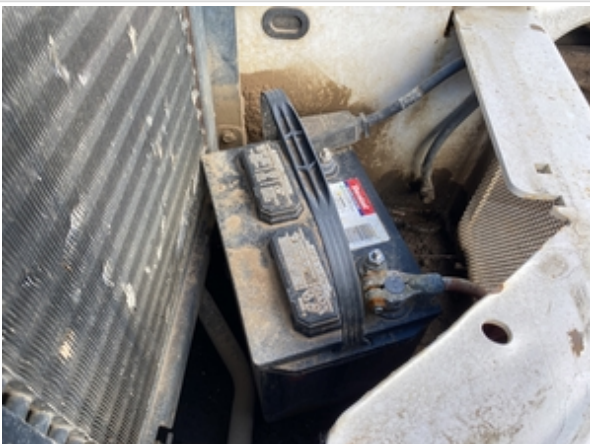
Blow-by (Visual Observation Check)	No	
Unusual Noises (Upon Start-up, Idle, Shutdown)	No	
Unusual Noise Notes	No unusual noises heard	
Engine Smoke (Upon Start-up, Idle, Shutdown)	No	
Engine Smoke Notes	No engine smoke issues observed	
Engine Exhaust Color	Clear, Other (see comments)	
Comments	Minor smoke at startup, goes away once warmed up	
Battery	3 - Normal Wear & Tear	
Battery Condition	Like new, recently replaced, Dusty & dirty appearance	
Comments	Battery just replaced	
Battery Condition Photos

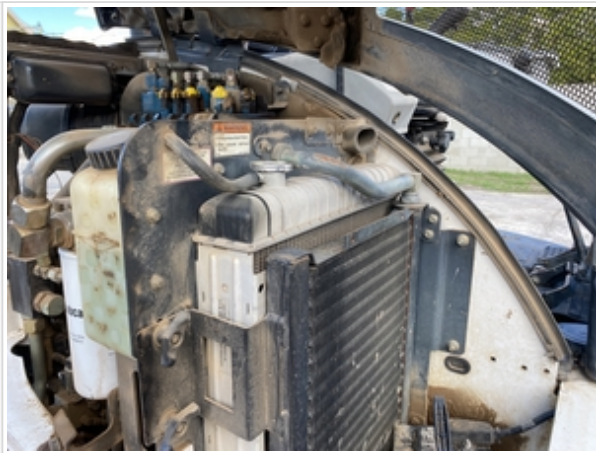
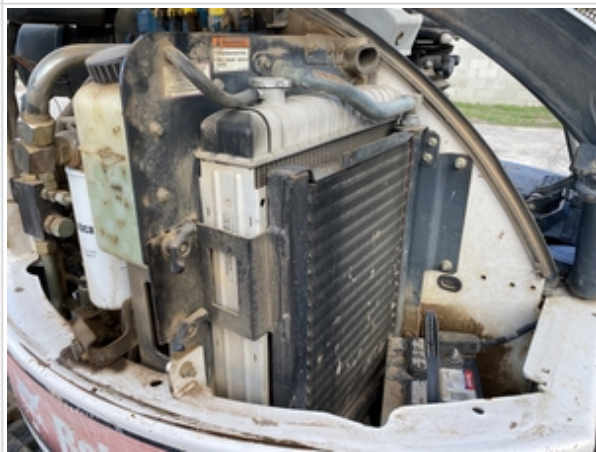
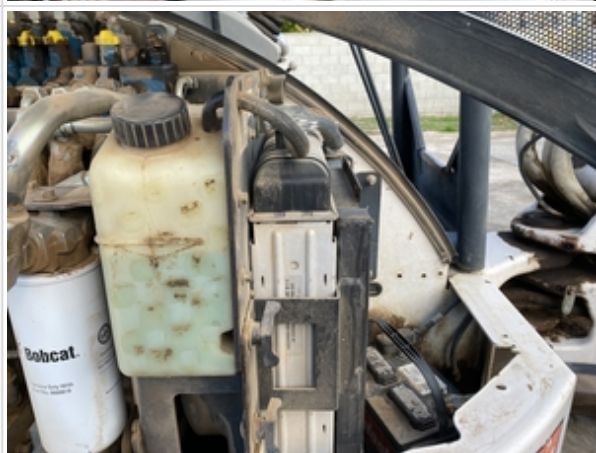
Radiator	3 - Normal Wear & Tear	
Radiator Condition	Radiator fins & components appear to be in good working order, no signs of damage or leaks

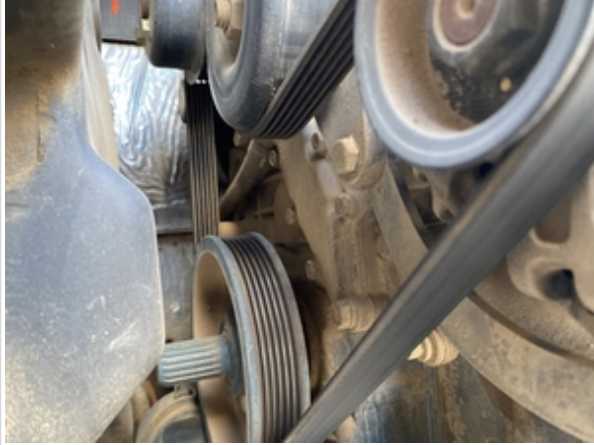
Belts	3 - Normal Wear & Tear
Belt Condition	Belts appear in good condition & alignment with proper tension

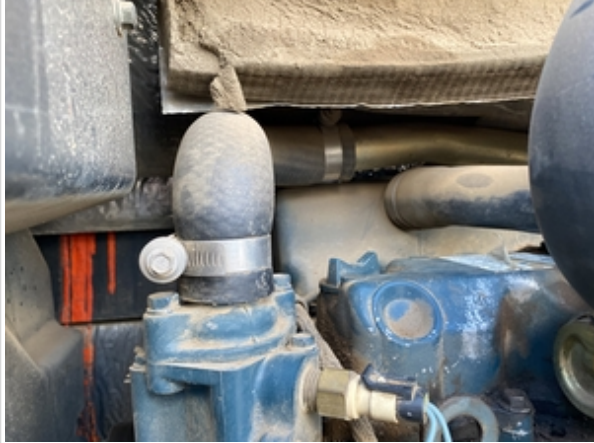
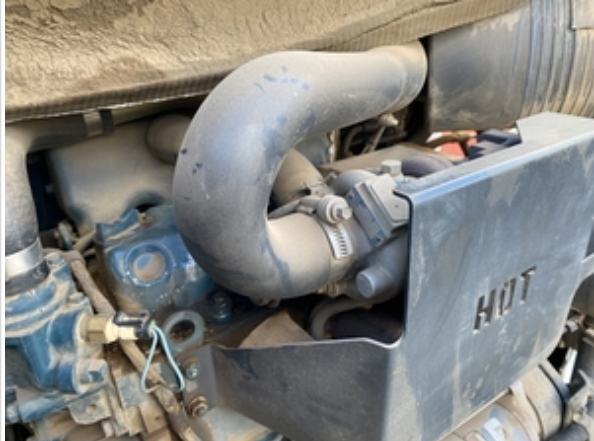
Hoses	3 - Normal Wear & Tear
Hose Condition	Firm, pliant hoses with no signs of wear or leaks
Hose Photos

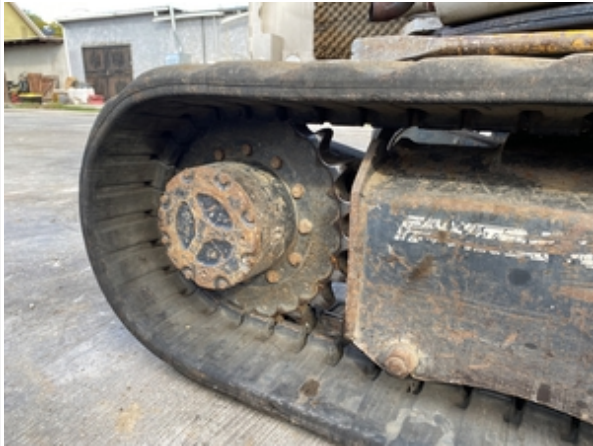
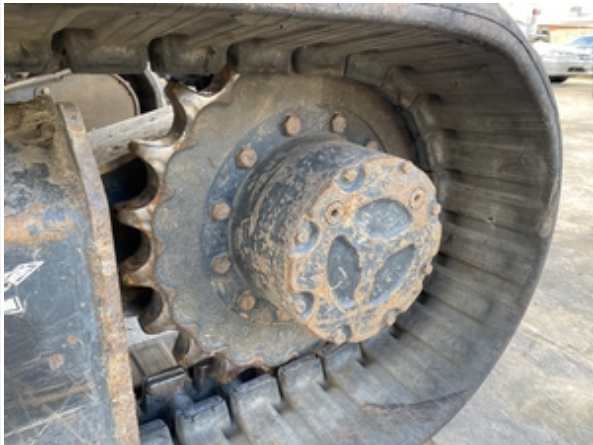
Hydrostatic Transmission?	Yes
2 Speed?	Yes
Hydrostatic Drive Configuration	Split Transmission
Drive Motors	2 - Above Average Wear
Drive Motor Photos

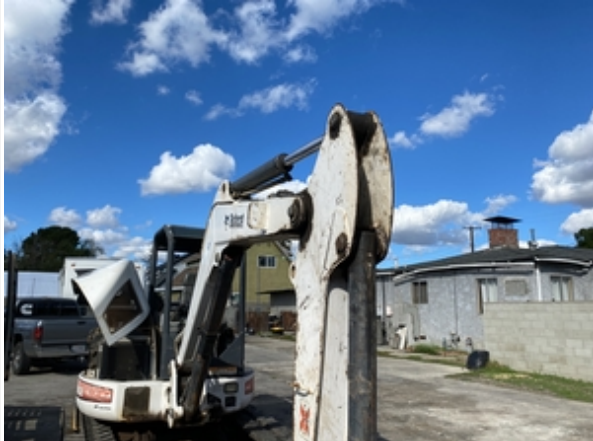
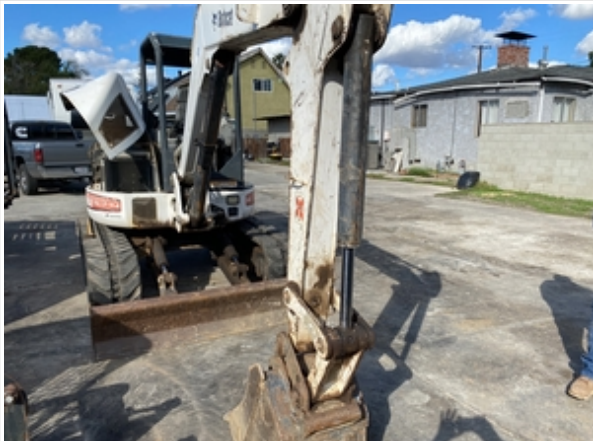
Boom Base Pin & Bushings	3 - Normal Wear & Tear	
Boom to Stick Pin & Bushings	3 - Normal Wear & Tear	
Stick to Bucket Pin & Bushings	3 - Normal Wear & Tear	
Comments	Stick to bucket coupler has some play (may need bushings or spacers)	
Turntable Bearing	3 - Normal Wear & Tear	
Turntable Bearing Photos

Overall Chassis Comments	Overall chassis in good condition. The excess play from stick to bucket coupler should be addressed.
--------------------------	--

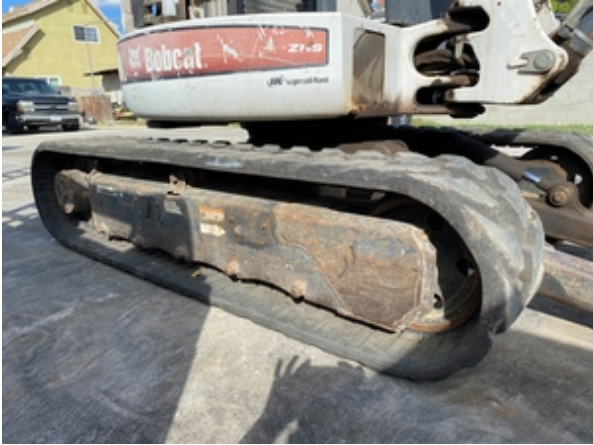
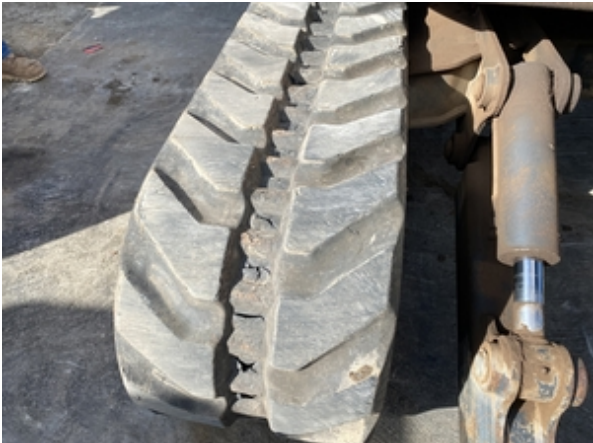
Track Belt	3 - Normal Wear & Tear	
Comments	About 30% to 40%	
Track Belt Photos

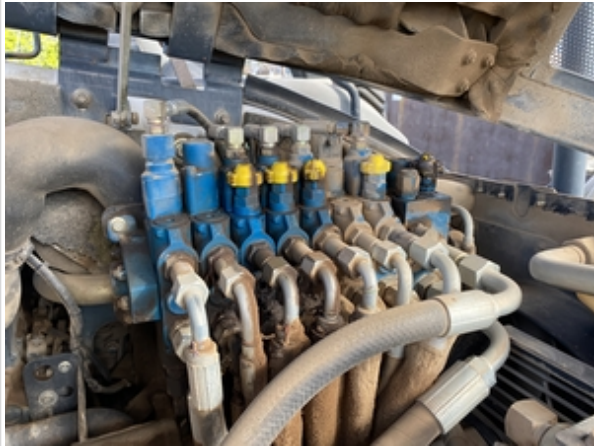
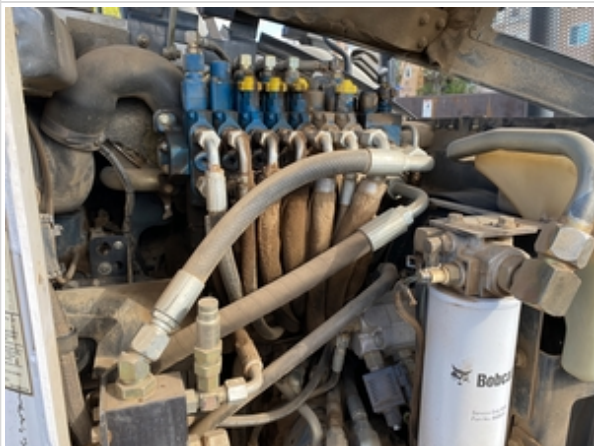
Wet or Damp Hydraulic Lines / Fittings	Yes
Appearance of Hydraulic Lines / Fittings	3 - Normal Wear & Tear
Hydraulic Lines / Fittings Condition	Hydraulic lines & fittings are clean and in good condition, Active leaks in hoses or fittings observed, Other (see comments)
Comments	Observed signs of small hydraulic leaks at main control valve

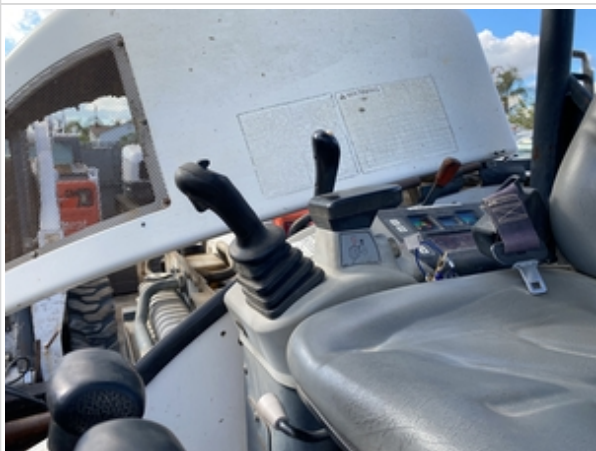
Unusual Noises (Hydraulic Pump)	No	
Hydraulic Pump Notes	No unusual noises heard during operation	
External Controls / Levers	3 - Normal Wear & Tear	
External Controls / Levers Condition	Good function & condition of hydraulic controls	
External Controls / Levers Photos

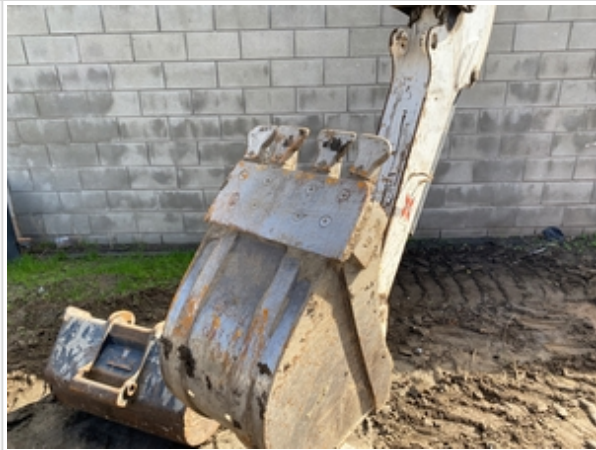
Bucket Hose & Fittings	3 - Normal Wear & Tear
Bucket Cylinder	3 - Normal Wear & Tear
Comments	Left side may need to be resealed soon

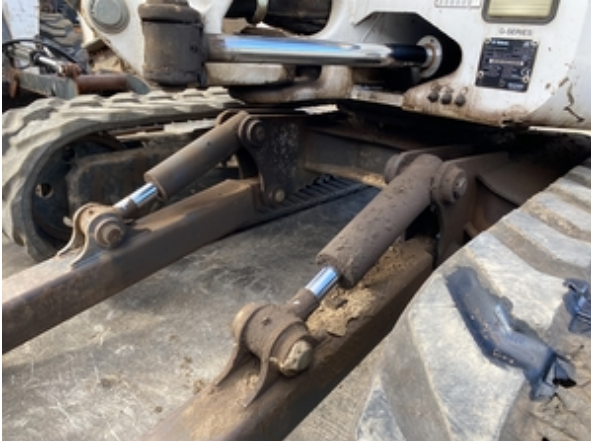
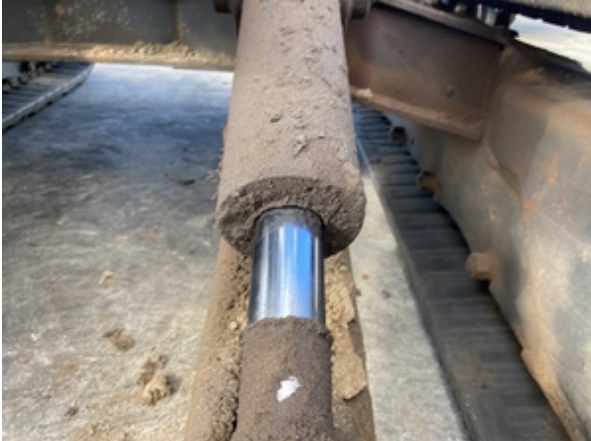
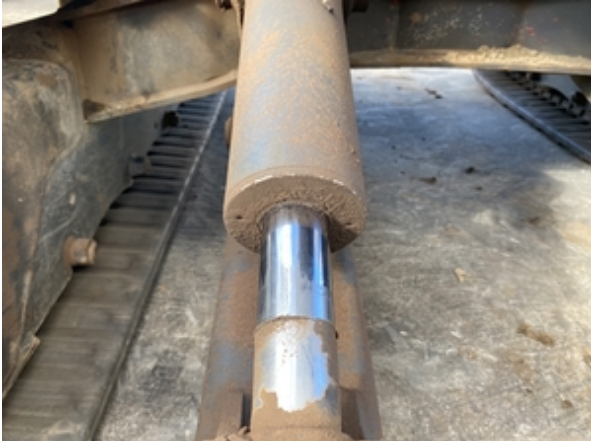
Blade Cylinder	3 - Normal Wear & Tear
Comments	Oil seepage observed at left side blade cylinder rod seal
Blade Cylinder Photos
