Inspection Report (Bulldozer)

Year	2015
Make	CAT
Model	D6T XL
Serial Number	KMR00412
Hour Meter Reading	5,264 Hours
Previous Application (e.g., earth moving, mining, demolition, etc)	General Construction

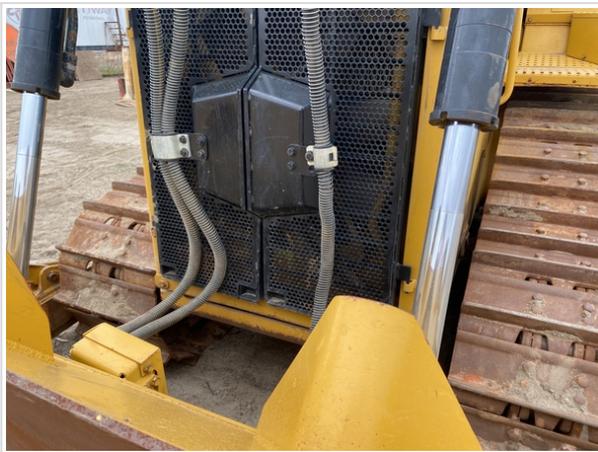
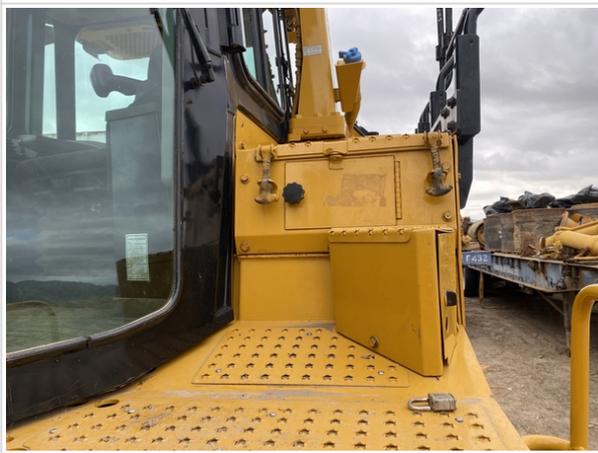
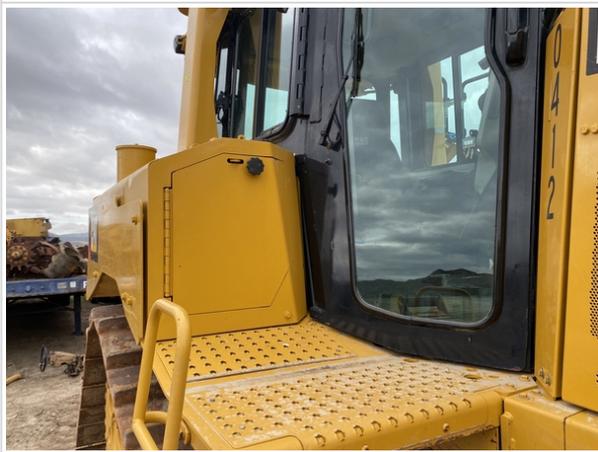
Rear	3 - Normal Wear & Tear
Rear Condition	No visible damage

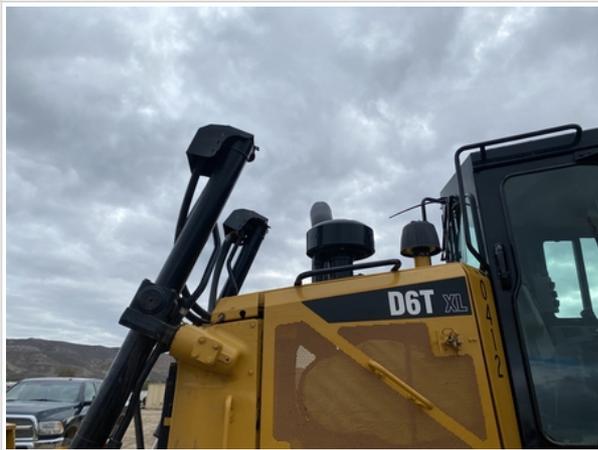
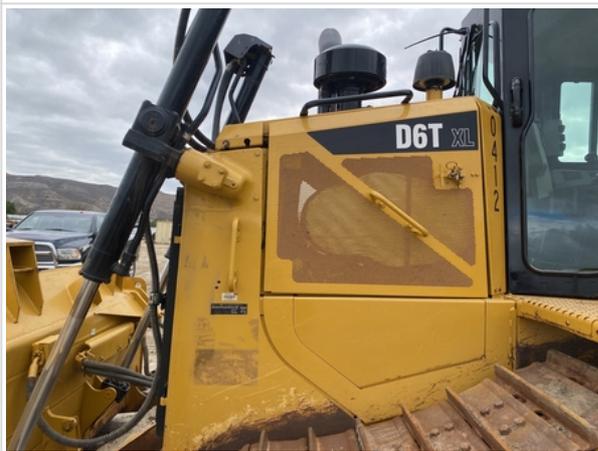
Left	3 - Normal Wear & Tear
Left Condition	No visible damage
Left Photos

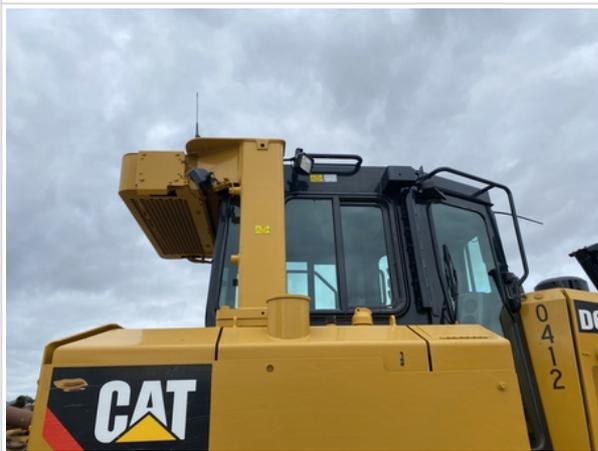
<p>Right</p>	<p>3 - Normal Wear & Tear</p>	
<p>Right Condition</p>	<p>No visible damage</p>	
<p>Right Photos</p>

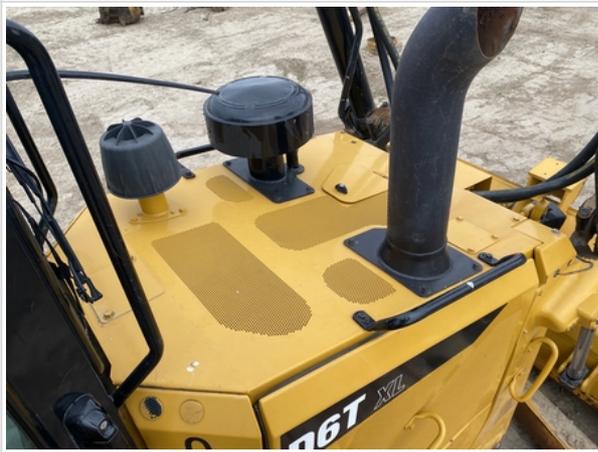
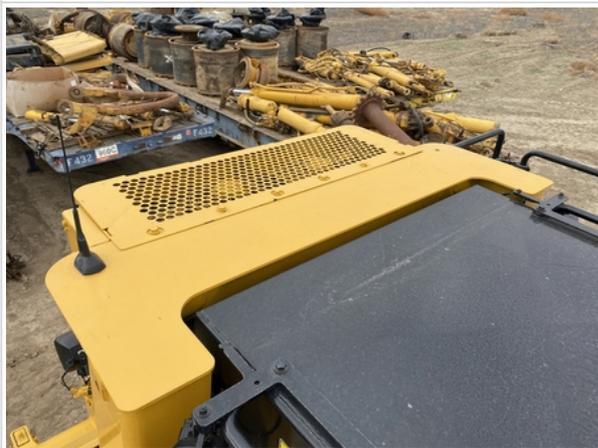
Upper	3 - Normal Wear & Tear	
Upper Photos

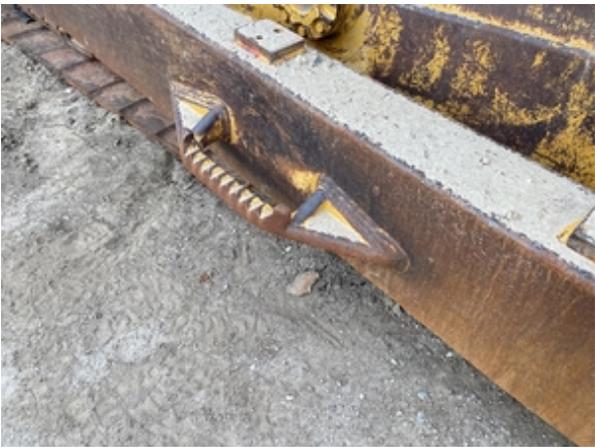
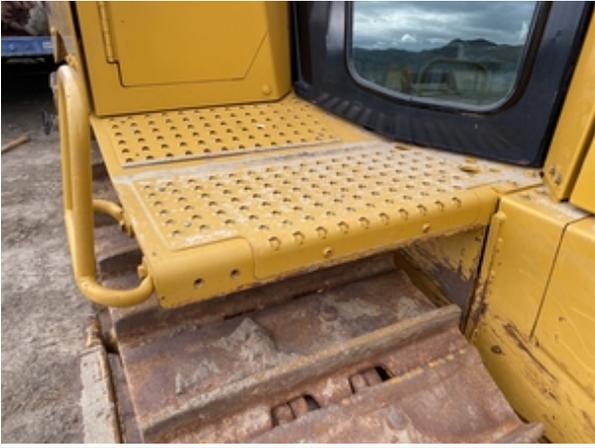
Steps / Ladders	3 - Normal Wear & Tear	
Steps / Ladders Condition	Steps/ladders are fully intact and appear structurally sound	
Steps / Ladders Photos

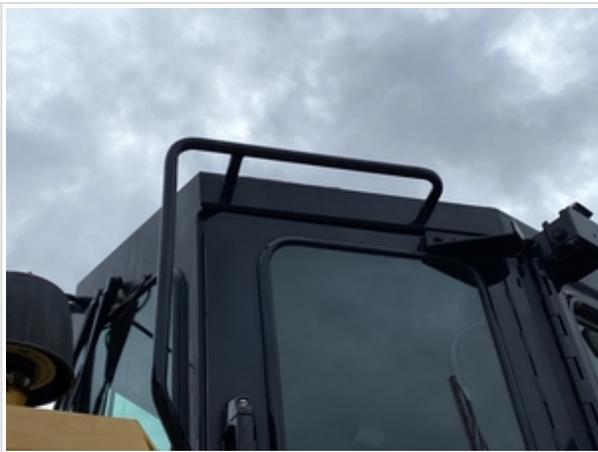
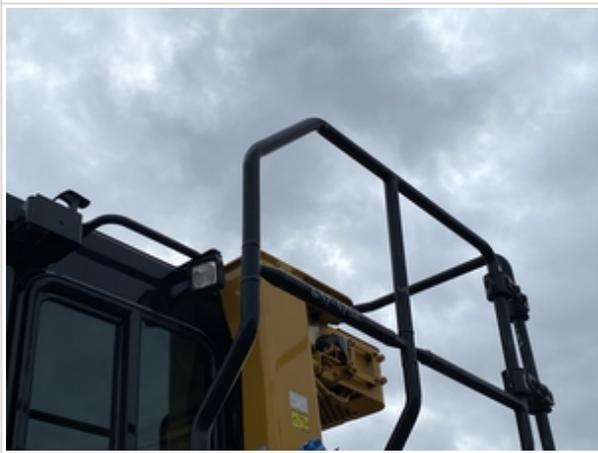
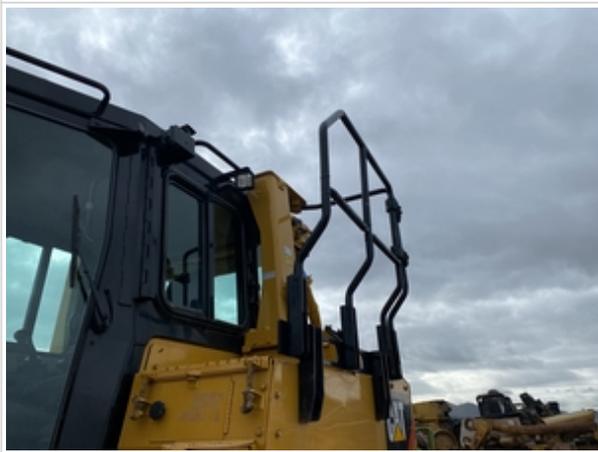
Handrails	3 - Normal Wear & Tear	
Handrails Condition	Handrails are fully intact and appear structurally sound	
Handrail Photos

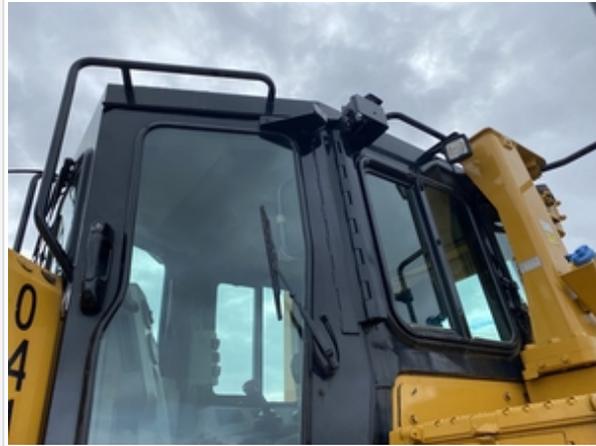
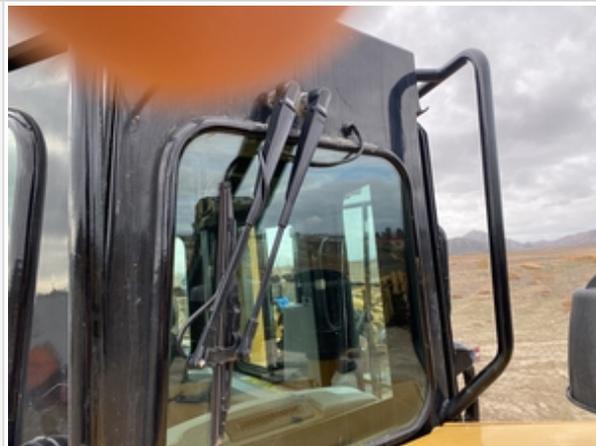
Glass Condition	3 - Normal Wear & Tear
Glass Condition Notes	Glass intact, no visible damage

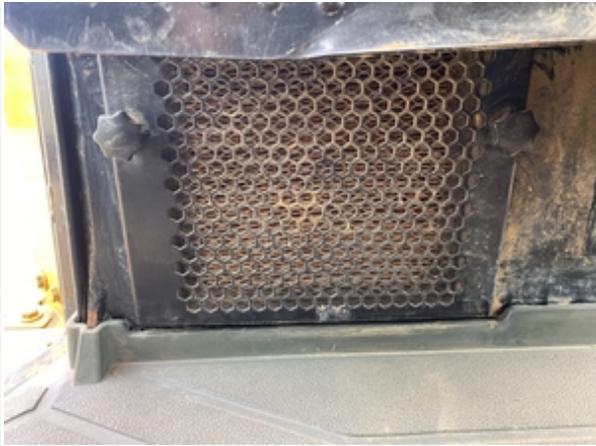
<p>Fans / Vents</p>	<p>3 - Normal Wear & Tear</p>
<p>Fans / Vents Condition</p>	<p>Fan vents are functional, in good condition, and move through a full adjustable range of motion</p>
<p>Fans / Vents Photos</p>

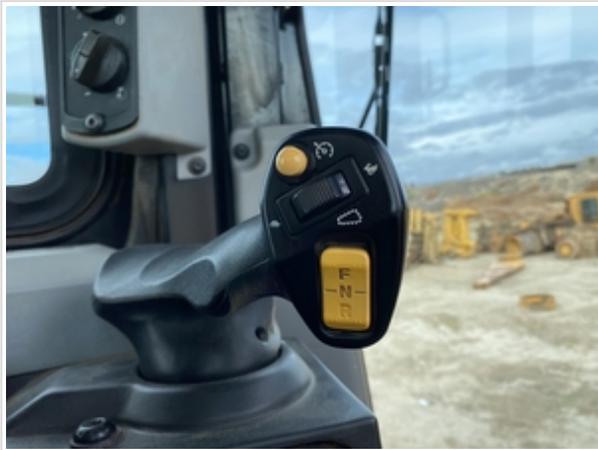
Shift Lever

3 - Normal Wear & Tear

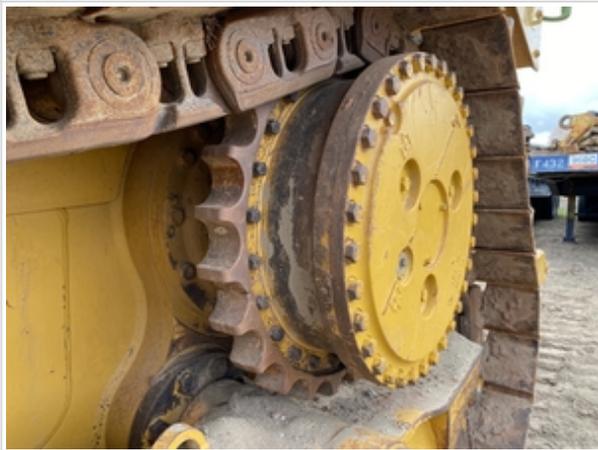
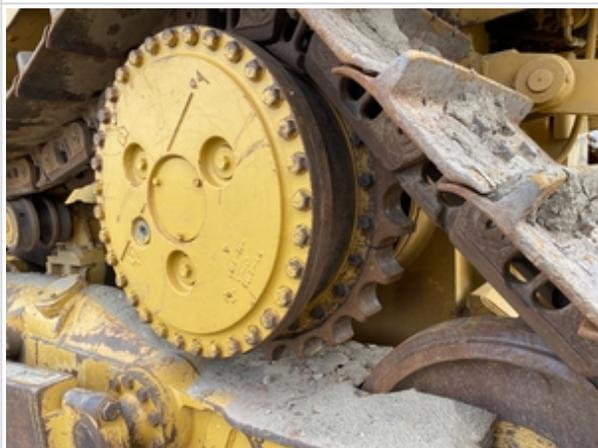
Left Drive Motor	3 - Normal Wear & Tear
Left Final Drive	3 - Normal Wear & Tear
Left Final Drive Photos

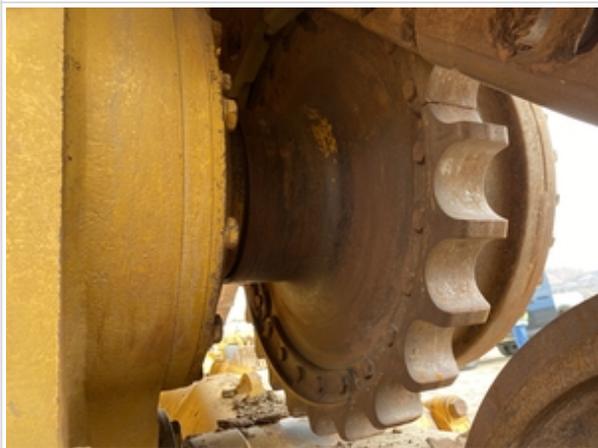
<p>Right Final Drive</p>	<p>3 - Normal Wear & Tear</p>	
<p>Right Final Drive Photos</p>

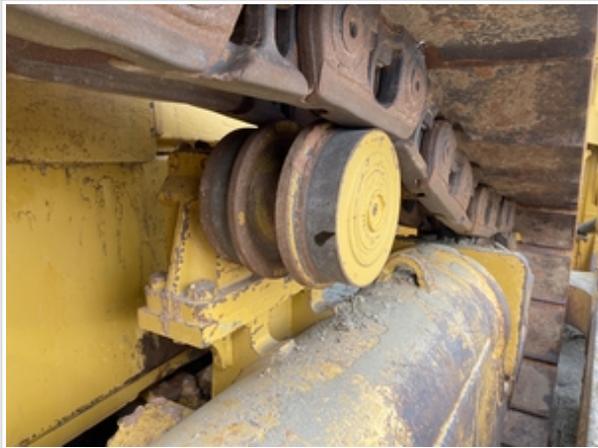
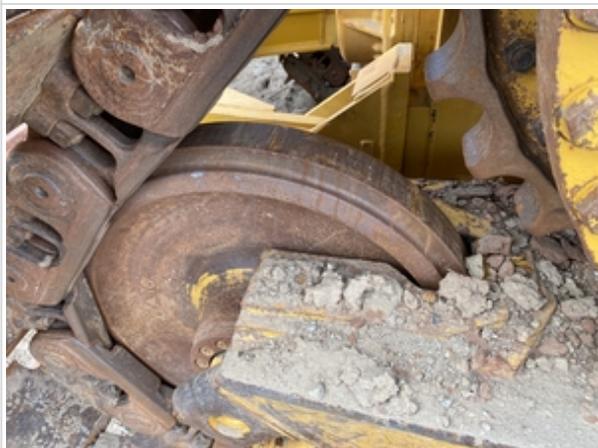
Undercarriage Overall Condition	3 - Normal Wear & Tear	
Comments	Overall thorough track inspection displays about an average of 65% of track wear left	
Undercarriage Overall Photos

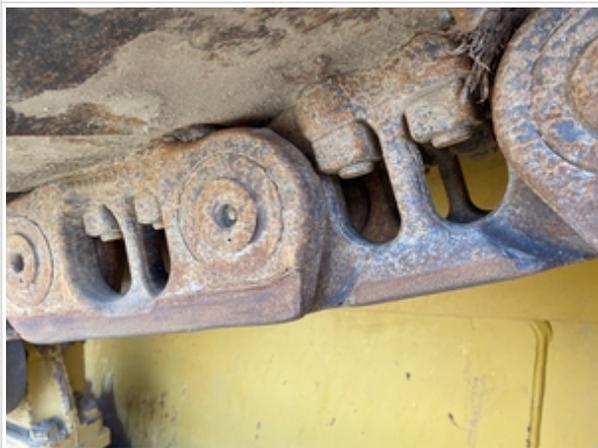
<p>Pin & Bushings</p>	<p>3 - Normal Wear & Tear</p>
<p>Pin & Bushings Photos</p>

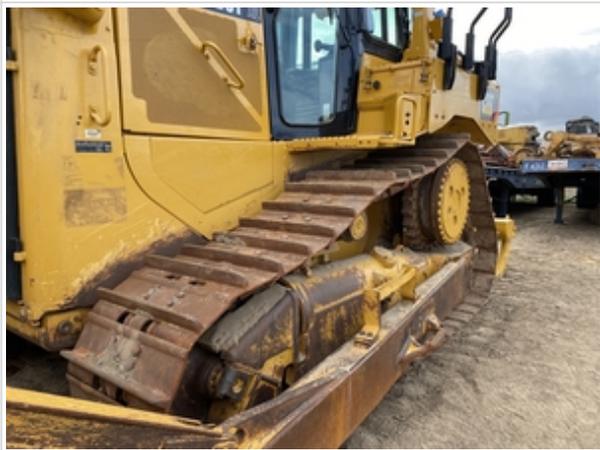
<p>Tracks</p>	<p>3 - Normal Wear & Tear</p>	
<p>Tracks Photos</p>

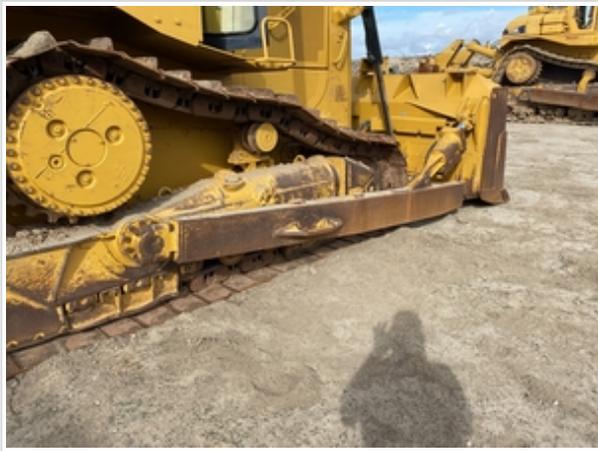
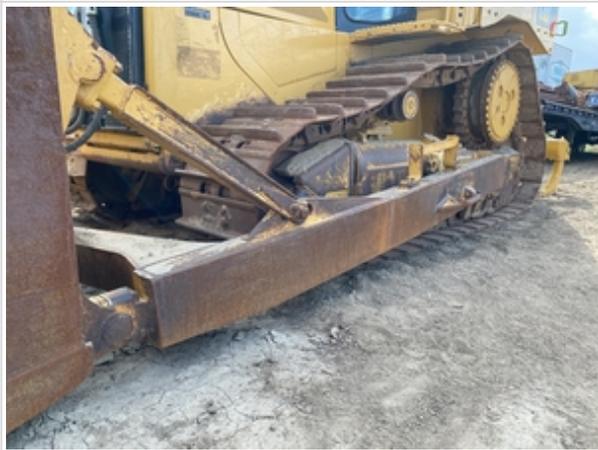
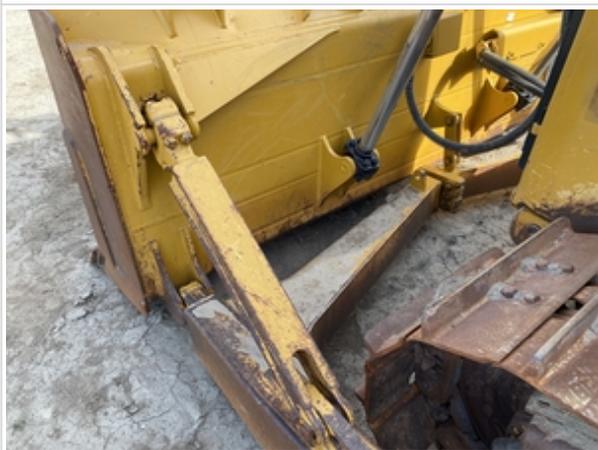
Push Arm / C-Frame Condition	3 - Normal Wear & Tear
Push Arm / C-Frame Photos

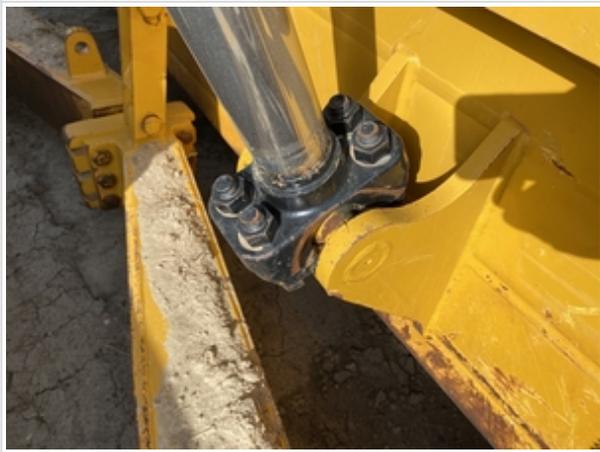
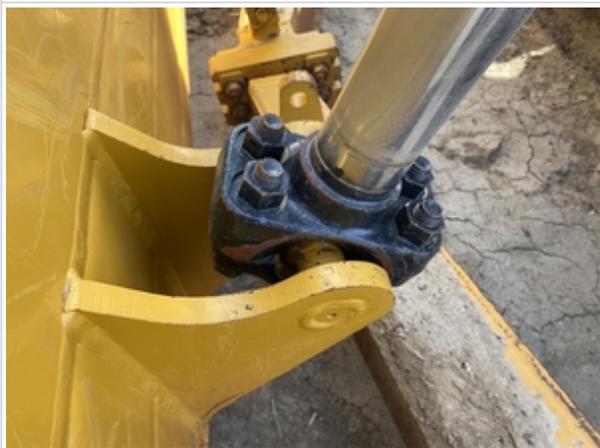
<p>Tilt Linkage Pin & Bushings</p>	<p>3 - Normal Wear & Tear</p>	
<p>Tilt Linkage Pin & Bushings Photos</p>

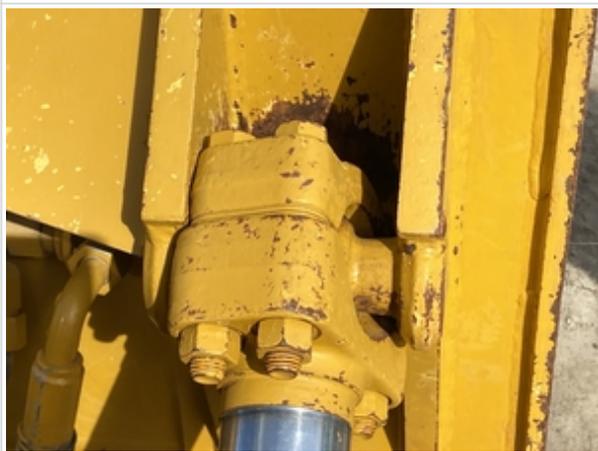
Angle Linkage Pin & Bushings	3 - Normal Wear & Tear	
Blade Trunnions / Bushings	3 - Normal Wear & Tear	
Blade Trunnions / Bushings Photos

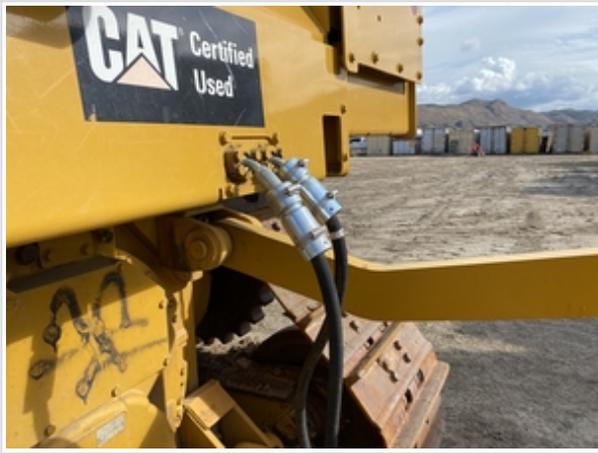
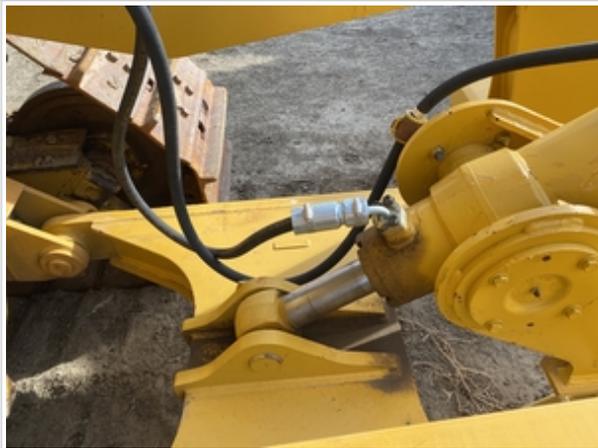
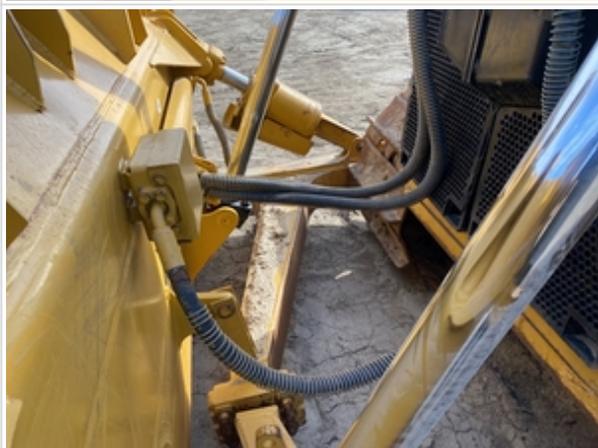
Appearance of Hydraulic Lines / Fittings	3
Hydraulic Lines / Fittings Condition	Hydraulic lines & fittings are clean and in good condition
Appearance of Hydraulic Lines / Fittings Photos

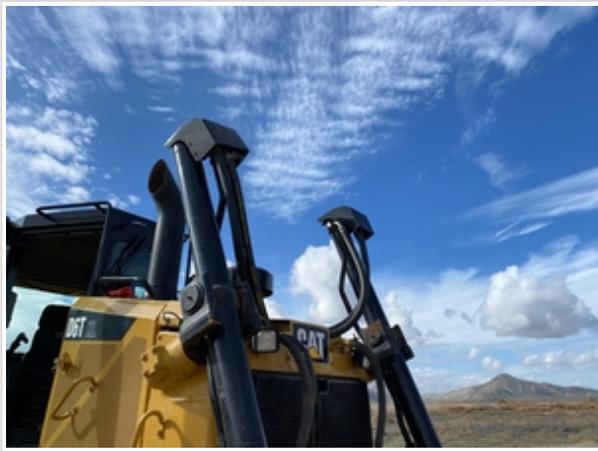
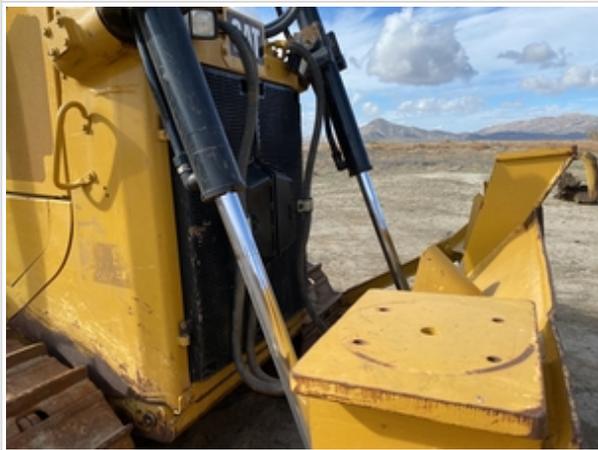
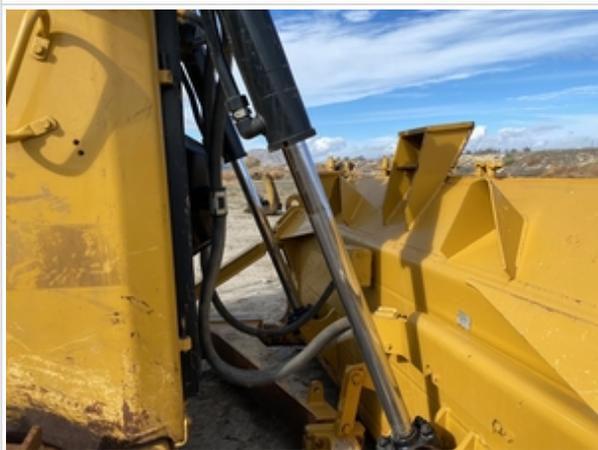
Lift Cylinder	Check the lift cylinder. Note any wear, pitting, discoloration, etc. Take photos.
Lift Cylinder: Mounting Pin	3

Lift Cylinder: Oil Leaks	No
Lift Cylinder Photos

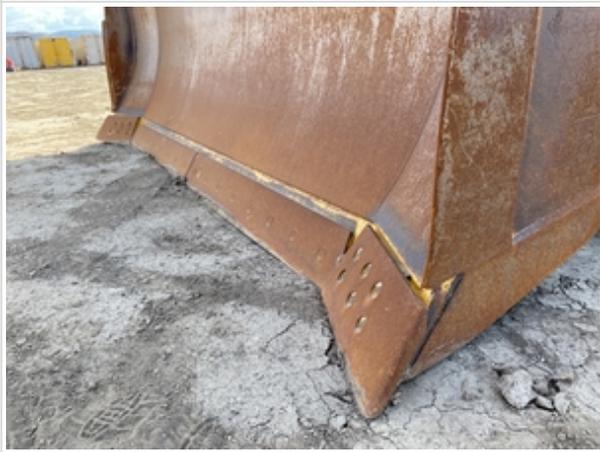
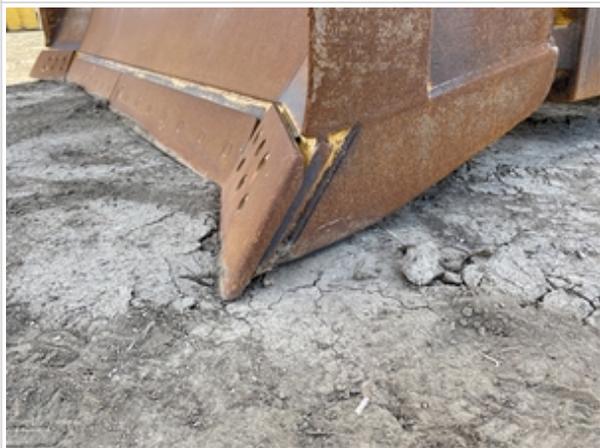
<p>Blade Edge</p>	<p>3 - Normal Wear & Tear</p>	
<p>Blade Edge Photos</p>

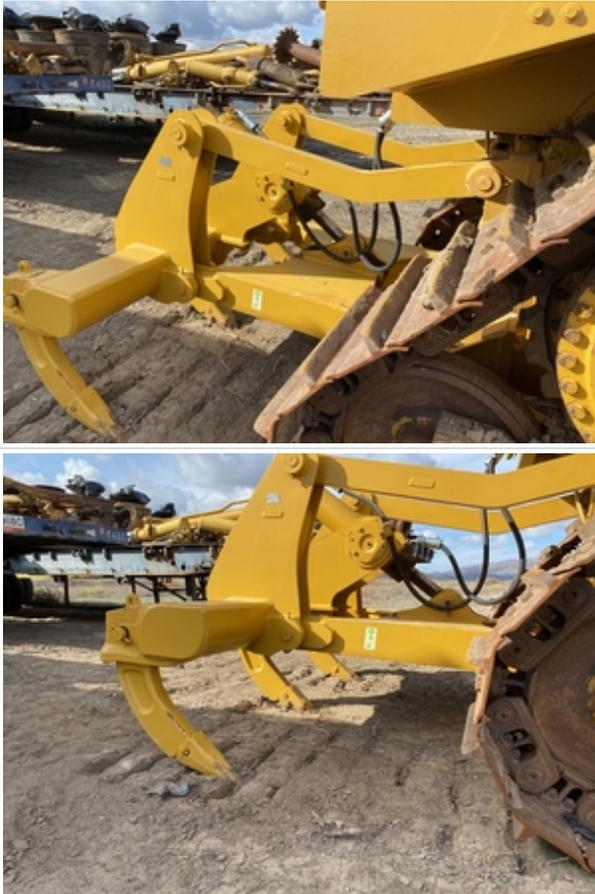
Ripper Condition	3 - Normal Wear & Tear
Ripper Photos
