Inspection Report (On-Highway Flatbed Truck)

Year	2013
Make	Ford
Model	F750
Serial Number	3FRWF7FG1DV019792
Truck Odometer Reading	29,140
Current Inspection / State Cert / DOT	N/A
Previous Application (e.g., earth moving, mining, demolition, etc)	General Construction

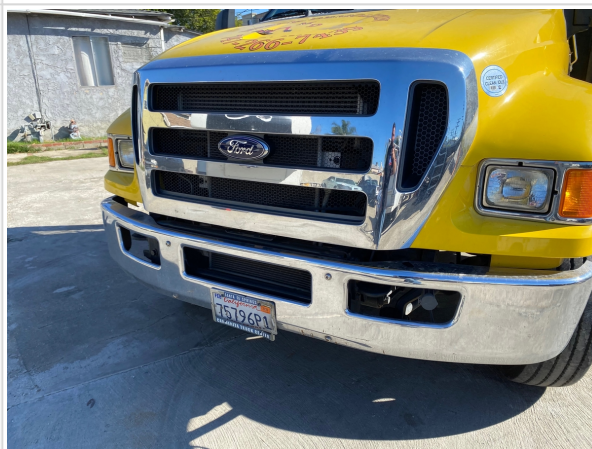
Front	3 - Normal Wear & Tear
Front Condition	No visible damage
Front Photos

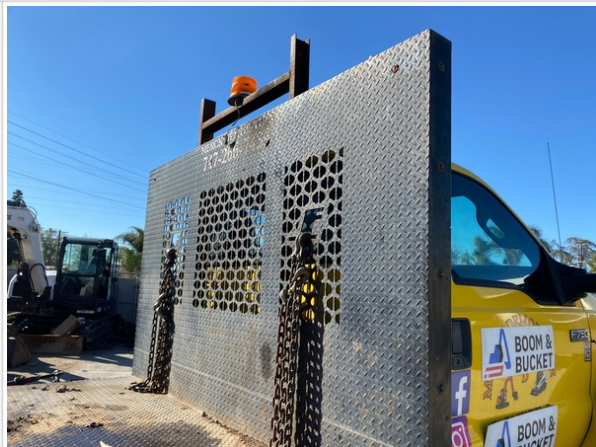
Rear	3 - Normal Wear & Tear	
Rear Condition	No visible damage	
Rear Photos

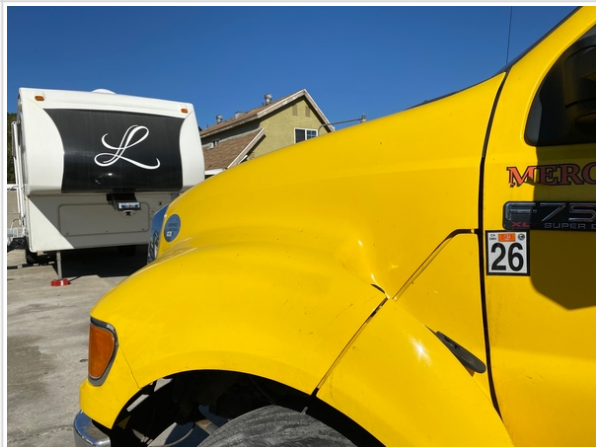
<p>Left</p>	<p>3 - Normal Wear & Tear</p>
<p>Left Condition</p>	<p>No visible damage</p>
<p>Left Photos</p>

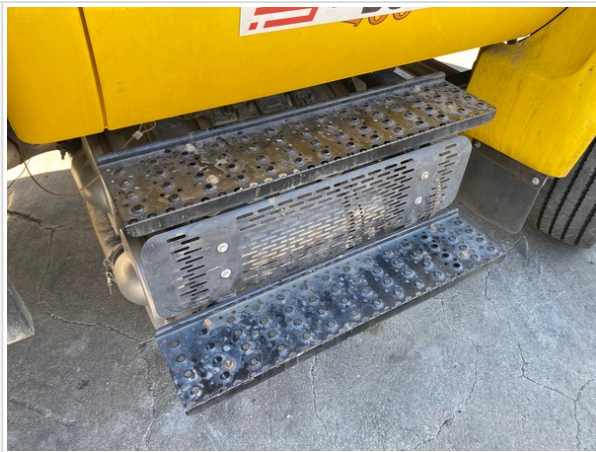
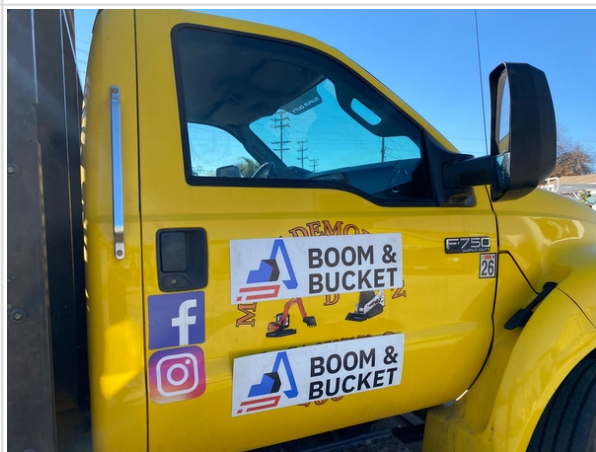
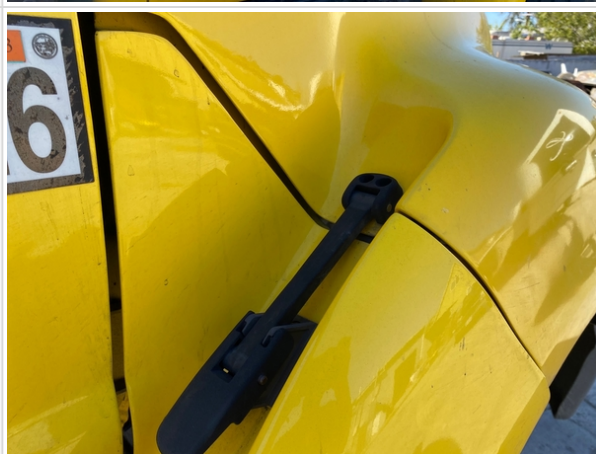
Right Photos

<p>Right</p>	<p>3 - Normal Wear & Tear</p>
<p>Right Condition</p>	<p>No visible damage</p>

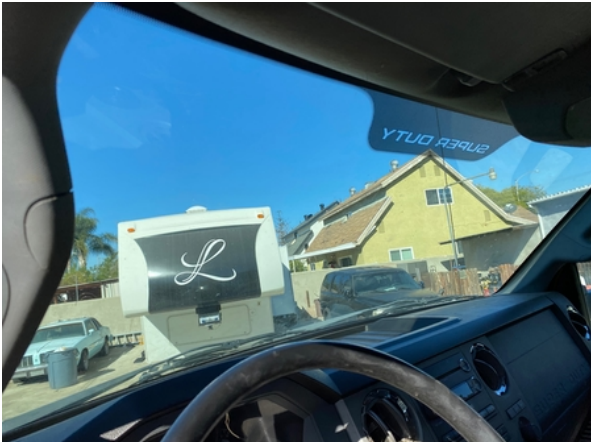
Steps / Ladders Condition	Steps/ladders are fully intact and appear structurally sound
Handrails	3 - Normal Wear & Tear
Handrails Condition	Handrails are fully intact and appear structurally sound
Glass Condition	3 - Normal Wear & Tear
Glass Condition Notes	Glass intact, no visible damage
Glass Condition Photos

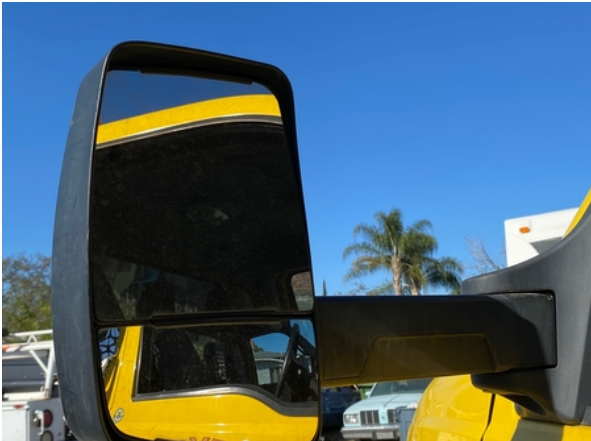
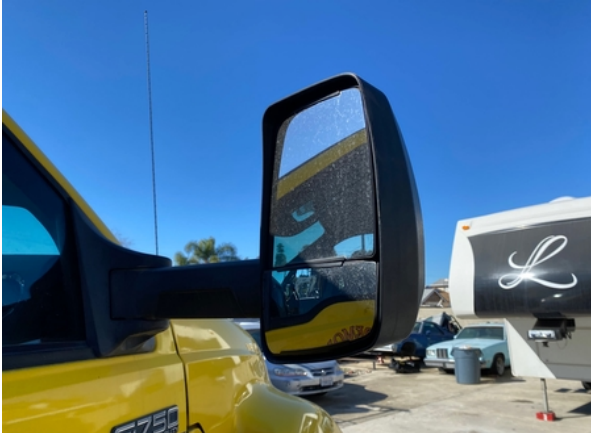
Mirrors	3 - Normal Wear & Tear
Mirror Condition Notes	Mirrors present and intact, no visible damage
Mirrors Photos

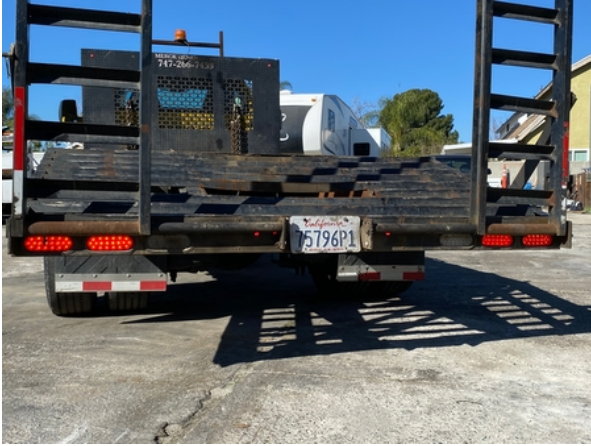
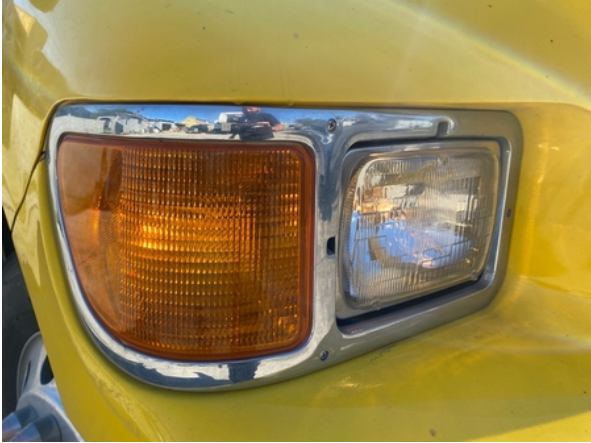
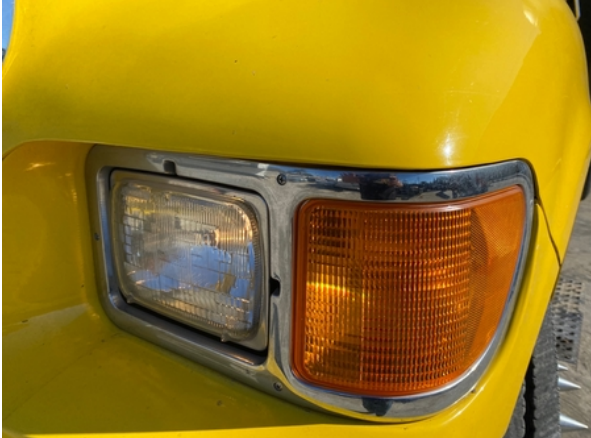
Lighting System	3 - Normal Wear & Tear
Lighting System Condition	No visible damage, lighting system is operational
Lighting System Photos

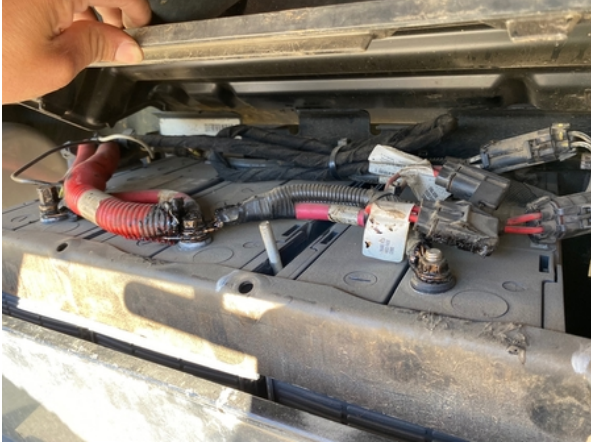
Battery Condition Photos

Blow-by (Visual Observation Check)	No
Unusual Noises (Upon Start-up, Idle, Shutdown)	No
Unusual Noise Notes	No unusual noises heard
Engine Smoke (Upon Start-up, Idle, Shutdown)	No
Engine Smoke Notes	No engine smoke issues observed
Engine Exhaust Color	Clear
Battery	3 - Normal Wear & Tear
Battery Condition	Dusty & dirty appearance

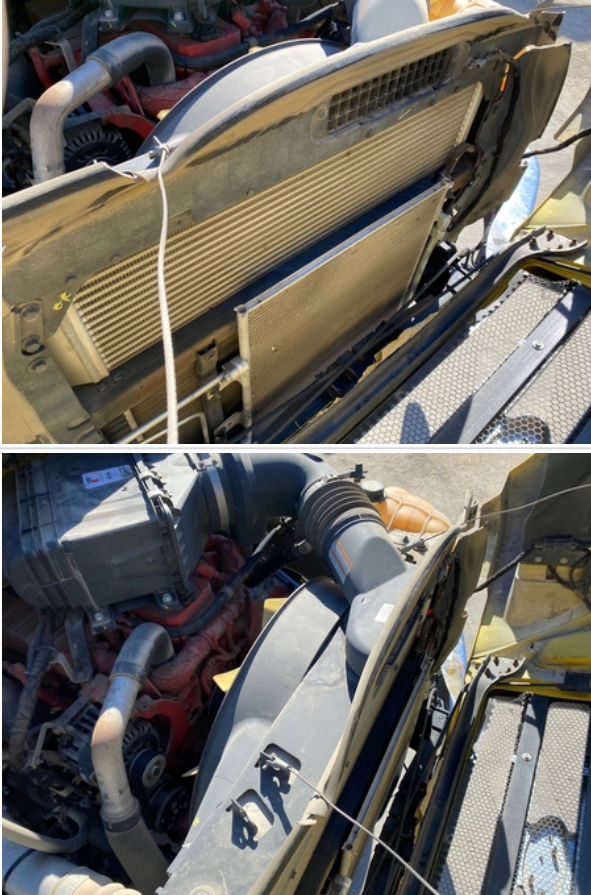
Radiator	3 - Normal Wear & Tear
Radiator Condition	Radiator fins & components appear to be in good working order, no signs of damage or leaks
Radiator Photos

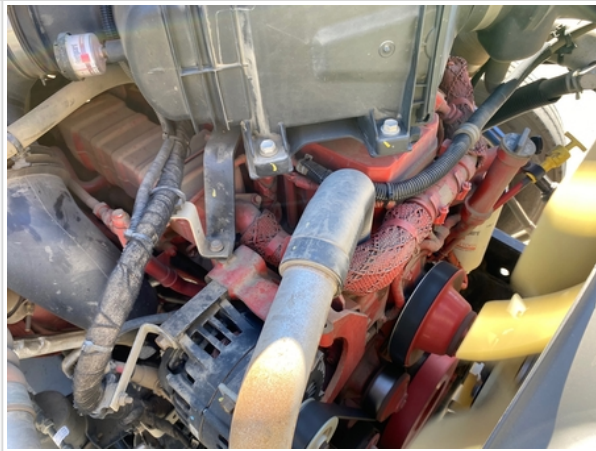
Belt Photos

Belts	3 - Normal Wear & Tear
Belt Condition	Belts appear in good condition & alignment with proper tension

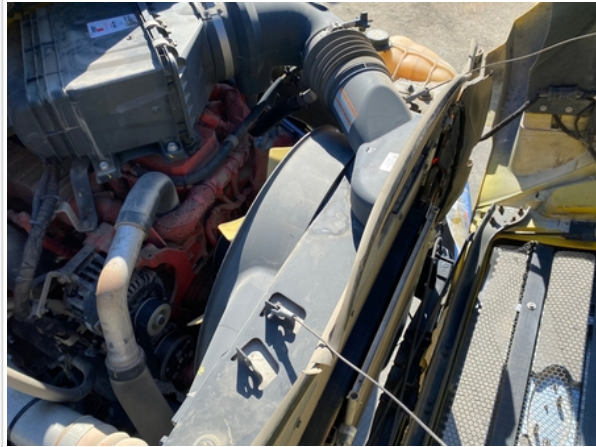
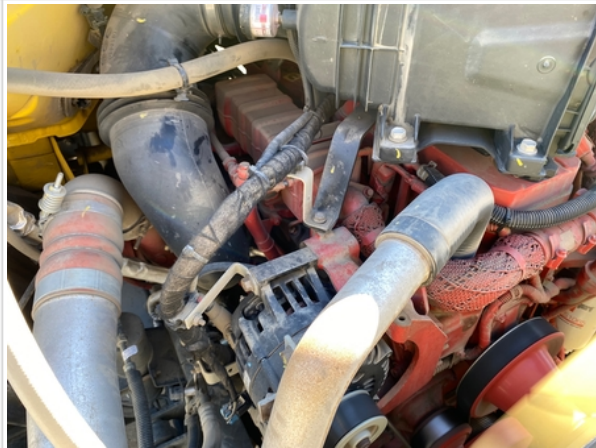
Hoses	3 - Normal Wear & Tear
Hose Condition	Firm, pliant hoses with no signs of wear or leaks
Hose Photos

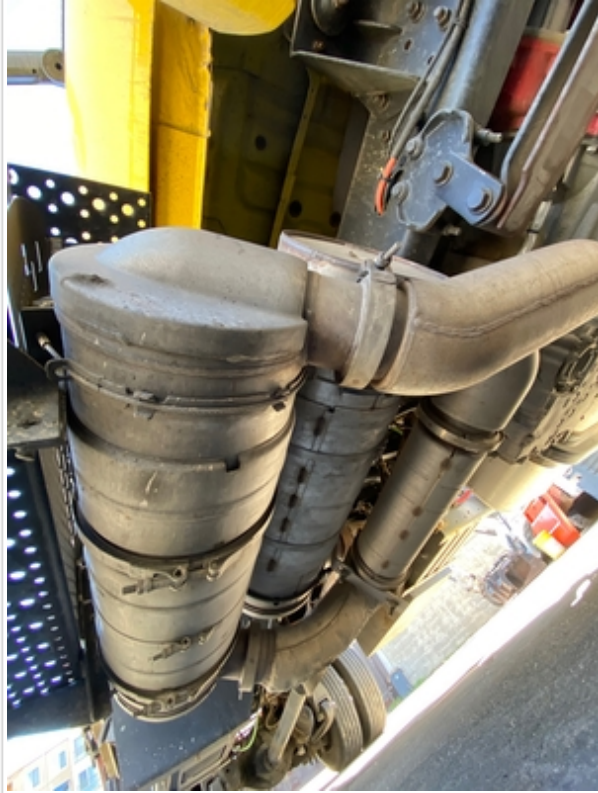
DPF Photos

Water Pump	3 - Normal Wear & Tear
Water Pump Condition	No unusual pump noises heard
Cooling System Leaks	No
Coolant Color / Appearance	3 - Normal Wear & Tear
Coolant Color/Appearance Notes	Normal Translucent appearance, no visual signs of contamination
Oil Leaks	No
Oil Color / Appearance	3 - Normal Wear & Tear
Oil Color / Appearance Notes	Clean oil appearance, no signs of cross contamination, Appropriate oil level
Fuel Leaks	No
Equipped with DPF (Diesel Particulate Filter)	Yes
DPF Condition	3 - Normal Wear & Tear
DPF Condition Notes	Filter housing is intact with no signs of damage or malfunction, DPF indicator is not illuminated

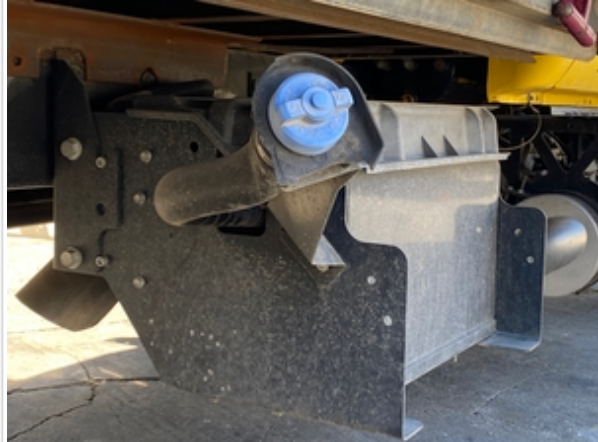
Requires DEF (Diesel Exhaust Fluid)	Yes
DEF Tank	3 - Normal Wear & Tear
DEF Tank Condition	Area around DEF tank cap is clean, fluid is clear & appears free of contaminants
DEF Tank Photos

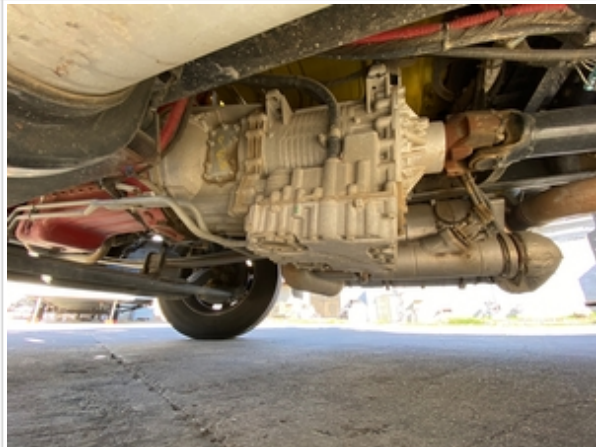
Transmission Info (Make/Model)	Allison- 6 Speed - Auto Trans.	
Drive Type	4X2	
Overdrive	Yes	
Transmission	3 - Normal Wear & Tear	
Transmission Condition	No unusual noises or vibrations	
Transmission Condition Photos

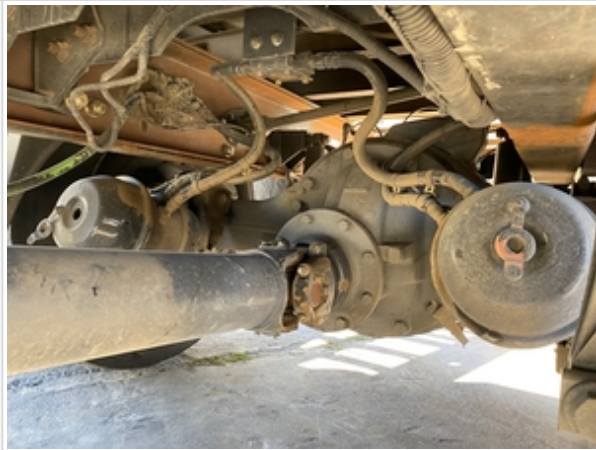
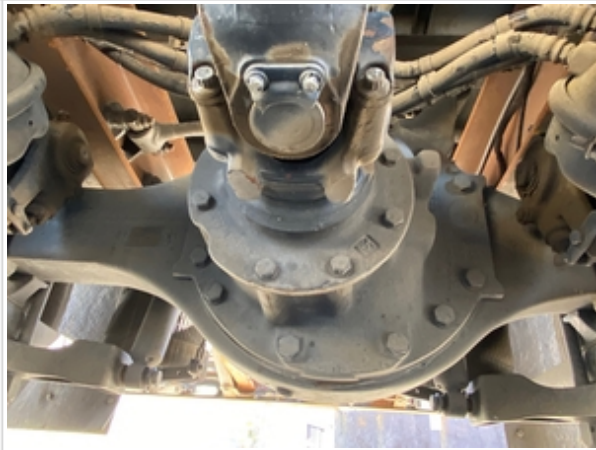
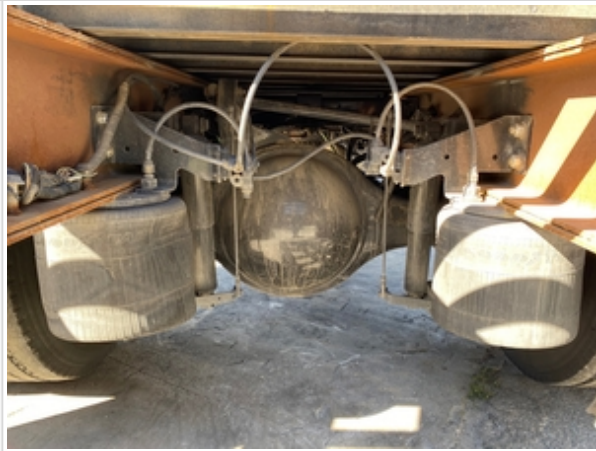
Rear Differential Photos

Clutch	0	
Shift Lever	3 - Normal Wear & Tear	
Shift Lever Condition	Good forward and reverse function	
Differential	Check condition of the differential(s). Take photos and notes as relevant.	
Rear Differential	3 - Normal Wear & Tear	
Rear Differential Condition	Dry housing appearance, no unusual noises heard during operation

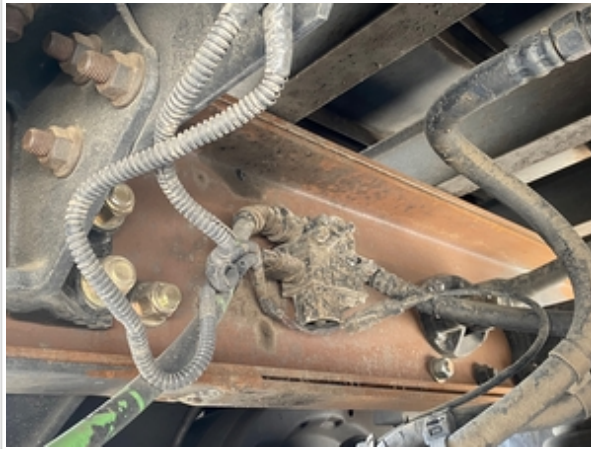
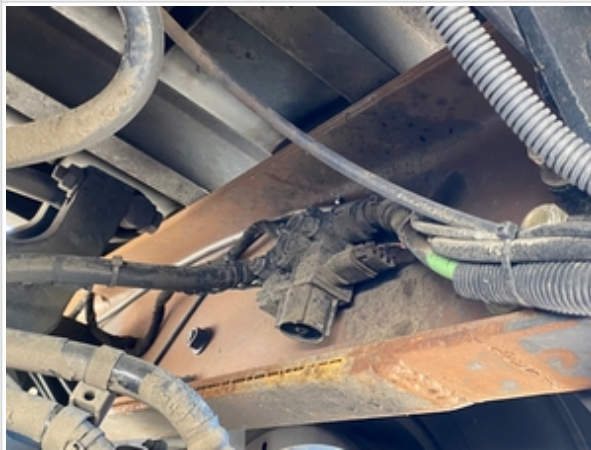
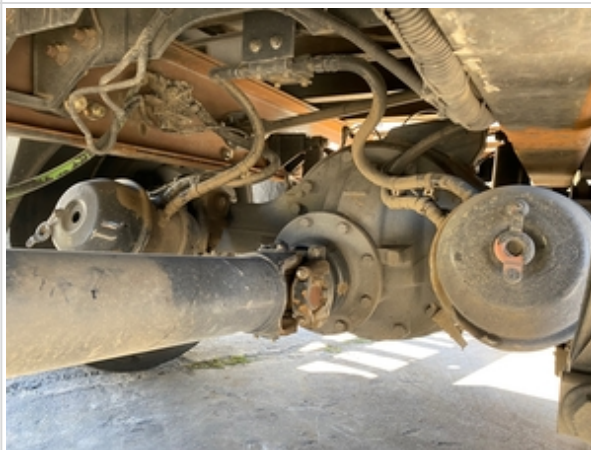
Air Brake System Photos

Front Differential	0
Brake System Type	Air Brakes
Air Brakes Build Correct Pressure	Yes
Air Brake System Leaks	Yes
Comments	Major air leak at seat suspension
Air Brake Hose Condition	3 - Normal Wear & Tear

Engine Brake Configuration	2 Position
Engine Brake	3 - Normal Wear & Tear
Parking Brake	3 - Normal Wear & Tear
Parking Brake Condition	Good brake function
Overall Drivetrain Comments	Overall drivetrain looks solid. No issues seen with major components. Air leak under driver seat observed.

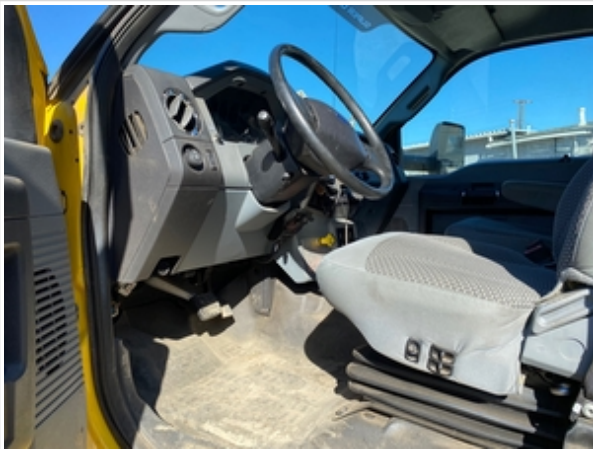
Foot Brake	3 - Normal Wear & Tear
Foot Brake Condition	Good brake function
Foot Brake Photos

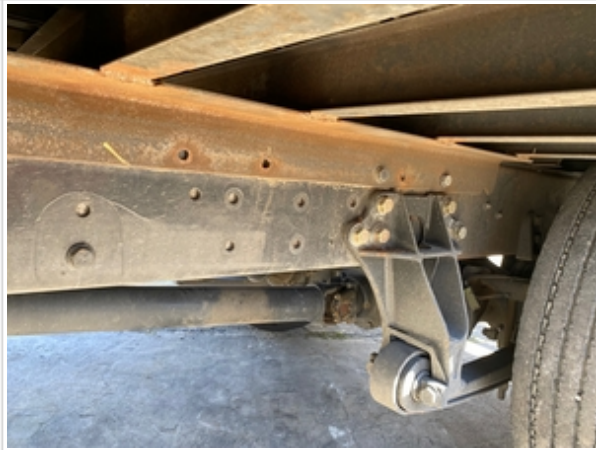
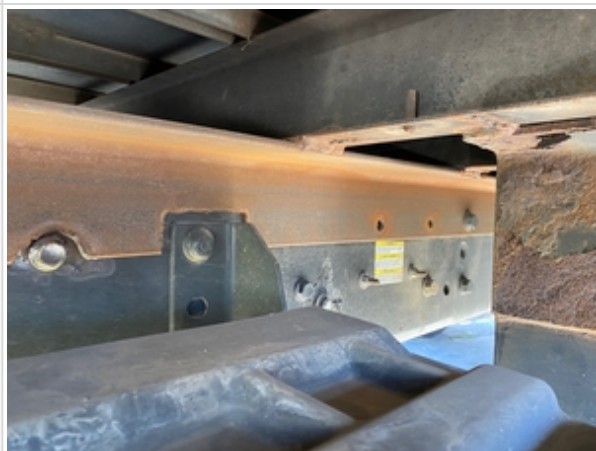
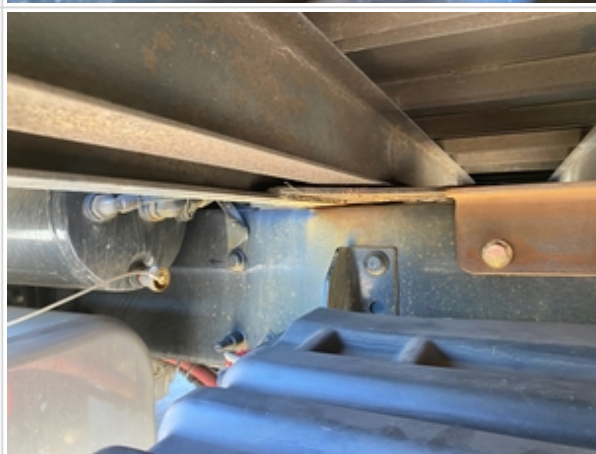
Frame Condition	3
Comments	Frame extended and double layered for extra strength .
Frame Photos

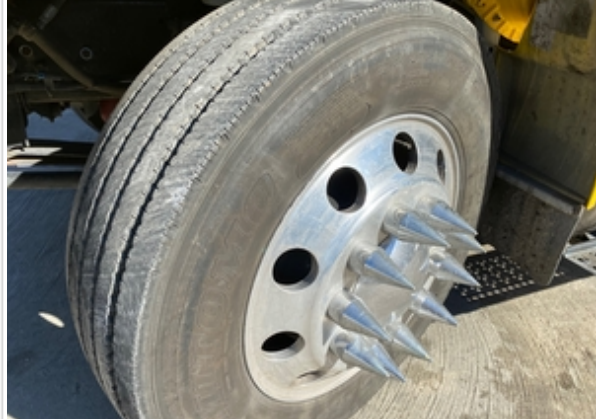
Wheels & Hub Condition	3
Comments	No oil seal leaks observed from inside rim area
Wheel Seal Leaks	No
Tire Brand	Sumitomo (Front) Michelin (Rear)
Tire Size	275/70R/22.5 (Front & Rear)
Front Left Tire - Ratio Remaining	70%
Front Left Tire Photos

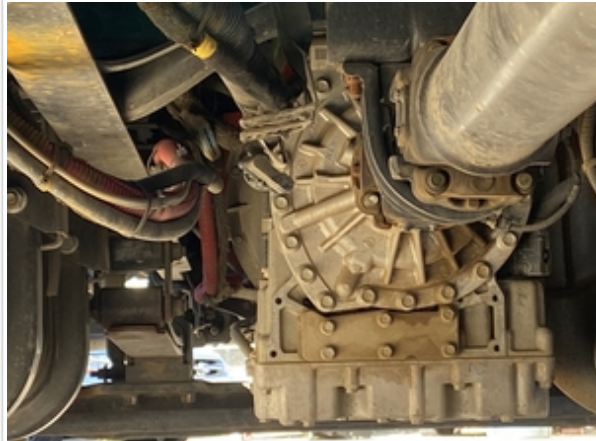
Overall Chassis	3	
Overall Chassis Comments	Overall chassis in solid condition with no major issues observed.	
Overall Chassis & Undercarriage Photos
