## Inspection Report (On-Highway Truck Cab + Chassis)

Year	2012
Make	Kenworth
Model	T800
Serial Number	1XKDDP9X5CJ335272
Truck Odometer Reading	551,326
Current Inspection / State Cert / DOT	Last inspection 05/2022 (In accordance with 49CFR,Part396,FMCSR)
Previous Application (e.g., earth moving, mining, demolition, etc)	Equipment Rental Hauler

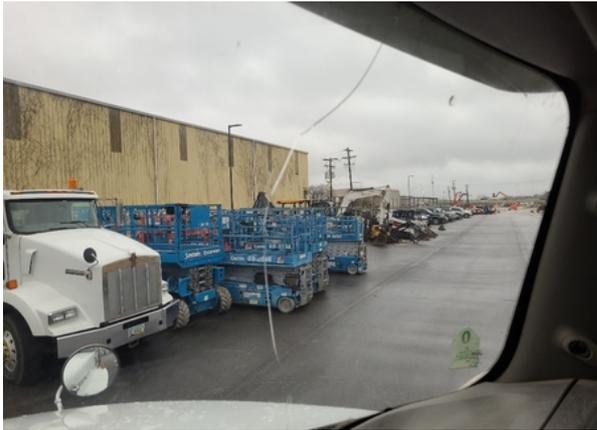
<b>Body Panels</b>	3 - Normal Wear & Tear
<b>Body Panel Condition</b>	No visible damage, good paint condition and panel fitment
<b>Doors / Canopy Latches</b>	3 - Normal Wear & Tear
<b>Doors / Canopy Latches Condition</b>	No visible damage
<b>Steps / Ladders</b>	3 - Normal Wear & Tear
<b>Steps / Ladders Condition</b>	Steps/ladders are fully intact and appear structurally sound
<b>Handrails</b>	3 - Normal Wear & Tear
<b>Handrails Condition</b>	Handrails are fully intact and appear structurally sound
<b>Glass</b>	3 - Normal Wear & Tear
<b>Glass Condition</b>	Major chips or cracks observed, Other (see comments)
<b>Comments</b>	Large crack at front right side of windshield
<b>Glass Condition Photos</b>

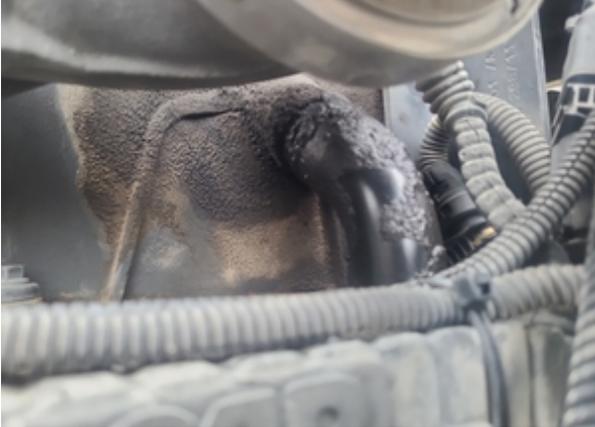
Oil Leak Photos

<b>Cooling System Leaks</b>	No
<b>Coolant Color / Appearance</b>	3 - Normal Wear & Tear
<b>Coolant Color/Appearance Notes</b>	Normal Translucent appearance, no visual signs of contamination
<b>Oil Leaks</b>	Yes
<b>Oil Leak Notes</b>	No oil leaks seen, Other (see comments)
<b>Comments</b>	very minor seepage out of breather tube

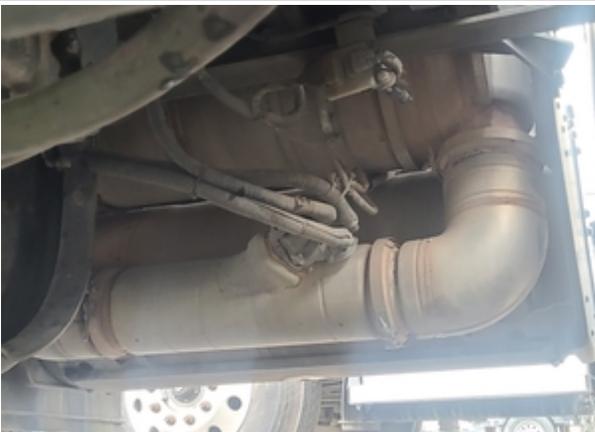
Oil Color / Appearance	3 - Normal Wear & Tear
Oil Color / Appearance Notes	Clean oil appearance, no signs of cross contamination, Appropriate oil level
Fuel Leaks	No
Equipped with DPF (Diesel Particulate Filter)	Yes
DPF Condition	3 - Normal Wear & Tear
DPF Condition Notes	Filter housing is intact with no signs of damage or malfunction, DPF indicator is not illuminated
DPF Photos

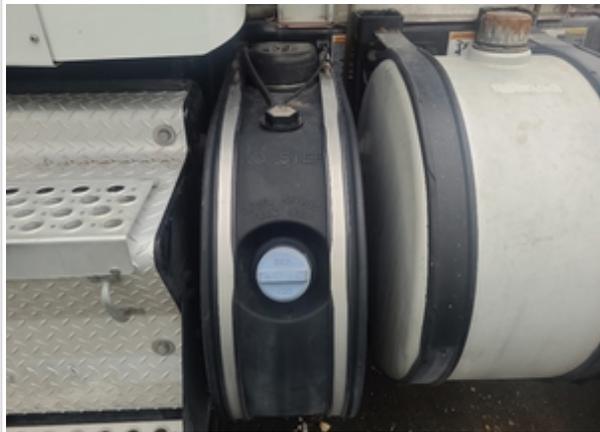
DEF Tank Photos

Requires DEF (Diesel Exhaust Fluid)	Yes
DEF Tank	3 - Normal Wear & Tear
DEF Tank Condition	Area around DEF tank cap is clean, fluid is clear & appears free of contaminants

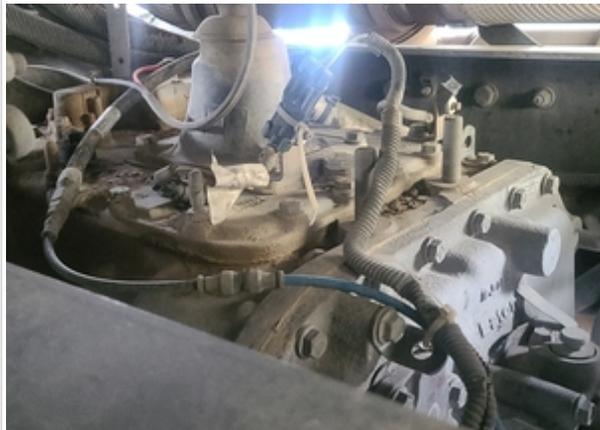
Transmission Info (Make/Model)	Eaton Fuller 13 Speed
Drive Type	4X6
Overdrive	N/A
Transmission	3 - Normal Wear & Tear
Transmission Condition	No unusual noises or vibrations
Transmission Condition Photos

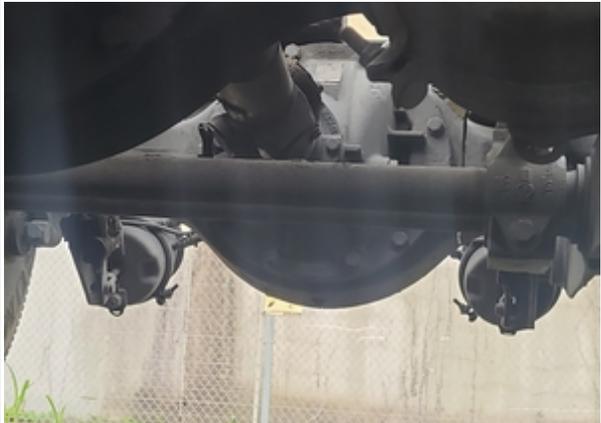
<b>Clutch</b>	3 - Normal Wear & Tear	
<b>Clutch Condition</b>	Clutch is functioning as expected	
<b>Shift Lever</b>	3 - Normal Wear & Tear	
<b>Differential</b>	Check condition of the differential(s). Take photos and notes as relevant.	
<b>Rear Differential</b>	3 - Normal Wear & Tear	
<b>Rear Differential Condition</b>	Dry housing appearance, no unusual noises heard during operation	
<b>Rear Differential Photos</b>

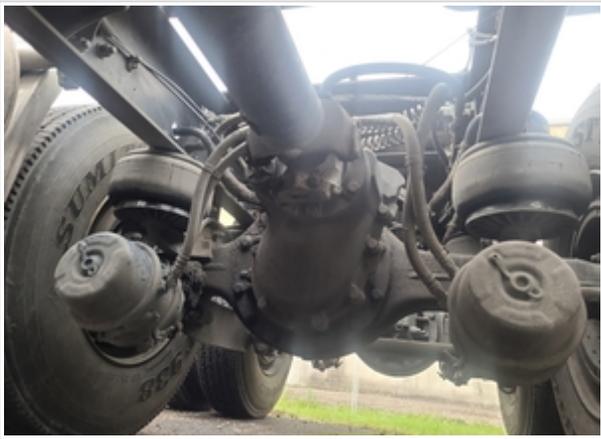
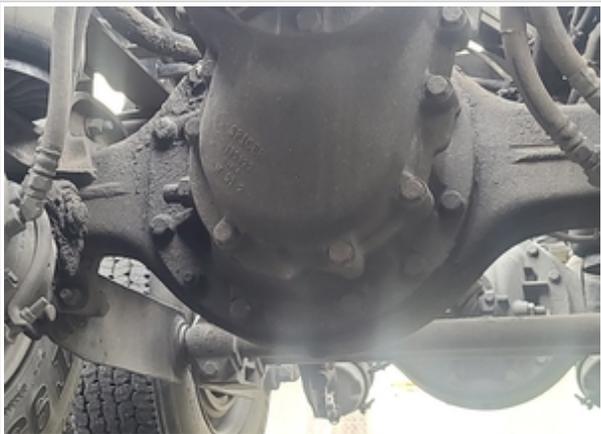
<b>Front Differential</b>	3 - Normal Wear & Tear	
<b>Front Differential Condition</b>	Dry housing appearance, no unusual noises heard during operation	
<b>Front Differential Photos</b>

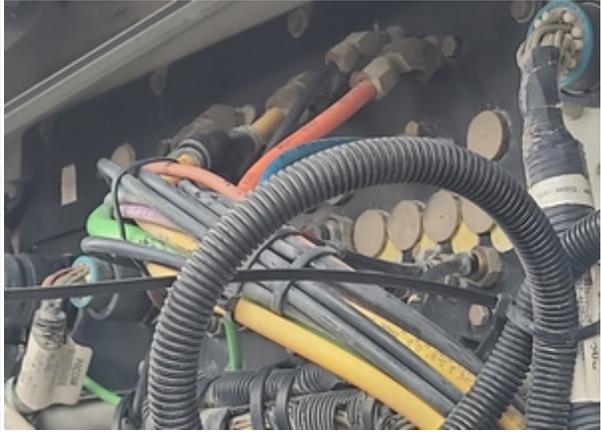
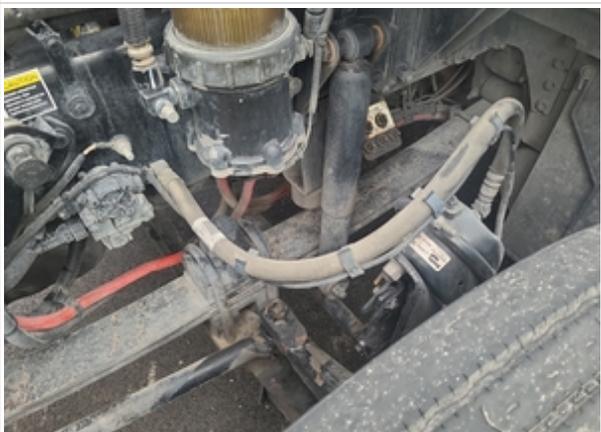
<b>Brake System Type</b>	Air Brakes	
<b>Air Brakes Build Correct Pressure</b>	Yes	
<b>Air Brake System Leaks</b>	Yes	
<b>Comments</b>	consistent air leak underneath rear cab	
<b>Air Brake Hose Condition</b>	3 - Normal Wear & Tear	
<b>Air Brake System Photos</b>

<b>Exterior Rating</b>	3 - Normal Wear & Tear
<b>Interior Rating</b>	3 - Normal Wear & Tear
<b>Safety Rating</b>	3 - Normal Wear & Tear
<b>Quality Rating</b>	3 - Normal Wear & Tear
<b>Functionality Rating</b>	3 - Normal, Operating as Expected
<b>Overall Rating</b>	3 - Normal Wear & Tear
<b>What's Great About the Machine</b>	Truck is in well maintained condition with no major leaks seen and no operating defects observed. Engine and transmission sound and work well
<b>What Needs Work</b>	Front windshield needs to be replaced. Driver side sear belts needs attention. Consistant air leak underneath cab needs to be repaired
<b>Date/Time</b>	12-20-2022

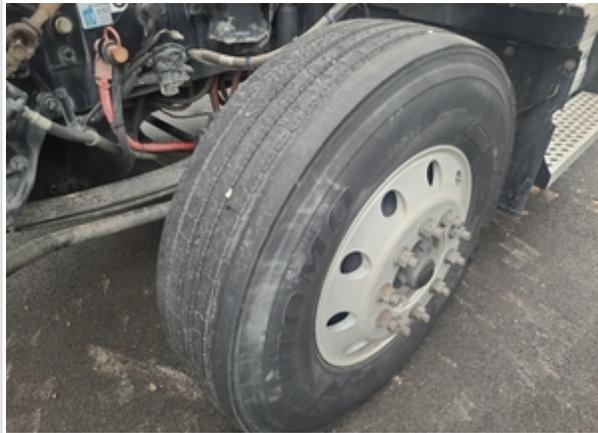
Wheels & Hub Condition	3
Wheel Seal Leaks	No
Tire Brand	Front - Michelin
Tire Size	11R22.5
Front Left Tire - Ratio Remaining	30%
Front Left Tire Photos

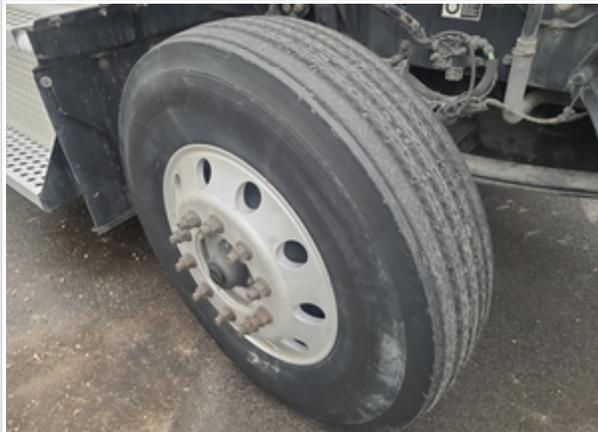
Front Right Tire - Ratio Remaining	30%
Front Right Tire Photos

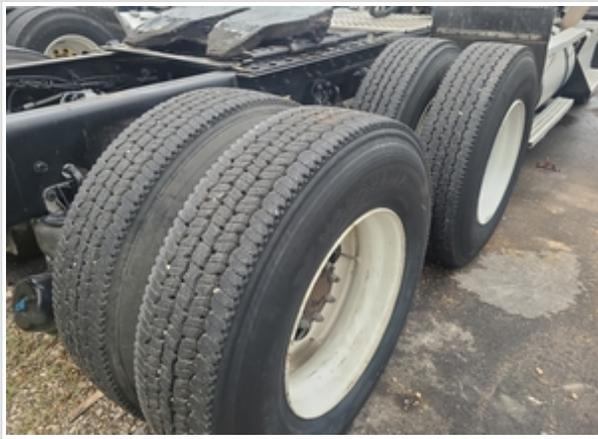
Rear Right Tire Photos

Rear Right Tire - Ratio Remaining	50%

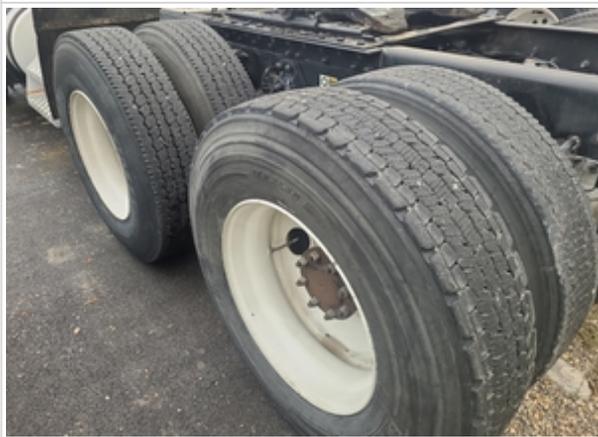
Rear Left Tire - Ratio Remaining	30%
Rear Left Tire Photos

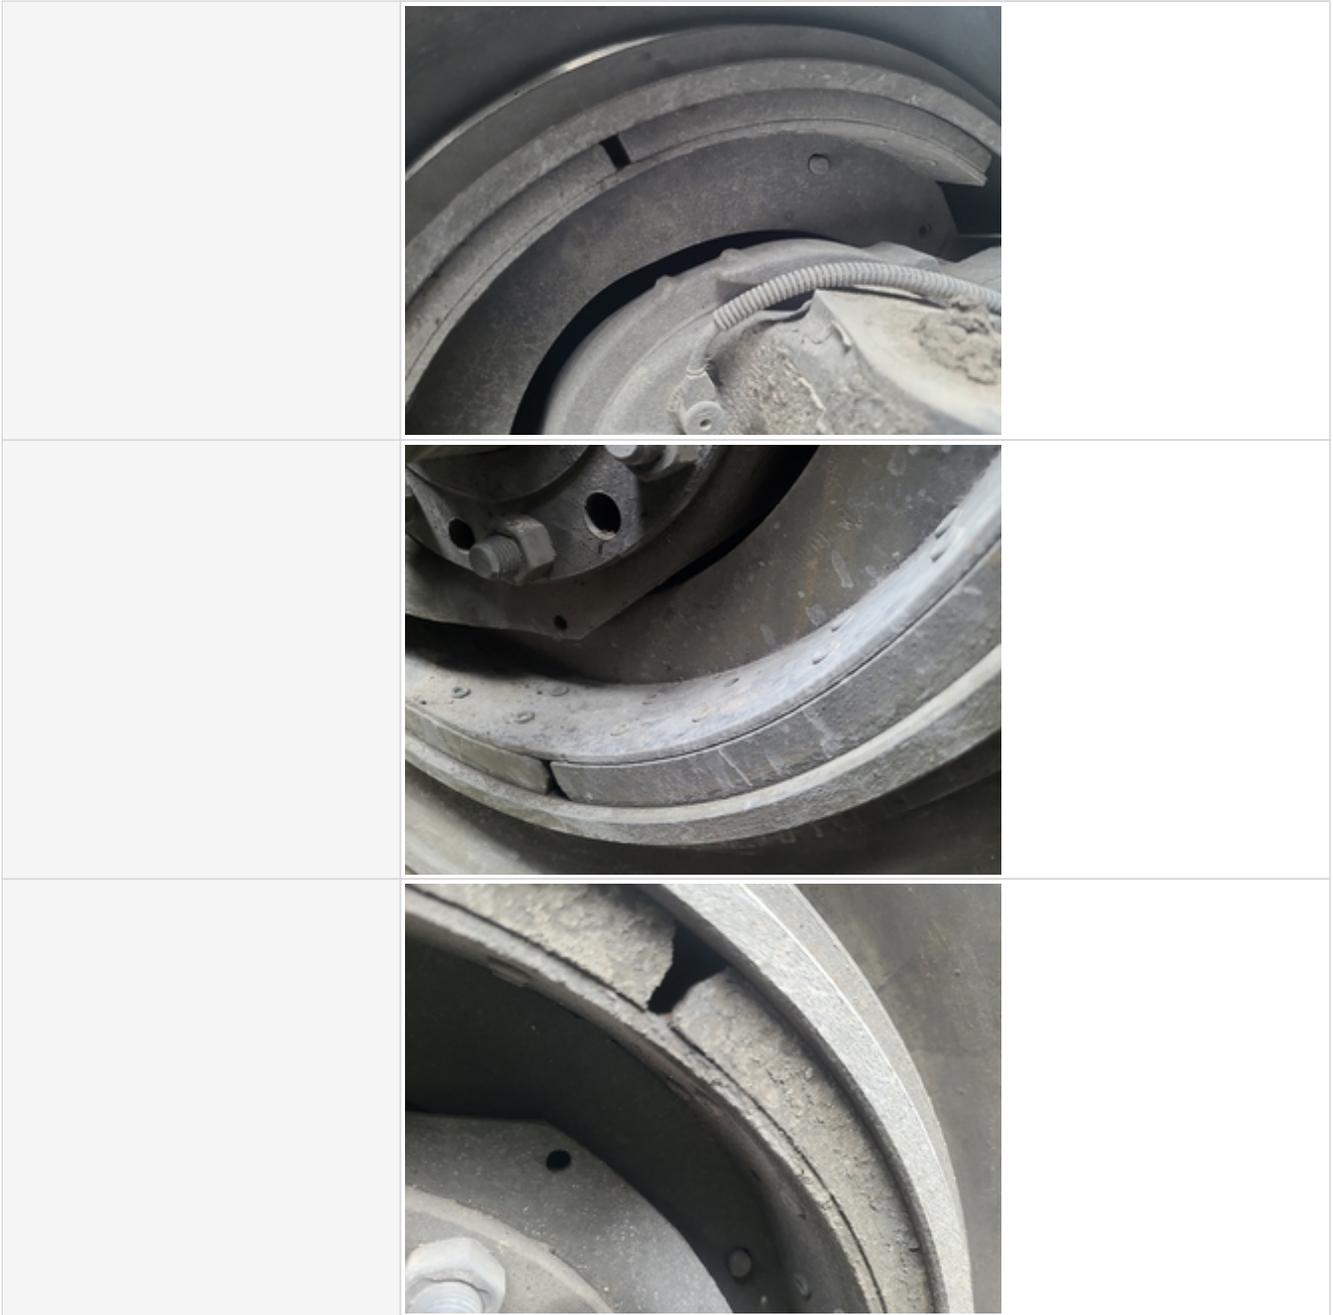
Brake Shoe Thickness	30%
Comments	most brakes above 70% of brake shoe material left
Brake Shoe Photos
