Inspection Report (Boom Lift)

Year	2019
Make	Platform Basket
Model	PB22.10
Serial Number	PB11078
Hour Meter Reading	345.0
Previous Application (e.g., earth moving, mining, demolition, etc)	Tree Services Contractor

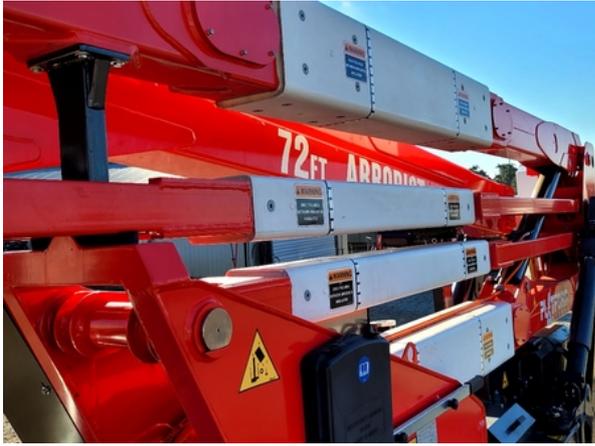
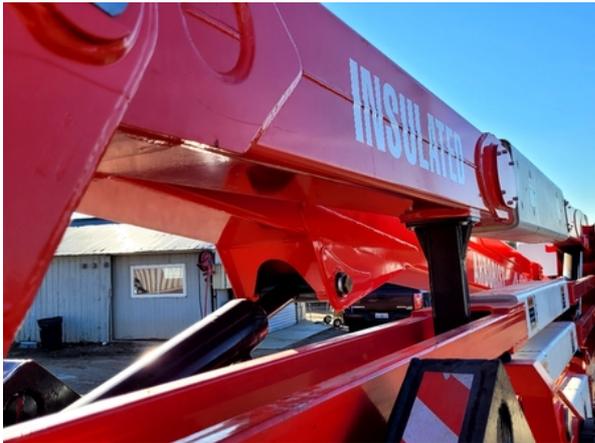
Front	4 - Like New, Recently Replaced
Front Photos

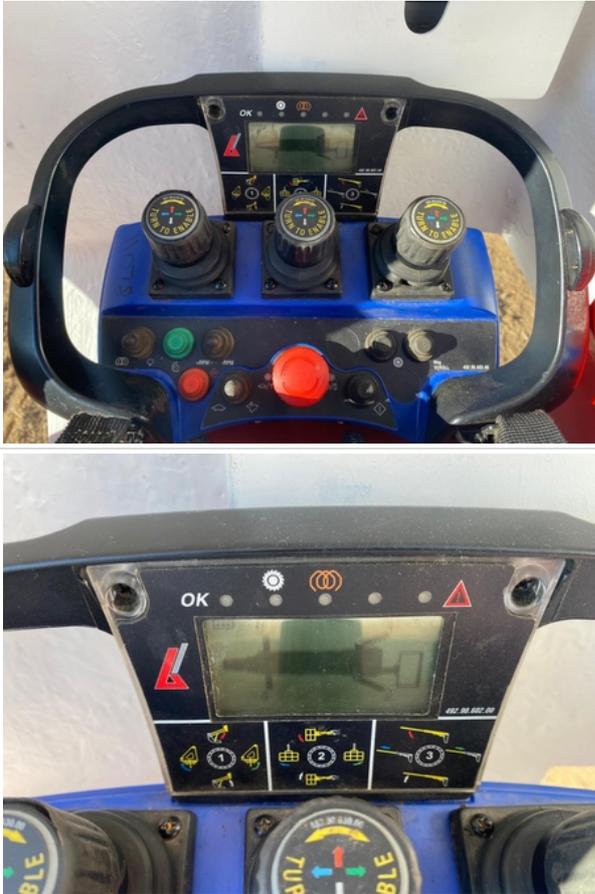
Hour Meter Activity	3 - Normal Wear & Tear
Other Gauge Activity	3 - Normal Wear & Tear
Controls & Switches	3 - Normal Wear & Tear
Horn	3 - Normal Wear & Tear
Travel Alarm	3 - Normal Wear & Tear
Swing Brake	3 - Normal Wear & Tear
Safety Lock Out / Stop	3 - Normal Wear & Tear
Platform Safety Rails & Appearance	0
Platform Floor	3 - Normal Wear & Tear
Platform Floor Photos

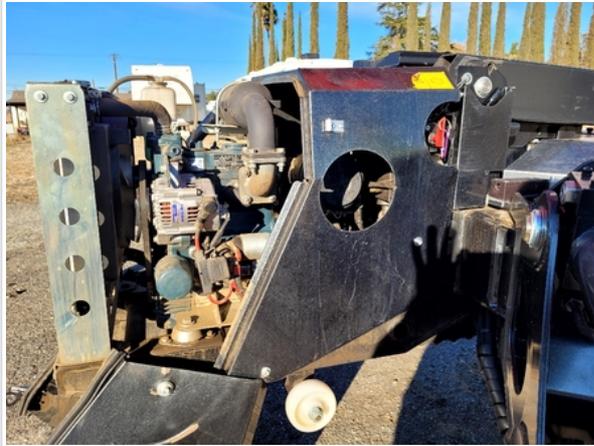
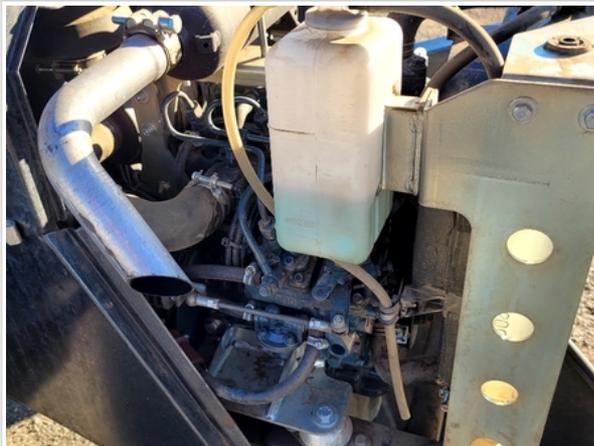
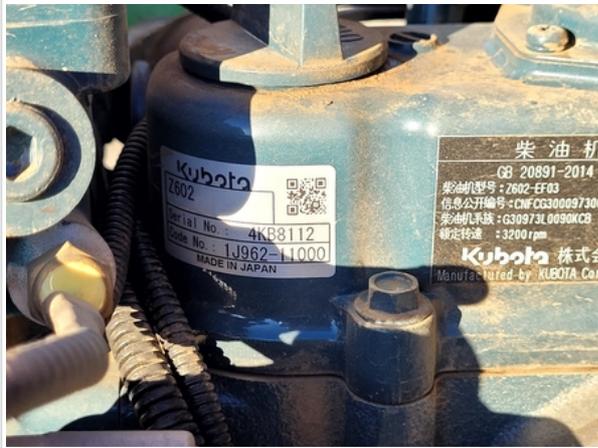
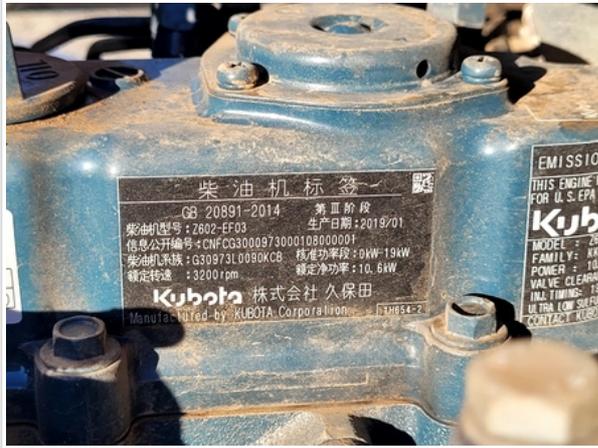
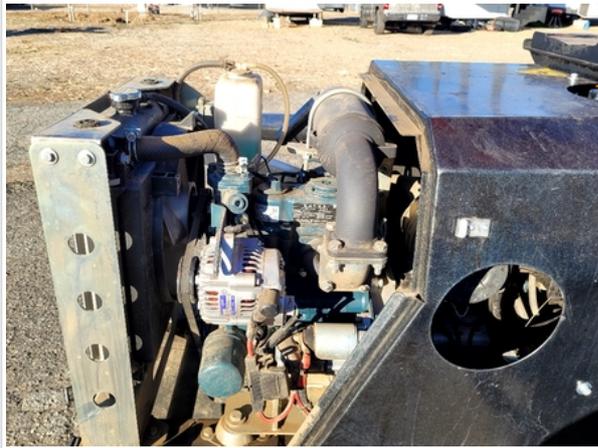
Engine Type (Make, Model, Cylinders, Hp)	Kubota - Z602-EF03 - 14HP - 2Cyl.
Emissions Tier	Tier 4F
Engine Serial Number	4KB8112
Engine Fuel Type	Diesel
Engine Photos

Blow-by (Visual Observation Check)	No
Unusual Noises (Upon Start-up, Idle, Shutdown)	No
Unusual Noise Notes	No unusual noises heard
Engine Smoke (Upon Start-up, Idle, Shutdown)	No
Engine Smoke Notes	No engine smoke issues observed
Engine Exhaust Color	Clear

Battery	3 - Normal Wear & Tear
Battery Condition	Like new, recently replaced
Radiator	3 - Normal Wear & Tear
Belts	3 - Normal Wear & Tear
Hoses	3 - Normal Wear & Tear
Water Pump	3 - Normal Wear & Tear
Cooling System Leaks	No
Coolant Color / Appearance	3 - Normal Wear & Tear
Coolant Color/Appearance Notes	Normal Translucent appearance, no visual signs of contamination
Oil Leaks	No
Oil Color / Appearance	3 - Normal Wear & Tear
Fuel Leaks	No
Equipped with DPF (Diesel Particulate Filter)	No
Requires DEF (Diesel Exhaust Fluid)	No
Overall Engine Appearance	Clean & dry
Overall Engine Comments	Overall engine like new and well maintained

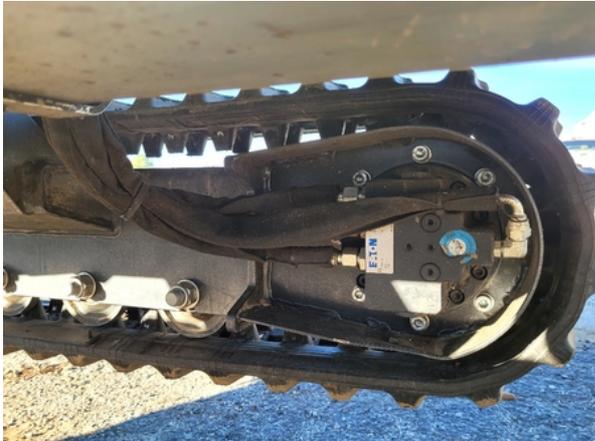
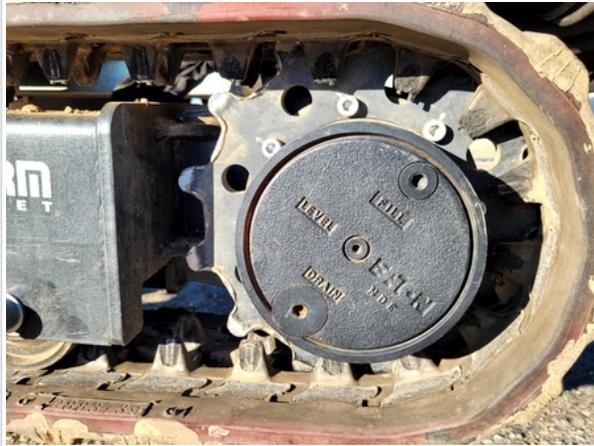
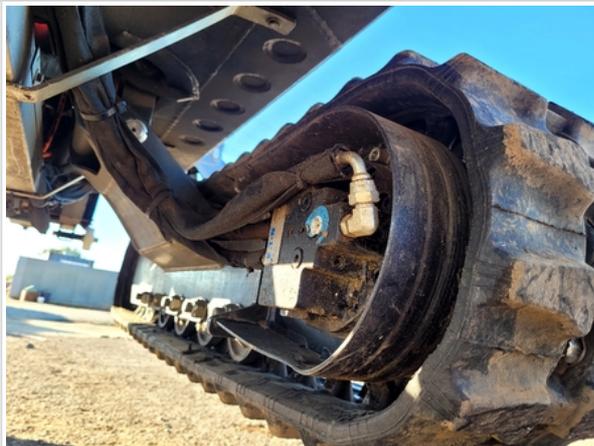
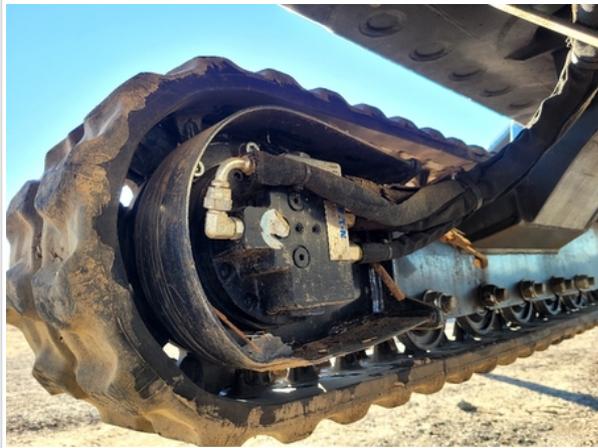
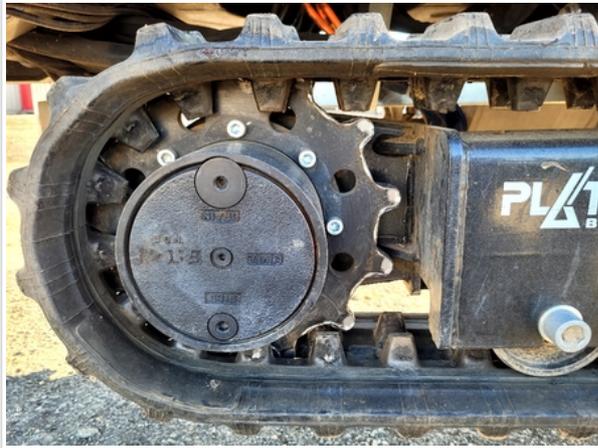
Hydrostatic Transmission?	Yes
2 Speed?	N/A
Hydrostatic Drive Configuration	Split Transmission
Drive Motors	2 - Above Average Wear
Drive Motor Photos

Hydrostatic Parking Brake	3 - Normal Wear & Tear
Hydrostatic Parking Brake Condition	Good brake function
Overall Drivetrain Comments	Overall drivetrain in great condition like new with no issues observed

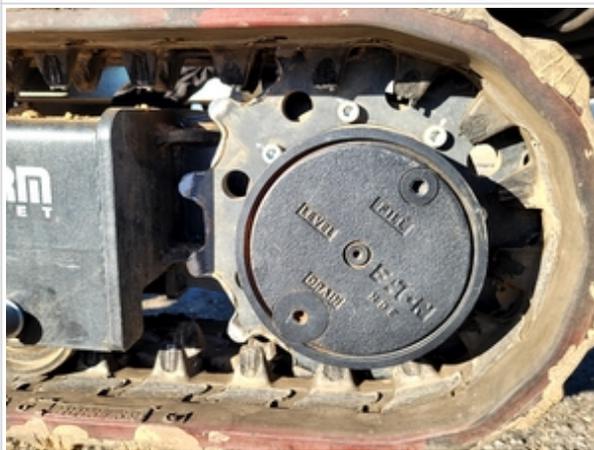
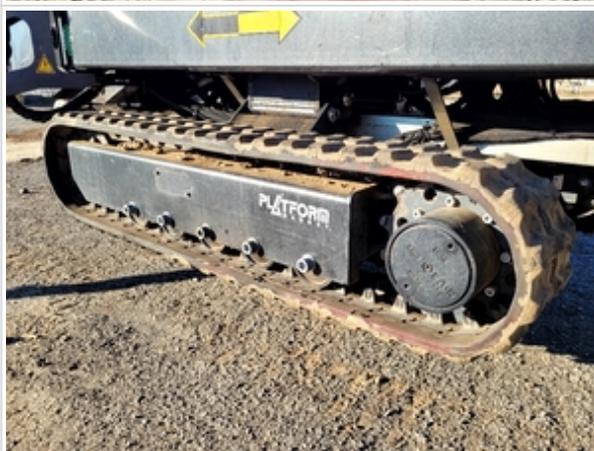
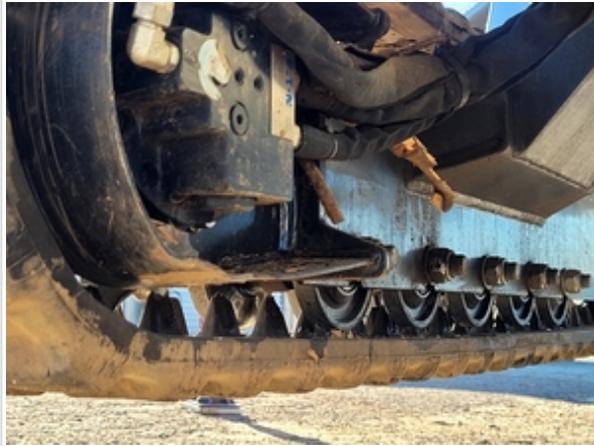
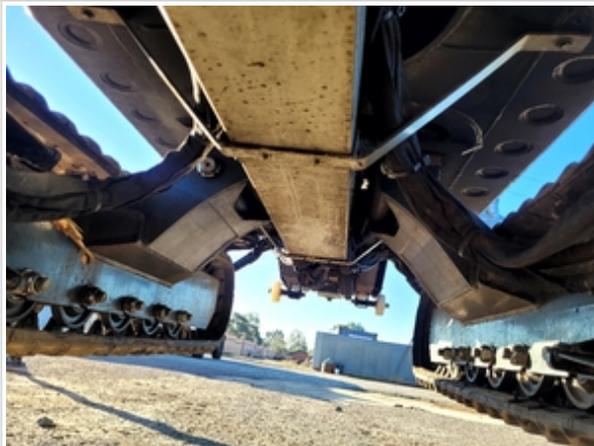
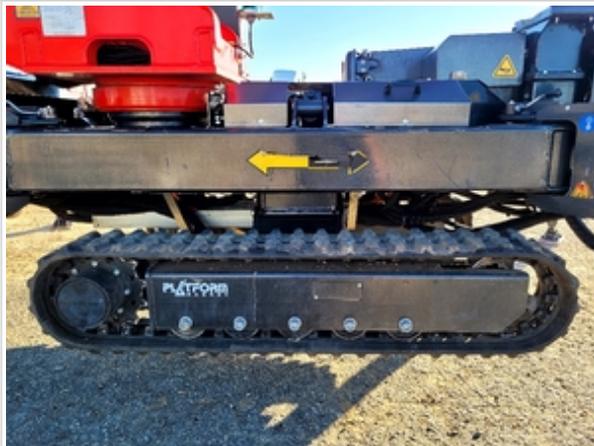
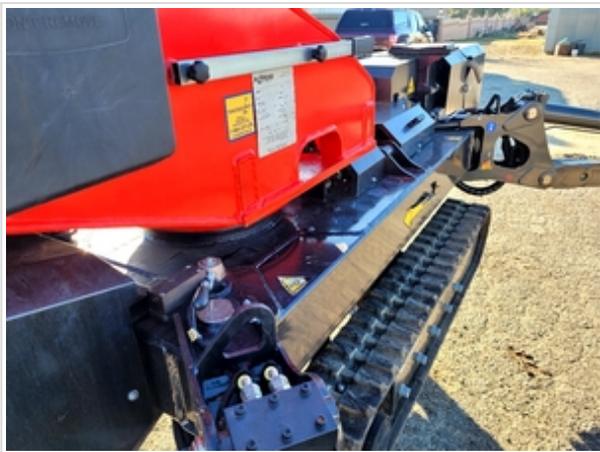
Frame	3 - Normal Wear & Tear
Stance	3 - Normal Wear & Tear
Front Axle Appearance	0
Rear Axle Appearance	0
Wheels & Tires	4 - Like New, Recently Replaced

Front Left Tire - Ratio Remaining	90%	
Rear Left Tire - Ratio Remaining	90%	
Front Right Tire - Ratio Remaining	90%	
Rear Right Tire - Ratio Remaining	90%	
Swivel Bearing	3 - Normal Wear & Tear	
Swivel Motor	3 - Normal Wear & Tear	
Swivel Joint	3 - Normal Wear & Tear	
Boom Condition	3 - Normal Wear & Tear	
Boom Condition Photos

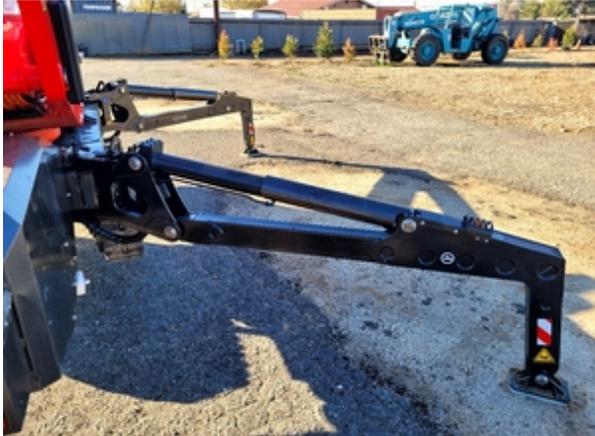
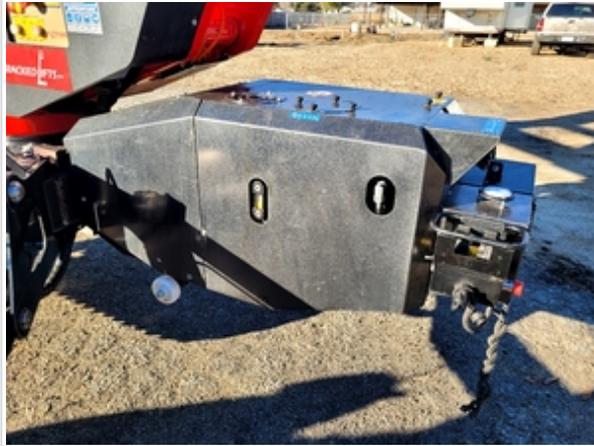
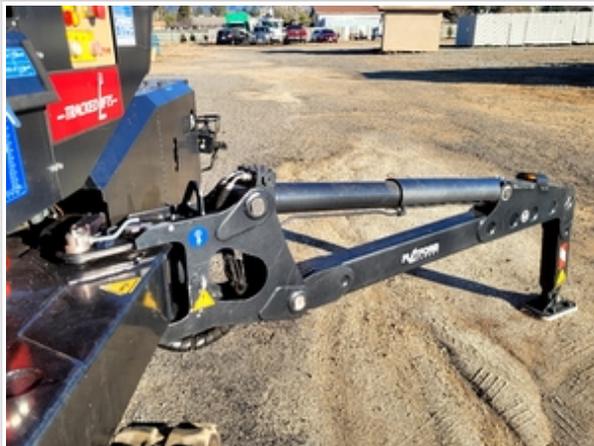
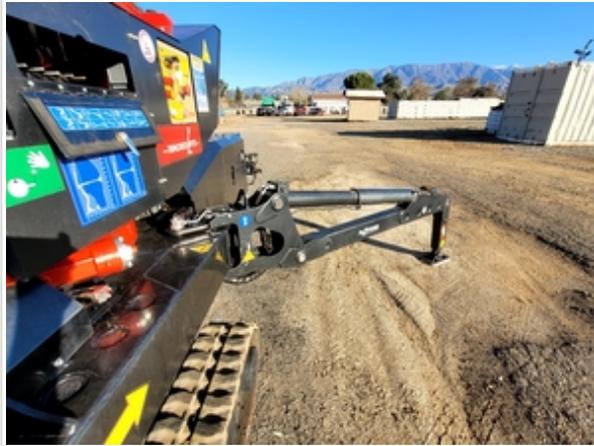
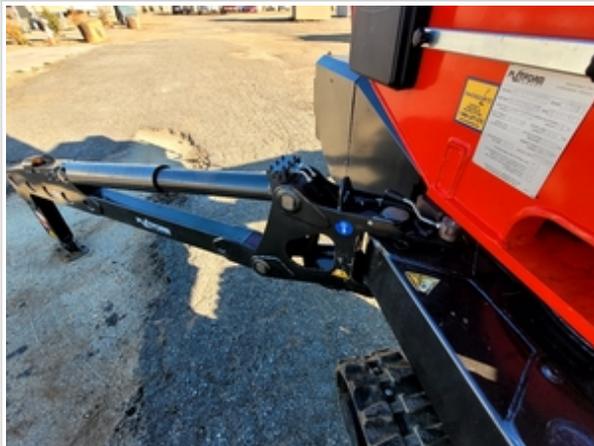
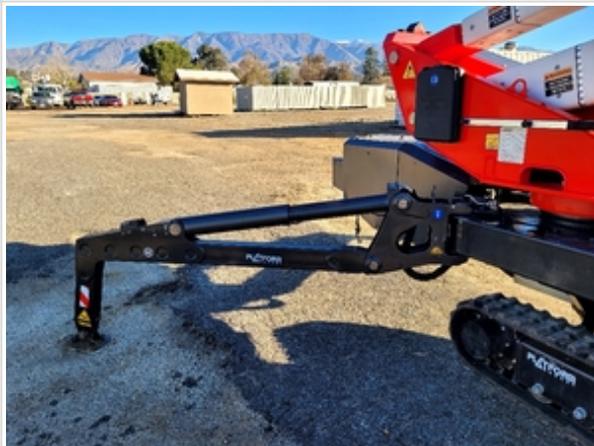
Boom Wear Guides	3 - Normal Wear & Tear	
Jib Condition	3 - Normal Wear & Tear	
Outriggers	3 - Normal Wear & Tear	
Outriggers Photos

Overall Chassis	4 - Like New, Recently Replaced
Overall Chassis Comments	Overall Chassis in excellent condition

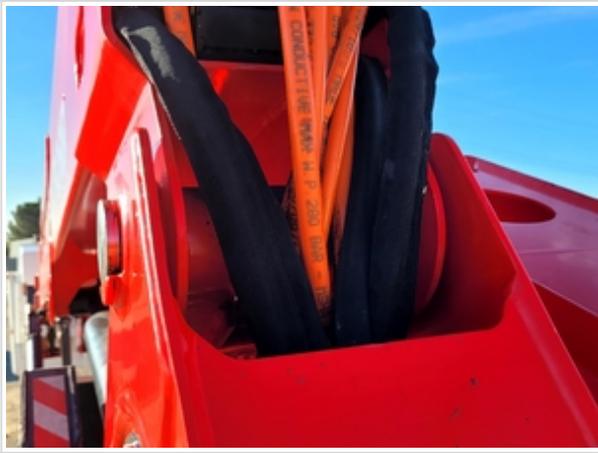
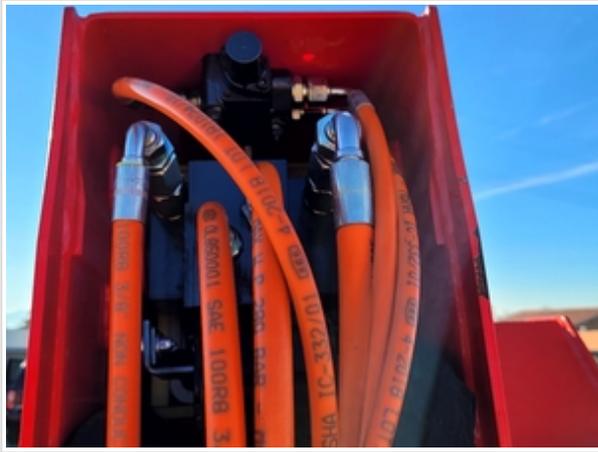
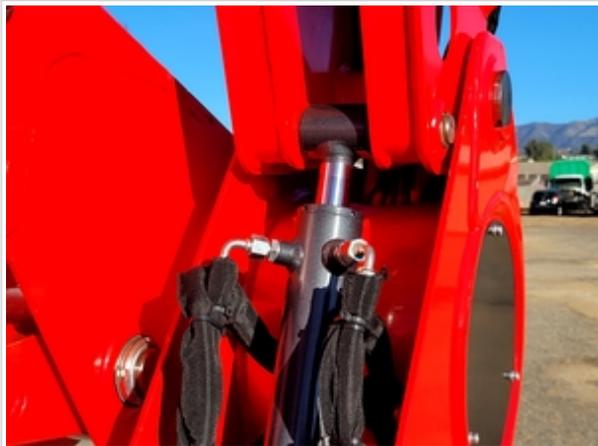
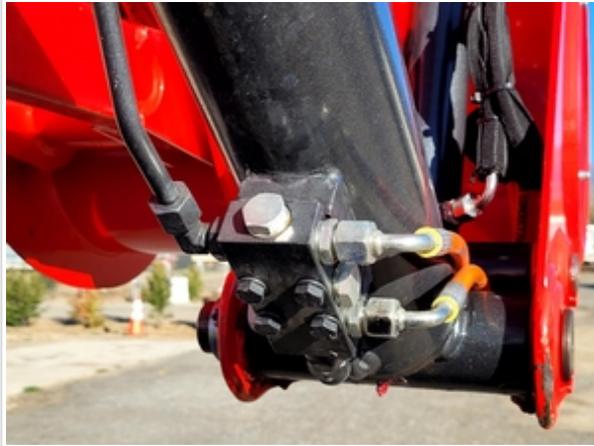
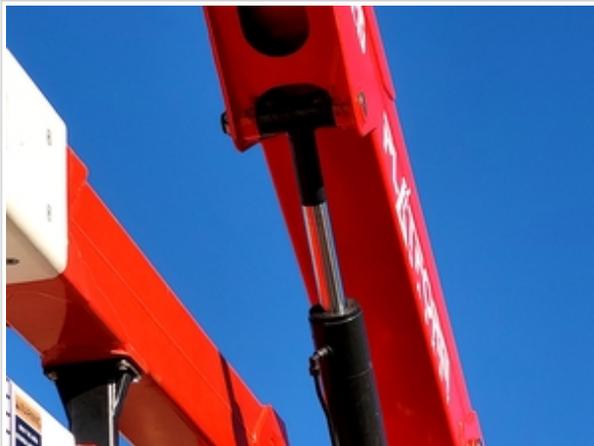
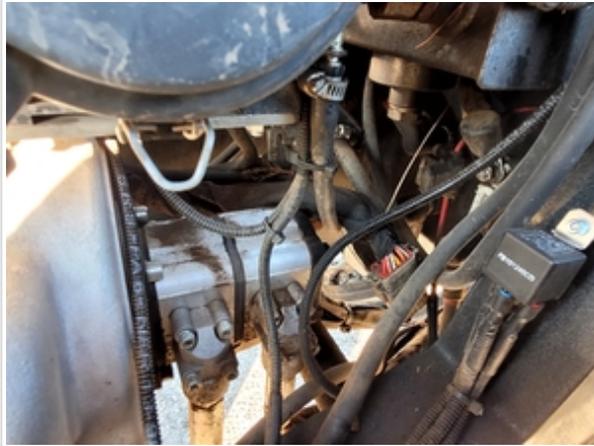
Hydraulics Overall	
Wet or Damp Hydraulic Lines / Fittings	No
Appearance of Hydraulic Lines / Fittings	4

<p>Hydraulic Lines / Fittings Condition</p>	<p>Hydraulic lines & fittings are clean and in good condition</p>
<p>Appearance of Hydraulic Lines / Fittings Photos</p>
