Inspection Report (Mini Excavator)

Year	2007
Make	CAT
Model	305C cr
Serial Number	HWJ02087
Hour Meter Reading	252Hrs.
Previous Application (e.g., earth moving, mining, demolition, etc)	General Construction

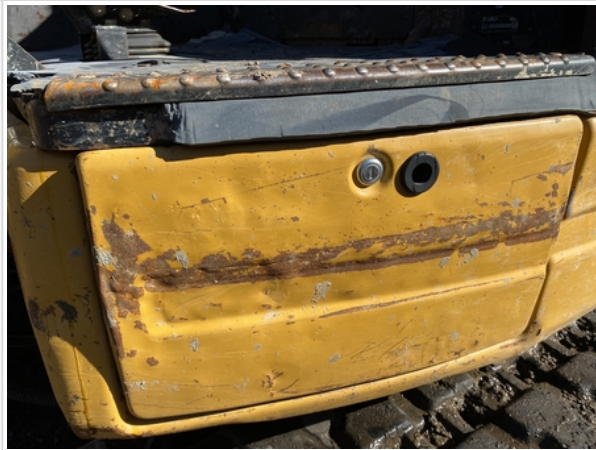
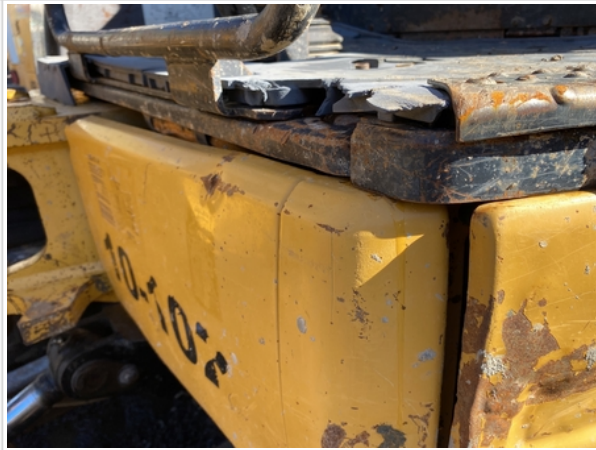
Body Panels Photos

Body Panels	3 - Normal Wear & Tear
Body Panel Condition	Some panel misalignment observed, Visible chipped paint or dents, Other (see comments)
Comments	Normal wear and tear

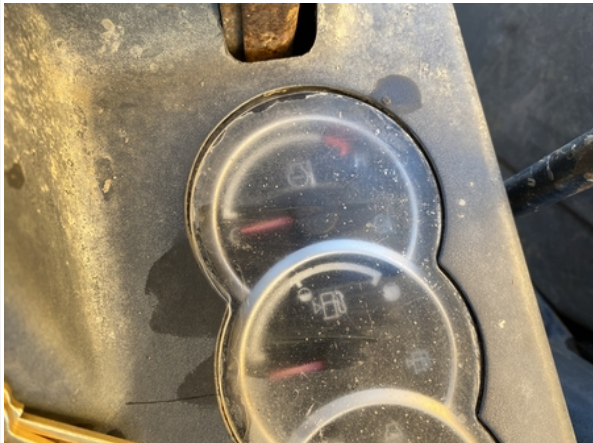
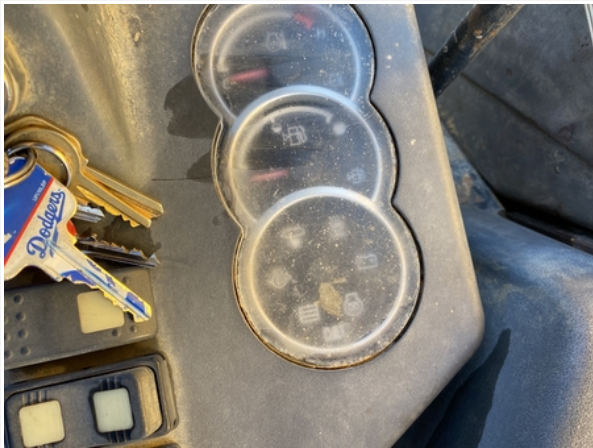
Other Gauge Activity	3 - Normal Wear & Tear	
Other Gauge Condition	All cockpit gauges are functional and in good condition	
Other Gauge Activity Photos

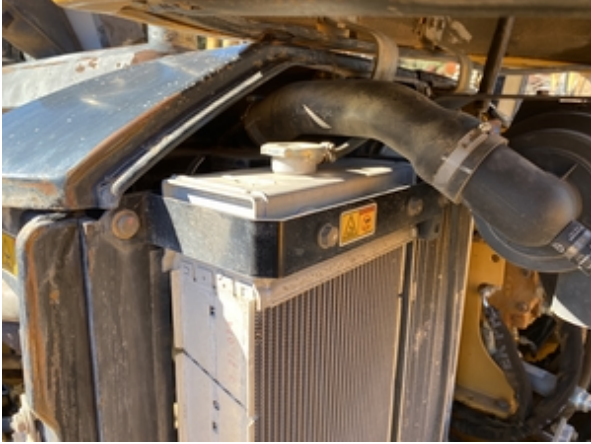
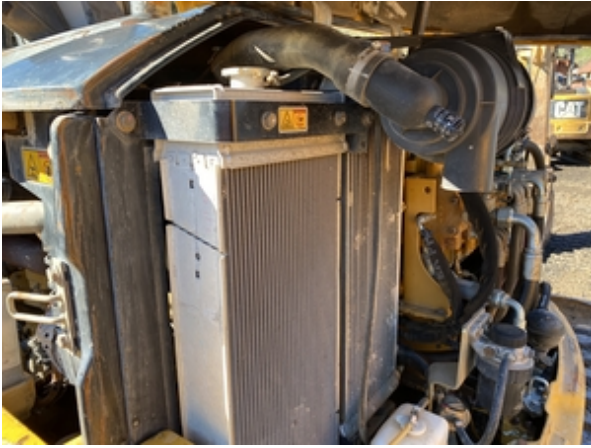
Radiator Photos

Engine Smoke Notes	Engine smoke observed upon start up, Other (see comments)
Comments	Small amount of engine smoke seen ONLY at startup
Engine Exhaust Color	Clear
Battery	3 - Normal Wear & Tear
Battery Condition	Clean & dry appearance, tight connections, Other (see comments)
Comments	Battery stamped 2/2021
Battery Condition Photos	 
Radiator	3 - Normal Wear & Tear
Radiator Condition	Radiator fins & components appear to be in good working order, no signs of damage or leaks

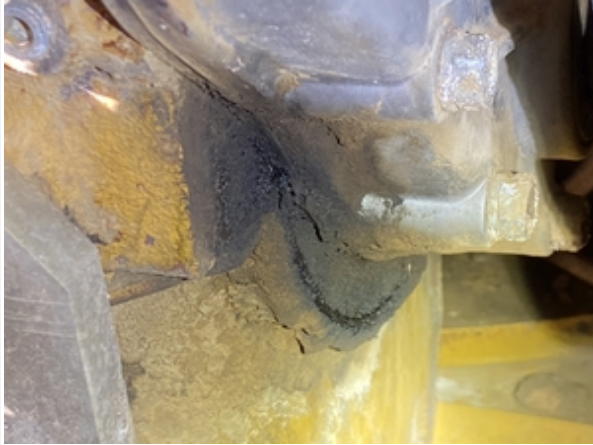
Oil Leak Photos

Belts	3 - Normal Wear & Tear
Belt Condition	Belts appear in good condition & alignment with proper tension
Hoses	3 - Normal Wear & Tear
Hose Condition	Firm, pliant hoses with no signs of wear or leaks
Water Pump	3 - Normal Wear & Tear
Water Pump Condition	No unusual pump noises heard
Cooling System Leaks	No
Coolant Color / Appearance	3 - Normal Wear & Tear
Coolant Color/Appearance Notes	Normal Translucent appearance, no visual signs of contamination
Oil Leaks	Yes
Oil Leak Notes	No oil leaks seen, Dried oil seepages seen
Comments	Minor oil seepage buildup seen at front of engine cover (no active leaks seen)

Oil Color / Appearance	3 - Normal Wear & Tear
Oil Color / Appearance Notes	Appropriate oil level, Other (see comments)
Comments	Engine service recommended
Fuel Leaks	No
Equipped with DPF (Diesel Particulate Filter)	No
Requires DEF (Diesel Exhaust Fluid)	No
Overall Engine Appearance	Clean & dry
Overall Engine Comments	Overall, engine well maintained with. I major problems observed.

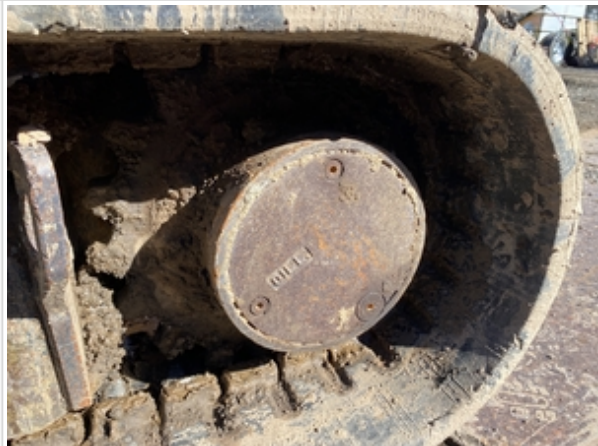
Hydrostatic Transmission?	Yes	
2 Speed?	Yes	
Hydrostatic Drive Configuration	Split Transmission	
Drive Motors	2 - Above Average Wear	
Drive Motor Photos

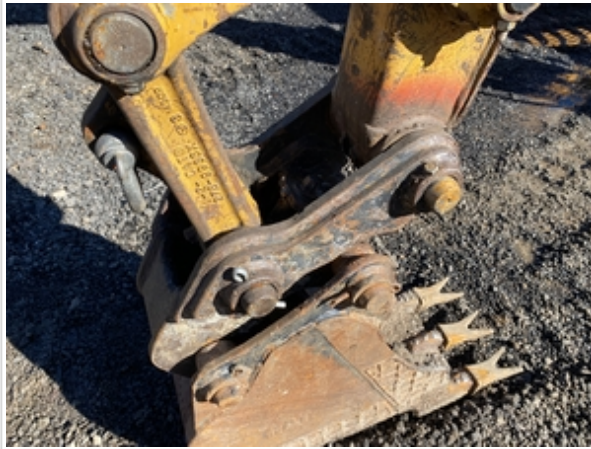
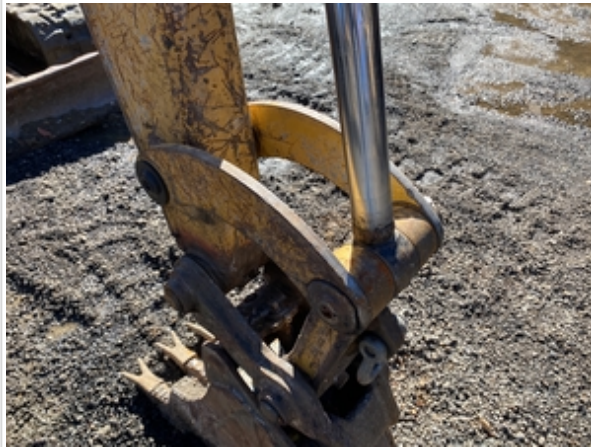
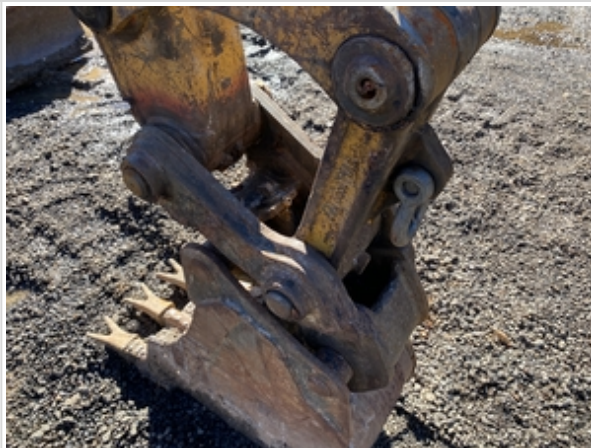
Boom to Stick Pin & Bushings	3 - Normal Wear & Tear	
Stick to Bucket Pin & Bushings	3 - Normal Wear & Tear	
Comments	Minor play in stick to bucket linkage pins	
Stick to Bucket Pin & Bushings Photos

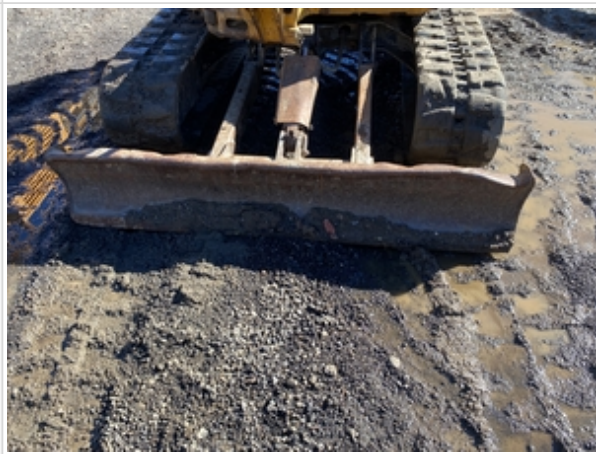
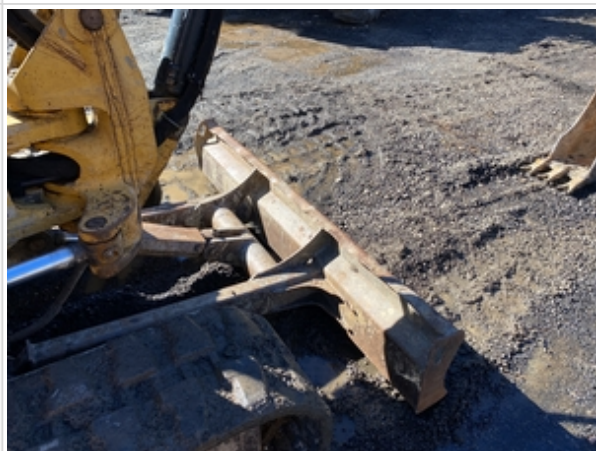
<p>Blade</p>	<p>3 - Normal Wear & Tear</p>	
<p>Blade Photos</p>

What's Great About the Machine	Machine has very low hours and has been well maintained. All implements tight and powertrain runs well. Undercarriage has plenty of life left and no leaks observed.
What Needs Work	Cosmetic damages all the way around. Top of blade has been slightly dented. Engine could use a service.
Date/Time	01-06-2023
