Inspection Report (Rough Terrain Crane)

Year	1978
Make	Grove
Model	RT518
Serial Number	42259
Hour Meter Reading	910hrs.
Previous Application (e.g., earth moving, mining, demolition, etc)	Yard Crane

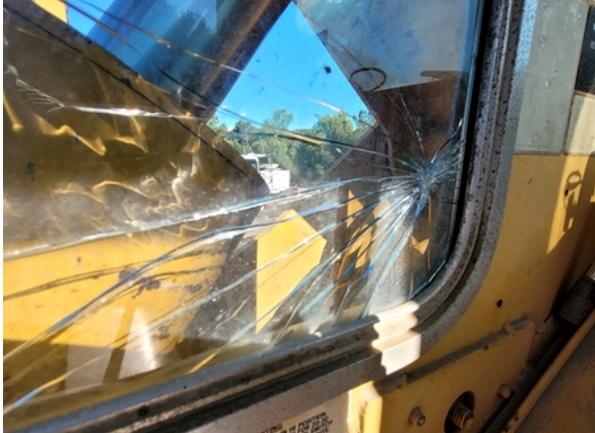
Body Panels	3 - Normal Wear & Tear	
Body Panel Condition	No visible damage, good paint condition and panel fitment	
Doors / Canopy Latches	3 - Normal Wear & Tear	
Doors / Canopy Latches Condition	No visible damage	
Steps / Ladders	3 - Normal Wear & Tear	
Steps / Ladders Condition	Steps/ladders are fully intact and appear structurally sound	
Handrails	3 - Normal Wear & Tear	
Handrails Condition	Handrails are fully intact and appear structurally sound	
Glass	2 - Above Average Wear	
Glass Condition	Major chips or cracks observed, Other (see comments)	
Comments	right side cab window cracked	
Glass Condition Photos

Overall Rating	3 - Normal Wear & Tear
What's Great About the Machine	Machine is old but running good as new. All functions work great and Crane is currently certified. All safety features intact and everything from the brakes, winch cable, hydraulics and powertrain solid. Tires have plenty of tread left and no immediate repairs needed to put this Machine to work.
What Needs Work	Back up alarm should be replaced. Cab right side window should be repaired.
Date/Time	01-06-2023

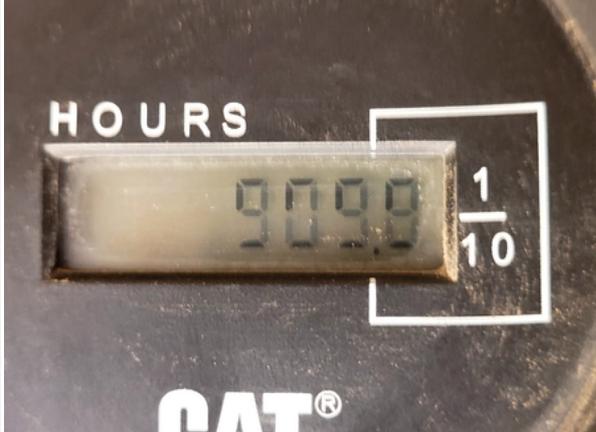
Operator Cabin Overall	3 - Normal Wear & Tear
Operator Cabin Overall Condition	Good cabin appearance, solid floors, panels, and ceiling, Minor cosmetic wear to cabin surfaces, floors, panels, and ceiling
Operator Seat	3 - Normal Wear & Tear
Operator Seat Condition	Seat(s) in good condition, no stains or tears in upholstery
Cabin Lights	0
Safety Lock Out / Stop	3 - Normal Wear & Tear
Safety Lock Out / Stop Condition	Safety lock out device is present, in good condition, and functional
Controls & Switches	3 - Normal Wear & Tear
Controls & Switches Condition	All switches are installed and functional
Hour Meter Activity	3 - Normal Wear & Tear
Hour Meter Condition	Hour meter is functional and in good condition
Hour Meter Activity Photos

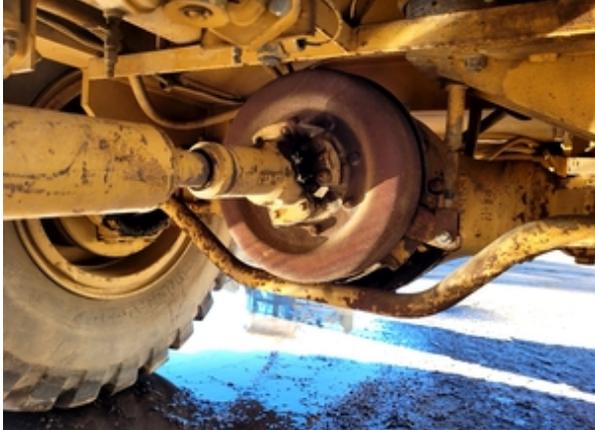
Hydrostatic Transmission?	No	
Transmission Info (Make/Model/Speeds)	Powershift - 3 Speed	
Transmission	3 - Normal Wear & Tear	
Transmission Condition	No unusual noises or vibrations	
Clutch	0	
Shift Lever	3 - Normal Wear & Tear	
Shift Lever Condition	Good forward and reverse function	
Foot Brake	3 - Normal Wear & Tear	
Inching Brake	0	
Parking Brake	3 - Normal Wear & Tear	
Parking Brake Condition	Good brake function	
Parking Brake Photos

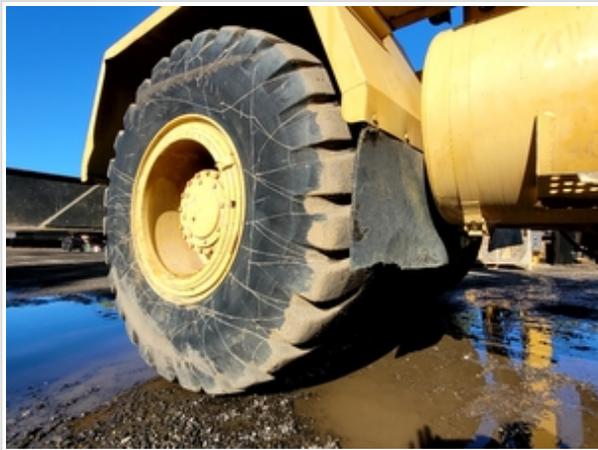
Tire Brand	General	
Tire Size	20.5 - 25	
Front Left Tire - Ratio Remaining	50%

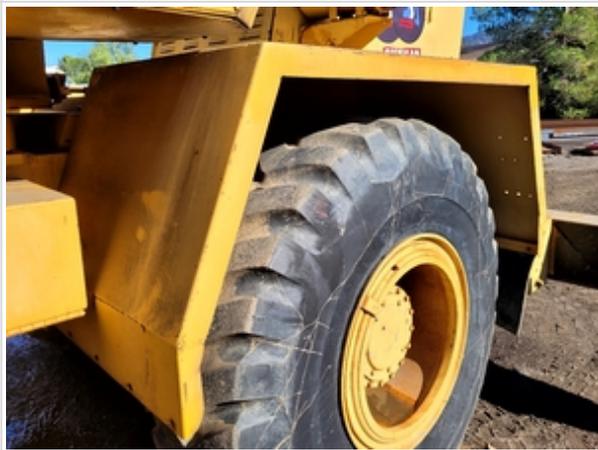
<p>Rear Left Tire - Ratio Remaining</p>	<p>70%</p>
<p>Rear Left Tire Photos</p>

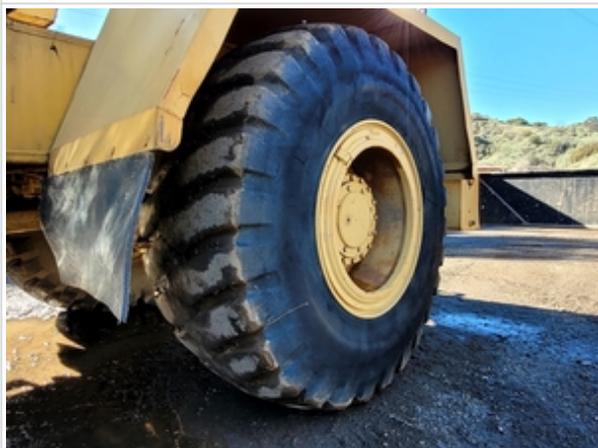
<p>Front Right Tire - Ratio Remaining</p>	<p>50%</p>
<p>Front Right Tire Photos</p>

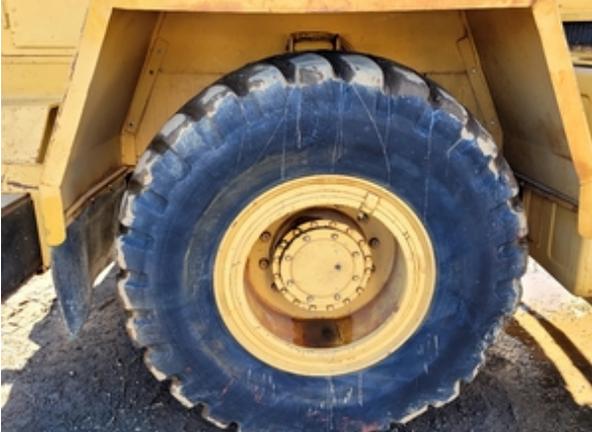
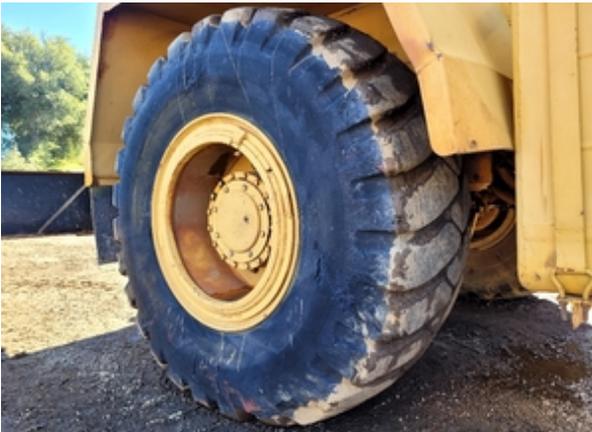
Rear Right Tire - Ratio Remaining	70%	
Rear Right Tire Photos

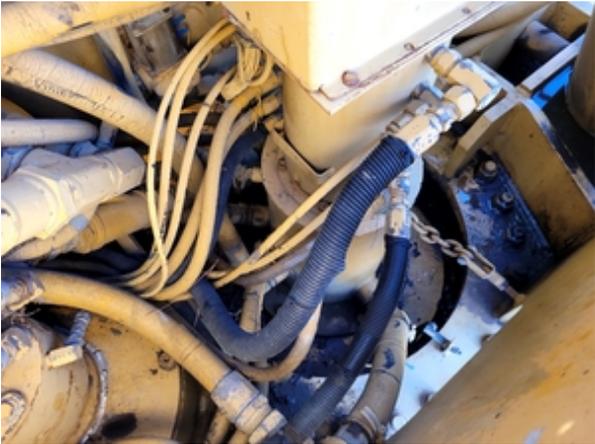
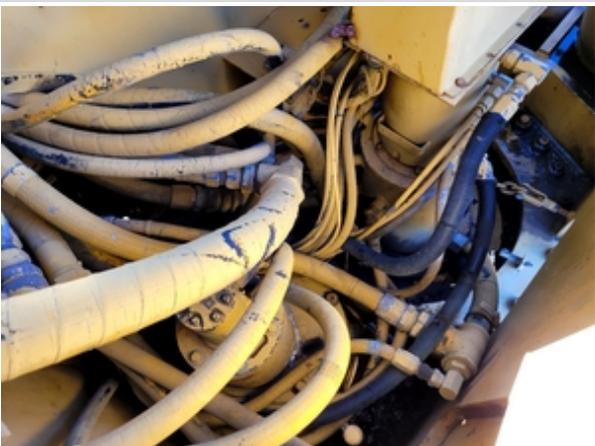
Wet or Damp Hydraulic Lines / Fittings	No
Appearance of Hydraulic Lines / Fittings	3 - Normal Wear & Tear
Hydraulic Lines / Fittings Condition	Hydraulic lines & fittings are clean and in good condition
Appearance of Hydraulic Lines / Fittings Photos

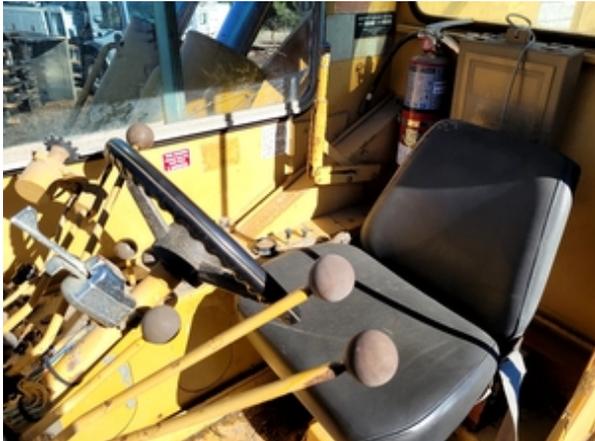
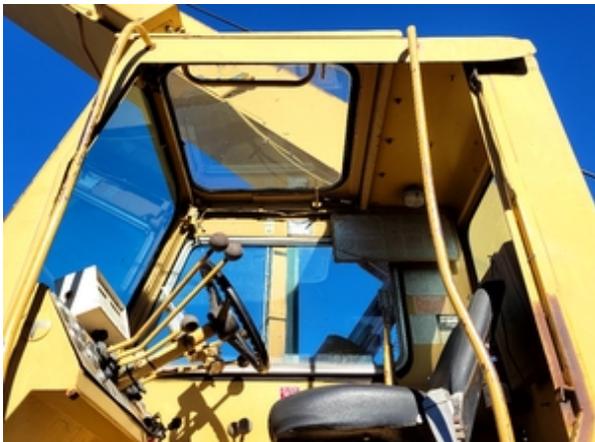
Unusual Noises (Hydraulic Pump)	No	
Hydraulic Pump Notes	No unusual noises heard during operation	
External Controls / Levers	3 - Normal Wear & Tear	
External Controls / Levers Condition	Good function & condition of hydraulic controls	
External Controls / Levers Photos
