## Inspection Report (Mini Excavator)

Year	2016
Make	John Deere
Model	50G
Serial Number	1FF050GXLGH284069
Hour Meter Reading	2,885
Previous Application (e.g., earth moving, mining, demolition, etc)	General Construction

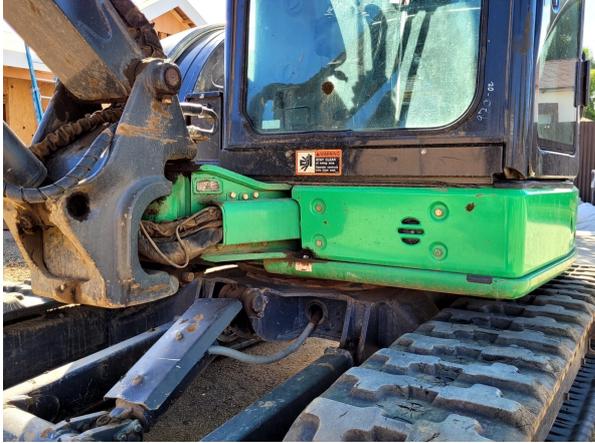
Front Photos

Front	3 - Normal Wear & Tear
Front Condition	No visible damage

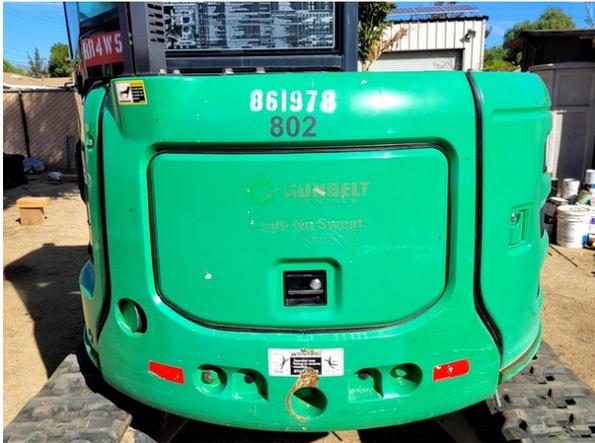
Rear	3 - Normal Wear & Tear
Rear Condition	No visible damage
Rear Photos

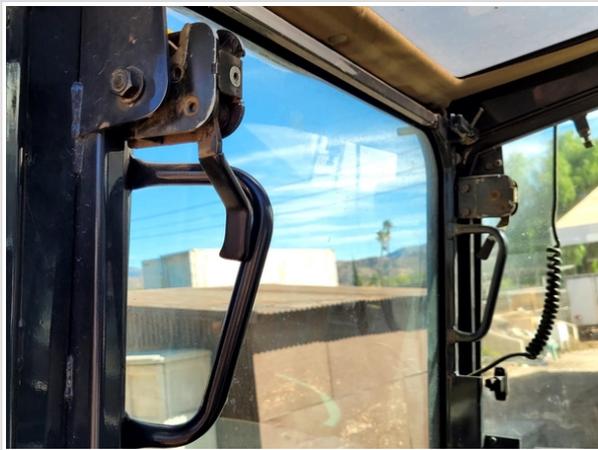
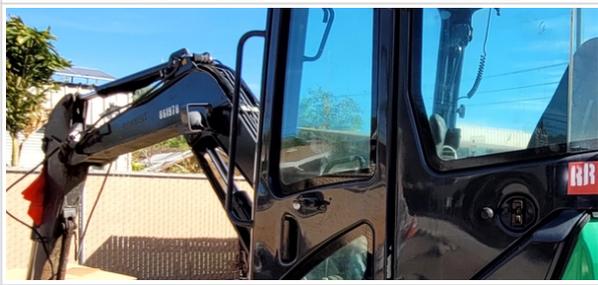
<p>Handrail Photos</p>

Left	3 - Normal Wear & Tear
Left Condition	No visible damage
Right	3 - Normal Wear & Tear
Right Condition	No visible damage
Upper	3 - Normal Wear & Tear
Upper Condition	No visible damage
Body Panels (Any Rust Damage?)	3 - Normal Wear & Tear
Body Panel Condition	No visible damage, good paint condition and panel fitment
Doors / Canopy Latches	3 - Normal Wear & Tear
Doors / Canopy Latches Condition	No visible damage
Steps / Ladders	0
Handrails	3 - Normal Wear & Tear
Handrails Condition	Handrails are fully intact and appear structurally sound

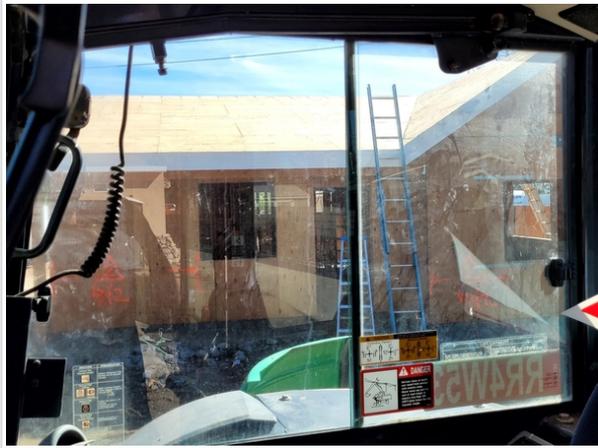
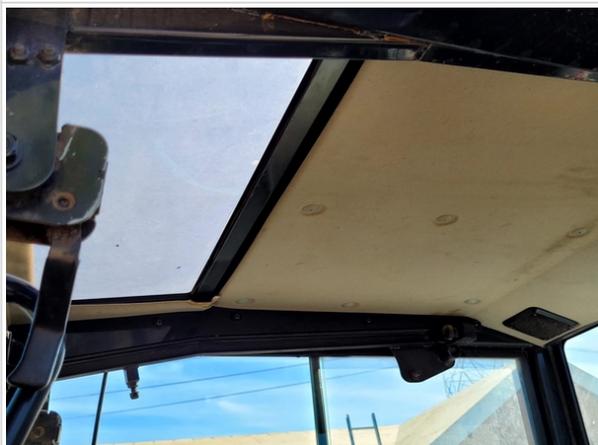
<p>Glass Condition</p>	<p>3 - Normal Wear &amp; Tear</p>
<p>Glass Condition Notes</p>	<p>Glass intact, no visible damage</p>
<p>Glass Condition Photos</p>

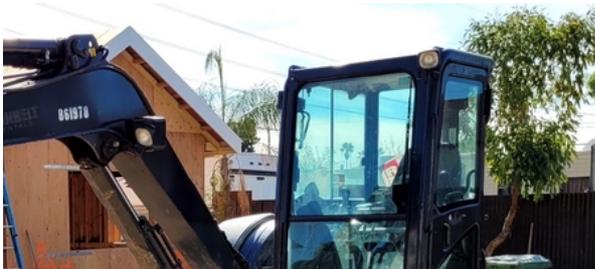
Mirrors	0
Lighting System	3 - Normal Wear & Tear
Lighting System Condition	No visible damage, lighting system is operational
Lighting System Photos

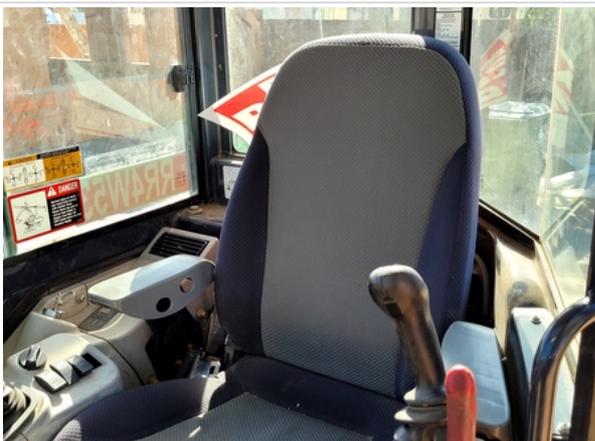
<b>Operator's Seat &amp; Arm Rests</b>	3 - Normal Wear & Tear	
<b>Operator's Seat &amp; Arm Rests Condition</b>	Seat(s) in good condition, no stains or tears in upholstery, Seat(s) have minor surface staining or small tears	
<b>Operator's Seat &amp; Arm Rests Photos</b>

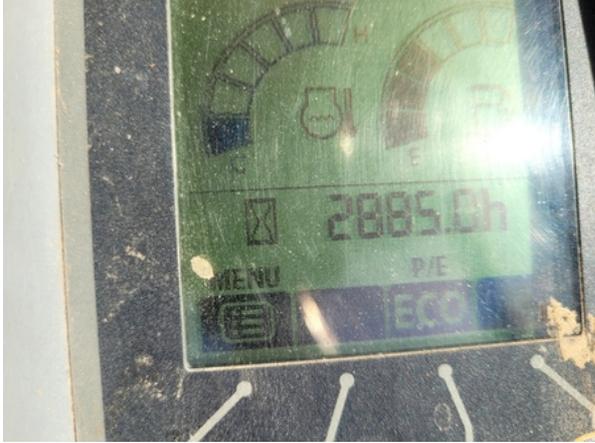
Hour Meter Activity Photos

<b>Seat Belt</b>	3 - Normal Wear & Tear
<b>Seat Belt Condition</b>	Seat belt secures properly. Belt is intact and in good condition
<b>Cabin Lights</b>	3 - Normal Wear & Tear
<b>Cabin Lights Condition</b>	Cabin lights are installed with all light covers in place, bulbs are installed and working properly
<b>Safety Lock Out / Stop</b>	3 - Normal Wear & Tear
<b>Safety Lock Out / Stop Condition</b>	Safety lock out device is present, in good condition, and functional
<b>Controls &amp; Switches</b>	3 - Normal Wear & Tear
<b>Controls &amp; Switches Condition</b>	All switches are installed and functional
<b>Hour Meter Activity</b>	3 - Normal Wear & Tear
<b>Hour Meter Condition</b>	Hour meter is functional and in good condition

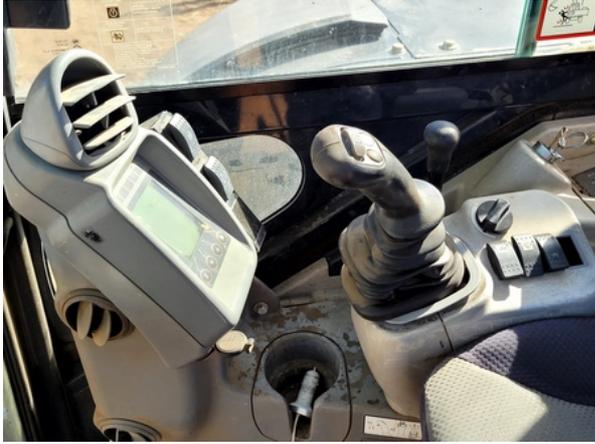
Other Gauge Activity	3 - Normal Wear & Tear
Other Gauge Condition	All cockpit gauges are functional and in good condition
Heater & A/C	3 - Normal Wear & Tear
Heater & A/C Condition	Heater and A/C work and transition through full temperature range
Fans / Vents	3 - Normal Wear & Tear
Fans / Vents Condition	Fan vents are functional, in good condition, and move through a full adjustable range of motion
Fans / Vents Photos

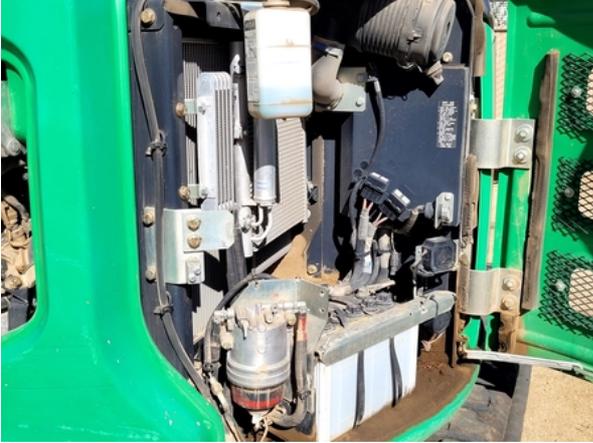
<b>Battery Condition Photos</b>

Blow-by (Visual Observation Check)	No
Unusual Noises (Upon Start-up, Idle, Shutdown)	No
Unusual Noise Notes	No unusual noises heard
Engine Smoke (Upon Start-up, Idle, Shutdown)	No
Engine Smoke Notes	No engine smoke issues observed
Engine Exhaust Color	Clear
Battery	3 - Normal Wear & Tear
Battery Condition	Clean & dry appearance, tight connections

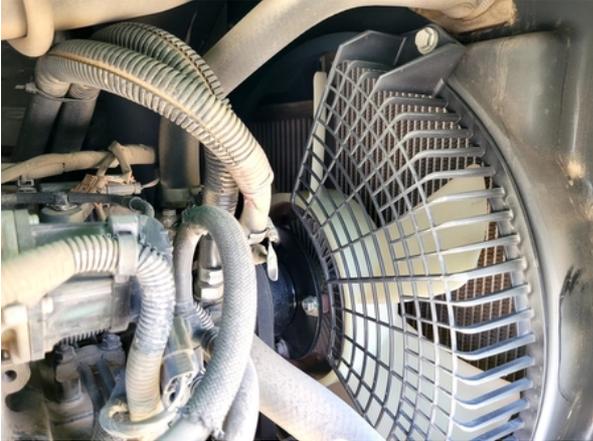
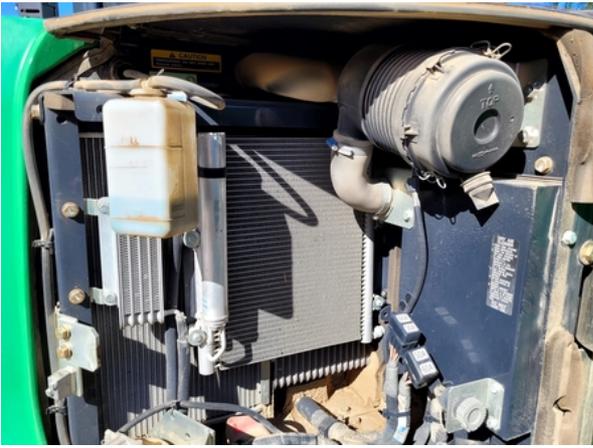
<b>Radiator</b>	3 - Normal Wear & Tear
<b>Radiator Condition</b>	Radiator fins & components appear to be in good working order, no signs of damage or leaks
<b>Radiator Photos</b>

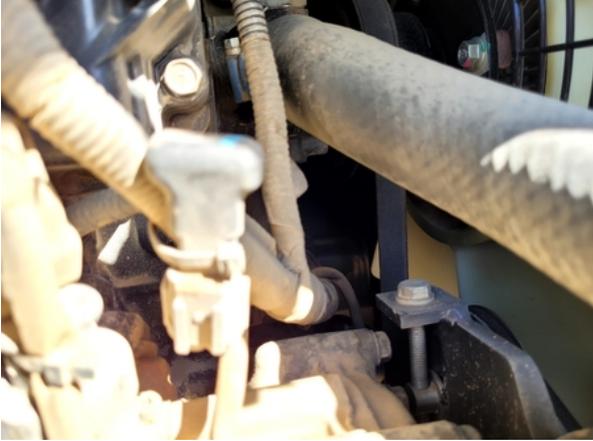
Hose Photos

<b>Belts</b>	3 - Normal Wear & Tear
<b>Belt Condition</b>	Belts appear in good condition & alignment with proper tension
<b>Hoses</b>	3 - Normal Wear & Tear
<b>Hose Condition</b>	Firm, pliant hoses with no signs of wear or leaks

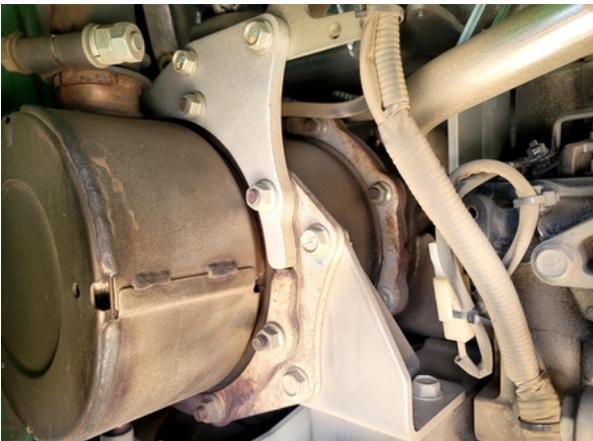
Water Pump	3 - Normal Wear & Tear
Water Pump Condition	No unusual pump noises heard
Cooling System Leaks	No
Coolant Color / Appearance	3 - Normal Wear & Tear
Coolant Color/Appearance Notes	Normal Translucent appearance, no visual signs of contamination
Oil Leaks	No
Oil Color / Appearance	3 - Normal Wear & Tear
Oil Color / Appearance Notes	Clean oil appearance, no signs of cross contamination, Appropriate oil level
Fuel Leaks	No
Equipped with DPF (Diesel Particulate Filter)	Yes
DPF Condition	3 - Normal Wear & Tear
DPF Condition Notes	Filter housing is intact with no signs of damage or malfunction, DPF indicator is not illuminated
DPF Photos

Requires DEF (Diesel Exhaust Fluid)	No
Overall Engine Appearance	Dusty & dry, Clean & dry
Overall Engine Comments	Engine in good condition. No issues found and running strong.

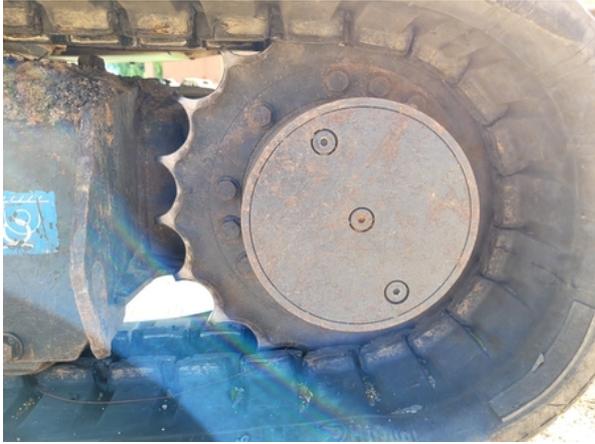
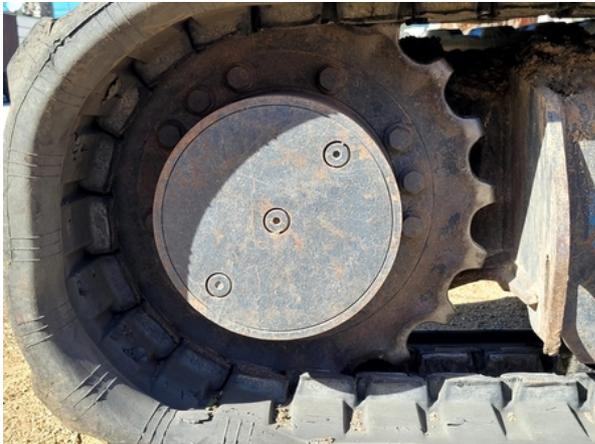
Drivetrain	
Hydrostatic Transmission?	Yes
2 Speed?	Yes
Hydrostatic Drive Configuration	Split Transmission
Drive Motors	2 - Above Average Wear
Drive Motor Photos

Hydrostatic Parking Brake	3 - Normal Wear & Tear
Hydrostatic Parking Brake Condition	Good brake function
Overall Drivetrain Comments	Overall drivetrain in good condition with no obvious problems found.

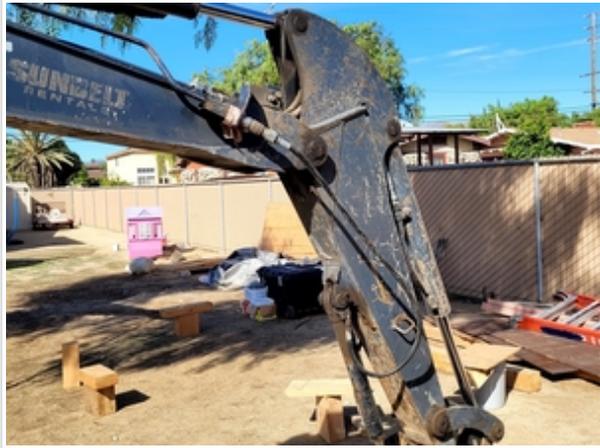
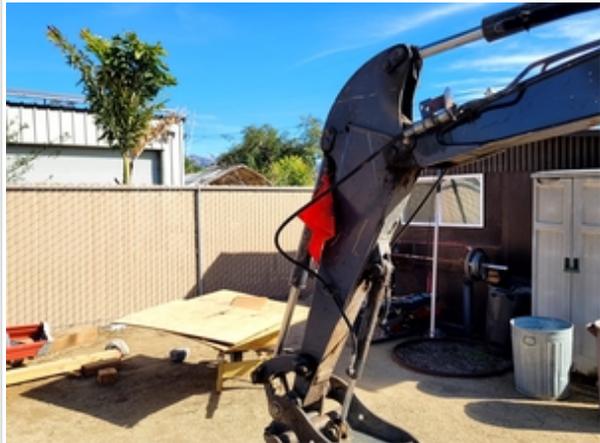
<p>Stick Condition</p>	<p>3 - Normal Wear &amp; Tear</p>	
<p>Stick Photos</p>

<b>What's Great About the Machine</b>	Machine is in great condition. This Excavator is equipped with a hydraulic thumb and 2 buckets. No active leaks seen and Powertrain sounds strong and healthy.
<b>What Needs Work</b>	Front auxiliary hoses loose and should be properly secured to implements. Scuff marks on front stick and counterweight.
<b>Date/Time</b>	11-17-2022

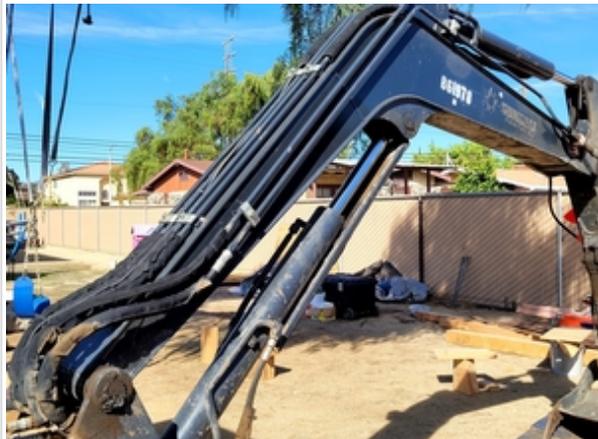
Hydraulics Overall	
Wet or Damp Hydraulic Lines / Fittings	No
Appearance of Hydraulic Lines / Fittings	3
Hydraulic Lines / Fittings Condition	Hydraulic lines & fittings are clean and in good condition
Appearance of Hydraulic Lines / Fittings Photos

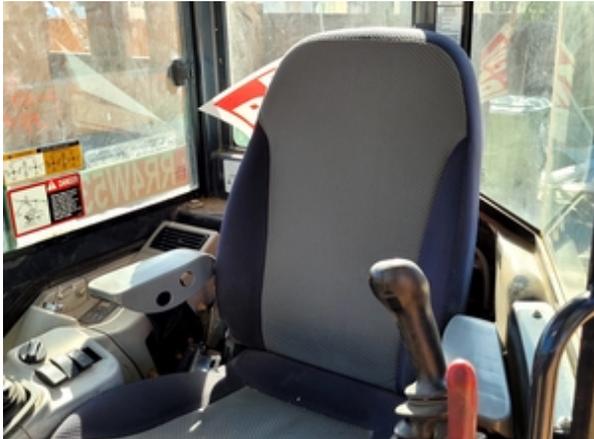
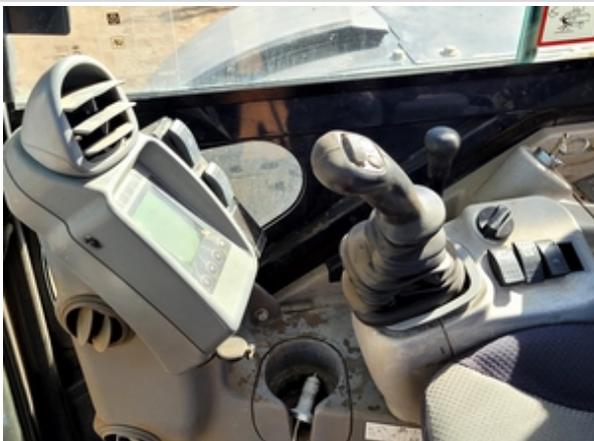
<b>Unusual Noises (Hydraulic Pump)</b>	No	
<b>Hydraulic Pump Notes</b>	No unusual noises heard during operation	
<b>External Controls / Levers</b>	3	
<b>External Controls / Levers Condition</b>	Good function & condition of hydraulic controls	
<b>External Controls / Levers Photos</b>

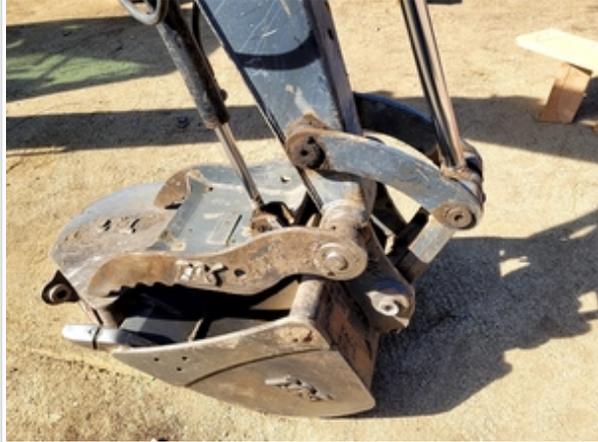
Attachment Type	Hydraulic Thumb
Attachment Make	TAG
Attachment Size / Specs	12"
Attachment Condition	3 - Normal Wear & Tear
Attachment Photos
