Inspection Report (Generator)

Year	2020
Make	SmartGen
Model	SGC-100GF
Serial Number	20201122655
Hour Meter Reading	2,999 Hrs.
Previous Application (e.g., earth moving, mining, demolition, etc)	General Construction

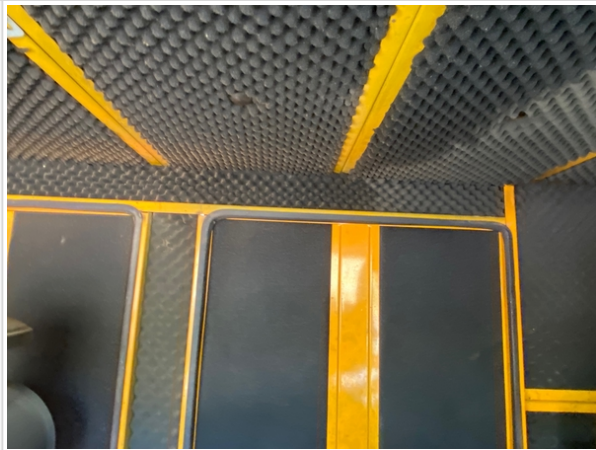
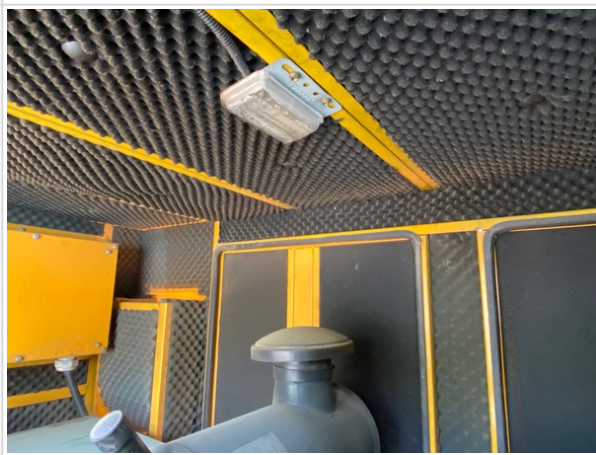
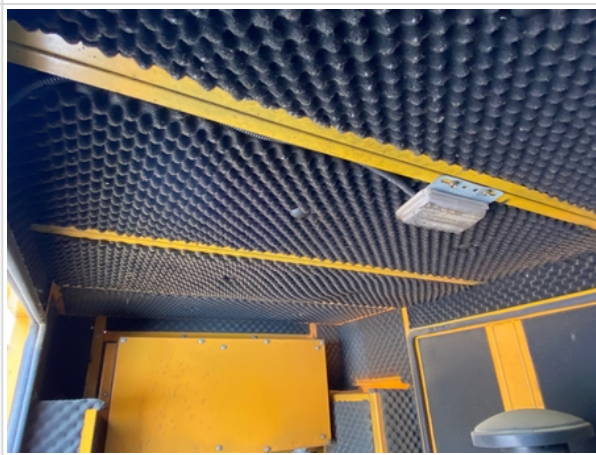
Body Panels	3 - Normal Wear & Tear	
Body Panel Condition	No visible damage, good paint condition and panel fitment	
Doors / Canopy Latches	3 - Normal Wear & Tear	
Doors / Canopy Latches Condition	No visible damage	
Steps / Ladders	0	
Handrails	0	
Glass	0

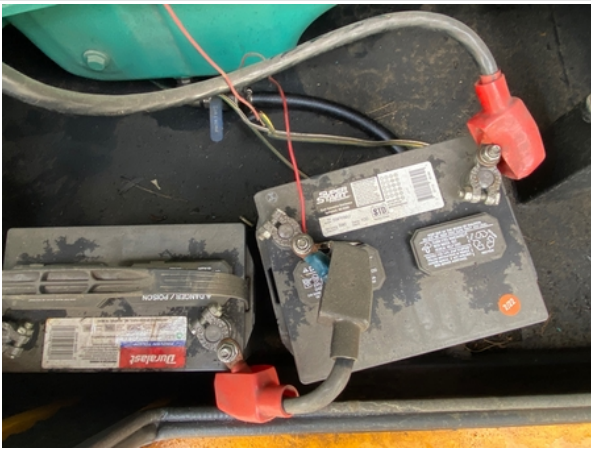
Battery Condition Photos

Blow-by (Visual Observation Check)	No
Unusual Noises (Upon Start-up, Idle, Shutdown)	No
Unusual Noise Notes	No unusual noises heard
Engine Smoke (Upon Start-up, Idle, Shutdown)	No
Engine Smoke Notes	No engine smoke issues observed
Engine Exhaust Color	Clear
Battery	2 - Above Average Wear
Battery Condition	Clean & dry appearance, tight connections, Other (see comments)
Comments	Battery hold downs not in place. Batteries working well with no issues at startup.

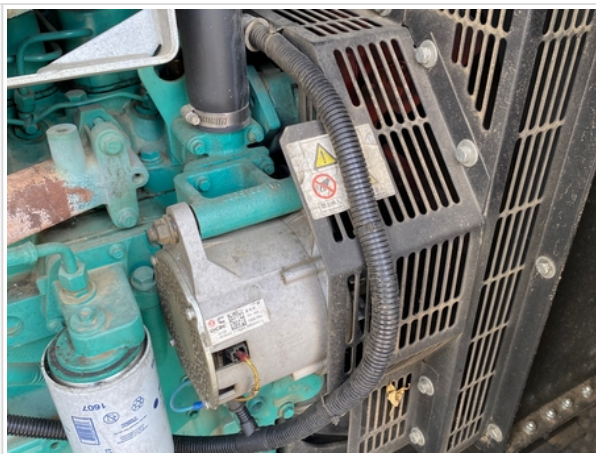
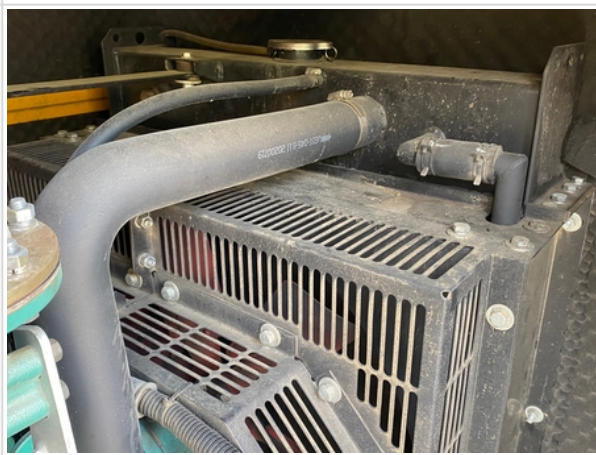
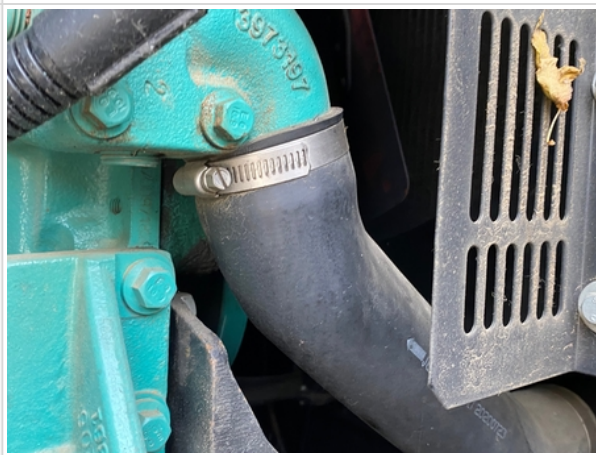
Radiator	3 - Normal Wear & Tear
Radiator Condition	Radiator fins & components appear to be in good working order, no signs of damage or leaks
Belts	3 - Normal Wear & Tear
Belt Condition	Belts appear in good condition & alignment with proper tension
Hoses	3 - Normal Wear & Tear
Hose Condition	Firm, pliant hoses with no signs of wear or leaks
Hose Photos

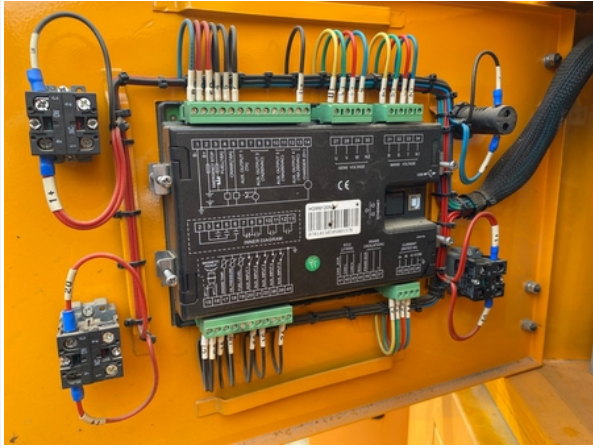
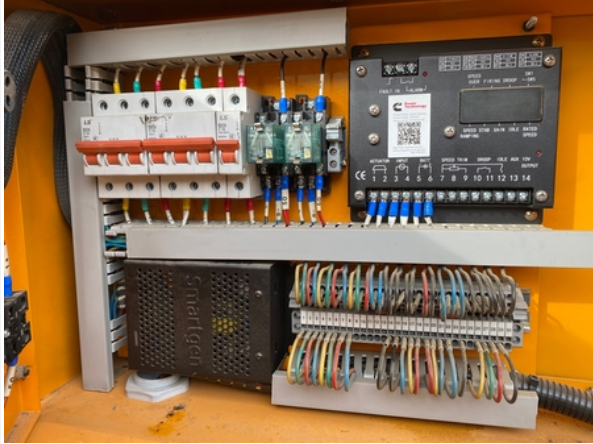
Wire Harness	3 - Normal Wear & Tear
Comments	custom made harness is for powering in line electric diesel fuel pump noticeable from fuel filter housing over to the dual batteries
Wire Harness Photos

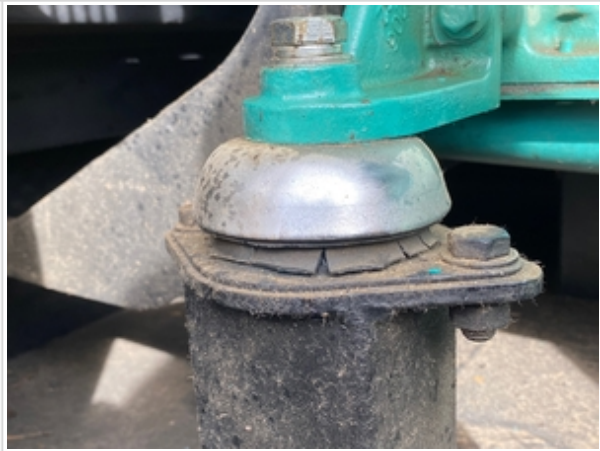
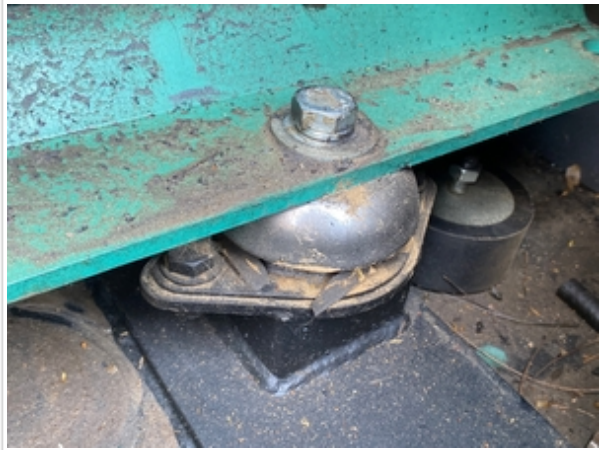
Overall Mounting Plate Appearance	3 - Normal Wear & Tear	
Comments	Some engine mounts showing small cracks in the rubber	
Mounting Plate Photos

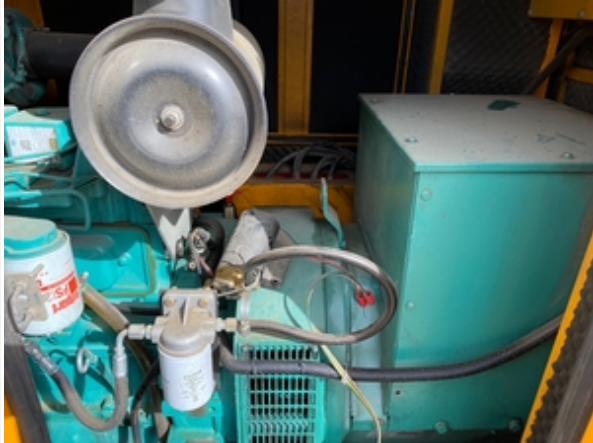
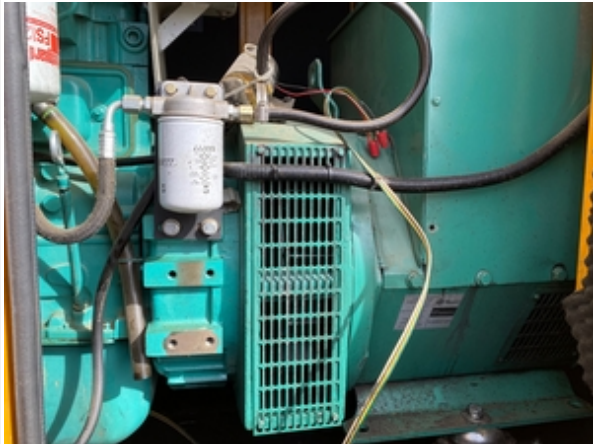
Fuel Tank Condition	3 - Normal Wear & Tear
Fuel Lines & Hoses	3 - Normal Wear & Tear
Comments	Some lines/hoses are not OEM due to inline electric fuel pump set in place
Fuel Lines & Hoses Photos
