Inspection Report (On-Highway Dump Truck)

Year	2011
Make	Peterbilt
Model	367
Serial Number	1NP - TLUOX - 6 - BD127980
Truck Odometer Reading	408,807
Previous Application (e.g., earth moving, mining, demolition, etc)	Asphalt Construction

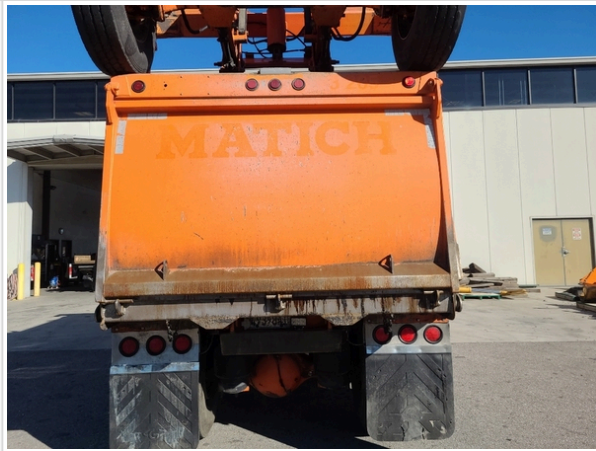
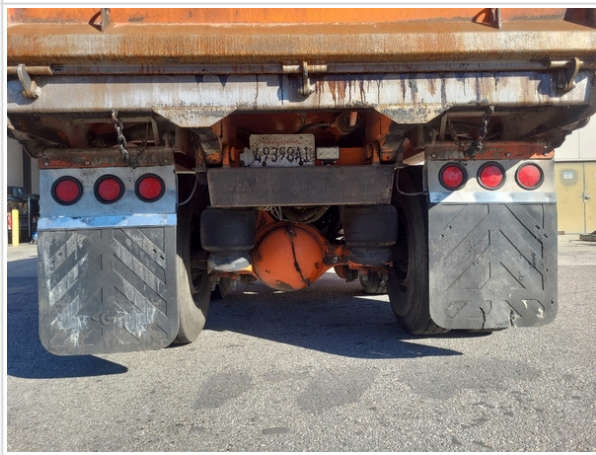
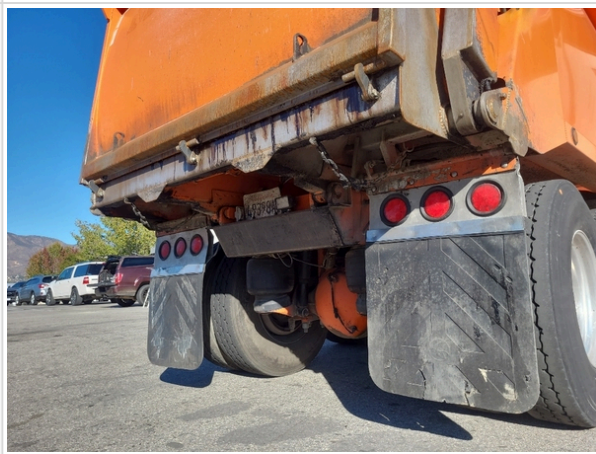
Rear	3 - Normal Wear & Tear	
Rear Condition	No visible damage, Other (see comments)	
Comments	normal wear and tear	
Rear Photos

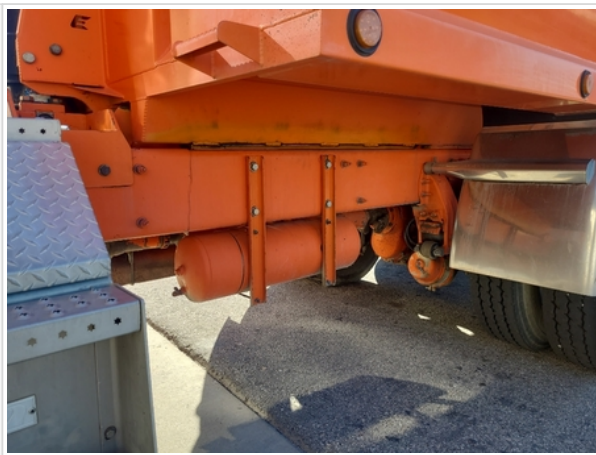
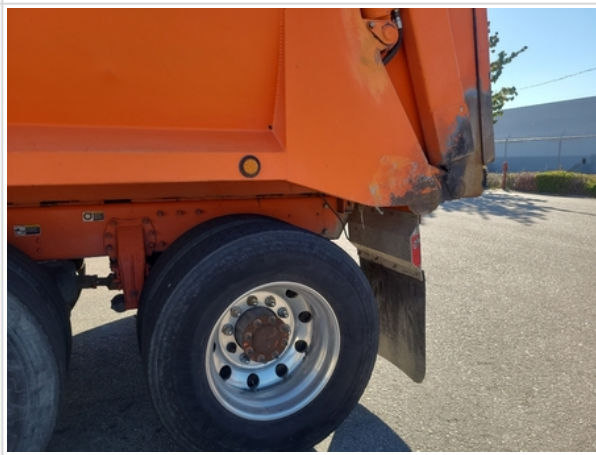
Left	3 - Normal Wear & Tear
Left Condition	No visible damage, Other (see comments)
Comments	a few paint chipping at front fender

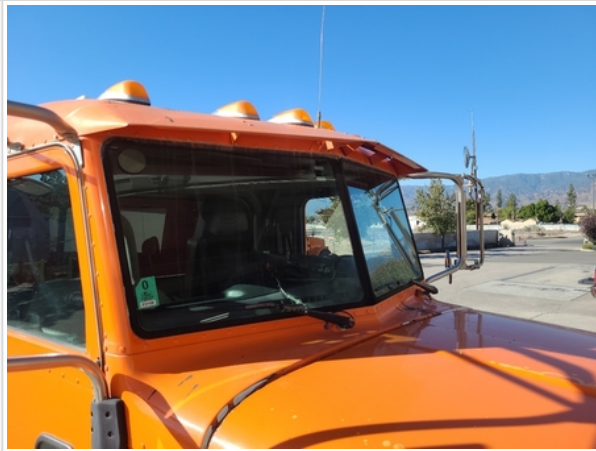
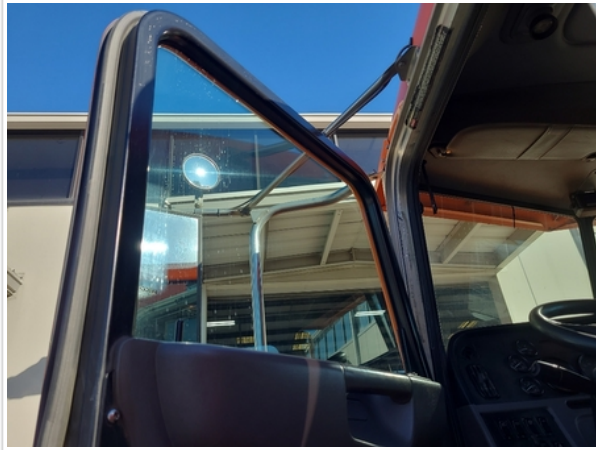
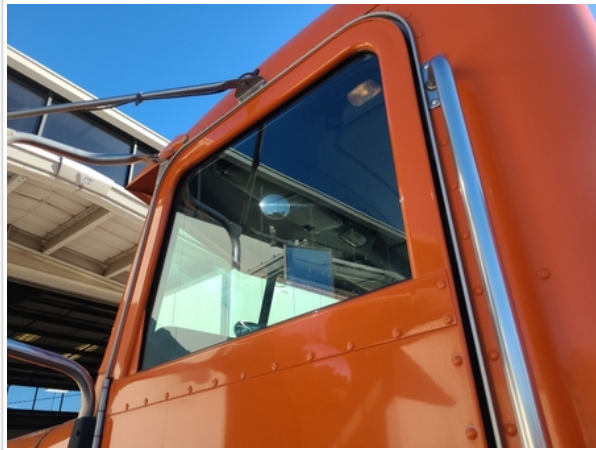
Glass Condition Photos

Glass Condition	3 - Normal Wear & Tear	
Glass Condition Notes	Glass intact, no visible damage

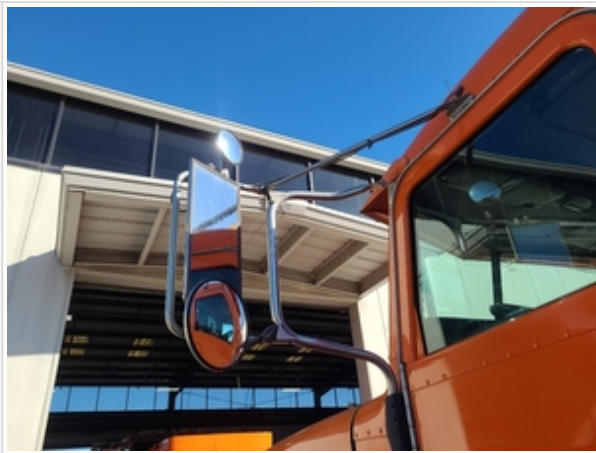
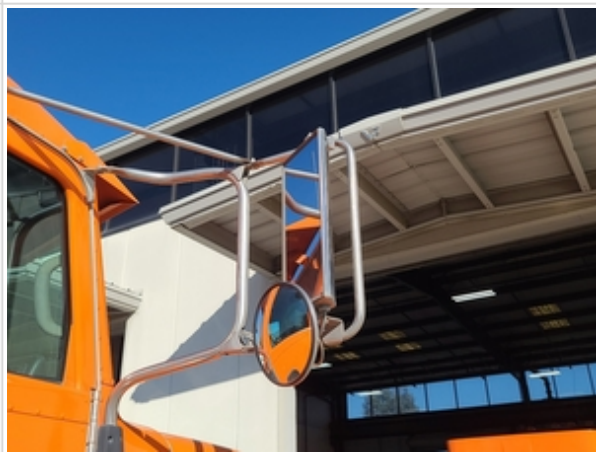
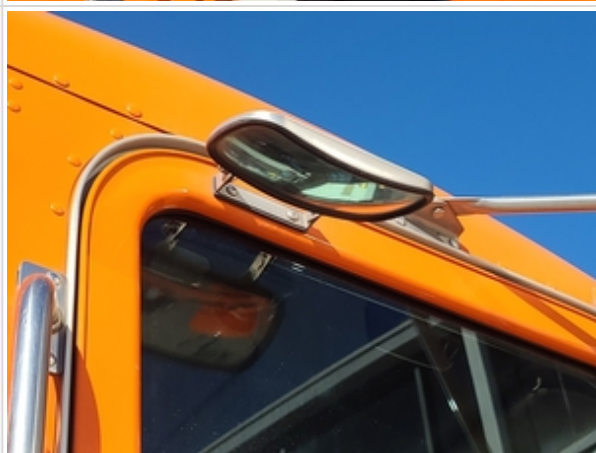
Mirrors Photos

Mirrors	3 - Normal Wear & Tear
Mirror Condition Notes	Mirrors present and intact, no visible damage

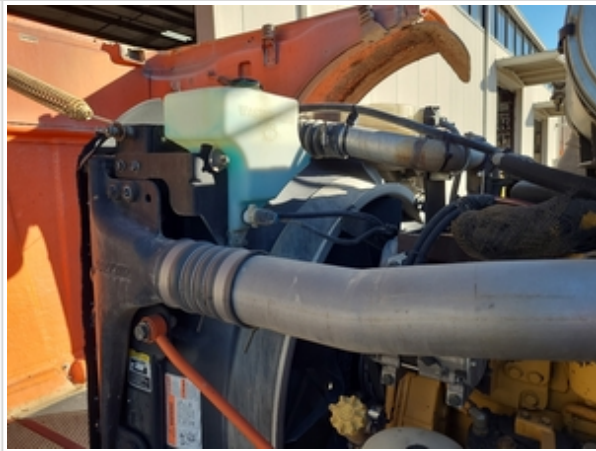
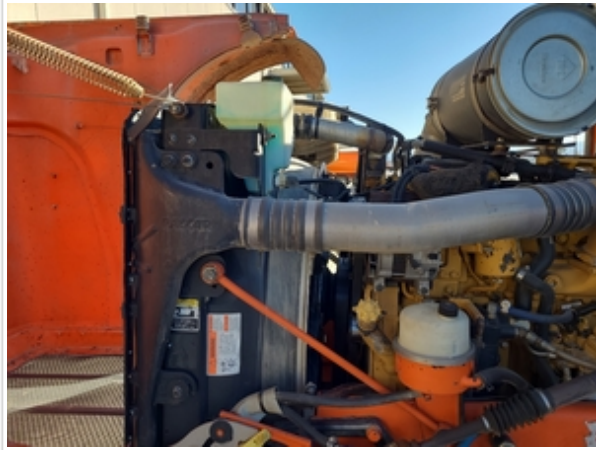
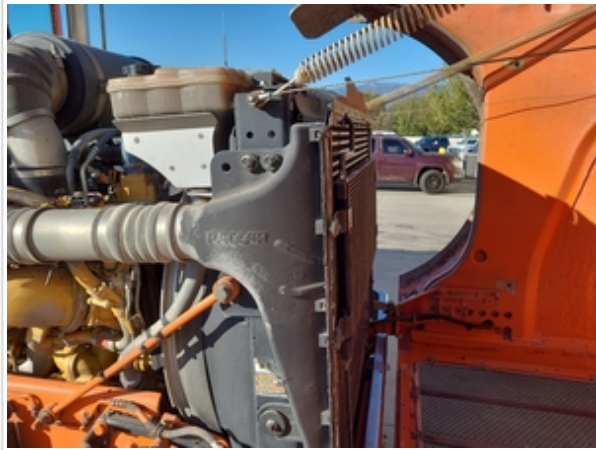
Radiator	3 - Normal Wear & Tear
Radiator Condition	Radiator fins & components appear to be in good working order, no signs of damage or leaks
Radiator Photos

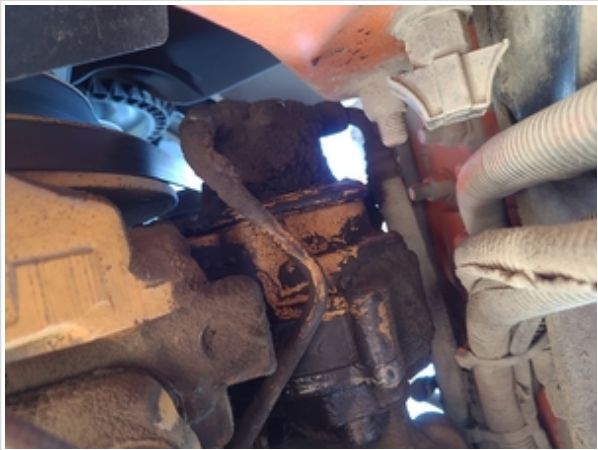
Cooling System Leaks	No	
Coolant Color / Appearance	3 - Normal Wear & Tear	
Coolant Color/Appearance Notes	Normal Translucent appearance, no visual signs of contamination	
Oil Leaks	Yes	
Oil Leak Notes	Wet areas with drops forming due to oil leakage, Other (see comments)	
Comments	small oil leak observed around bell housing & Small oil leak at front left side of engine	
Oil Leak Photos

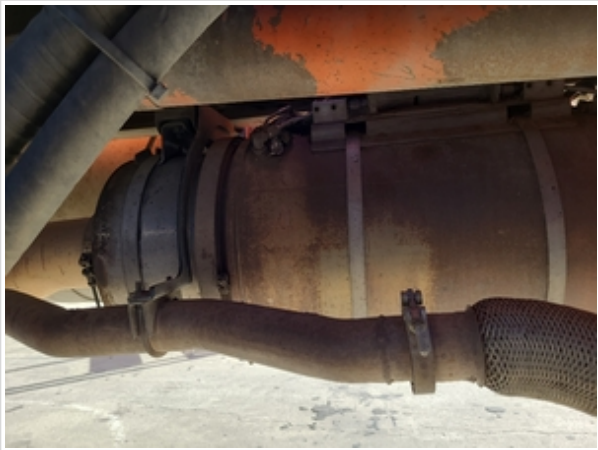
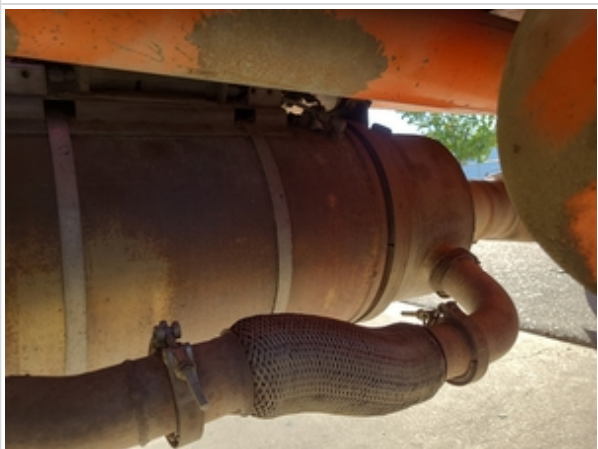
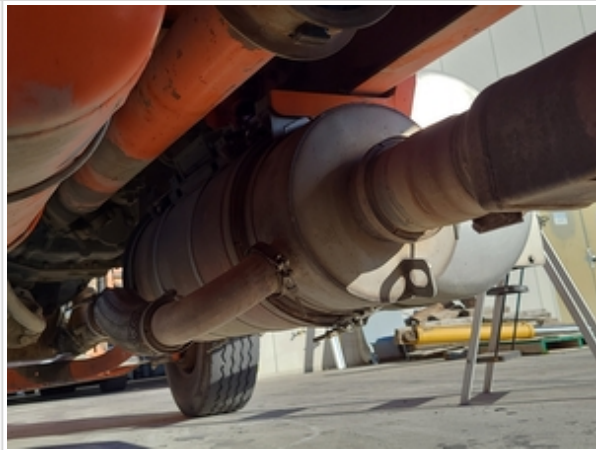
Oil Color / Appearance	3 - Normal Wear & Tear	
Oil Color / Appearance Notes	Clean oil appearance, no signs of cross contamination, Appropriate oil level	
Fuel Leaks	No	
Equipped with DPF (Diesel Particulate Filter)	Yes	
DPF Condition	3 - Normal Wear & Tear	
DPF Condition Notes	Filter housing is intact with no signs of damage or malfunction, DPF indicator is not illuminated	
DPF Photos

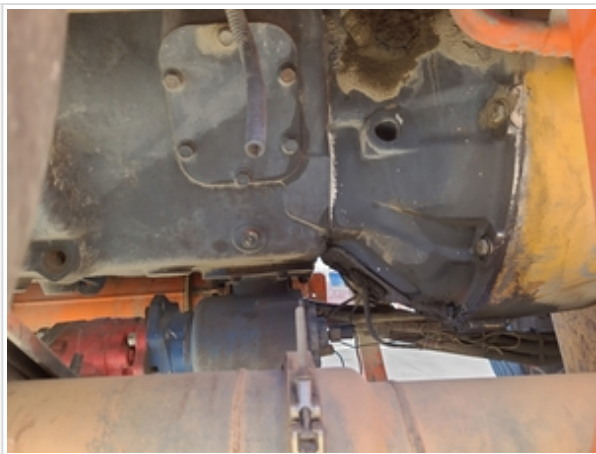
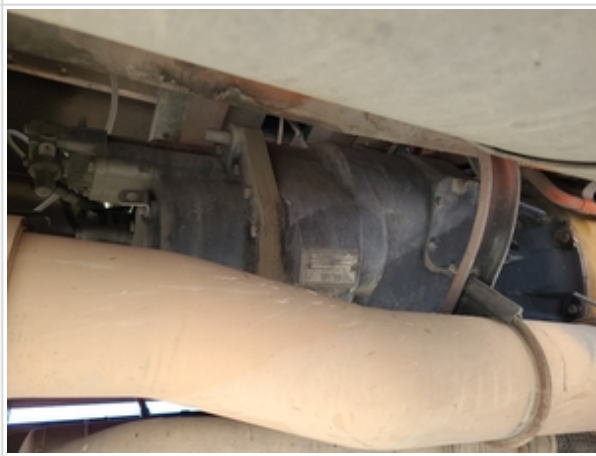
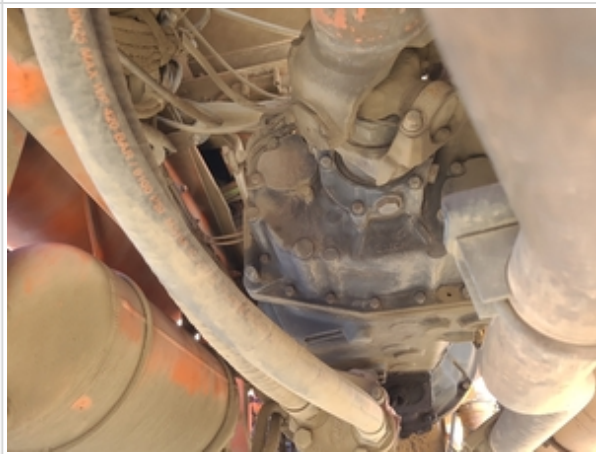
Transmission Info (Make/Model)	Eaton 10 Speed Manual Transmission
Drive Type	6X4
Overdrive	N/A
Transmission	3 - Normal Wear & Tear
Transmission Condition	No unusual noises or vibrations
Transmission Condition Photos

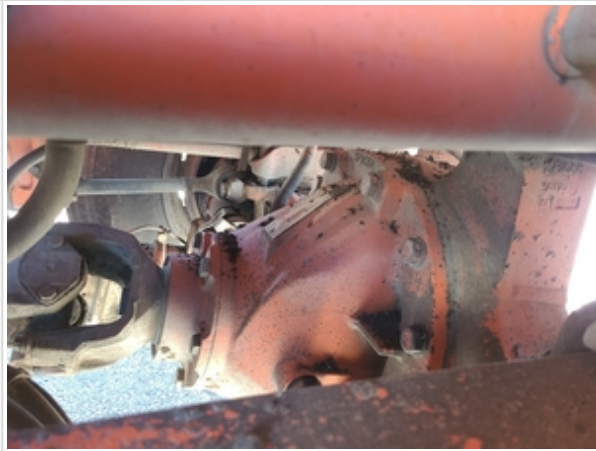
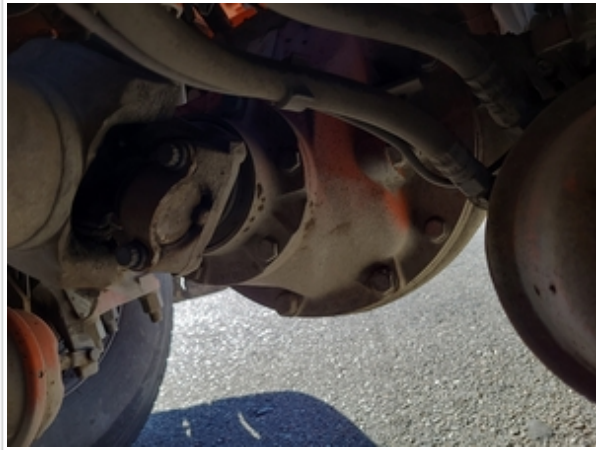
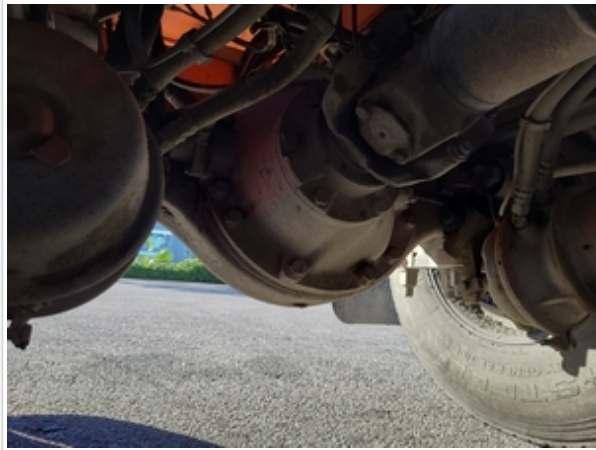
Differential	Check condition of the differential(s). Take photos and notes as relevant.
Rear Differential	3 - Normal Wear & Tear
Rear Differential Condition	Dry housing appearance, no unusual noises heard during operation
Rear Differential Photos

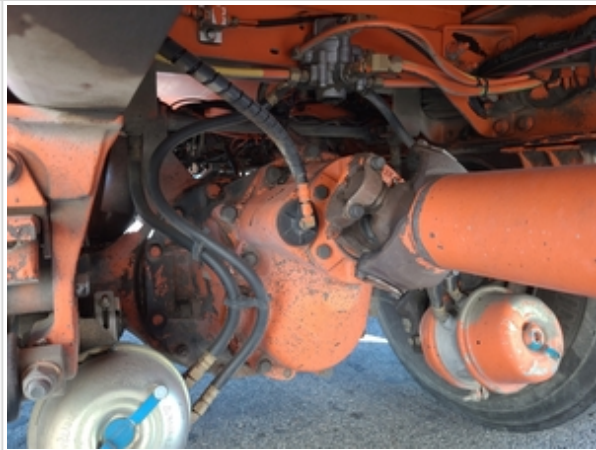
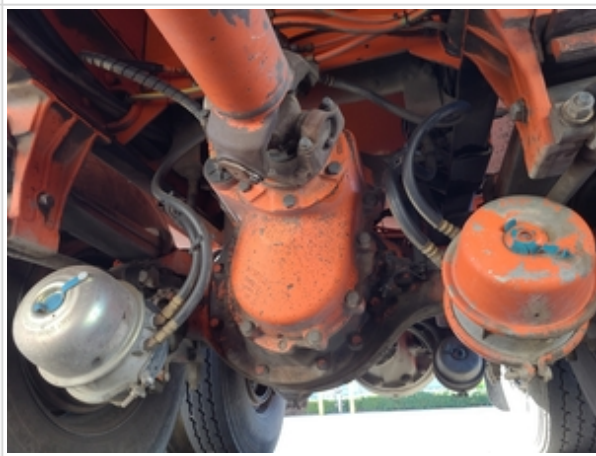
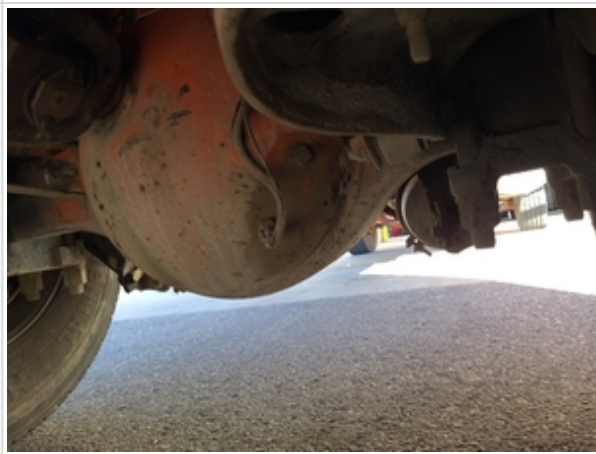
Front Differential Photos

Front Differential	3 - Normal Wear & Tear
Front Differential Condition	Dry housing appearance, no unusual noises heard during operation

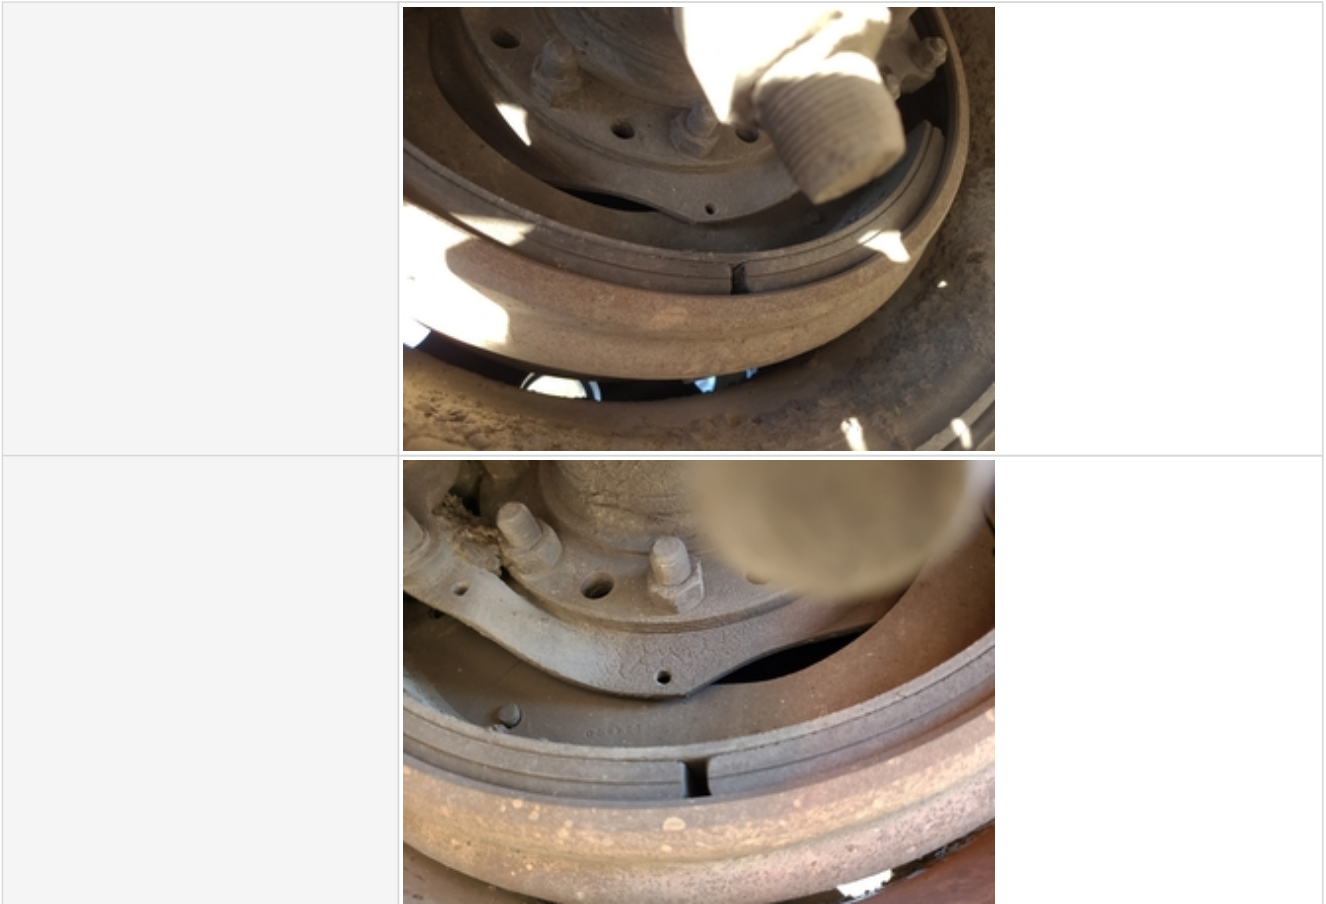
Brake Shoe Thickness	50%
Comments	front left side low rest okay
Brake Shoe Photos

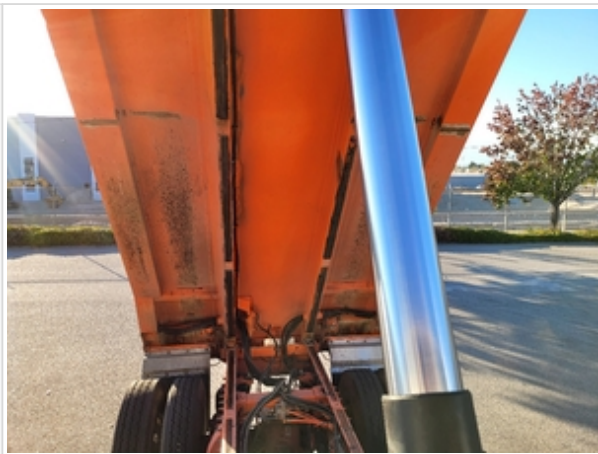
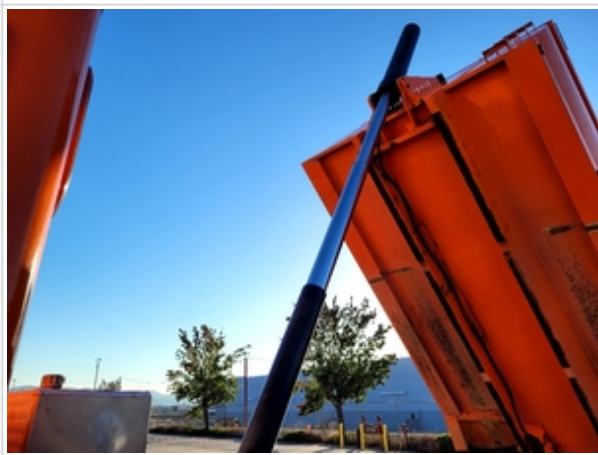
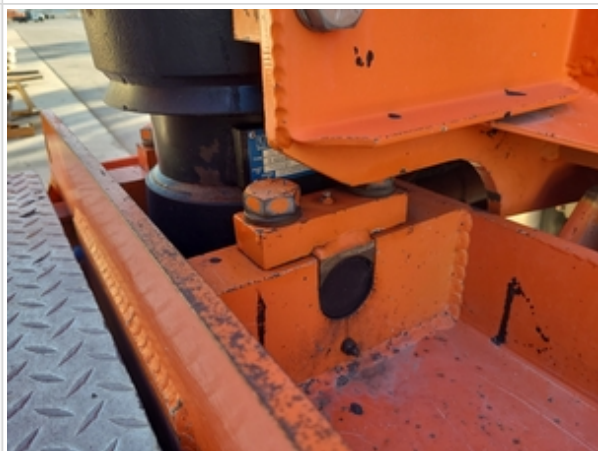
Hydraulic Function	3 - Normal Wear & Tear
Comments	Dump bed lift cylinder retract abnormal

Exterior Rating	3
Interior Rating	3
Safety Rating	3
Quality Rating	3
Functionality Rating	3
Overall Rating	3
What's Great About the Machine	This truck is in excellent condition simply because it has been well maintained bumper to bumper. No obvious major repairs found in powertrain or suspension. The interior is super clean and the exterior looks great.
What Needs Work	Most tires need to be replaced soon. Front brake shoes need to be replaced soon. Dump body lift cylinder should be further inspected to determine possible hydraulic retract problem.
Date/Time	11-14-2022
