Inspection Report (On-Highway Dump Truck)

Year	2011
Make	Peterbilt
Model	367
Serial Number	1NP - TLUOX - 6 - BD127977
Truck Odometer Reading	443,015
Previous Application (e.g., earth moving, mining, demolition, etc)	Asphalt Construction

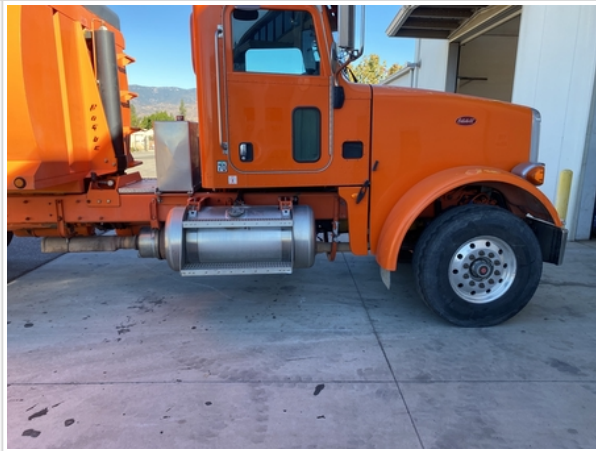
Upper	3 - Normal Wear & Tear
Upper Condition	No visible damage
Upper Photos

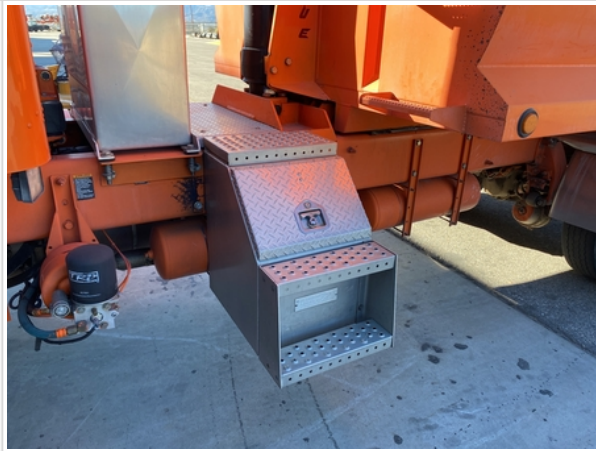
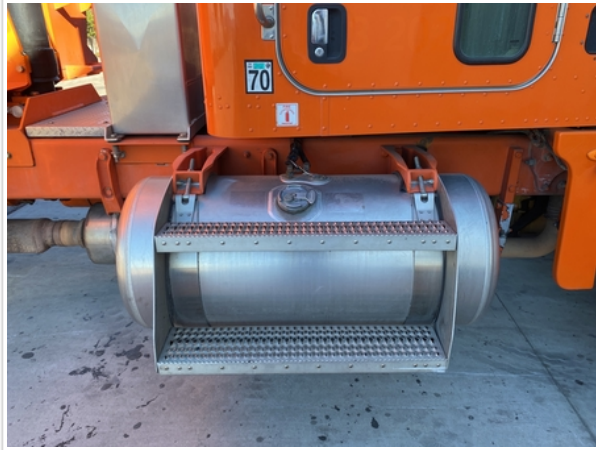
Handrails	3 - Normal Wear & Tear
Handrails Condition	Handrails are fully intact and appear structurally sound
Handrail Photos

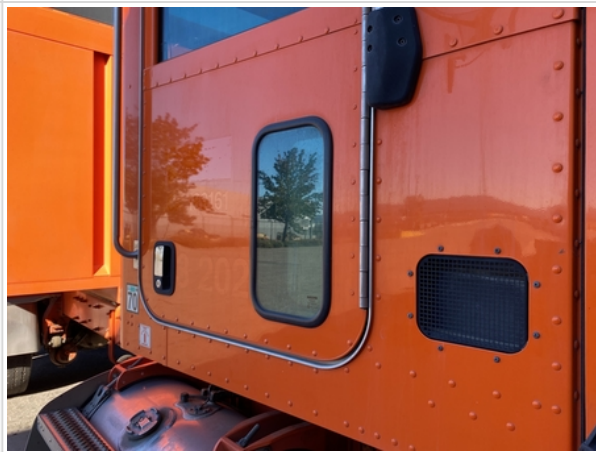
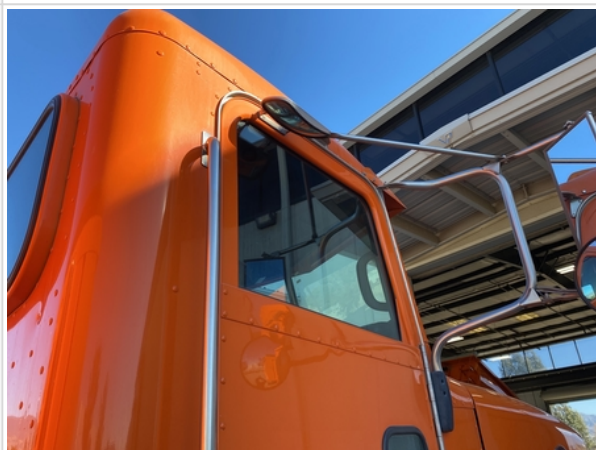
Glass Condition	3 - Normal Wear & Tear	
Glass Condition Notes	Glass intact, no visible damage	
Glass Condition Photos

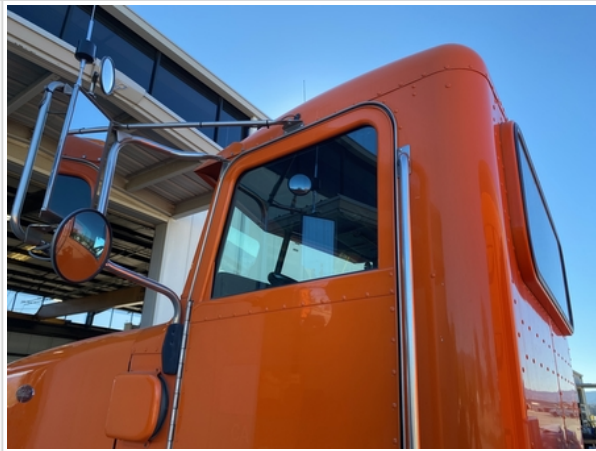
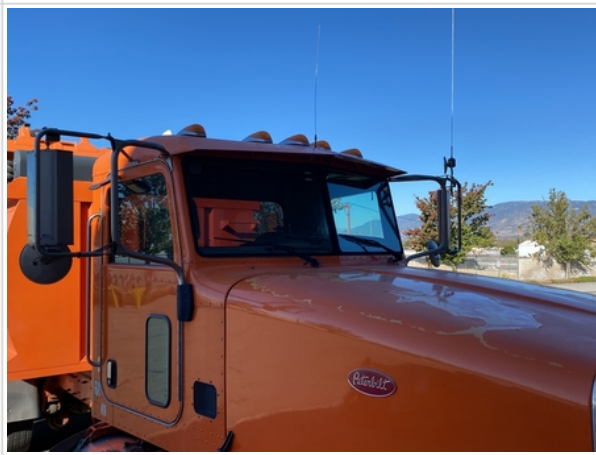
Mirrors	3 - Normal Wear & Tear
Mirror Condition Notes	Mirrors present and intact, no visible damage
Mirrors Photos

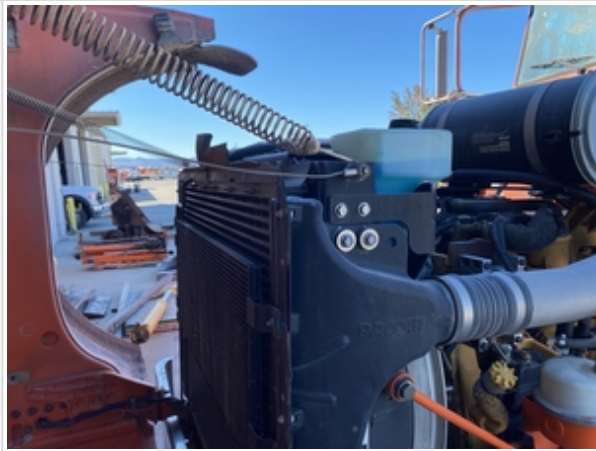
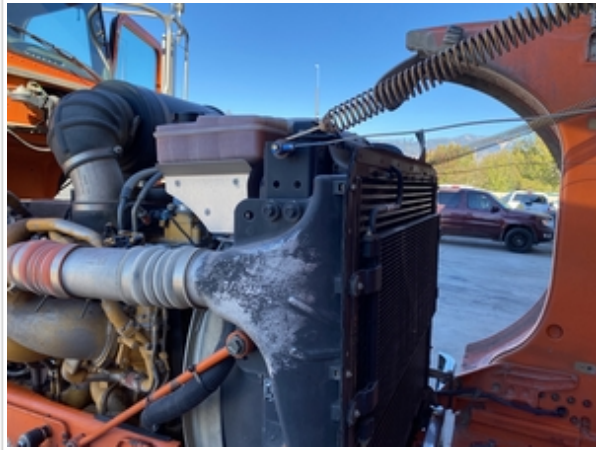
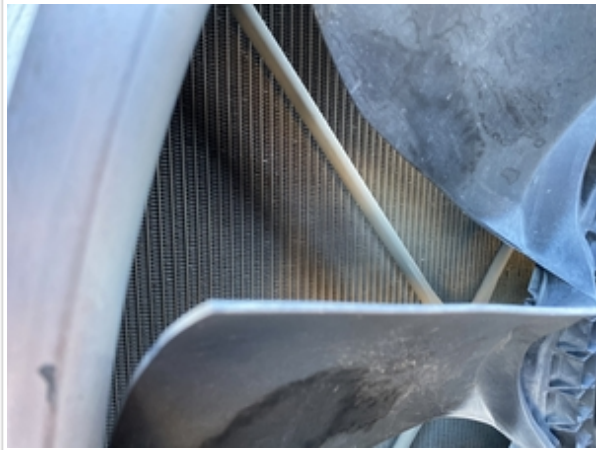
Belts	3 - Normal Wear & Tear
Belt Condition	Belts appear in good condition & alignment with proper tension

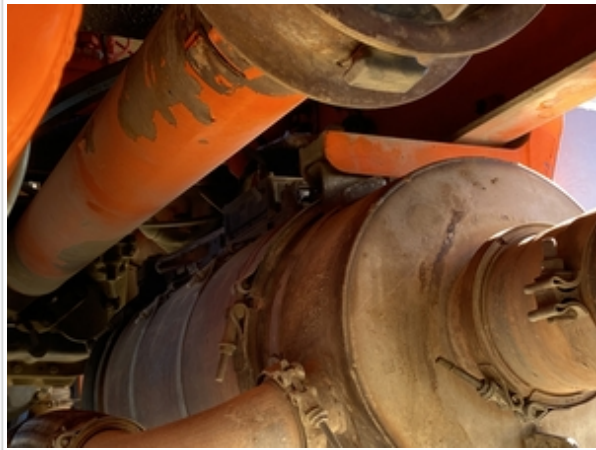
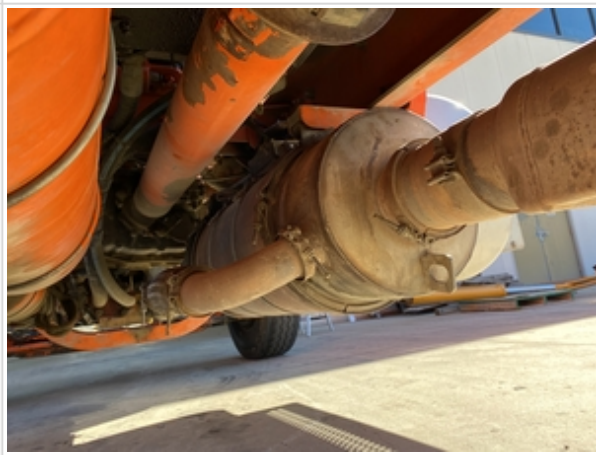
DPF Photos

Oil Color / Appearance	3 - Normal Wear & Tear	
Oil Color / Appearance Notes	Clean oil appearance, no signs of cross contamination, Appropriate oil level	
Fuel Leaks	No	
Equipped with DPF (Diesel Particulate Filter)	Yes	
DPF Condition	3 - Normal Wear & Tear	
DPF Condition Notes	Filter housing is intact with no signs of damage or malfunction, DPF indicator is not illuminated

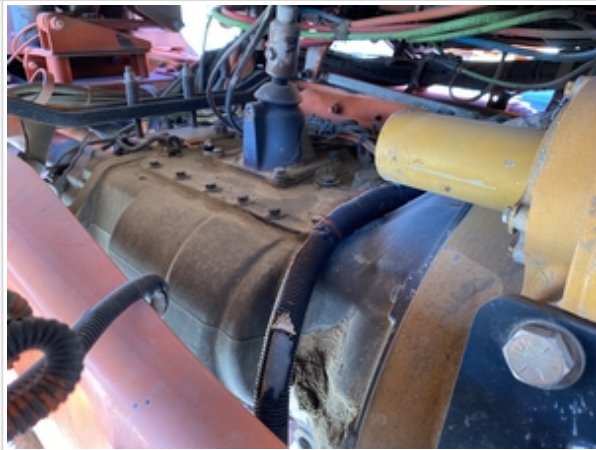
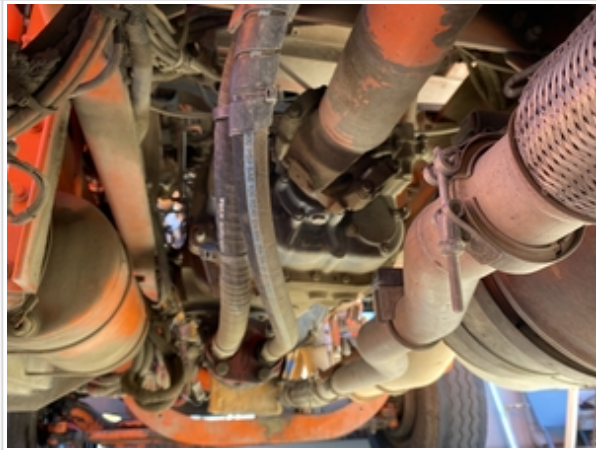
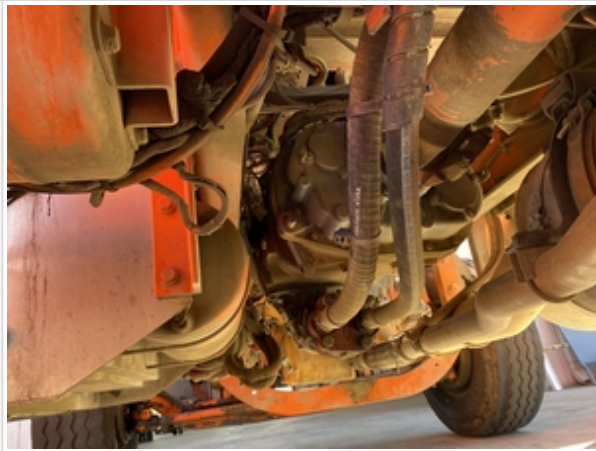
Transmission Condition Photos

Transmission Info (Make/Model)	Eaton Fuller 10 Speed
Drive Type	6X4
Overdrive	No
Transmission	3 - Normal Wear & Tear
Transmission Condition	No unusual noises or vibrations

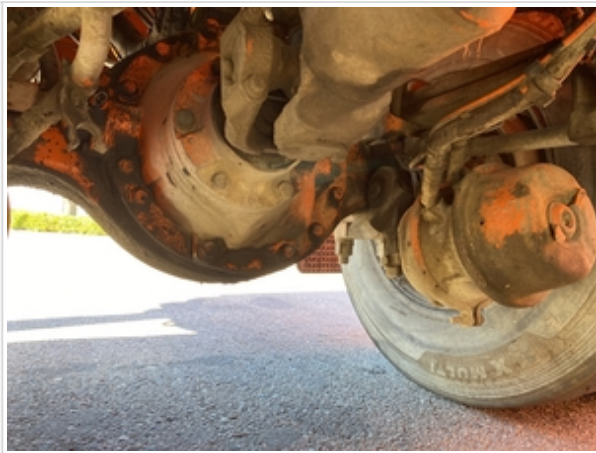
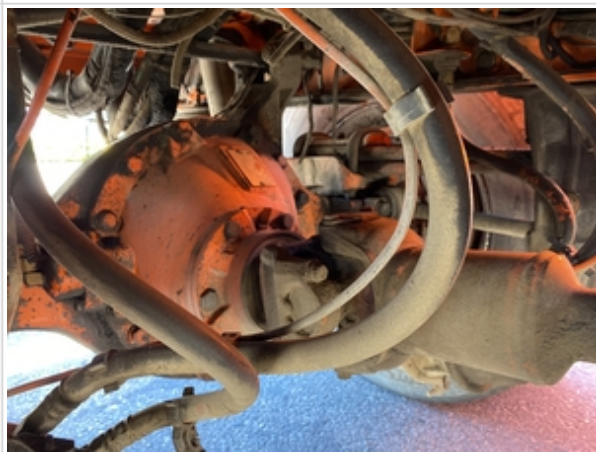
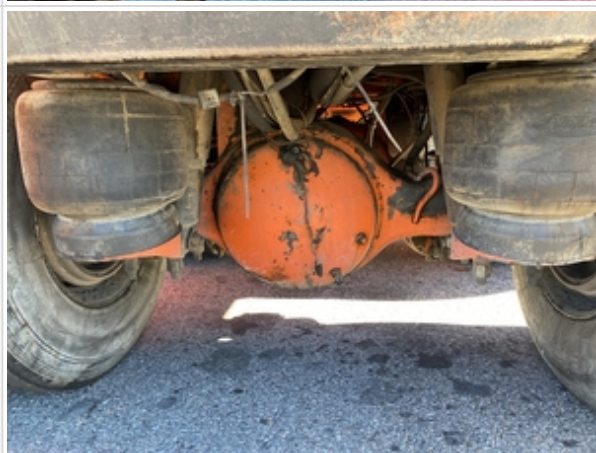
Rear Differential Photos

Clutch	3 - Normal Wear & Tear
Clutch Condition	Clutch is functioning as expected
Shift Lever	3 - Normal Wear & Tear
Shift Lever Condition	Good forward and reverse function
Differential	Check condition of the differential(s). Take photos and notes as relevant.
Rear Differential	3 - Normal Wear & Tear
Rear Differential Condition	Dry housing appearance, no unusual noises heard during operation

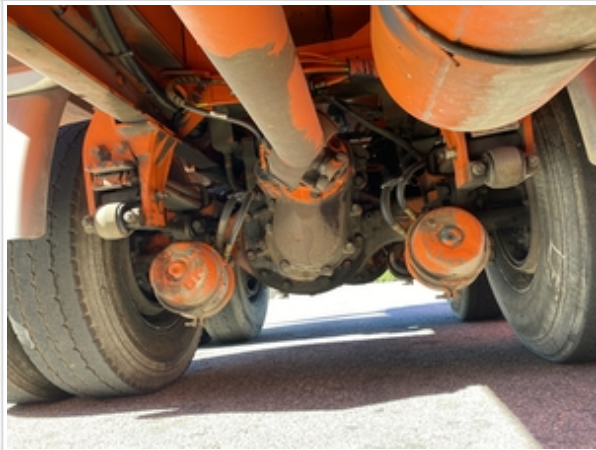
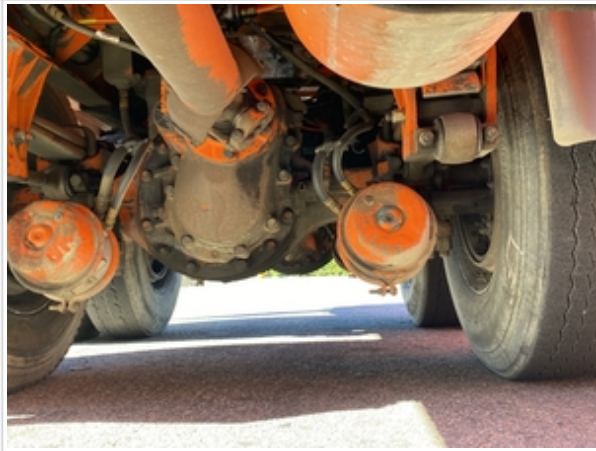
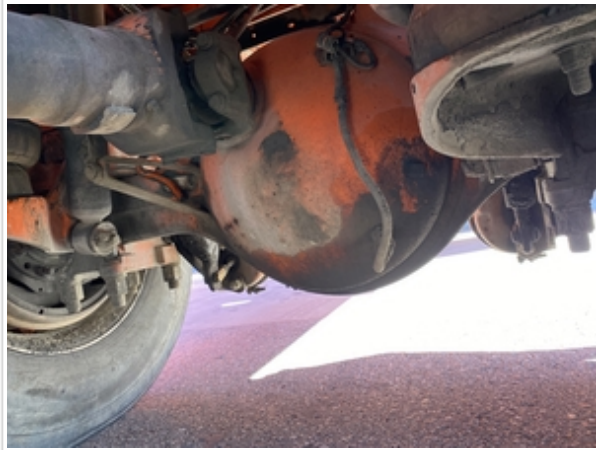
Front Differential Photos

Front Differential	3 - Normal Wear & Tear
Front Differential Condition	Dry housing appearance, no unusual noises heard during operation

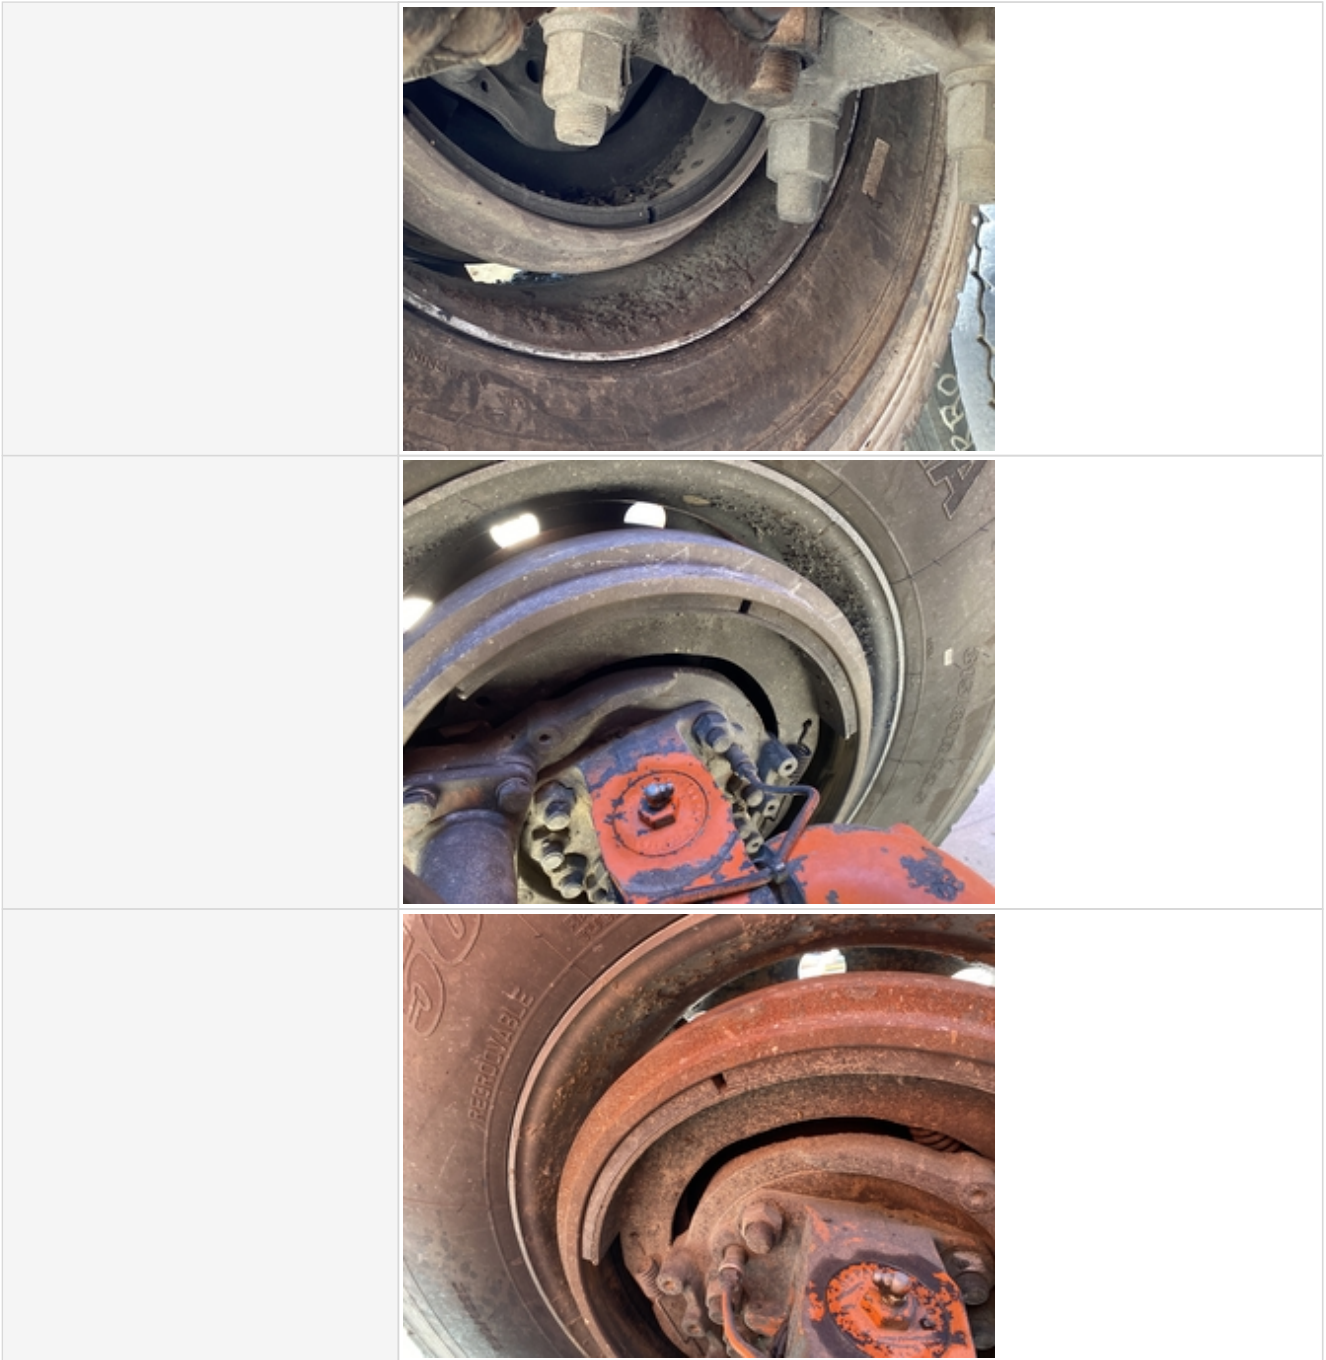
Brake Shoe Photos

<p>Brake Shoe Thickness</p>	<p>10%</p>
-----------------------------	------------

Exterior Rating	3
Interior Rating	3
Safety Rating	3
Quality Rating	3
Functionality Rating	3
Overall Rating	3
What's Great About the Machine	This truck is well maintained by a professional, experienced shop that does not cut corners. All their trucks are treated the same and it shows. Very few issues found.
What Needs Work	Few cosmetic issues with clearcoat. Tires need to be replaced soon and some brake shoes getting low.
Date/Time	11-15-2022
