Inspection Report (Boom Lift)

Year	2014
Make	JLG
Model	600AJ
Serial Number	0300192692
Hour Meter Reading	2,377
Previous Application (e.g., earth moving, mining, demolition, etc)	Equipment Rentals

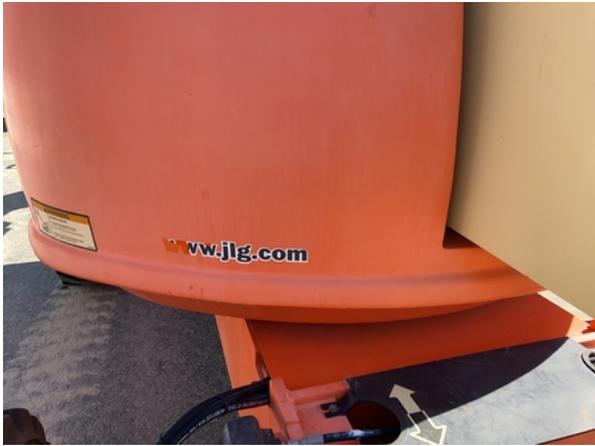
Body Panels	3 - Normal Wear & Tear
Body Panel Condition	No visible damage, good paint condition and panel fitment, Other (see comments)
Comments	Minor scuff marks on hoods
Doors / Canopy Latches	3 - Normal Wear & Tear
Doors / Canopy Latches Condition	No visible damage
Steps / Ladders	0
Handrails	3 - Normal Wear & Tear
Handrails Condition	Handrails are fully intact and appear structurally sound
Glass	0
Mirrors	0
Exterior Lights	0

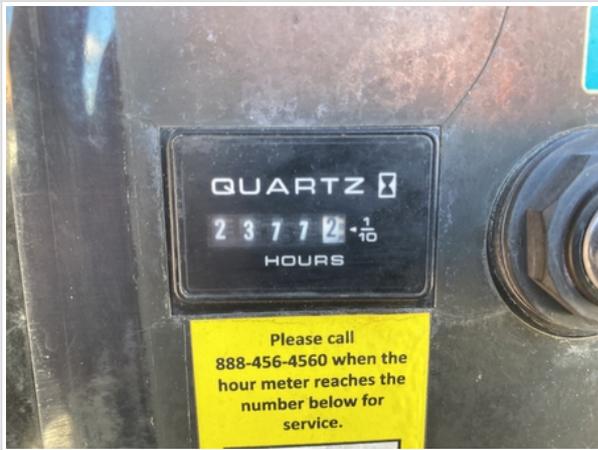
Hour Meter Activity Photos

Hour Meter Activity	3 - Normal Wear & Tear

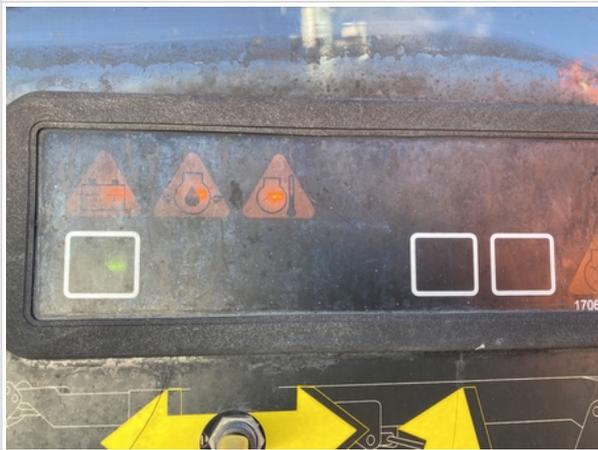
Other Gauge Activity	3 - Normal Wear & Tear
Other Gauge Activity Photos

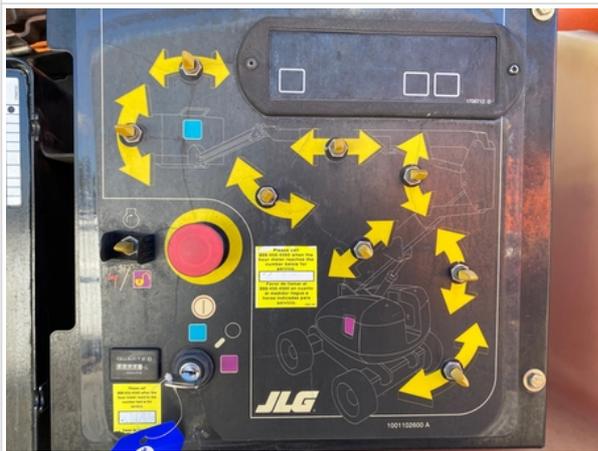
Controls & Switches	3 - Normal Wear & Tear
Controls & Switches Photos

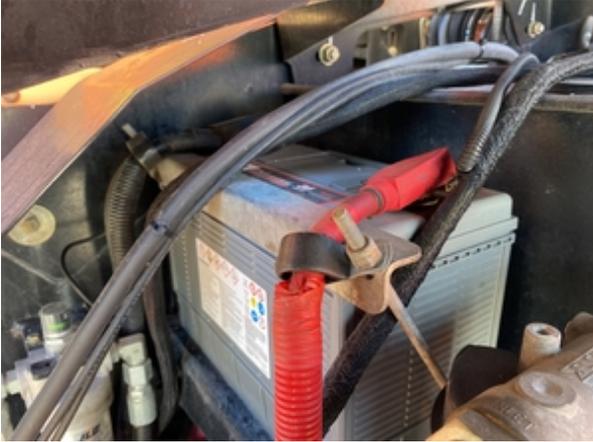
Blow-by (Visual Observation Check)	No
Unusual Noises (Upon Start-up, Idle, Shutdown)	No
Unusual Noise Notes	No unusual noises heard
Engine Smoke (Upon Start-up, Idle, Shutdown)	No
Engine Smoke Notes	No engine smoke issues observed
Engine Exhaust Color	Clear
Battery	3 - Normal Wear & Tear
Battery Condition	Like new, recently replaced, Other (see comments)
Battery Condition Photos

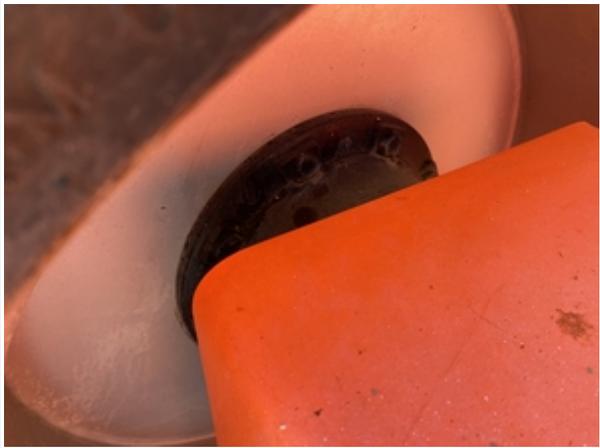
Hydrostatic Transmission?	Yes	
2 Speed?	Yes	
Hydrostatic Drive Configuration	Split Transmission	
Drive Motors	4 - Like New, Recently Replaced	
Comments	All wheel drive	
Hydrostatic Parking Brake	3 - Normal Wear & Tear	
Hydrostatic Parking Brake Condition	Good brake function	
Overall Drivetrain Comments	Overall drivetrain looks and operates well with no active leaks observed.

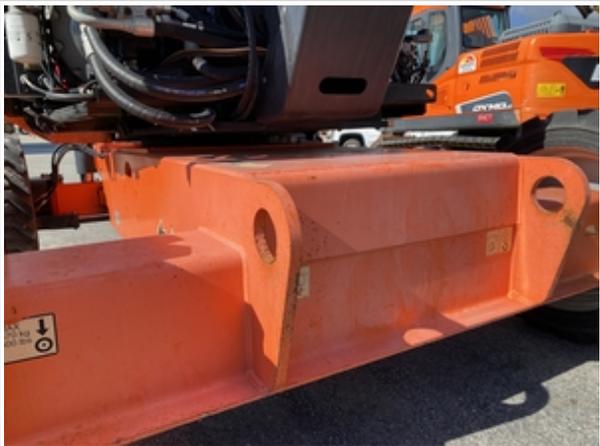
Frame	3 - Normal Wear & Tear	
Frame Photos

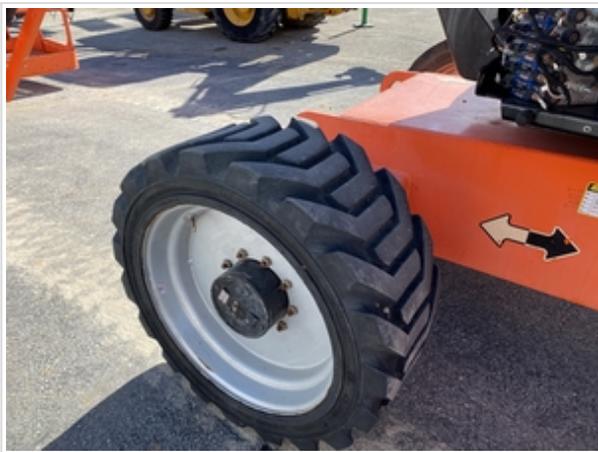
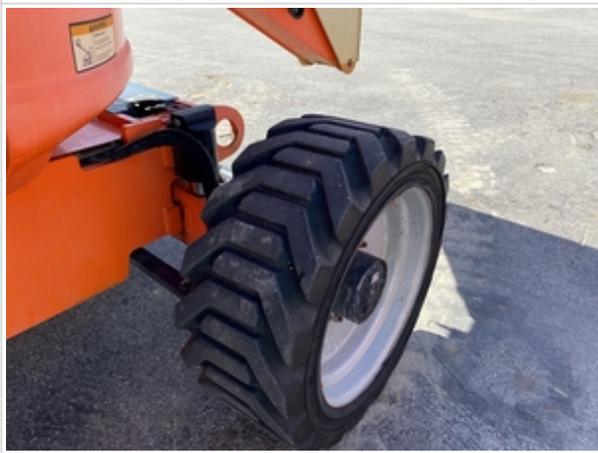
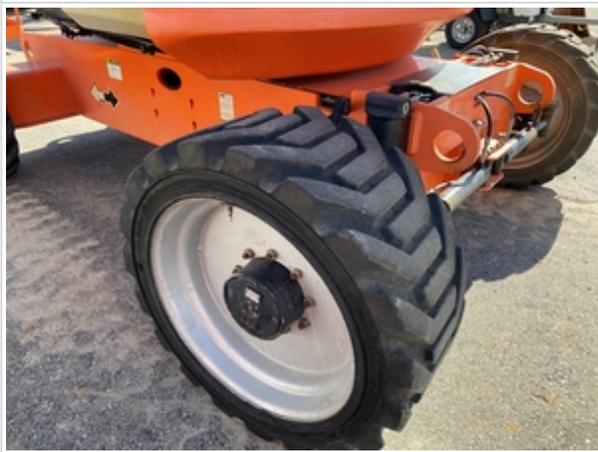
Wheels & Tires Photos

Wheels & Tires	3 - Normal Wear & Tear
Comments	Foam Filled, a bit chewed up on the side edges but above 70% below 90%

Tire Brand	OTR - Outrigger
Tire Size	355/55D625 NHS
Front Left Tire - Ratio Remaining	70%
Rear Left Tire - Ratio Remaining	70%
Front Right Tire - Ratio Remaining	70%
Rear Right Tire - Ratio Remaining	70%
Swivel Bearing	3 - Normal Wear & Tear

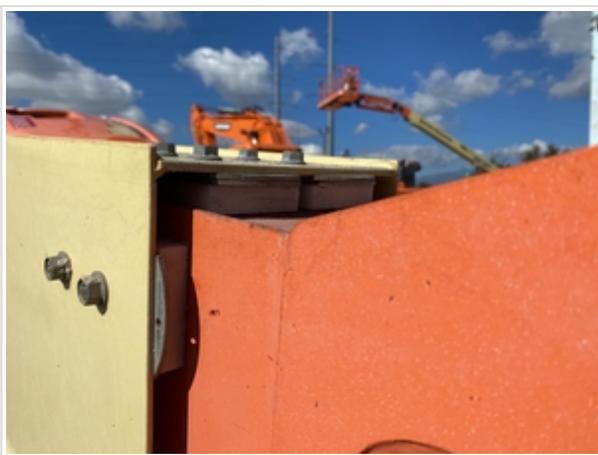
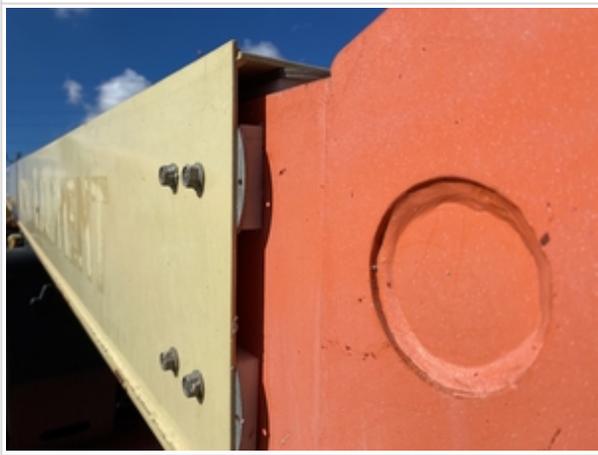
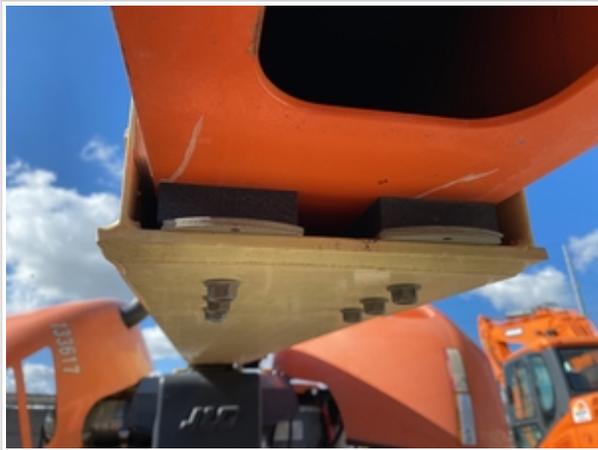
<p>Boom Wear Guides Photos</p>

Boom Wear Guides	3 - Normal Wear & Tear
Comments	Like new

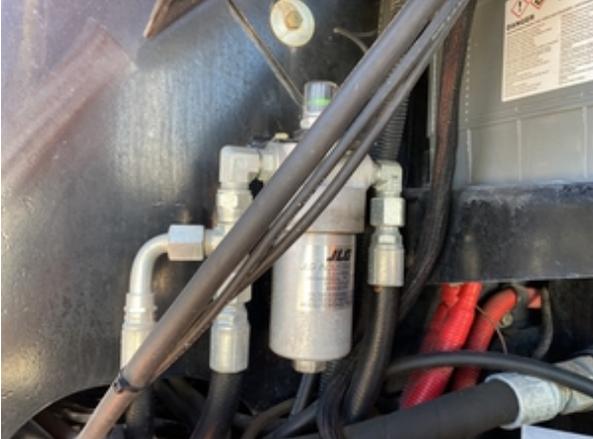
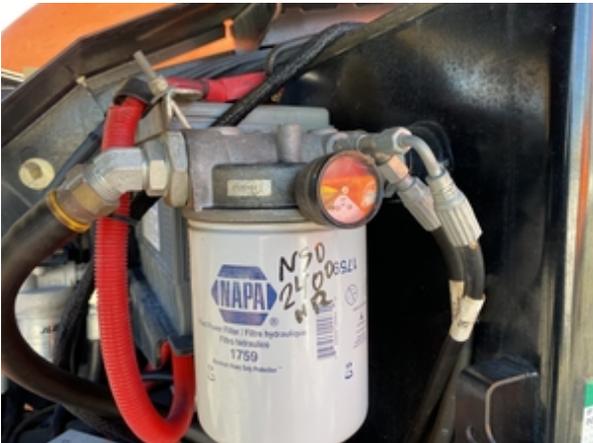
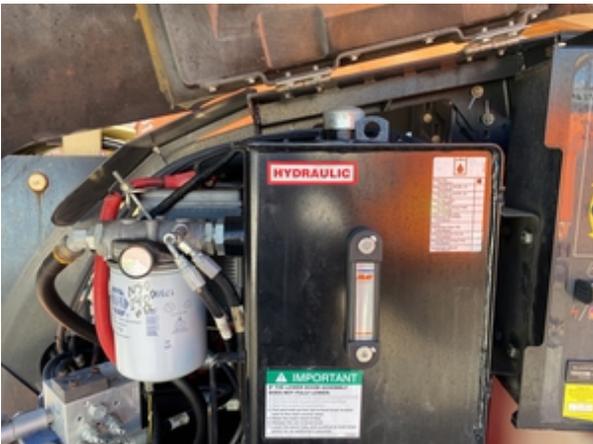
Wet or Damp Hydraulic Lines / Fittings	No
Appearance of Hydraulic Lines / Fittings	3 - Normal Wear & Tear
Hydraulic Lines / Fittings Condition	Hydraulic lines & fittings are clean and in good condition
Unusual Noises (Hydraulic Pump)	No
Hydraulic Pump Notes	No unusual noises heard during operation
Comments	Hydraulics visual in prestine condition
