## Inspection Report (Telehandler)

Year	2013
Make	JLG
Model	G12-55
Serial Number	0160051257
Hour Meter Reading	5,988
Previous Application (e.g., earth moving, mining, demolition, etc)	Equipment Rentals

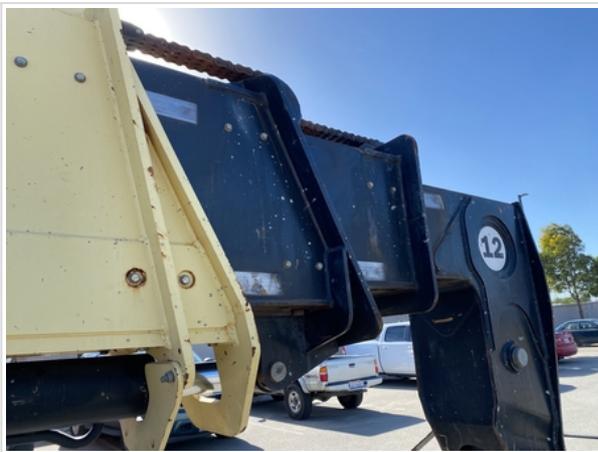
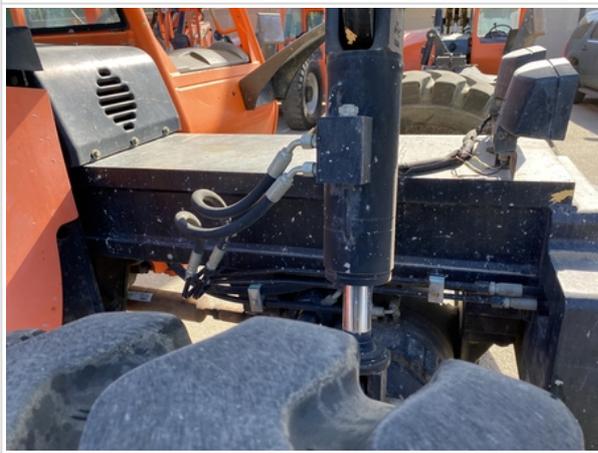
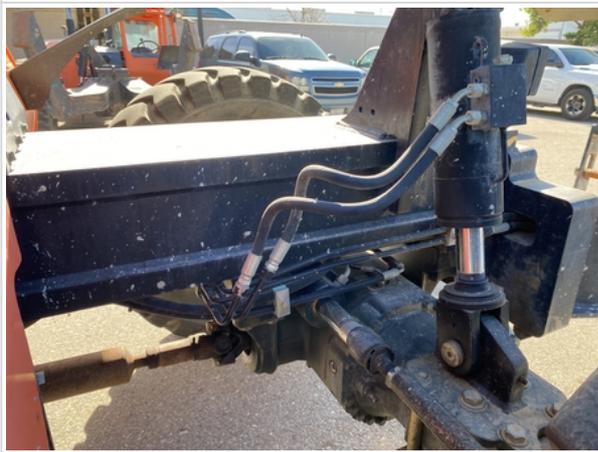
<b>Body Panels</b>	3 - Normal Wear & Tear
<b>Body Panel Condition</b>	Other (see comments)
<b>Comments</b>	Normal wear and tear scuff marks all around
<b>Doors / Canopy Latches</b>	3 - Normal Wear & Tear
<b>Doors / Canopy Latches Condition</b>	No visible damage
<b>Steps / Ladders</b>	3 - Normal Wear & Tear
<b>Steps / Ladders Condition</b>	Steps/ladders are fully intact and appear structurally sound

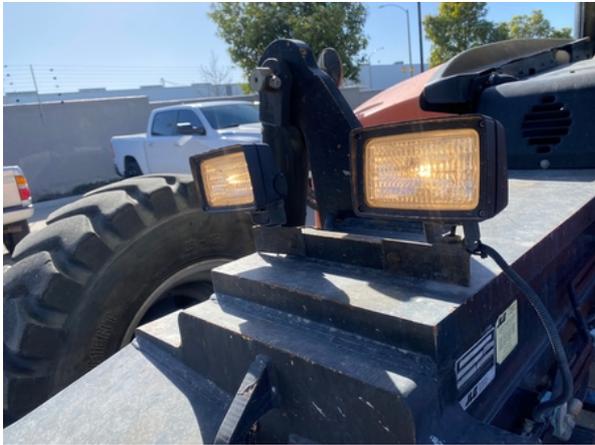
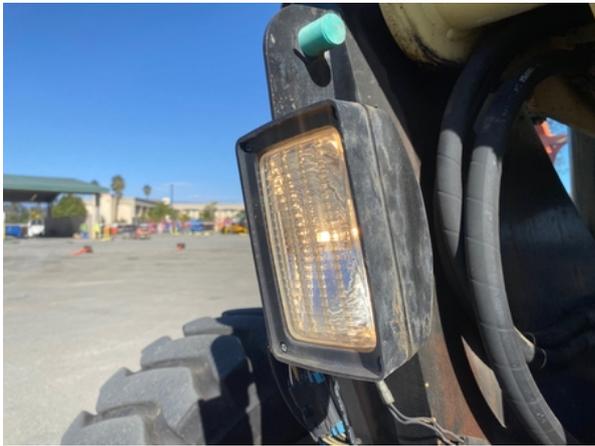
Handrails	3 - Normal Wear & Tear
Handrails Condition	Handrails are fully intact and appear structurally sound
Glass	3 - Normal Wear & Tear
Glass Condition	Glass intact, no visible damage
Mirrors	3 - Normal Wear & Tear
Mirror Condition	Mirrors present and intact, no visible damage
Exterior Lights	3 - Normal Wear & Tear
Exterior Lights Condition	No visible damage, lighting system is operational, Other (see comments)
Exterior Lights Photos

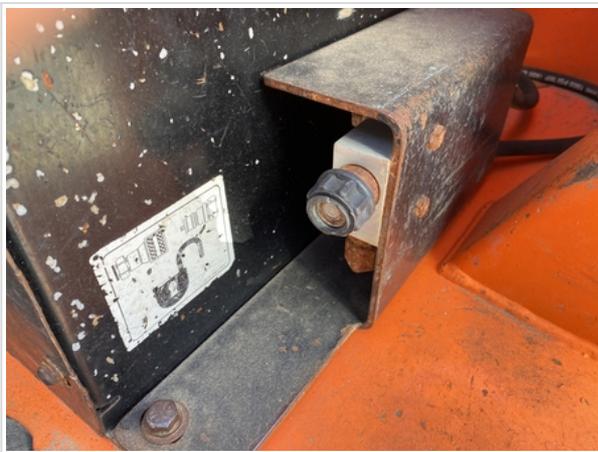
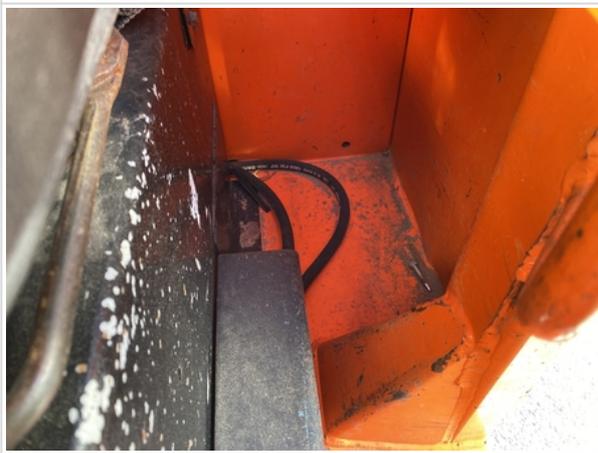
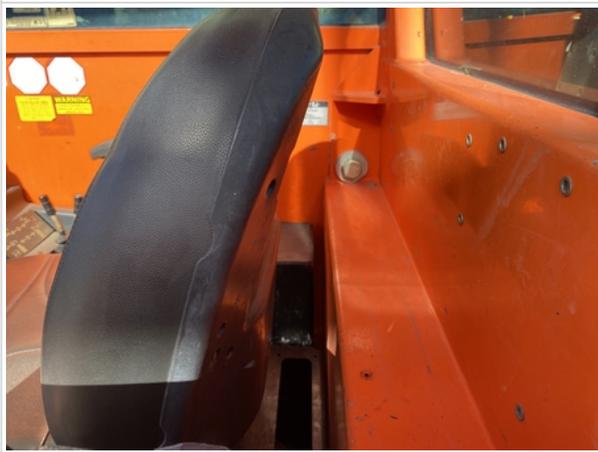
<b>Operator Cabin Overall</b>	3 - Normal Wear & Tear
<b>Operator Cabin Overall Condition</b>	Good cabin appearance, solid floors, panels, and ceiling
<b>Operator Seat</b>	3 - Normal Wear & Tear
<b>Operator Seat Condition</b>	Seat(s) in good condition, no stains or tears in upholstery
<b>Cabin Lights</b>	0
<b>Safety Lock Out / Stop</b>	3 - Normal Wear & Tear
<b>Safety Lock Out / Stop Condition</b>	Safety lock out device is present, in good condition, and functional

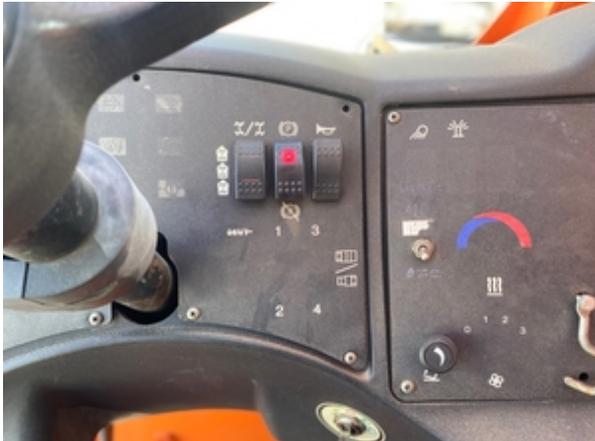
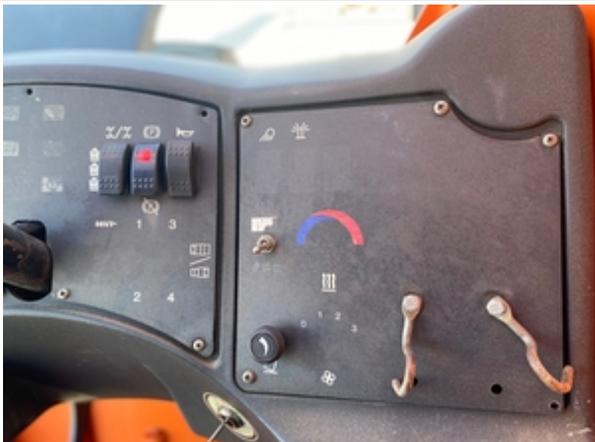
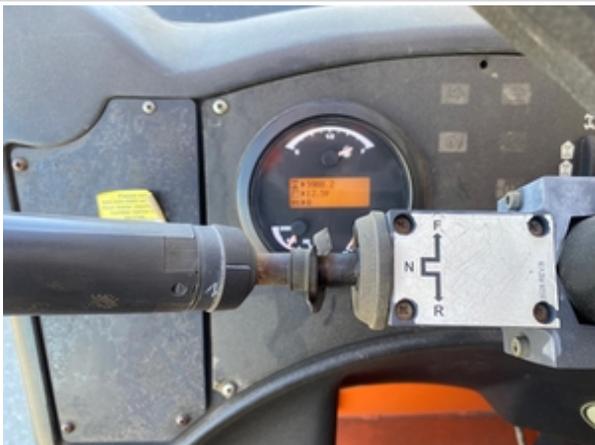
Controls & Switches	3 - Normal Wear & Tear
Controls & Switches Condition	All switches are installed and functional
Controls & Switches Photos

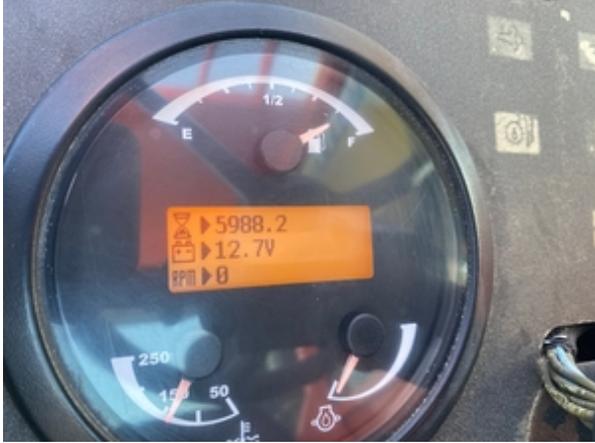
Hour Meter Activity	3 - Normal Wear & Tear
Hour Meter Condition	Hour meter is functional and in good condition

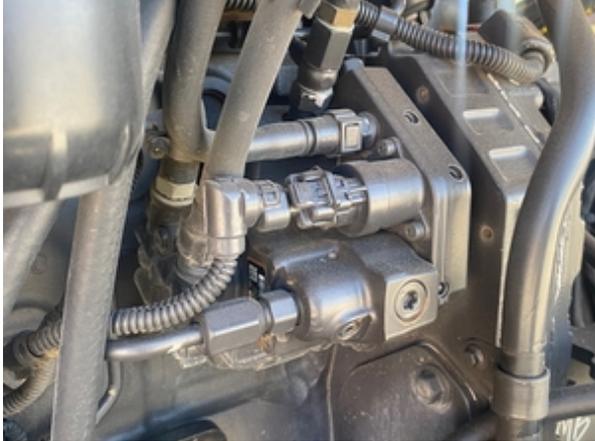
<b>Blow-by (Visual Observation Check)</b>	No
<b>Unusual Noises (Upon Start-up, Idle, Shutdown)</b>	No
<b>Unusual Noise Notes</b>	No unusual noises heard
<b>Engine Smoke (Upon Start-up, Idle, Shutdown)</b>	No
<b>Engine Smoke Notes</b>	No engine smoke issues observed
<b>Engine Exhaust Color</b>	Clear
<b>Battery</b>	3 - Normal Wear & Tear
<b>Battery Condition</b>	Like new, recently replaced
<b>Radiator</b>	3 - Normal Wear & Tear
<b>Radiator Condition</b>	Radiator fins & components appear to be in good working order, no signs of damage or leaks
<b>Belts</b>	3 - Normal Wear & Tear
<b>Belt Condition</b>	Belts appear in good condition & alignment with proper tension
<b>Hoses</b>	3 - Normal Wear & Tear
<b>Hose Condition</b>	Firm, pliant hoses with no signs of wear or leaks
<b>Water Pump</b>	3 - Normal Wear & Tear
<b>Water Pump Condition</b>	No unusual pump noises heard
<b>Cooling System Leaks</b>	No
<b>Coolant Color / Appearance</b>	3 - Normal Wear & Tear

<b>Coolant Color/Appearance Notes</b>	Normal Translucent appearance, no visual signs of contamination
<b>Oil Leaks</b>	No
<b>Oil Color / Appearance</b>	3 - Normal Wear & Tear
<b>Oil Color / Appearance Notes</b>	Clean oil appearance, no signs of cross contamination, Appropriate oil level
<b>Fuel Leaks</b>	No

Requires DEF (Diesel Exhaust Fluid)	No
Overall Engine Appearance	Clean & dry
Overall Engine Comments	Overall engine runs well and sounds healthy under load. Engine is well maintained and no major obvious issues seen during the inspection.

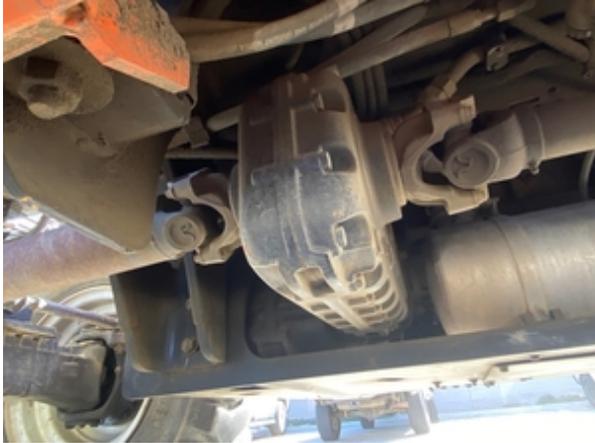
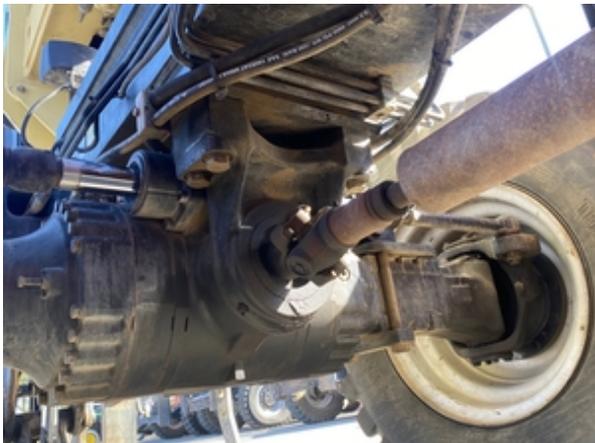
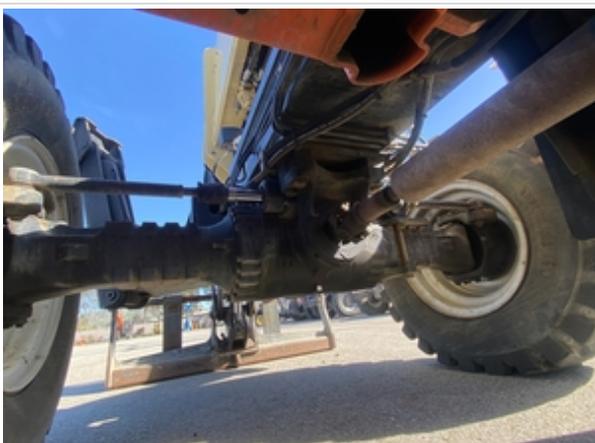
Hydrostatic Transmission?	No
Transmission Info (Make/Model/Speeds)	Powershift 4 Speed Forward 3 Speed reverse
Transmission	3 - Normal Wear & Tear
Transmission Condition	No unusual noises or vibrations
Clutch	0
Shift Lever	3 - Normal Wear & Tear
Shift Lever Condition	Good forward and reverse function
Foot Brake	3 - Normal Wear & Tear
Foot Brake Condition	Good brake function
Inching Brake	0
Parking Brake	3 - Normal Wear & Tear
Parking Brake Condition	Good brake function
Overall Drivetrain Comments	Overall drivetrain in good condition

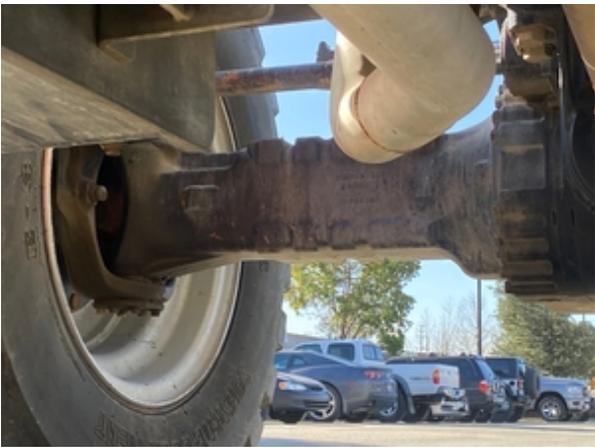
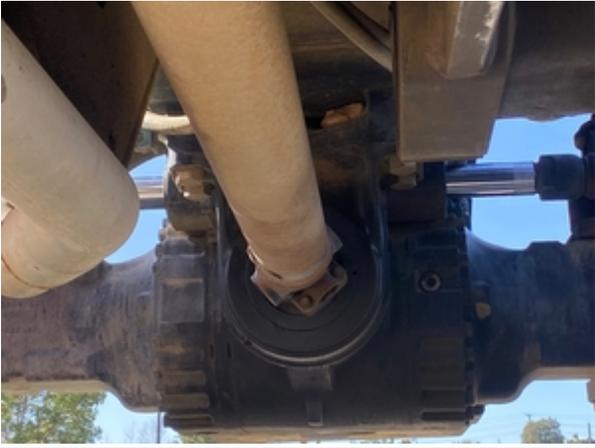
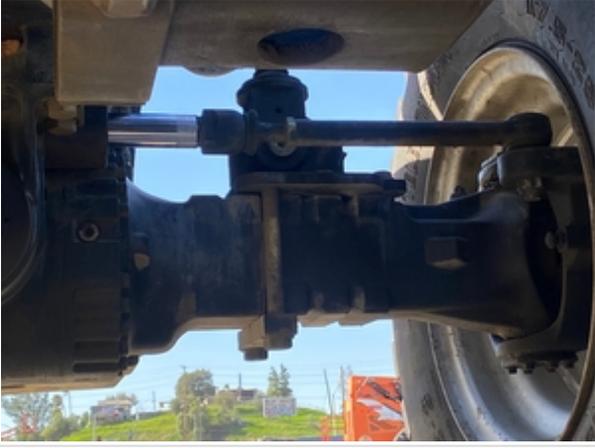
<b>Oscillating Pin Appearance</b>	3 - Normal Wear & Tear	
<b>Wheels &amp; Tires</b>	3 - Normal Wear & Tear	
<b>Comments</b>	Tires are foam filled and in great condition

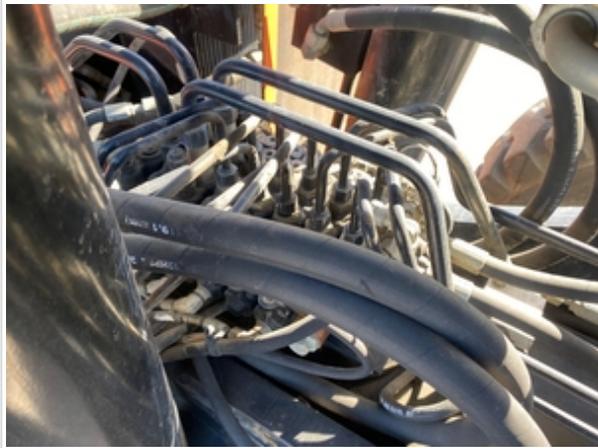
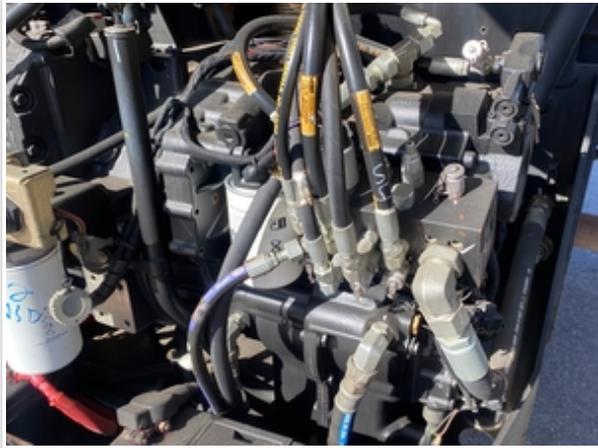
<b>Wet or Damp Hydraulic Lines / Fittings</b>	No
<b>Appearance of Hydraulic Lines / Fittings</b>	3 - Normal Wear & Tear
<b>Hydraulic Lines / Fittings Condition</b>	Hydraulic lines & fittings are clean and in good condition
<b>Unusual Noises (Hydraulic Pump)</b>	No
<b>Hydraulic Pump Notes</b>	No unusual noises heard during operation

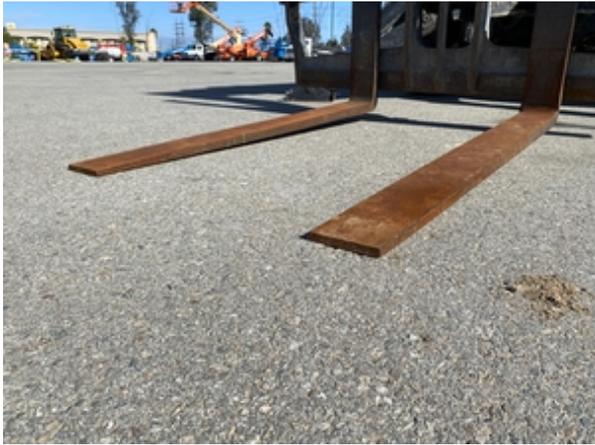
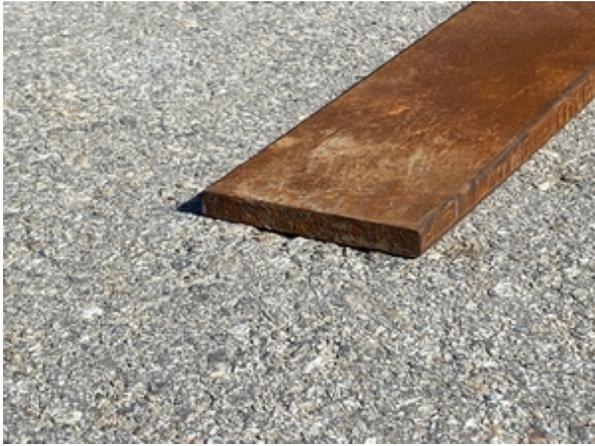
Forks / Work Tool Condition	2 - Above Average Wear
Comments	Front tapered portion of tips cut off and shortened
Forks / Work Tool Photos
