Inspection Report (On-Highway Service Truck)

Year	2015
Make	Chevrolet
Model	2500
Serial Number	1GB2CUEG2FZ547955
Truck Odometer Reading	182,741
Current Inspection / State Cert / DOT	N/A
Previous Application (e.g., earth moving, mining, demolition, etc)	Billboard Services

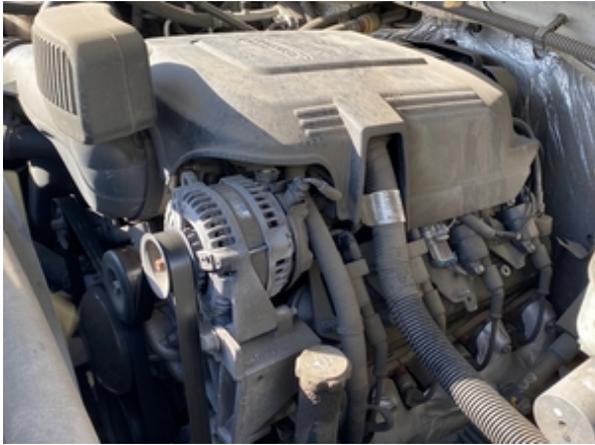
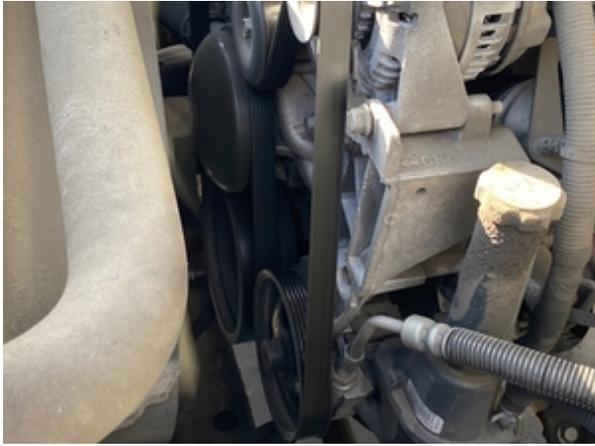
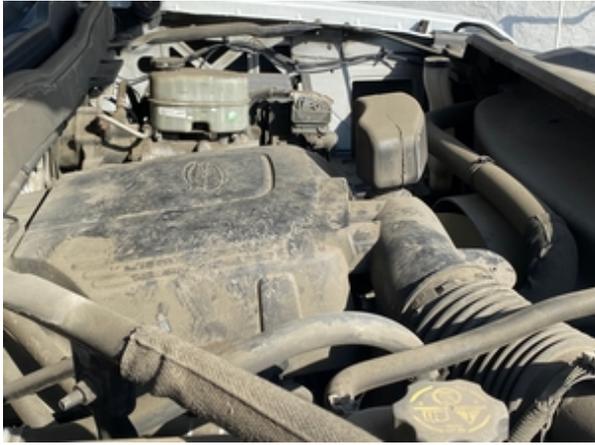
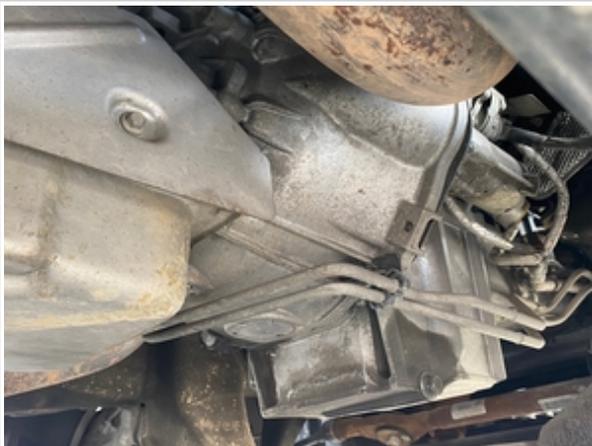
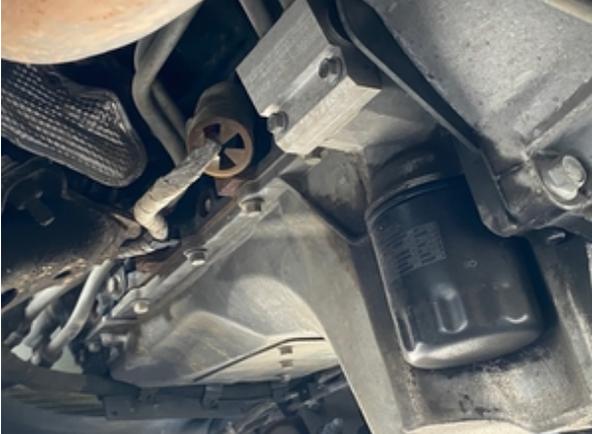
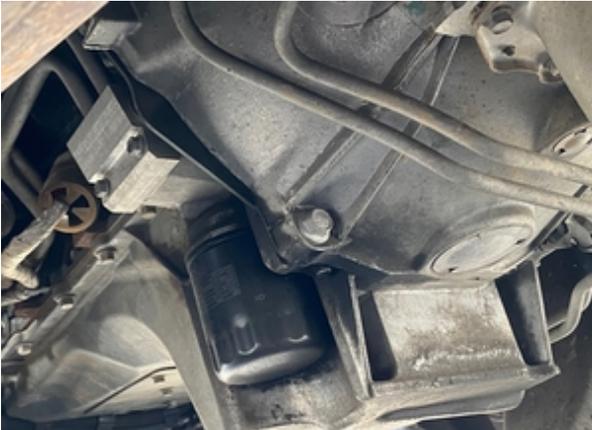
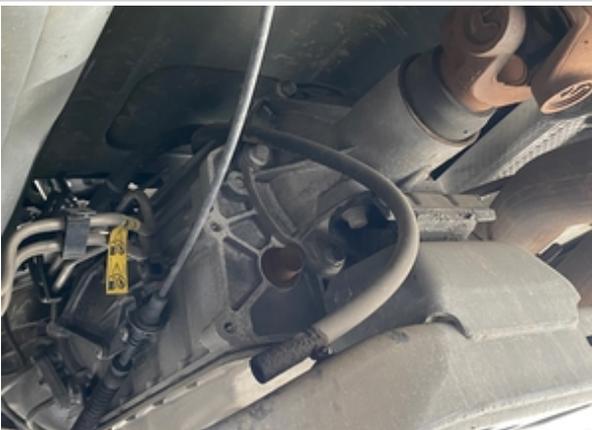
Engine	
Engine Type (Make, Model, Cylinders, Hp)	Chevy - 6.0L - V8 - 360HP
Emissions Tier	Undetermined
Engine Serial Number	N/A
Engine Fuel Type	Gasoline
Engine Photos

Blow-by (Visual Observation Check)	N/A	
Unusual Noises (Upon Start-up, Idle, Shutdown)	No	
Unusual Noise Notes	No unusual noises heard	
Engine Smoke (Upon Start-up, Idle, Shutdown)	No	
Engine Smoke Notes	No engine smoke issues observed	
Engine Exhaust Color	Clear

Battery	3 - Normal Wear & Tear
Battery Condition	Clean & dry appearance, tight connections
Radiator	3 - Normal Wear & Tear
Radiator Condition	Radiator fins & components appear to be in good working order, no signs of damage or leaks
Belts	3 - Normal Wear & Tear
Belt Condition	Belts appear in good condition & alignment with proper tension
Hoses	3 - Normal Wear & Tear
Hose Condition	Firm, pliant hoses with no signs of wear or leaks
Water Pump	3 - Normal Wear & Tear
Water Pump Condition	No unusual pump noises heard
Cooling System Leaks	No
Coolant Color / Appearance	3 - Normal Wear & Tear
Coolant Color/Appearance Notes	Normal Translucent appearance, no visual signs of contamination
Oil Leaks	No
Oil Color / Appearance	3 - Normal Wear & Tear
Oil Color / Appearance Notes	Appropriate oil level, Clean oil appearance, no signs of cross contamination
Fuel Leaks	No
Requires DEF (Diesel Exhaust Fluid)	No
Overall Engine Appearance	Dusty & dry

Overall Engine Comments	Engine in solid, well maintained condition with no active leaks observed during the inspection.

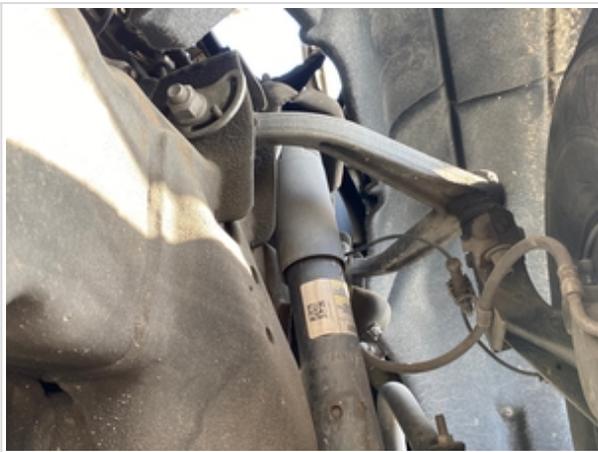
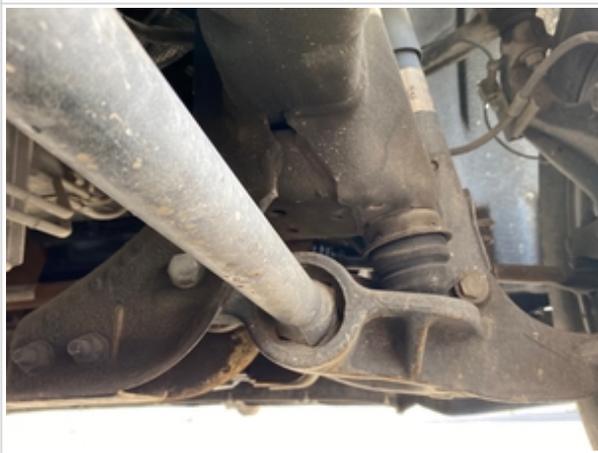
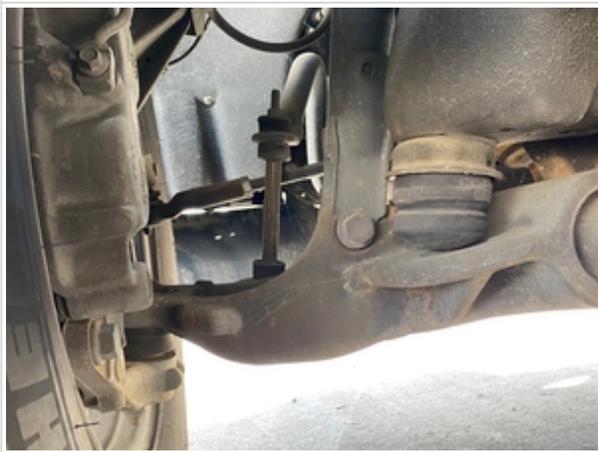
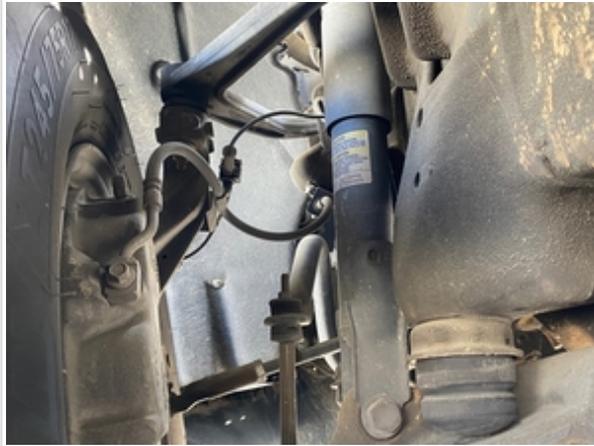
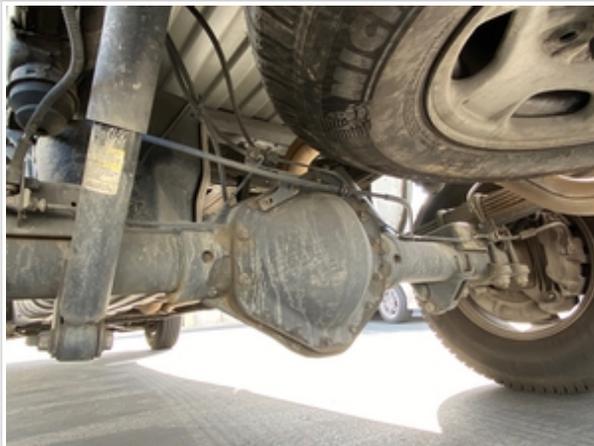
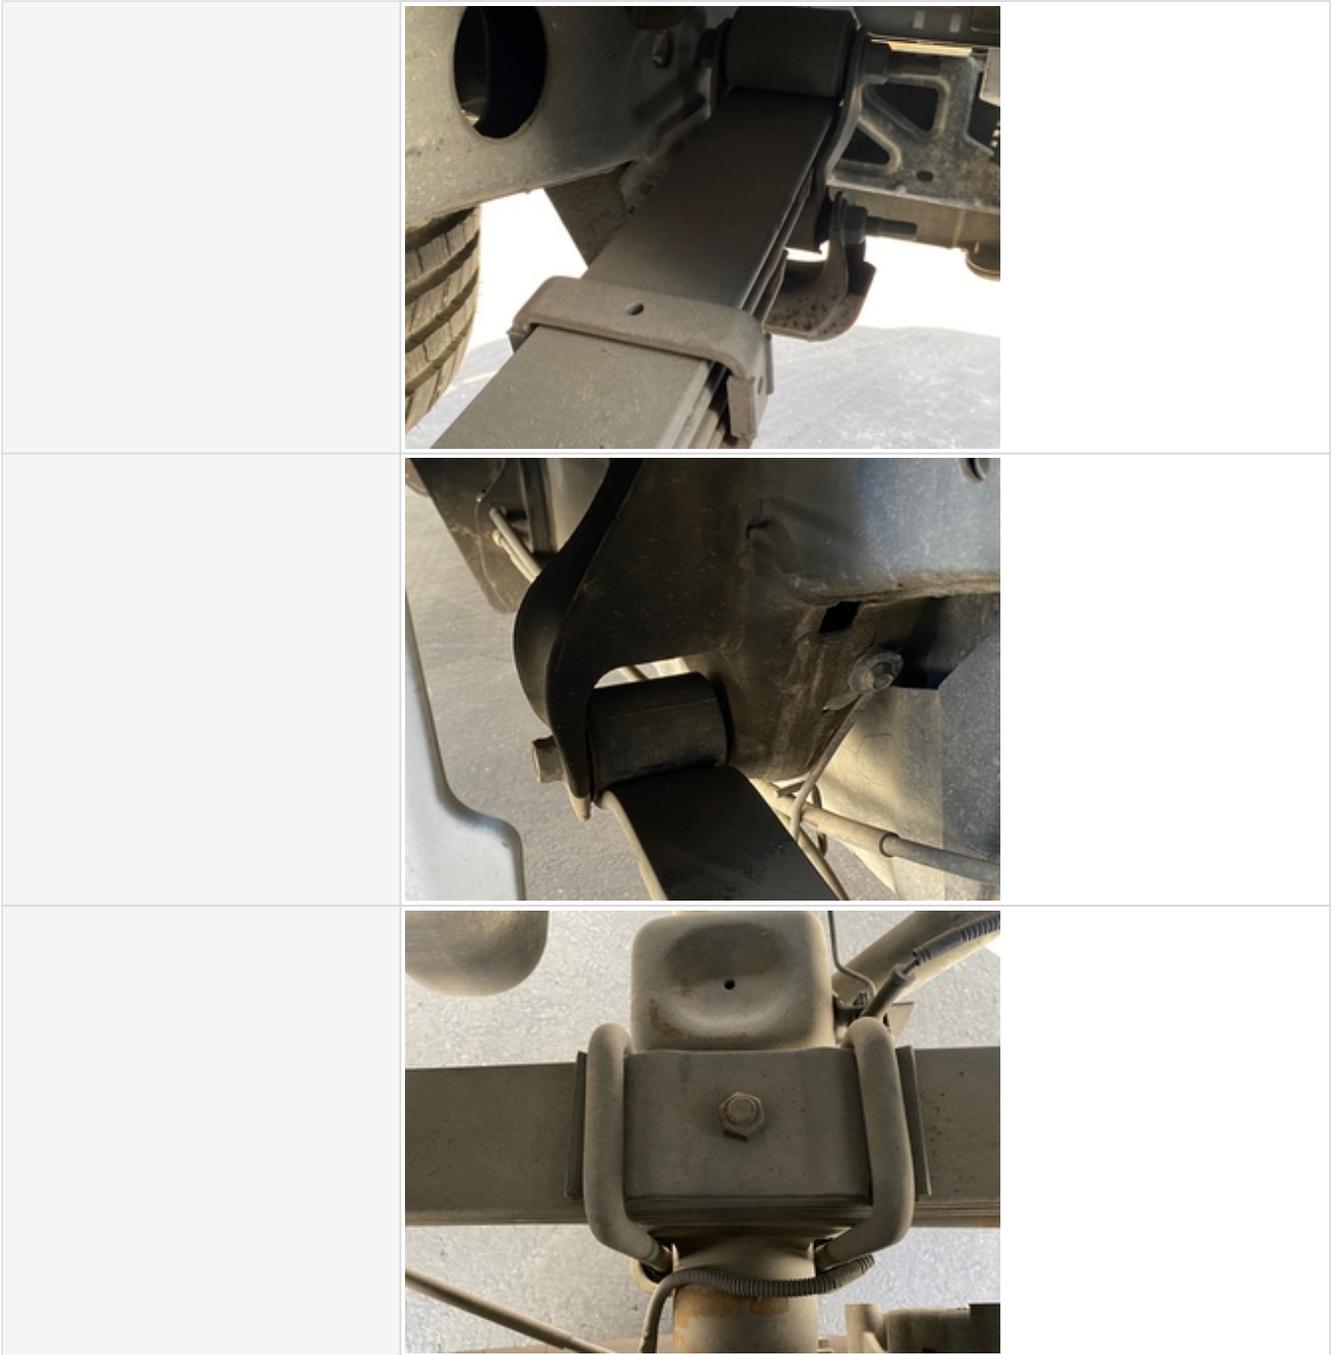
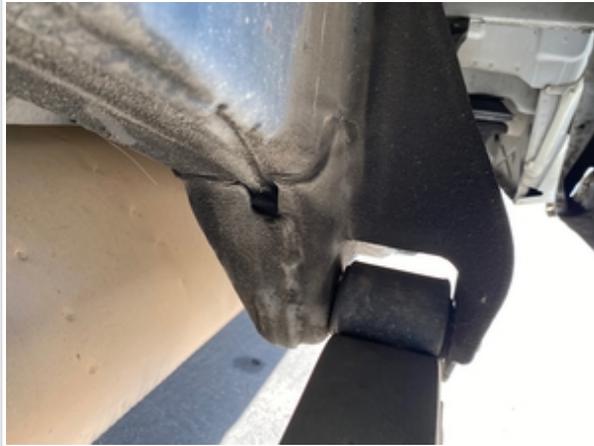
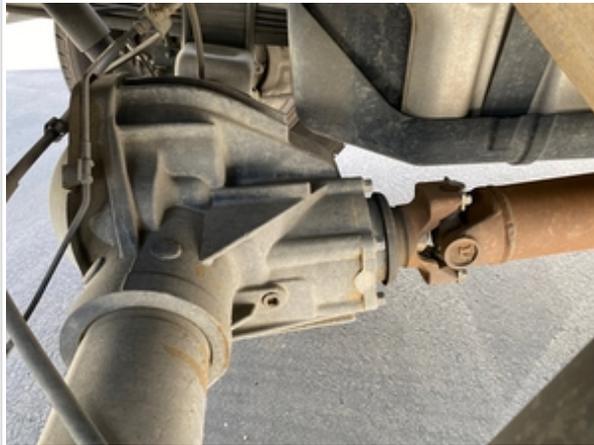
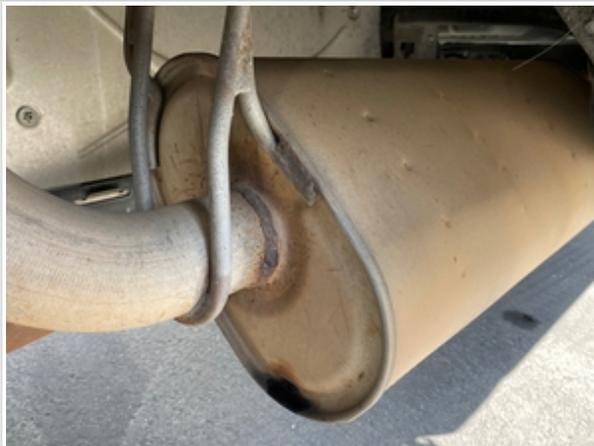
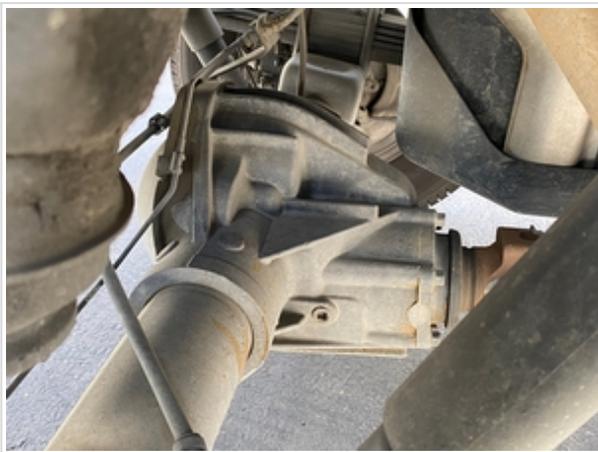
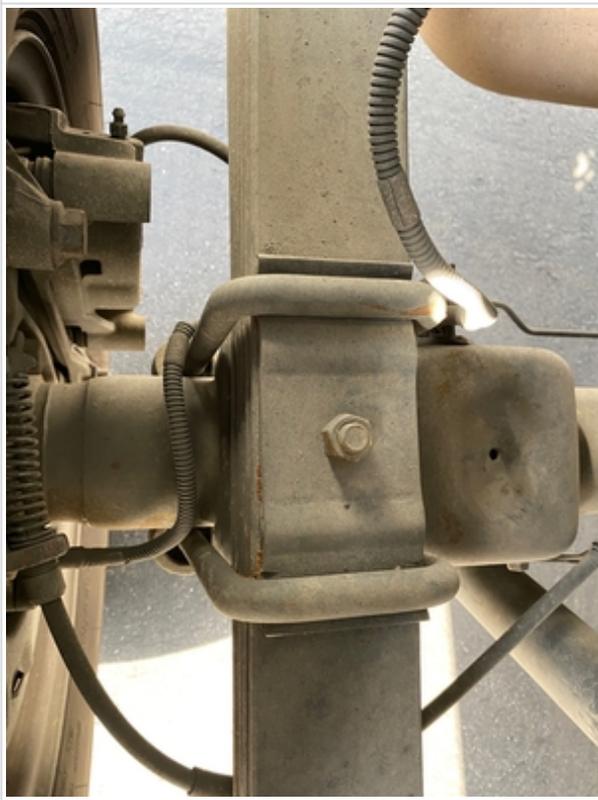
<p>Chassis & Undercarriage Photos</p>

Frame	3 - Normal Wear & Tear
Suspension	3 - Normal Wear & Tear
Steer Axle Condition	0
Steering Components	3 - Normal Wear & Tear
Overall Chassis Condition	3 - Normal Wear & Tear
Overall Chassis Comments	Chassis in good condition. Suspension and rear axle look healthy. No problems observed underneath vehicle.

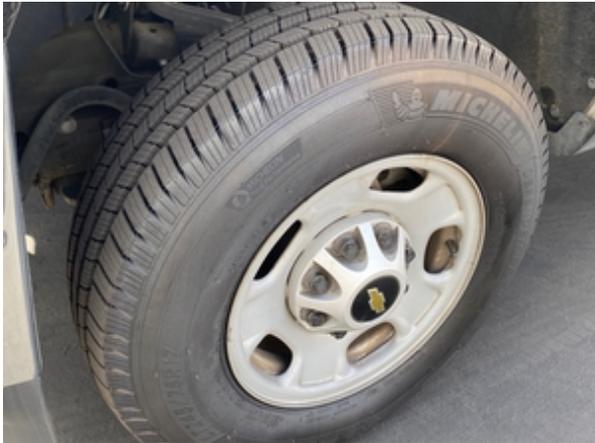
Wheels & Hub Condition	3
Wheel Seal Leaks	N/A
Tire Brand	Michelin
Tire Size	LT245/75/R17
Front Left Tire - Ratio Remaining	90%
Front Left Tire Photos

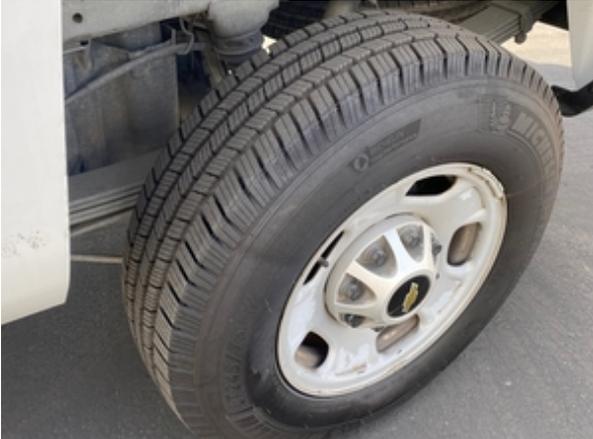
Rear Left Tire - Ratio Remaining	90%
Rear Left Tire Photos
